Remedial Investigation / Feasibility Study Report

4 Corners Cleaners

2386 SE Kent-Kangley Road
Maple Valley, Washington 98038-6848

AEG Project #: 17-126
Date of Report: March 14, 2019

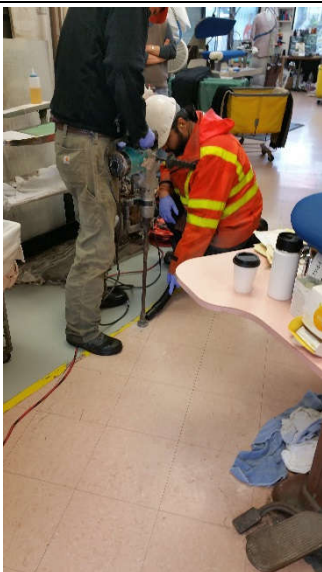
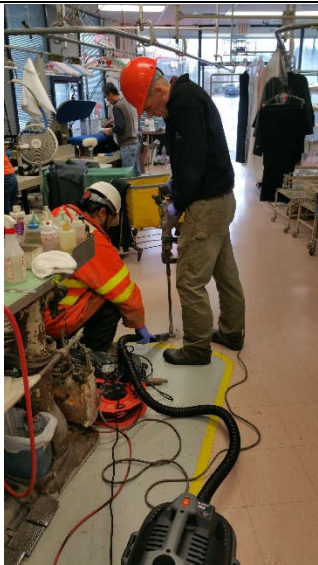
<p>Photo #1:</p> <p>Coring through concrete at sample location B-1.</p>	<p>Photo #2:</p> <p>Coring through concrete at sample location B-2.</p>

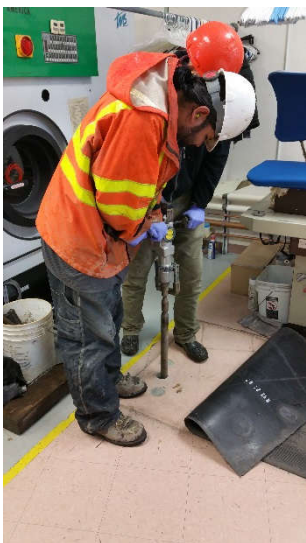
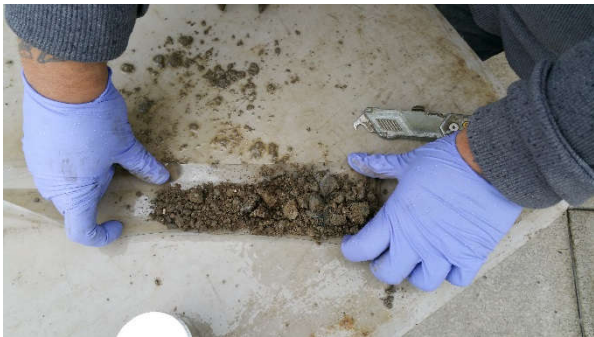
<p>Photo #2:</p> <p>Core barrel advance at sample location B-3.</p>	<p>Photo #4:</p> <p>Soil sample material from B-1 refusal at 22 inches bsg.</p>

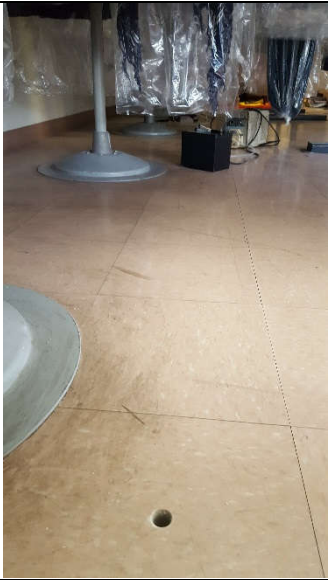
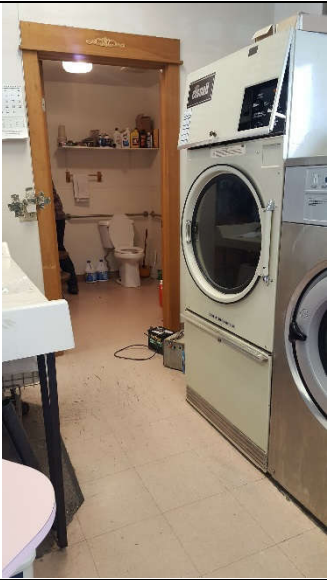
Photo #9:	Sample location of SV-3.	Photo #10:	Sample location of SV-7 and SV-14.

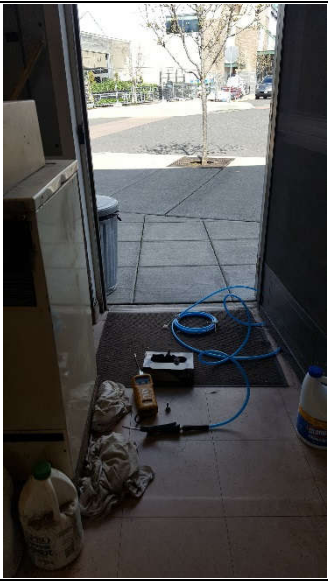
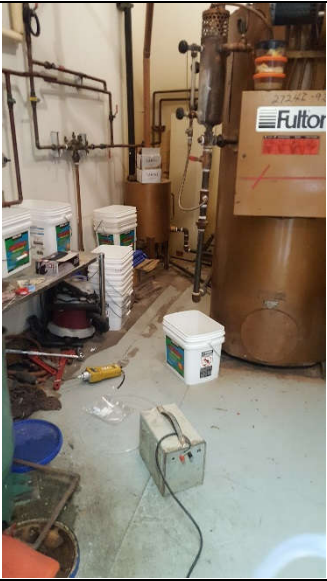
Photo #11:	Vapor sample collection from sample location SV-8.	Photo #12:	Vapor sample SV-9 from the boiler room.

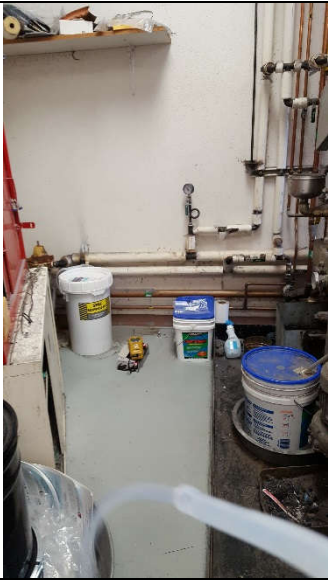
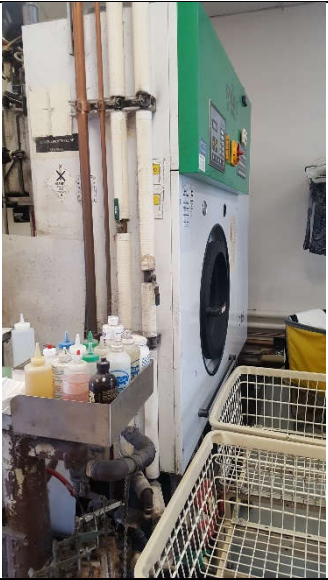
<p>Photo #13:</p> <p>Vapor sample collection from sample location SV-11, behind the current dry cleaning machine..</p>	<p>Photo #14:</p> <p>Vapor sample SV-12 collected in front of the cleaning machine.</p>

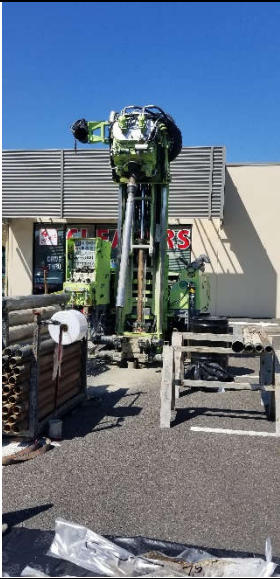
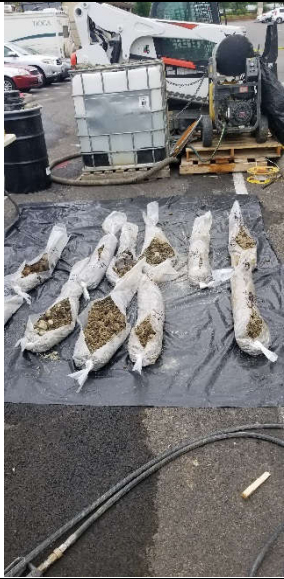
<p>Photo #15:</p> <p>Installation of boring B-4 east of building in the parking lot area facing west.</p>	<p>Photo #16:</p> <p>Typical soil types for all drilling locations.</p>

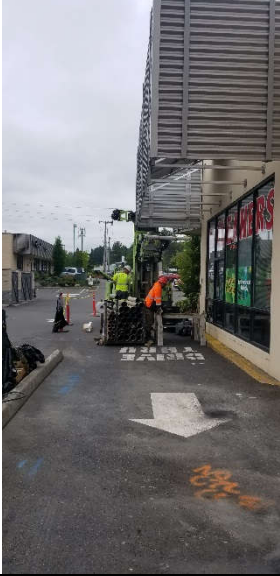
Photo #17:	Installation of boring B-6 in the drive thru lane east of the building facing south.	Photo #18:	Installation of boring B-7 in the drive thru lane east of the building facing north.

Photo #19:	Installation of boring B-10 in the front parking lot south of the building facing north.	Photo #20:	Installation of boring B-13 in the sidewalk north of the building facing east.

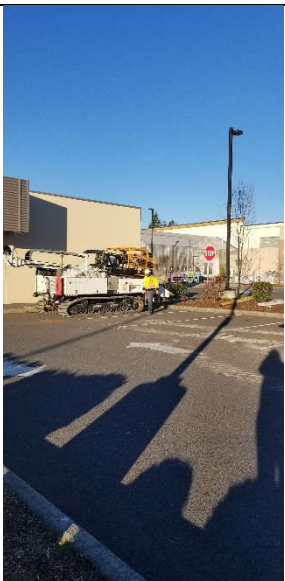
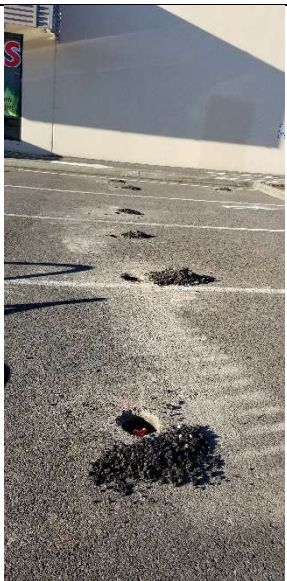
Photo #1:	Installation of temporary point T-1.		Photo #2:	All temporary vapor points installed in parking area facing the east 4 Corners Cleaners building wall.

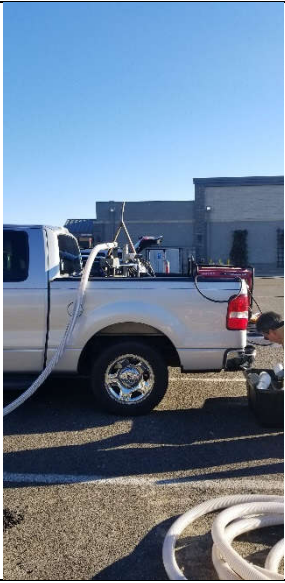
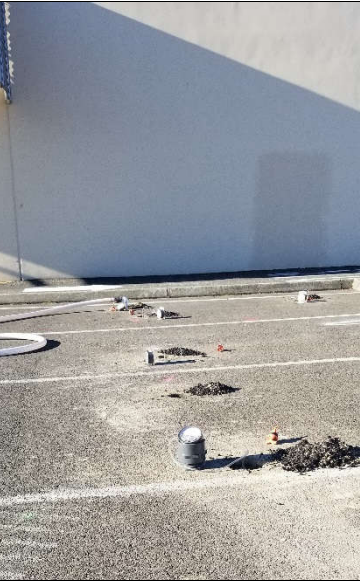
Photo #3:	Portable SVE equipment and generator.		Photo #4:	Extraction point T-1 showing vacuum gauges on all temporary vacuum monitoring wells.
