# Kenmore Industrial Park Site and Kenmore Area Public Meeting

## Kenmore Industrial Park Site

# KIP Deferred Industrial Maintenance

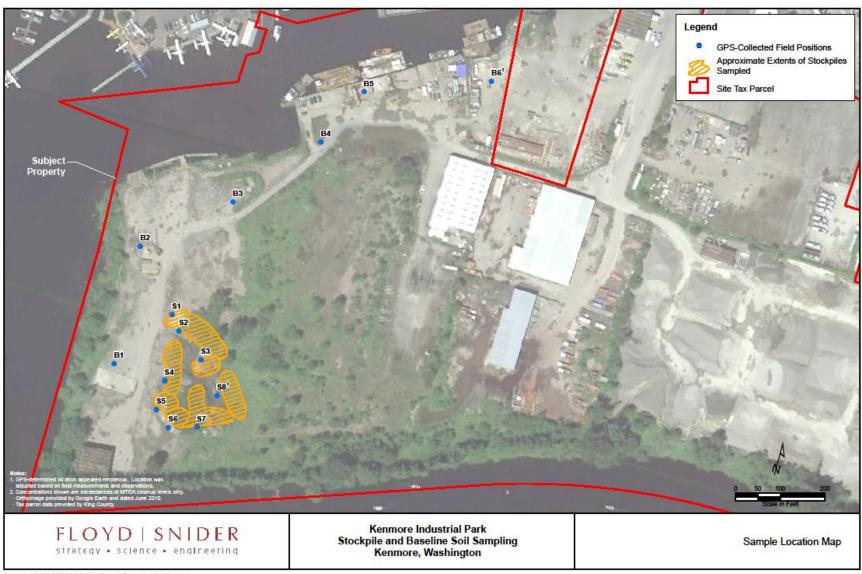
P:(projects/KG-520 BRIDGE/GIS/Other/Figure 1 (Sample Location Map).mird 1/14/2011

- Stockpile & Baseline Soil Results Jan 2011
  - 14 soil samples
  - -Analyses metals, petroleum, organic compounds, PCBs and Pesticides
- KGM Soil Results May 2012
  - -6 samples -2 composites
  - -Analyses metals, petroleum, organic compounds, PCBs and pesticides
- All results -below cleanup level

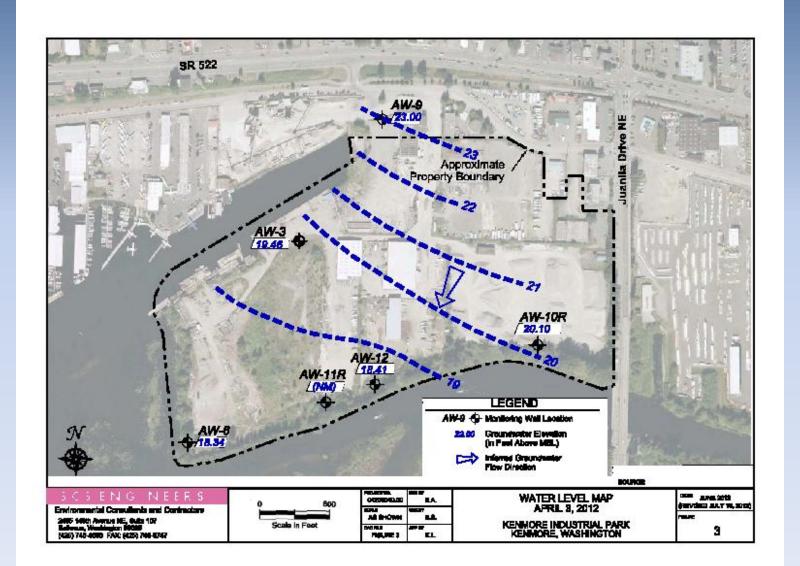
## KIP Groundwater Flow

- Groundwater flow direction SW
- Seasonal lake level changes
- Location of compliance monitoring wells
- New storm water drainage system
  - 3 drainage basins at west 14 acre area
  - 100 year storm capacity
  - Perimeter berm to protect shoreline & wetlands

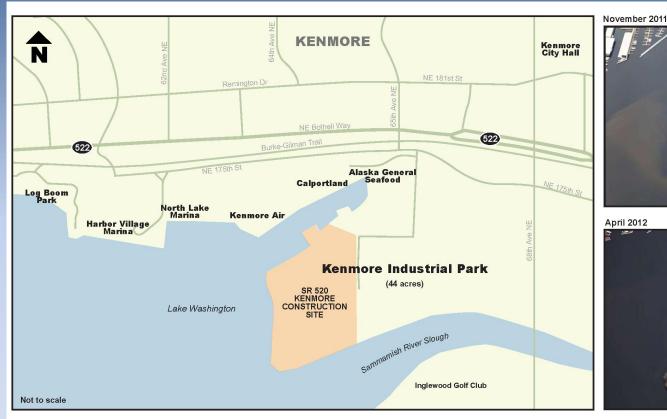
#### Kenmore Industrial Park Area

Area Proposed Sediment Sampling Plans by City and Ecology - summer 2012

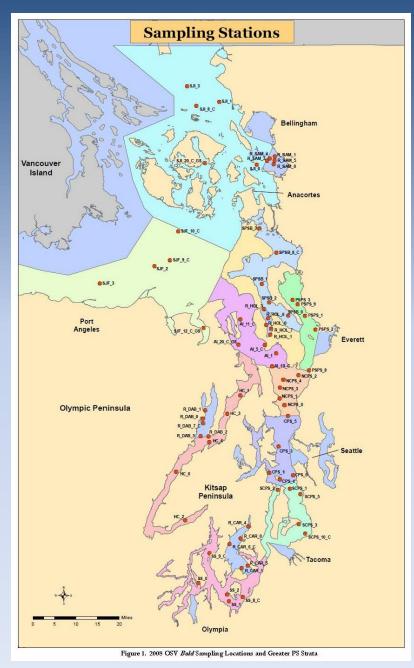
### DMMP OSV Bold 2008 Sediment Survey Locations

- Samples away from urban embayments.
- Samples away from known point sources.
- Samples away from cleanup projects.
- 70 total samples plus 5 field replicates analyzed for 43 standard sediment chemical analytes plus high resolution PCB analysis and dioxin analysis.

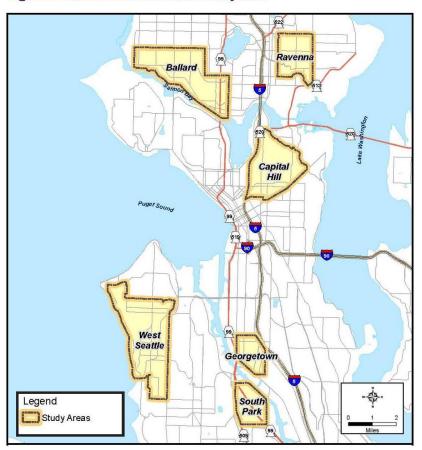
Figure 2. Seattle urban soil dioxin study area.

Ecology 2011 soil study (not sediments)

- Range: 1.7 to 114 pptr dioxin TEQ
- Neighborhood averages ranged
   7.5 tp 35.5 pptr dioxin TEQ

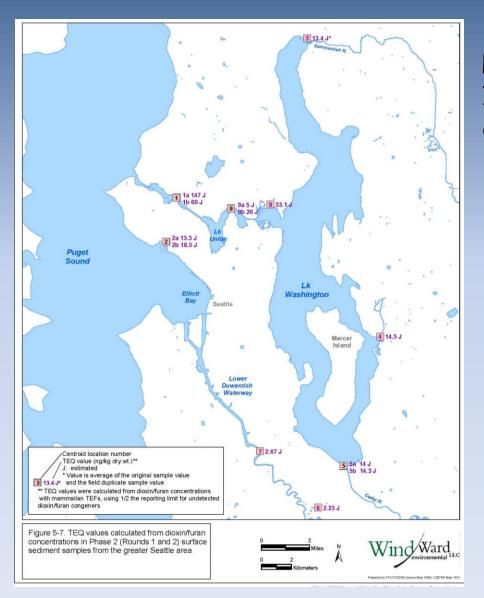
### Greater Seattle area SEDIMENT dioxins

Lower Duwamish Remedial Investigation Phase 2 sediment dioxin data

- Range: 5 to 147 pptr dioxin TEQ
- Sample location # 3 located in the Kenmore vicinity, 13 pptr dioxin TEQ

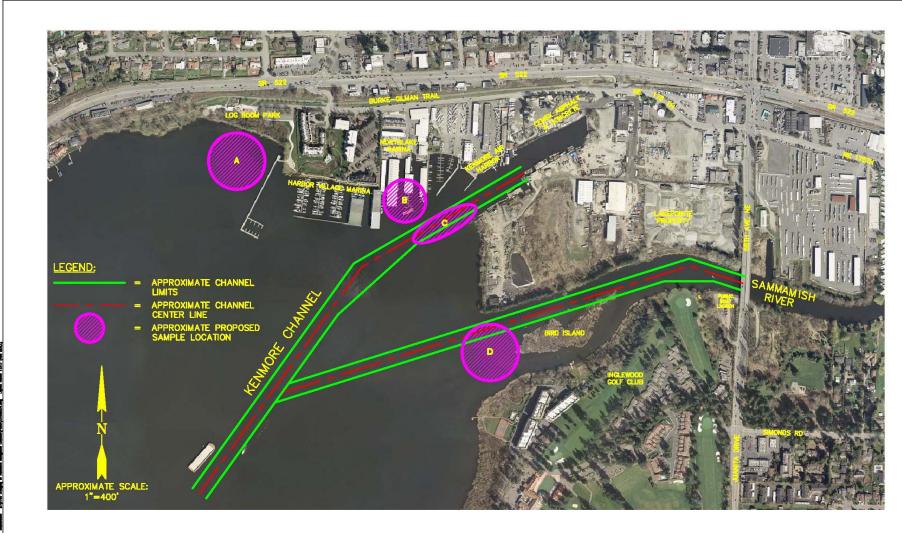
KENMORE NAVIGATION CHANNEL SAMPLE LOCATION EXHIBIT

- The City Council approved a contract with Anchor QEA on May 14, 2012 to conduct sediment sampling and analysis;
- Sampling and analysis will occur in the navigation channel, near the shore at Log Boom Park, and near the mouth of the Sammamish River;
- Dredged Material Management Program to receive sampling and analysis plan by July 27<sup>th</sup>;
- Field sampling anticipated for end of August;
- Sampling and Analysis Report completed October 2012.

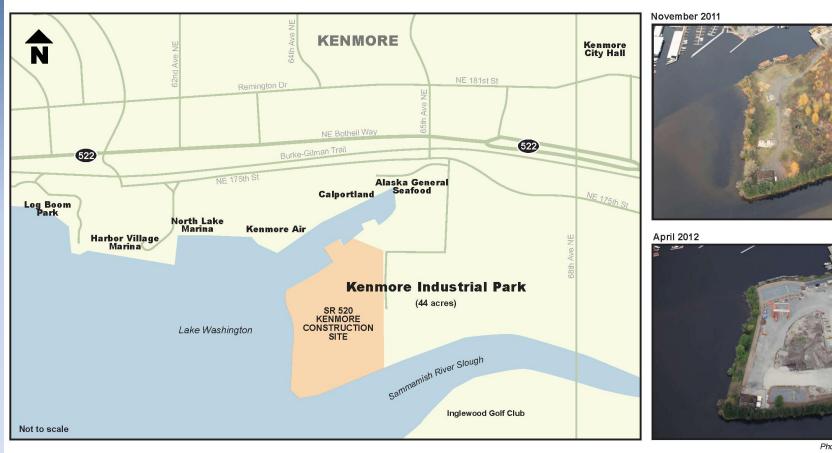
### Kenmore Industrial Park Area

### Proposed Sediment Sampling & Analysis Plans

- City of Kenmore 12 samples
- Ecology Anchor QEA LLC with King County Dept Natural Resources
   10 samples
- SSAPs are independent & parallel
- Purpose estimate lateral extent
