Well Destruction and Remediation Compound Removal Report

Site No. 0700

100 East Wine Country Road

Grandview, Washington

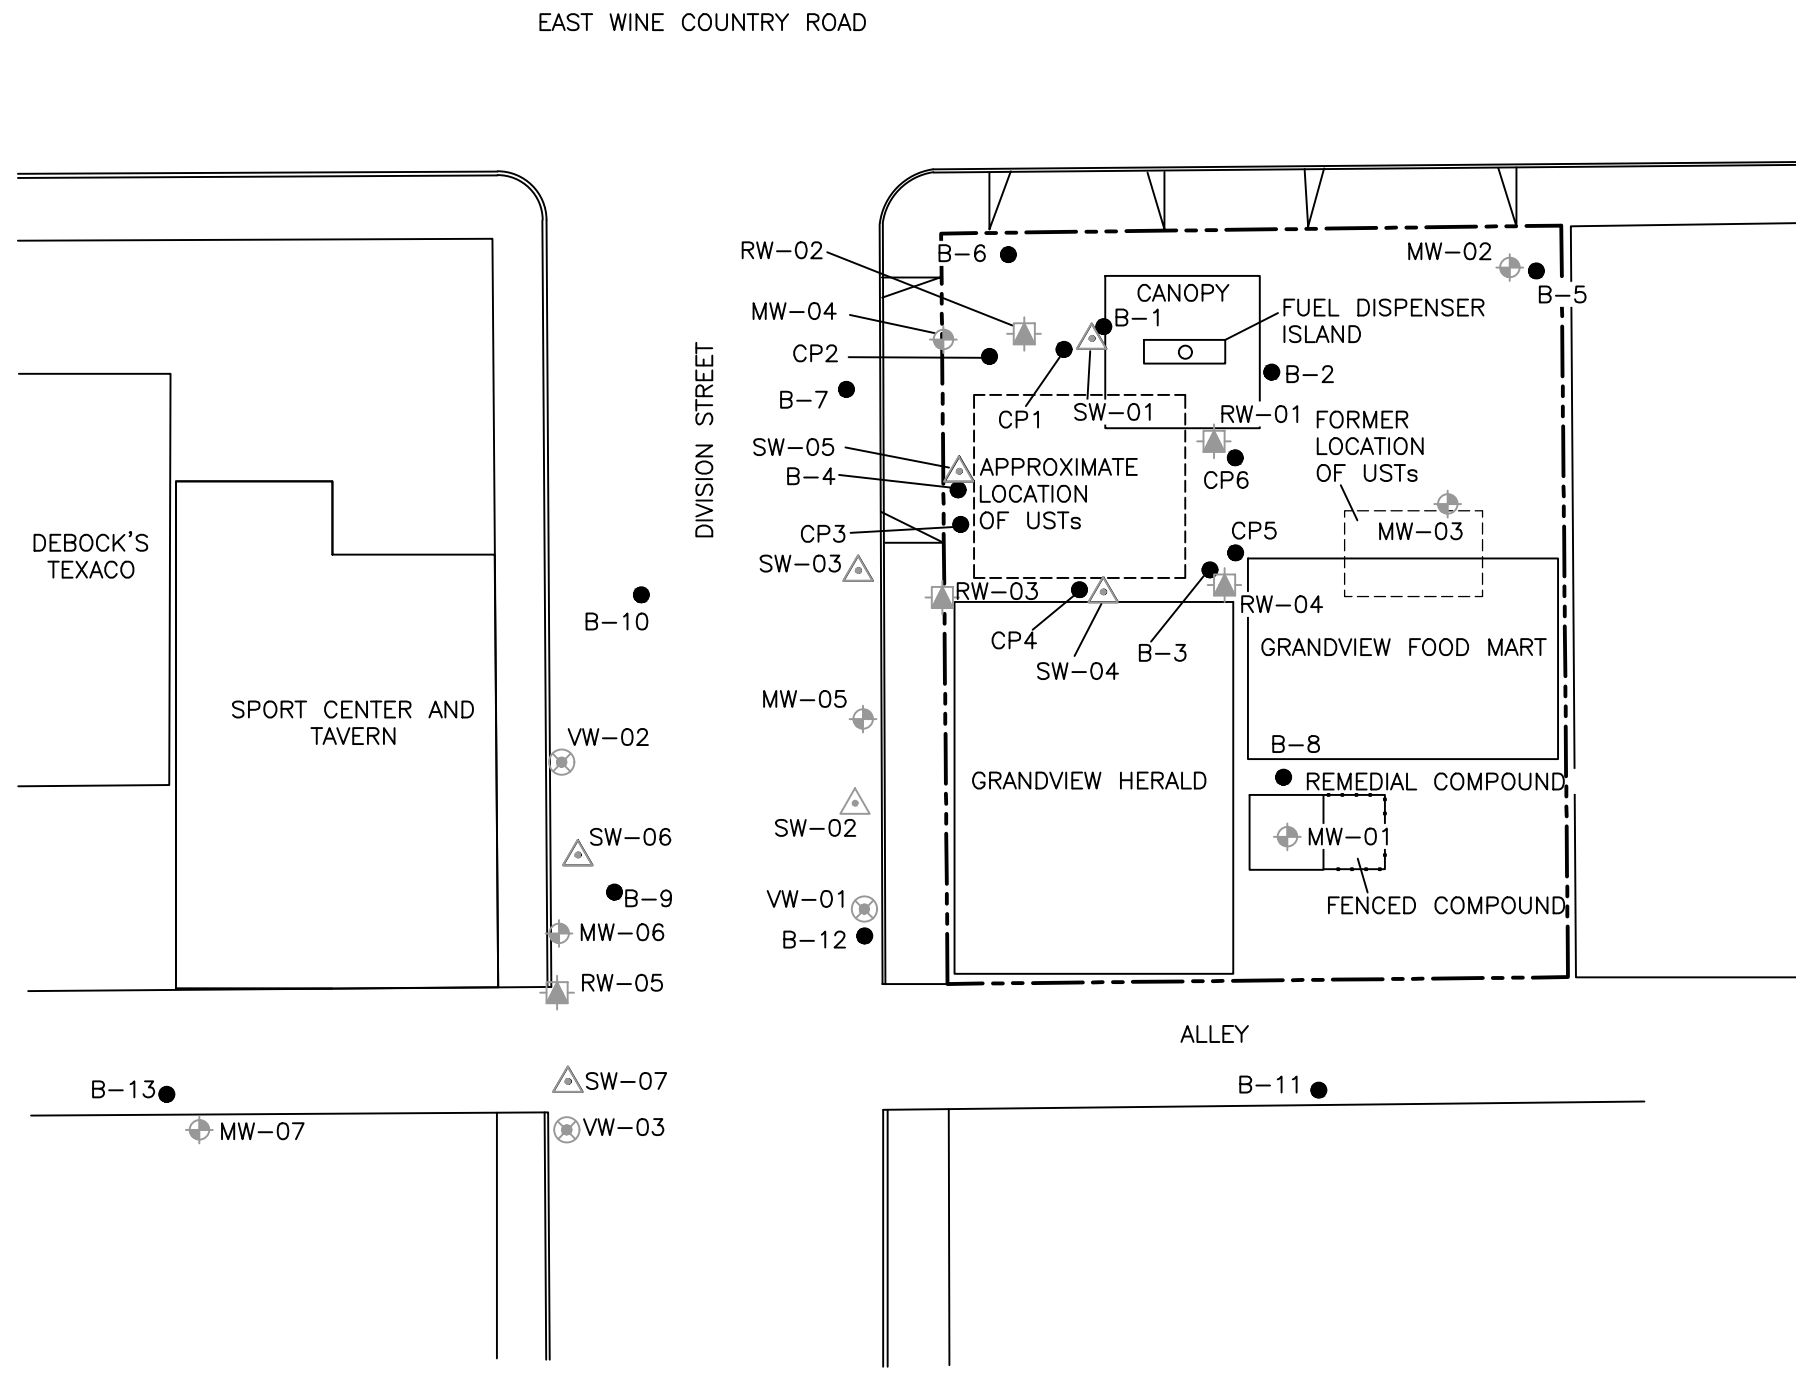
FIGURE 2
SITE PLAN
 Site No. 0700
 100 E. Wine Country Road
 Grandview, Washington

Well destruction activities were performed as part of site closure activities for the site. Six groundwater monitoring wells (MW-1 through MW-6), three vapor extraction wells (VW-01 through VW-03), five recovery wells (RW-01 through RW-05), and seven sparge wells (SW-01 through SW-07) were destroyed as part of this scope of work. The remediation system compound and equipment were also decommissioned as part of the field activities. The former well locations and the former location of the remediation system compound are shown in **Figure 2**.

The wells were constructed of either 2-inch or 4-inch diameter schedule 40 polyvinyl chloride (PVC) well casing and PVC screen material. The total well depths ranged from approximately 25 to 35 feet below ground surface (bgs). Well destruction details are summarized in **Table 1**. The approximate locations of the destroyed wells are illustrated in **Figure 2**.

Onsite wells were decommissioned by first removing the upper portion of the flush mounted, steel well monuments or vaults. The well casings were then filled with 3/8 inch, hydrated bentonite chips up to approximately 3 feet below ground surface. Remediation system conveyance piping was capped below ground surface, as necessary. The remaining portion of the well monuments were then filled with concrete up to ground surface and dyed black to match existing surface conditions.

Well monuments located in the public ROW were left in place at the direction of the City. These wells were decommissioned by filling the casing with 3/8 inch, hydrated bentonite chips up to approximately 3 feet below ground surface. Remediation piping lines were capped in place and the well monuments were then filled with concrete up to within 4 inches of the surface and the lids replaced. The *Resource Protection Well Decommissioning Reports* are presented as **Appendix E**.
