INITIAL INVESTIGATION FIELD REPORT

<u>Site Name (Name over door):</u> Go East Corp Landfill	<u>Site Address (including City, State and Zip):</u> 4330 108th St SE Everett, WA 98208	<u>Phone</u> <u>Email</u>
<u>Site Contact, Title, Business:</u>	<u>Site Contact Address (including City, State and Zip):</u>	<u>Phone</u> <u>Email</u>
<u>Site Owner, Title, Business:</u> P&GE LLC	<u>Site Owner Address (including City, State and Zip):</u> 6677 NE Windermere Rd Seattle, WA 98155	<u>Phone</u> <u>Email</u>
<u>Site Owner Contact, Title, Business:</u>	<u>Site Owner Contact Address (including City, State and Zip):</u>	<u>Phone</u> <u>Email</u>
<u>Previous Site Owner(s):</u>	<u>Additional Info (for any Site Information Item):</u>	
<u>Alternate Site Name(s):</u> Rekaway Landfill

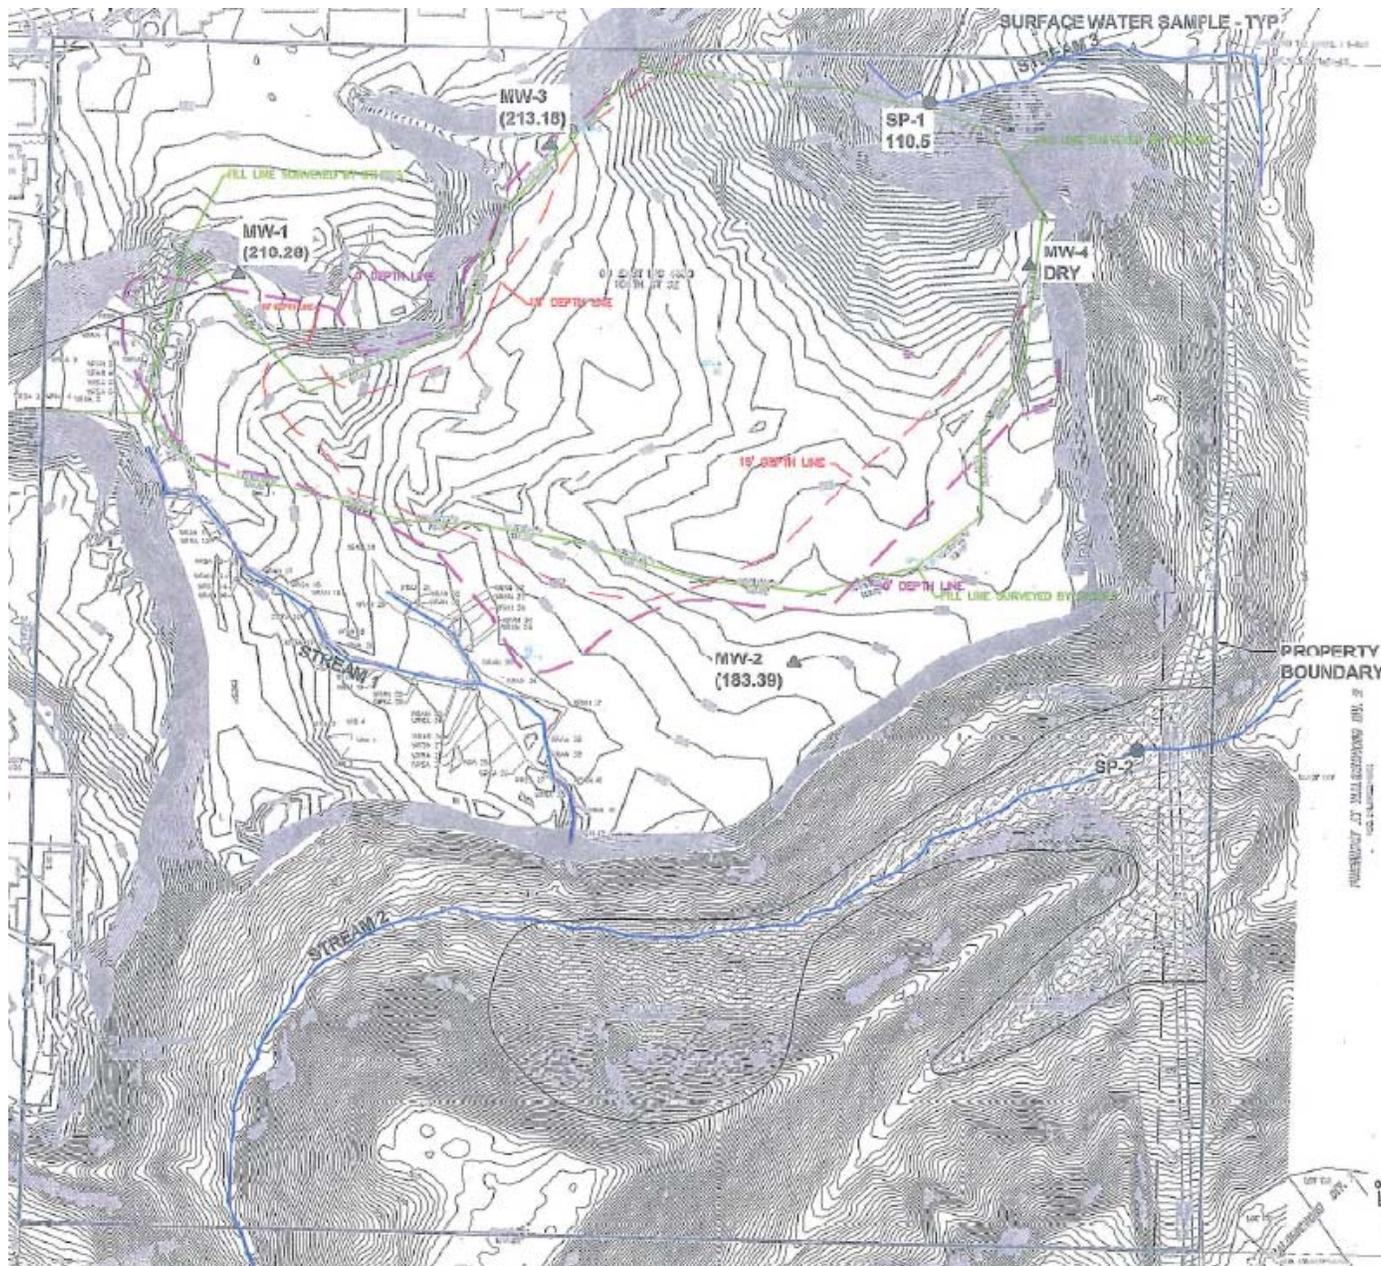
Locations of 2009 sampling of groundwater (MW) and surface water (SP). Current approximate boundaries of landfill area are indicated by the purple dashed line; consolidation of the landfill area is included in the closure plan. Locations of earlier sampling are not clear from available reports, although some surface water is specified as coming from Stream 3 (northeast area of property). Figure from Associated Earth Sciences Inc. Revised Hydrogeology, Ground Water, and Surface Water Quality Report (Appendix B of landfill closure plan).
