**LIMITED PHASE II  
SITE INVESTIGATION**

Villa One-Hour Cleaners at  
Lakewood Towne Center  
Lakewood, Washington

Herrera Environmental Consultants, Inc.  
2200 Sixth Avenue, Suite 1100  
Seattle, Washington 98121  
Telephone: 206/441-9080

July 1, 2003

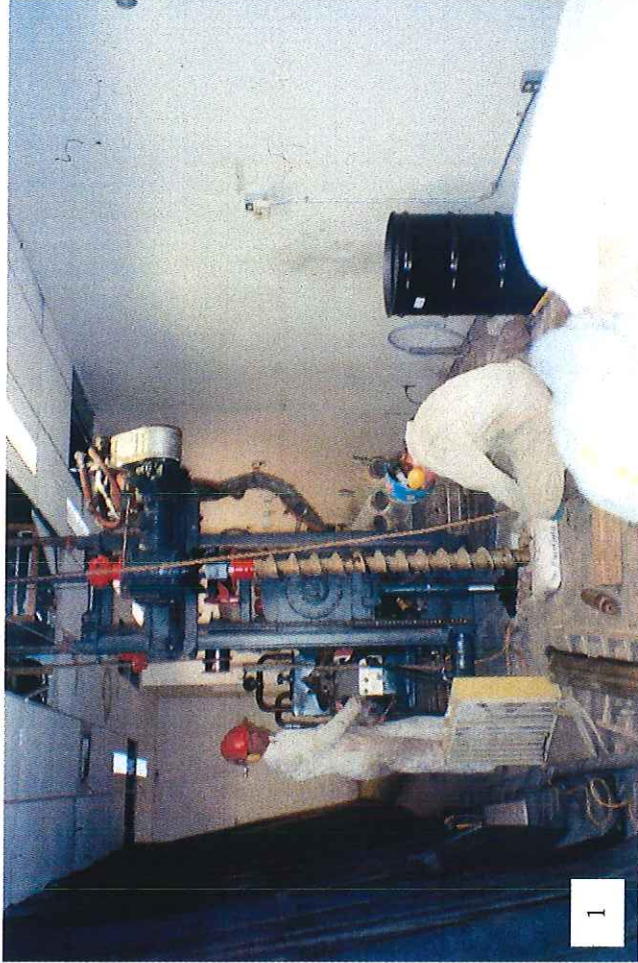
Photo Number	Photo Description
1	Drilling at soil boring SB-4 located inside and eastern half of the tenant space occupied by Villa One-Hour Cleaners. The stain on the wall to the right of the drill rig is where the former dry cleaning equipment and operations were conducted.
2	View of the tenant space after drilling activities was completed, looking to the north-northeast. The square cutout in the foreground was soil boring SB-4 location, with the second square cutout north of SB-4 in the background.
3	View of the tenant space, looking to the south.
