Soil Management Plan
Hillyard Rail Lead Site
Spokane, Washington

28 June 2019

Prepared for
BNSF Railway Company
605 Puyallup Avenue
Tacoma, Washington 98421

KJ Project No. 1996114.00

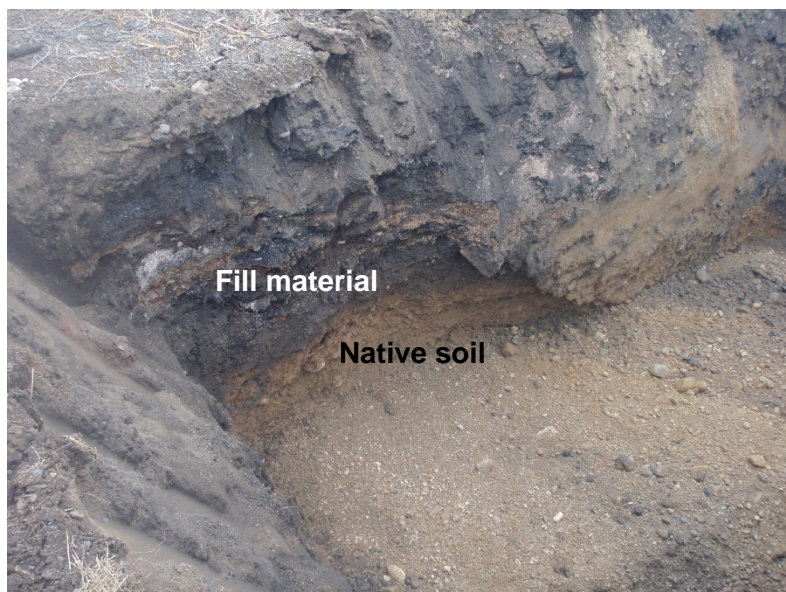
Photograph 2 – Potentially constituent-impacted fill material over native site soil (photograph taken 12 August 2009)

Historically, impacted soil observed on the Site during investigative and remedial activities has consisted of gray-black sandy silt that is believed to have been placed on the Site as fill. This material was occasionally observed to contain ash, clinkers, and debris. The impacted material was visually distinct from native Site soil, which consists of brown gravel and sand with varying amounts of silt.

Photographs of impacted fill material and native site soil are included as Appendix C.
