Remedial Investigation Report

Parcel 15 (Portac) Investigation

Ecology Facility Site No. 1215 / Cleanup Site No. 3642

February 2018

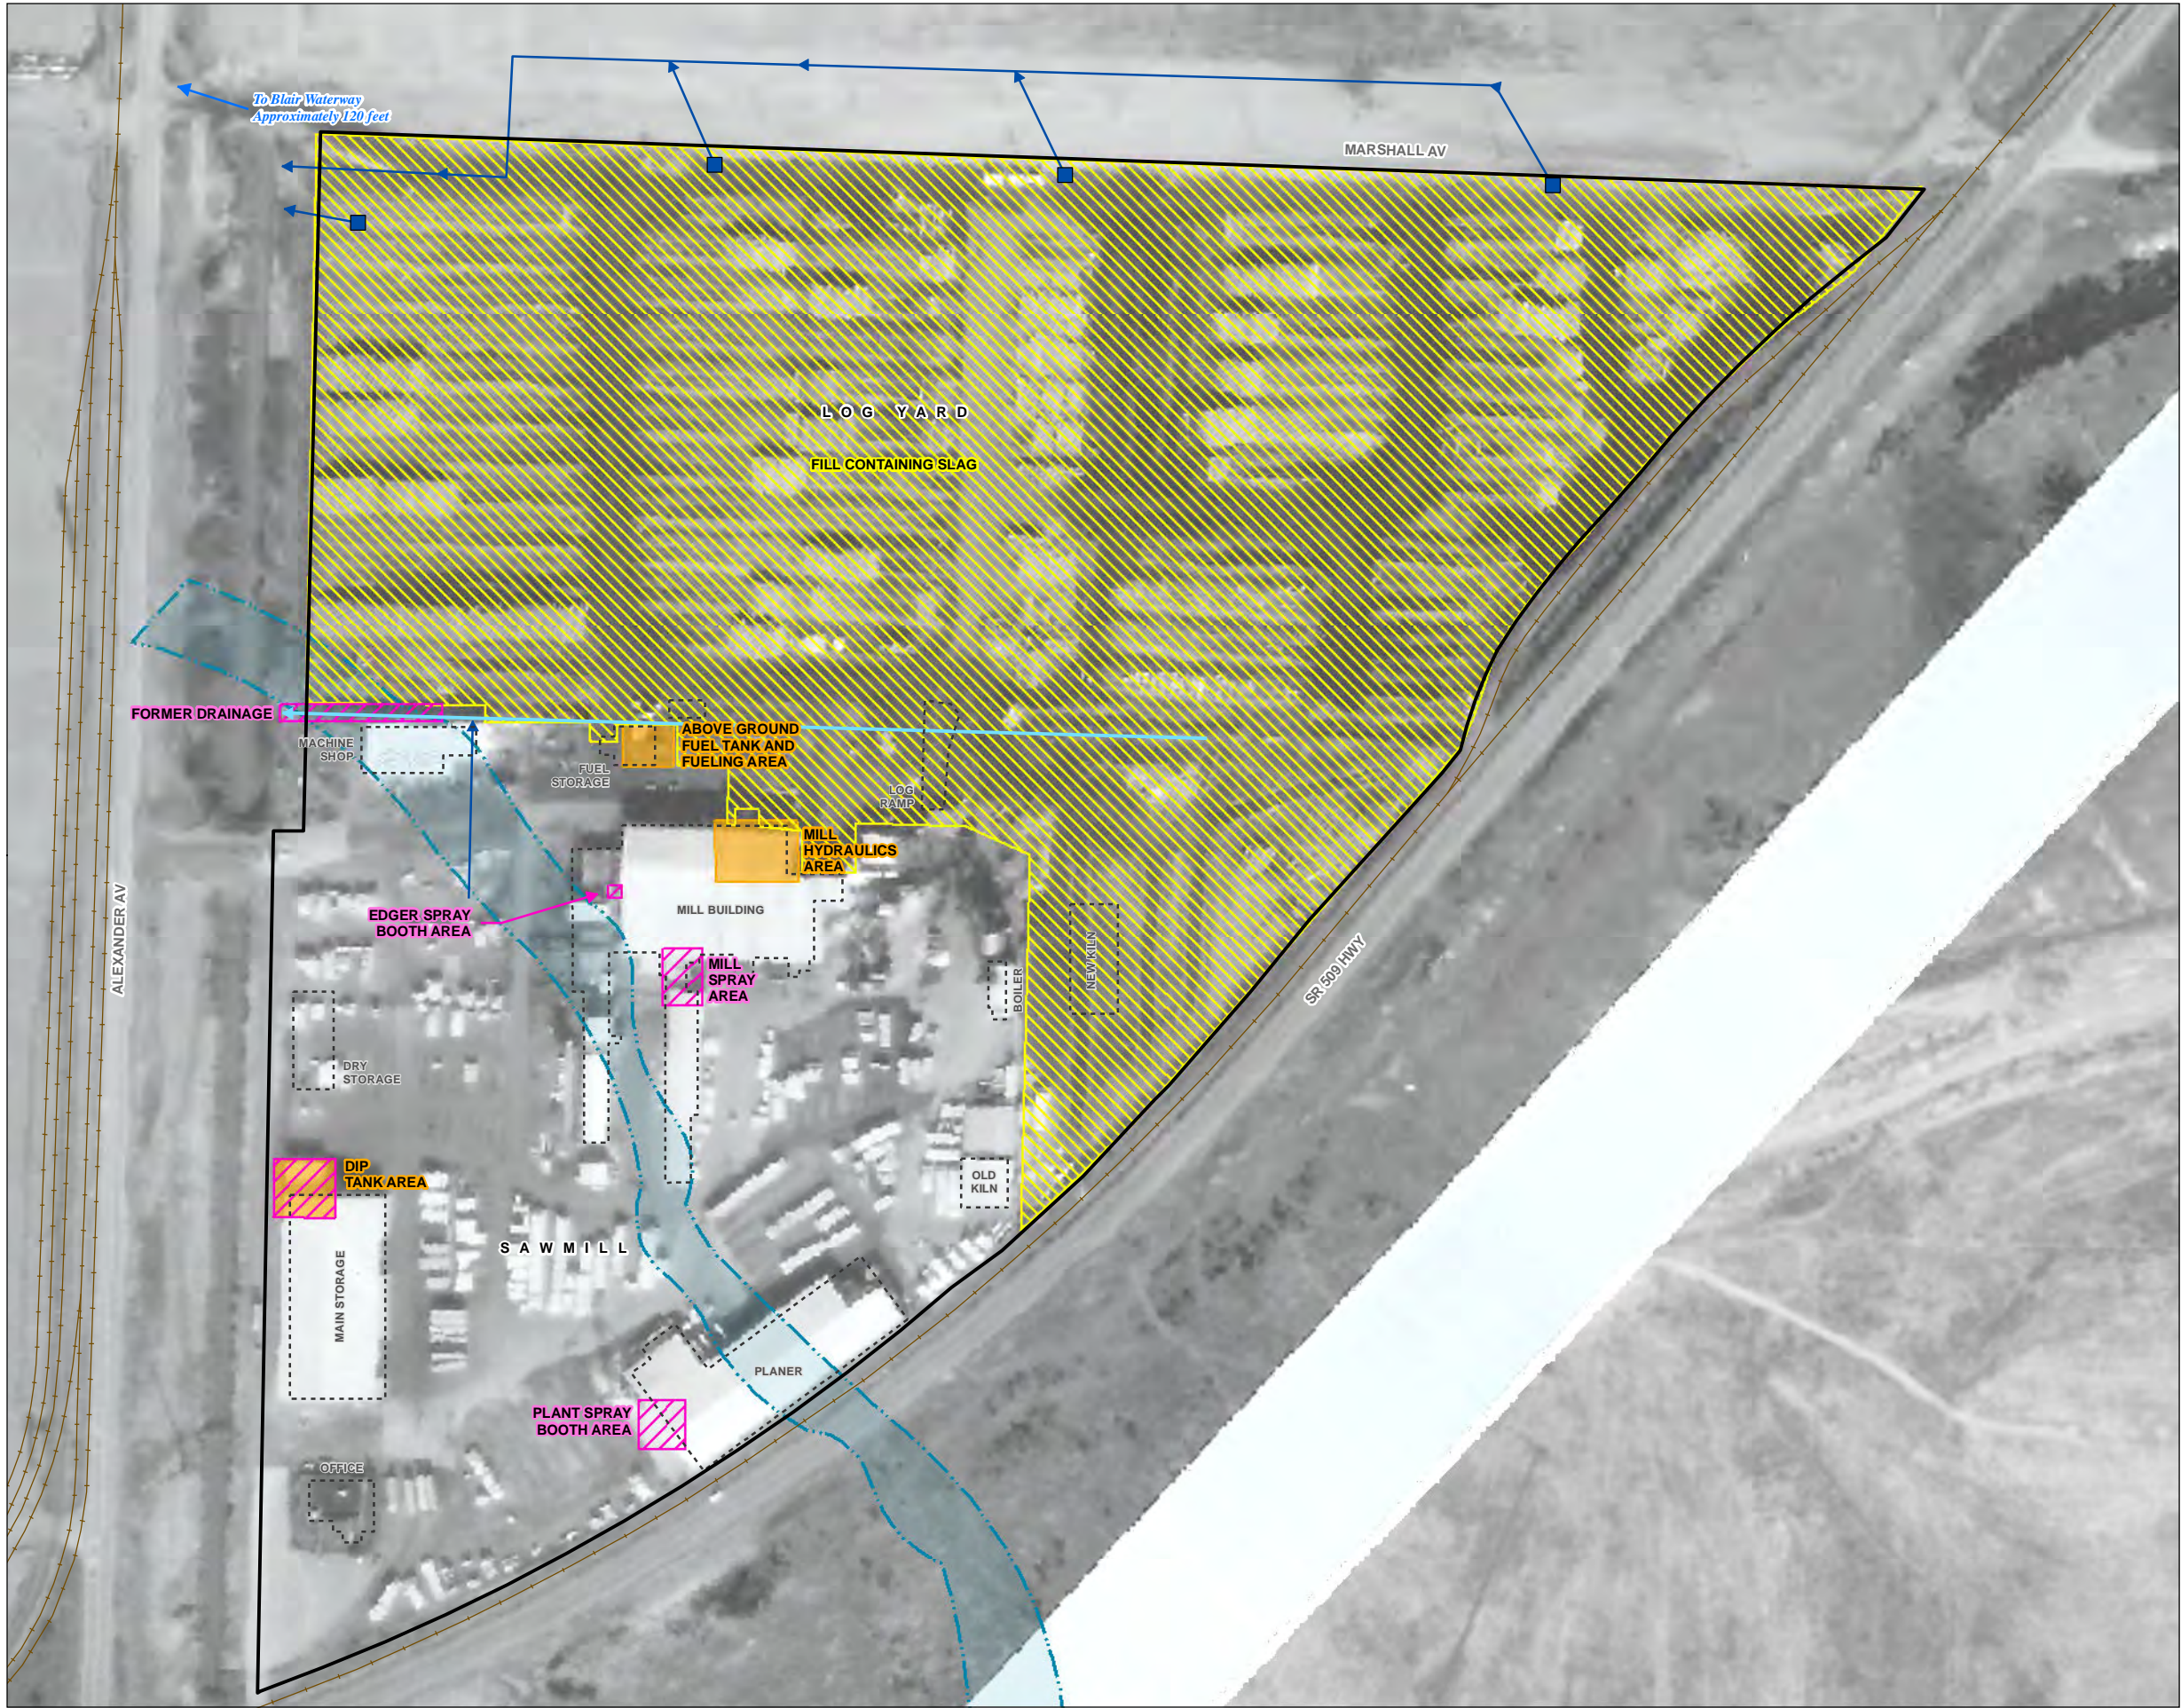
FIGURE 2-2
Historical Site Features
and Source Areas
 Remedial Investigation Report
 Parcel 15
 Tacoma, WA

3. Source area boundaries in the sawmill area are based on the "approximate soil clean-up area boundaries" shown on Figure 12 of the Lumber Mill Cleanup Report (WES, 2009). PCP source area in the central drainage ditch reflects the lower 200 feet of the ditch which is noted to be the extent of impact in Section 7.3 of the Portac Log Yard Remediation Plan (HC, 1988). The approximate extent of the slag fill matches the lower boundary of the phased Portac Log Sort Yard Paving Project which is shown in Sheet 2 of the associated drawing set (HC, 1988).

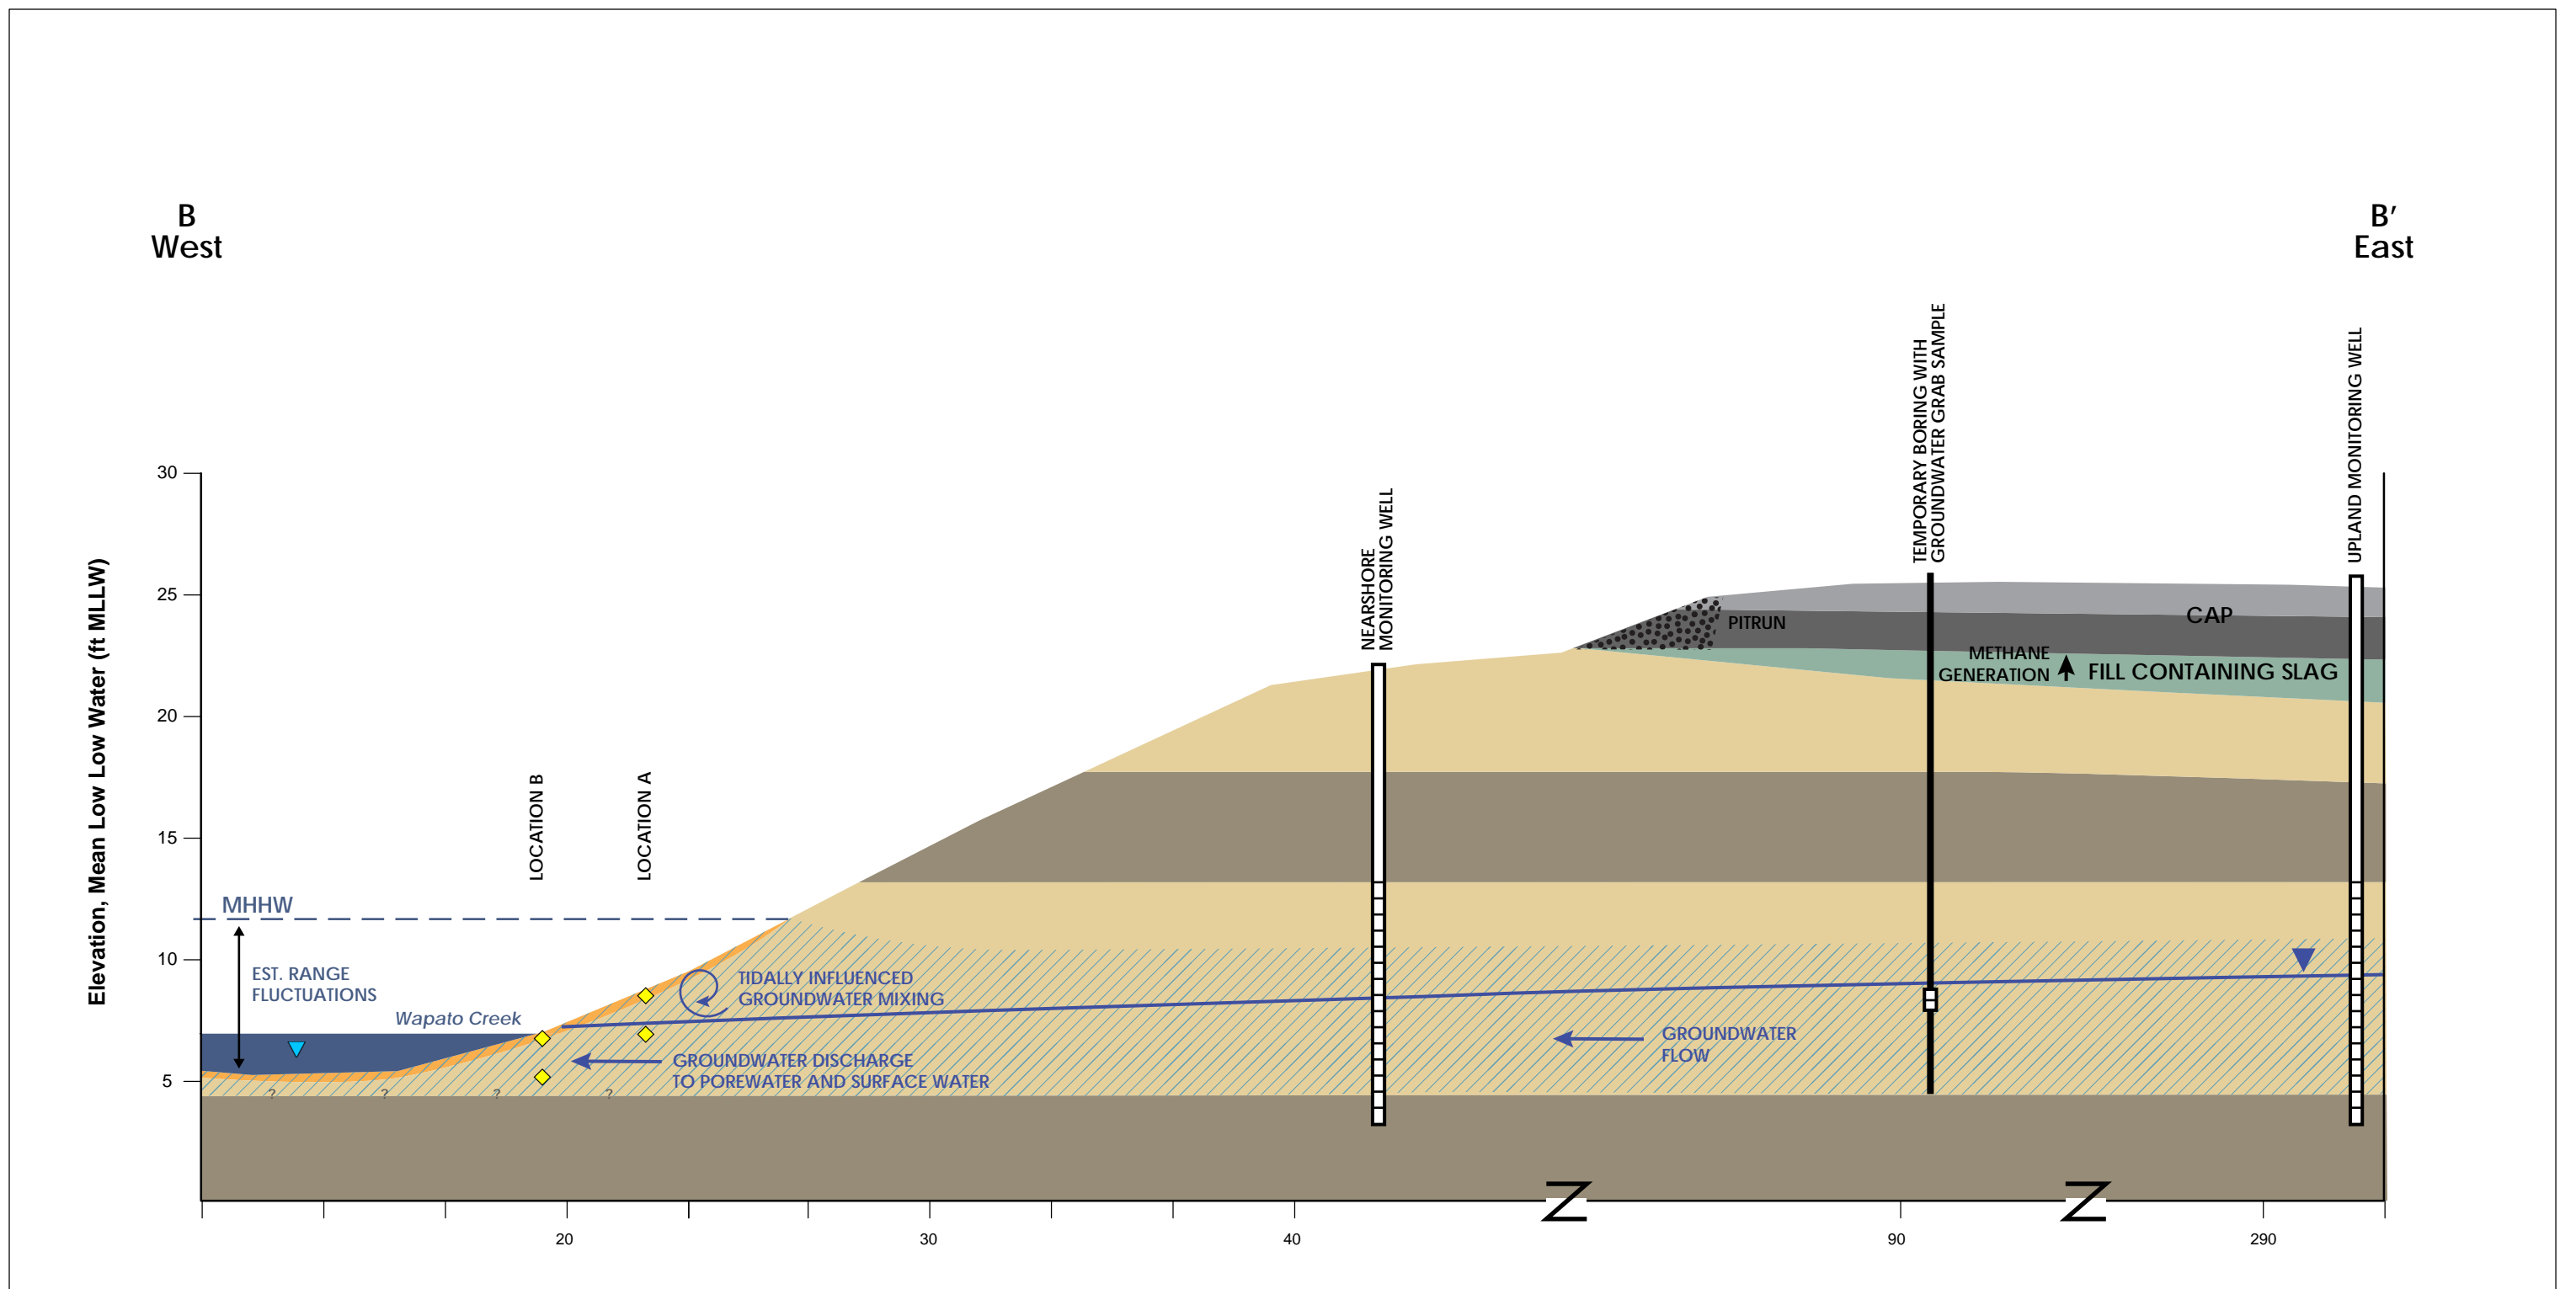
- LEGEND**
- ◆ Porewater/Sediment Grab Sample (0-10 cm, 40-50 cm)
 - ▼ Surface Water Sample (1' above mud line)
 - New Monitoring Well
 - ▭ Approximate Range in Groundwater Levels
 - ▾ Approximate Static Water Level (April 1988)

- Geology**
- Roller Compacted Concrete
 - Gravel Base Course
 - Fill Containing Slag
 - Silty Sand
 - Silt
 - Biozone

Surface water samples from Wapato Creek were collected near Location B in each transect, as shown schematically in Figure 3-4. Two additional surface water samples were collected for reference, including a sample in Wapato Creek upstream of the Site, and a sample in the Blair Waterway (Figure 3-1). The surface water samples in Wapato Creek were collected approximately 10 cm above the mudline during low-tide conditions, when groundwater discharge would be expected to be most prevalent. Surface water samples were analyzed for same constituents as groundwater and porewater, including the Standard Analytical Suite plus the expanded Geochemical Suite (Table 3-4). Field measurements were taken for temperature, pH, specific conductance, ORP, and DO (Table 3-6).

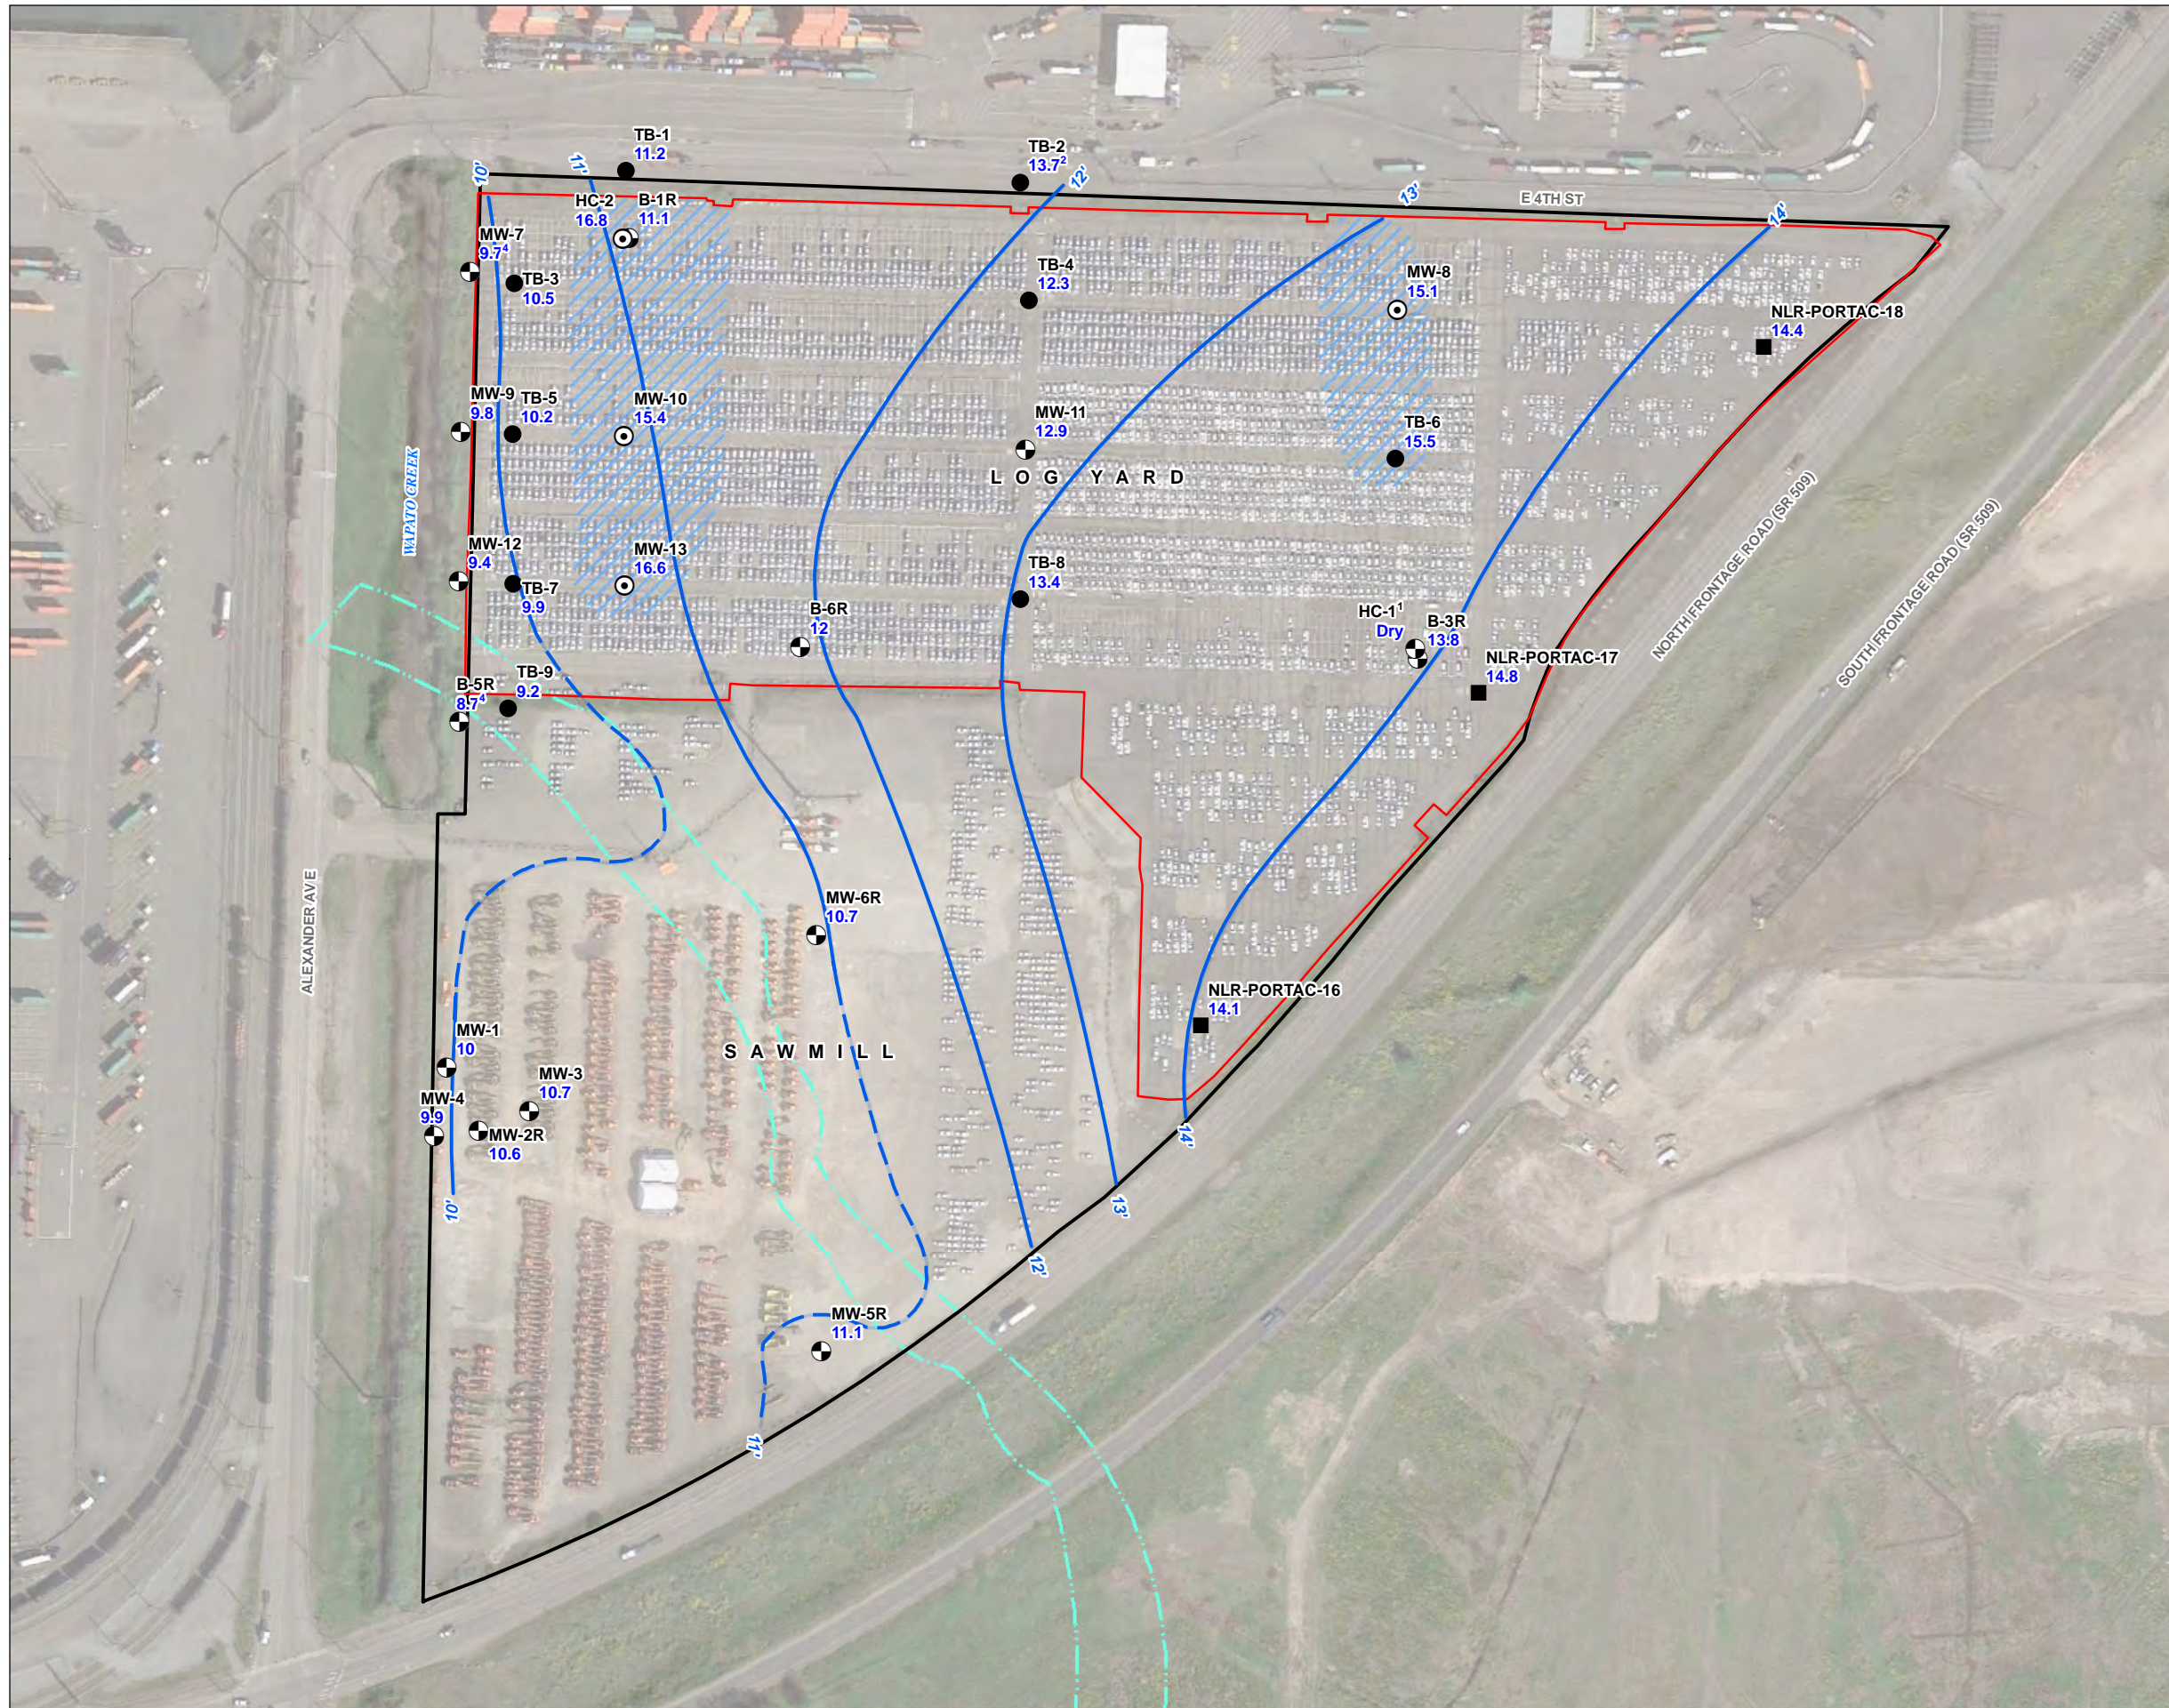
FIGURE 4-12
Event 1: May 2016
Groundwater Contour Map
 Remedial Investigation Report
 Parcel 15
 Tacoma, WA

- Monitoring Well³
- Perched Monitoring Well³
- Piezometer³
- Temporary Boring³
- Groundwater Elevation Contour (ft MLLW), Dashed Where Inferred
- Observed Perched Zone
- All Other Features**
- Site Boundary⁵
- Cap⁶
- Former Wapato Creek Channel⁷

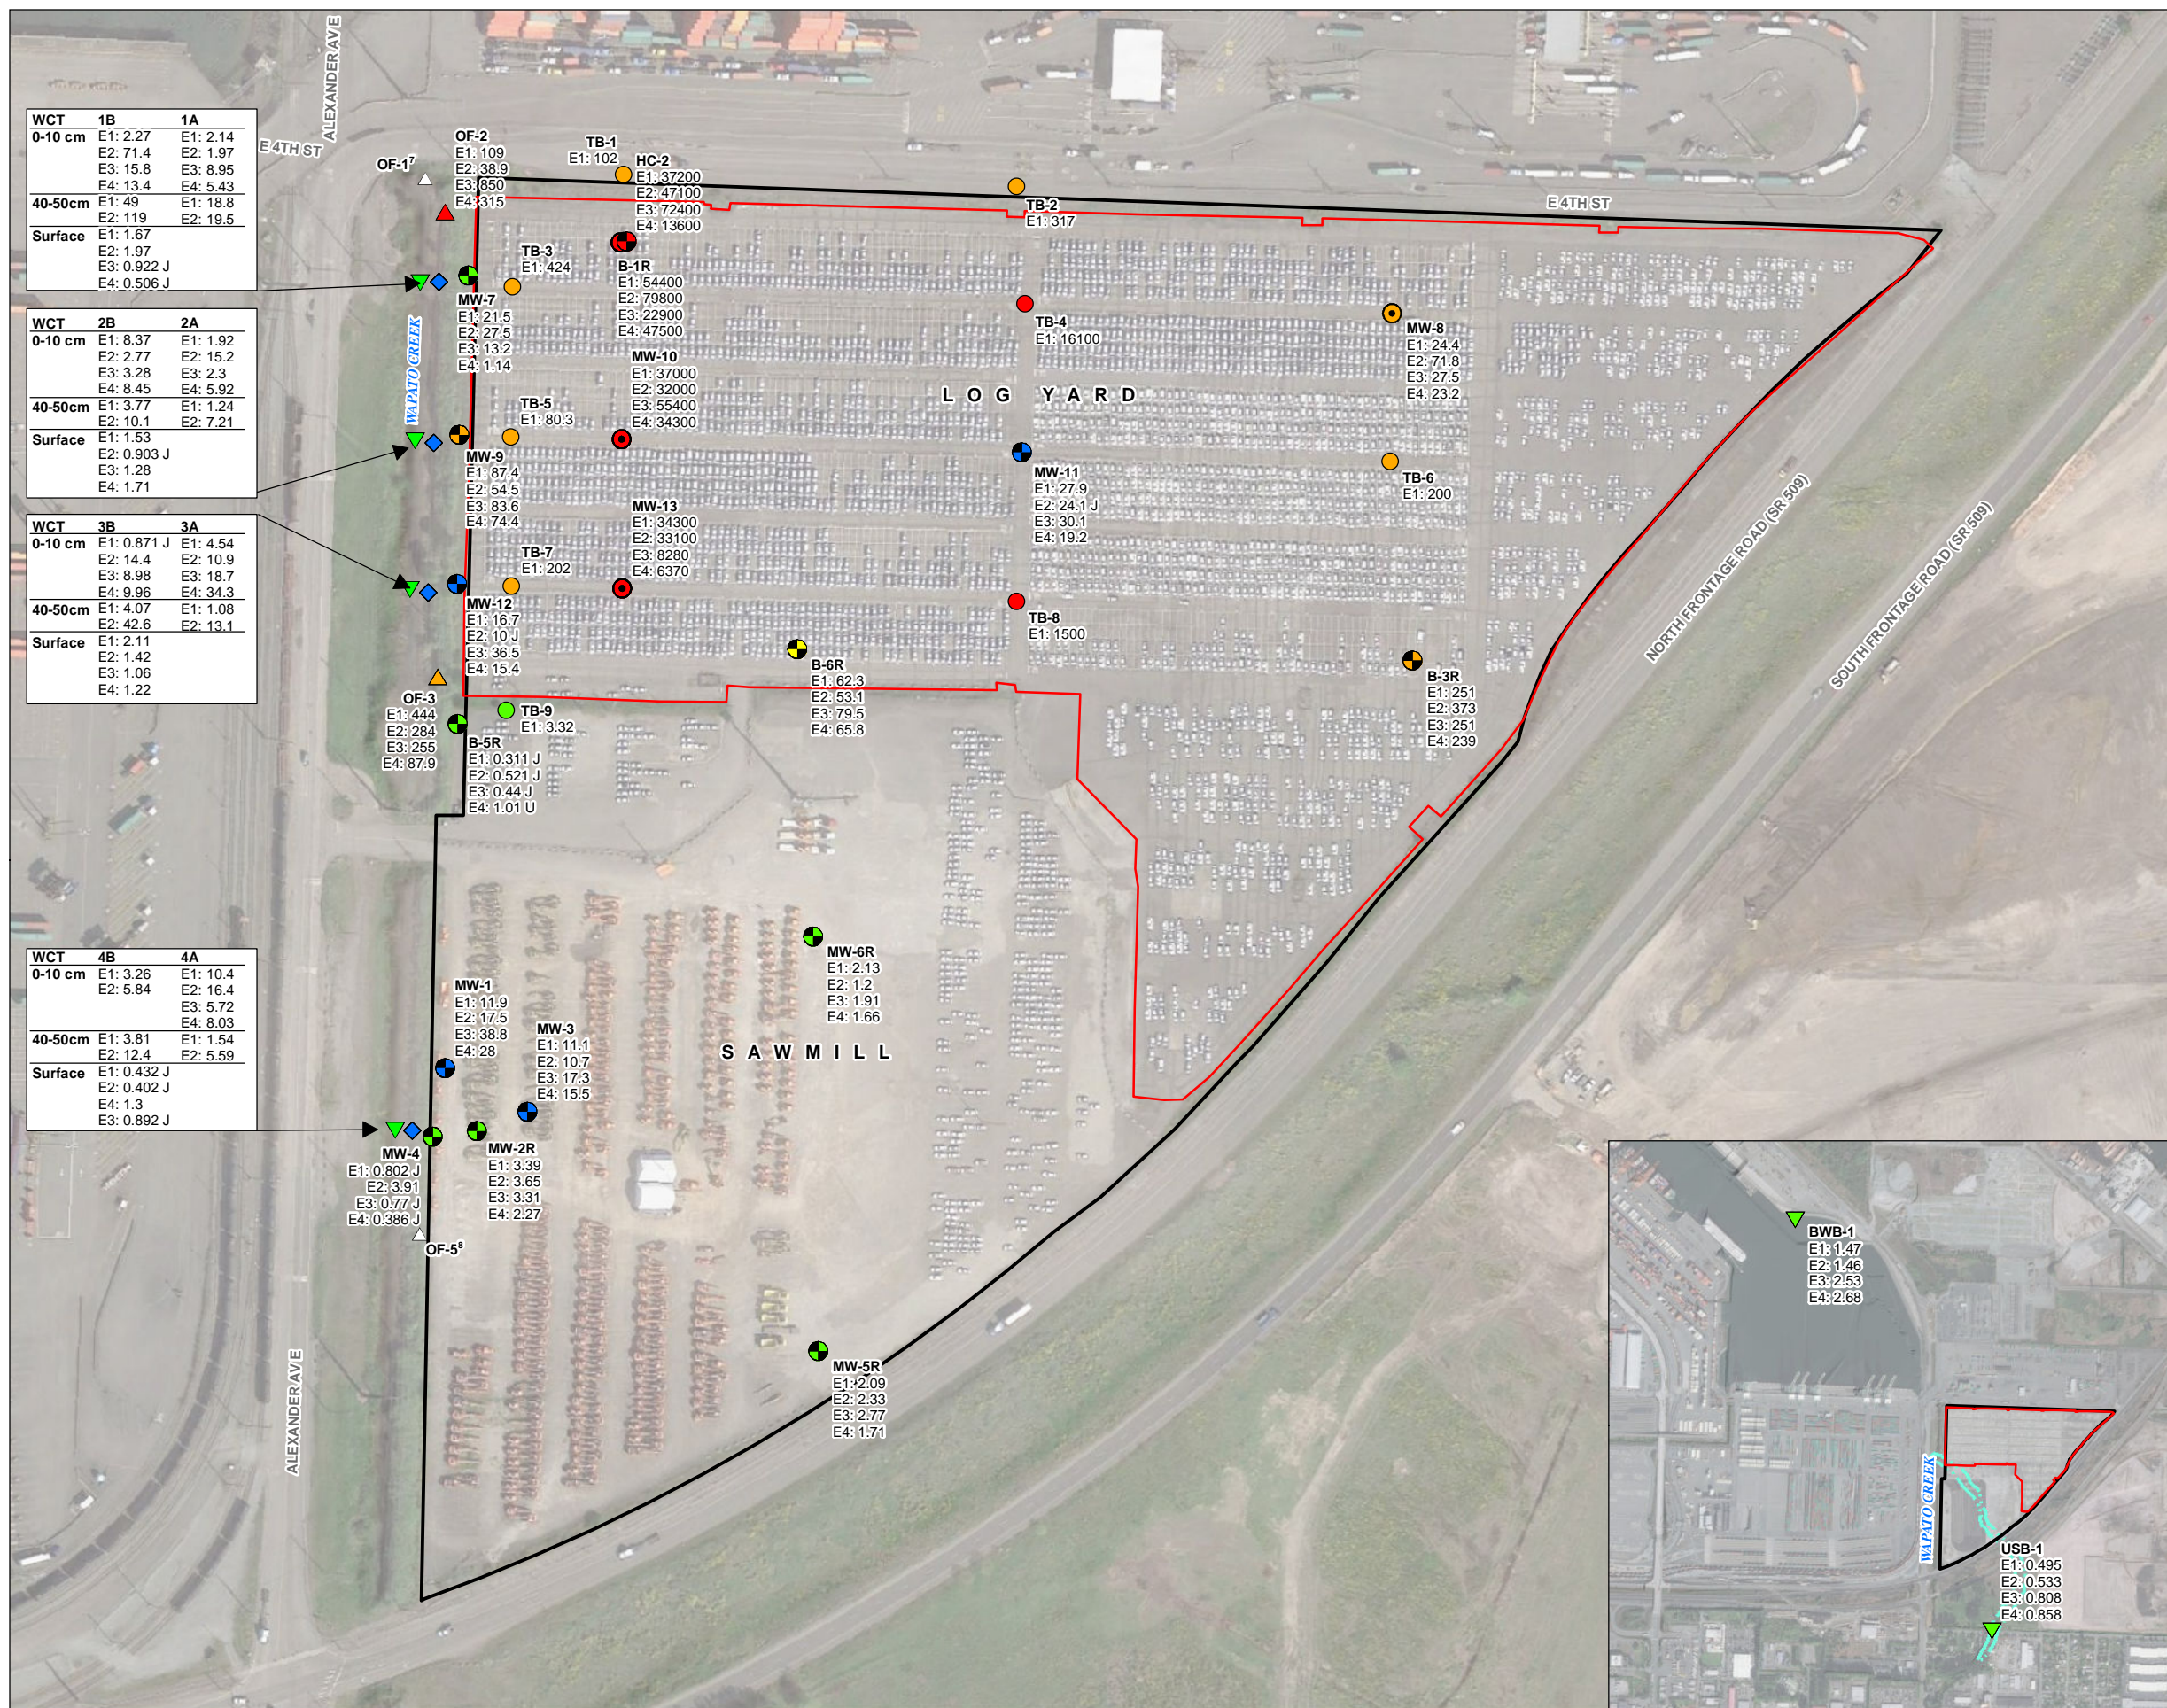
FIGURE 7-3
Arsenic Concentrations in Groundwater, Porewater, Surface Water, and Outfall Discharge - Event 1 through Event 4
 Remedial Investigation Report
 Parcel 15
 Tacoma, WA

WCT	1B	1A
0-10 cm	E1: 2.27 E2: 71.4 E3: 15.8 E4: 13.4	E1: 2.14 E2: 1.97 E3: 8.95 E4: 5.43
40-50cm	E1: 49 E2: 119	E1: 18.8 E2: 19.5
Surface	E1: 1.67 E2: 1.97 E3: 0.922 J E4: 0.506 J

WCT	2B	2A
0-10 cm	E1: 8.37 E2: 2.77 E3: 3.28 E4: 8.45	E1: 1.92 E2: 15.2 E3: 2.3 E4: 5.92
40-50cm	E1: 3.77 E2: 10.1	E1: 1.24 E2: 7.21
Surface	E1: 1.53 E2: 0.903 J E3: 1.28 E4: 1.71

Given the presence of a turbidity artifact in the porewater samples, only dissolved arsenic concentrations were used in the screening evaluation. Shallow porewater results from Event 1 through Event 4 are shown in Table 7-6 relative to the MTCA Method A value, adjusted for background (5 µg/L) and the chronic aquatic toxicity SL (36 µg/L). Shallow porewater concentrations were variable between event and between the nearshore “A” and offshore “B” stations on each transect. With one exception (WCTPW001B-10-E2), all results were less than the chronic aquatic toxicity SL, but most samples exceeded the background concentration of 5 µg/L. The bioactive zone porewater results are included in Figure 7-3 and the fate and transport of arsenic in the transition zone are discussed further in Section 7.3.1 and Appendix H.

Total and dissolved arsenic in both of the samples stormwater outfalls had concentrations exceeding the chronic aquatic toxicity SL (36 µg/L), with dissolved arsenic concentrations up to 850 µg/L and 444 µg/L for outfalls #2 and #3, respectively (Table 7-7; and Figure 7-3). As discussed in Section 4.2.3, the source of the arsenic potentially could be leakage of perched groundwater in the source area into the stormwater conveyance system, along seams in the stormwater pipes and the ring joints in the spill containment vessels. Arsenic in the stormwater system will be addressed in the FS.

Tables 7-5 shows the total and dissolved arsenic results in Event 1 through Event 4 groundwater and transition zone porewater samples, in comparison to the MTCA Method A value, adjusted for background (5 µg/L) and the chronic aquatic toxicity SL (36 µg/L). Figure 7-3 shows the dissolved arsenic results relative to these SLs. With the exception of the Event 3 (November 2016) sample from MW-1, all other groundwater and transition zone porewater samples in the Sawmill had arsenic concentrations below the chronic aquatic toxicity screening criteria of 36 µg/L. The other arsenic results from MW-1 and MW-3 also exceeded background values. During Event 2, the total arsenic result in MW-2R was similar to the marine background value, but the dissolved arsenic result was below it.

Table 7-6 and Figure 7-3 show shallow dissolved arsenic porewater results from Event 1 through Event 4 relative to the MTCA Method A value, adjusted for background (5 µg/L) and the chronic aquatic toxicity value (36 µg/L). For dissolved arsenic, three of the six shallow porewater sample results at transect WCT-4 were greater than the groundwater background SL and five of the six were greater than the marine water background SL.
