**UNDERGROUND STORAGE TANK DECOMMISSIONING  
AND SITE ASSESSMENT  
MORSE CONSTRUCTION GROUP  
5500 SOUTH 1ST STREET  
EVERETT, WASHINGTON 98203  
INCIDENT NUMBER 17401**

**DLH ENVIRONMENTAL CONSULTING  
1335 NORTH NORTHLAKE WAY  
SUITE 101  
SEATTLE, WASHINGTON 98103**

**OCTOBER 11, 1994**

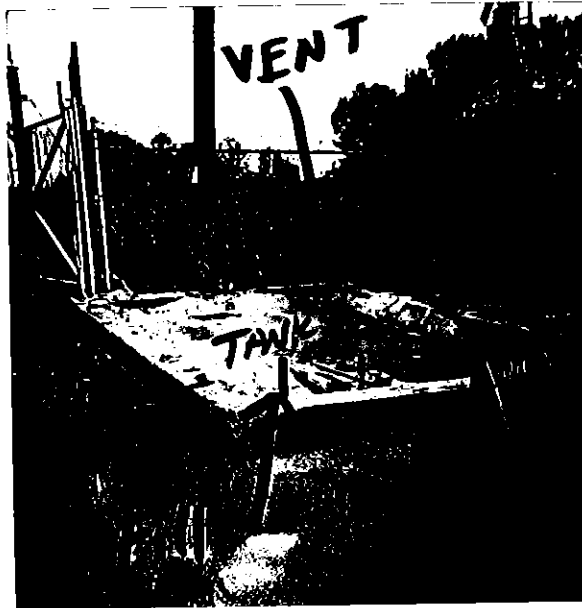
9/1/94 - FACING NORTH

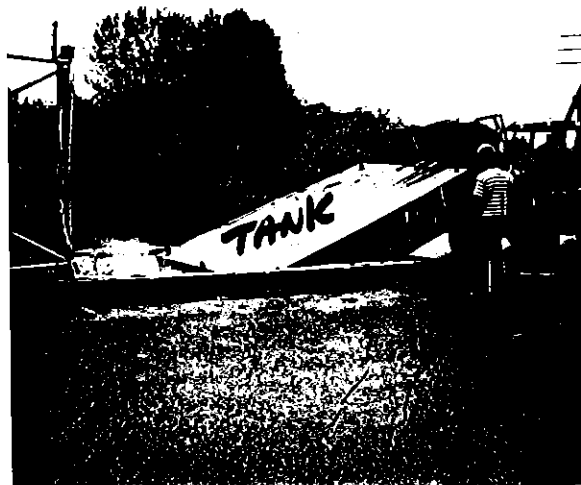
After removal, a visual inspection of the tank indicated that it was in good condition with no cracks or heavy corrosion.

9/1/94  
TANK REMOVAL

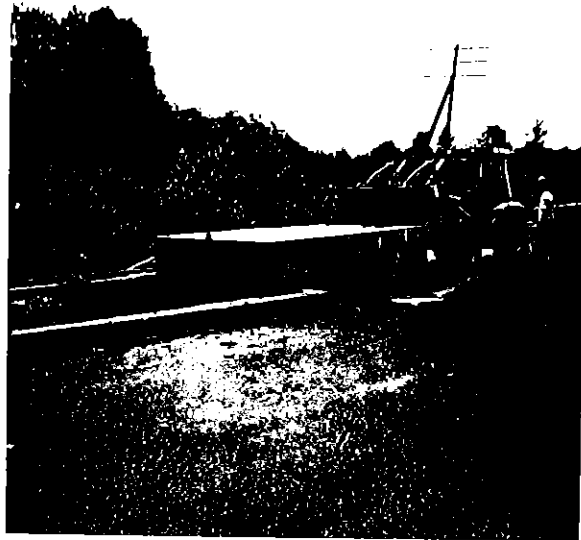
9/1/94  
TANK REMOVAL
