Re: **Remedial Excavation Soil Sampling**  
2119 Mildred Street  
Fircrest, Washington 98466

EconCon, Inc., (ECI), per your request, completed soil sampling activities following the excavation of tetrachloroethylene (PCE) impacted soil on August 7<sup>th</sup> and 8<sup>th</sup>, 2012. The project was located at 2119 Mildred Street, Fircrest, Washington (the "Subject Property / Property"; Figures 1 and 2). This work was completed to supplement previous subsurface investigations where PCE impacted soil had been identified.

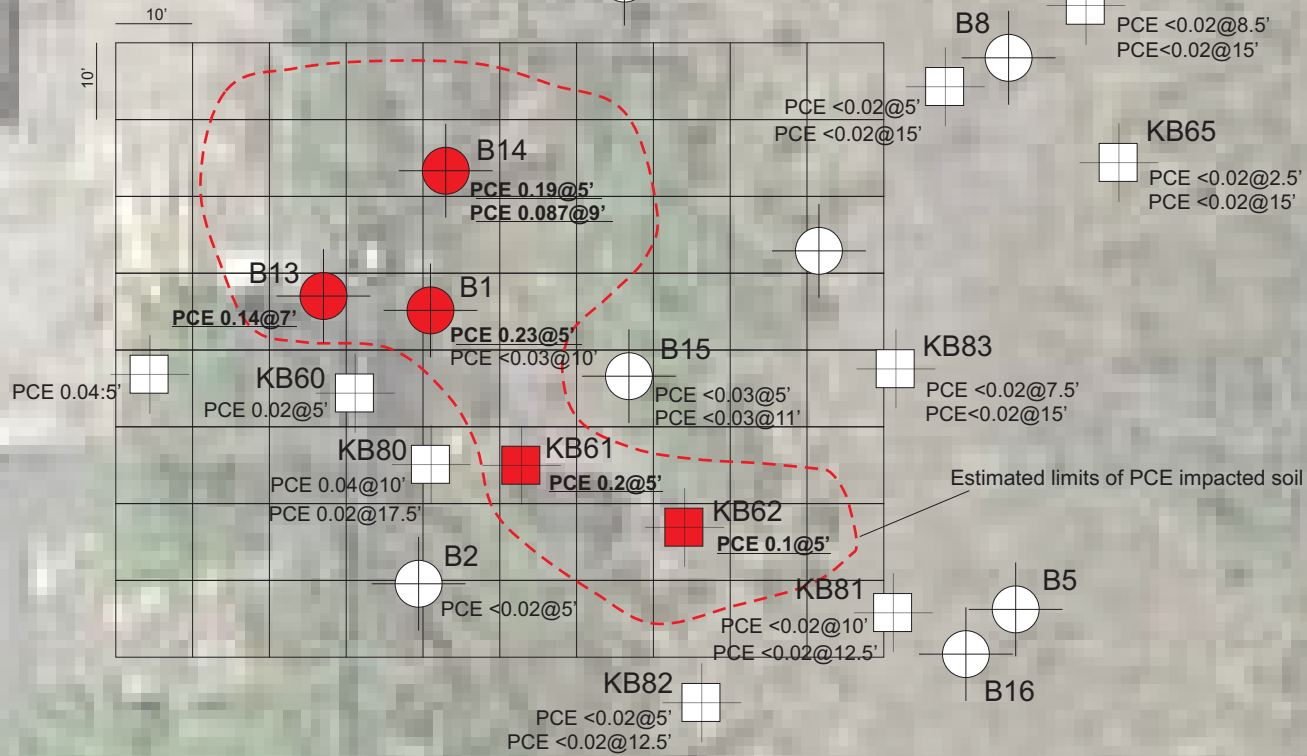
Figure No.:  
**03**  
Sheet 03 of 05

- ECI 2011 Boring Locations
- ECI 2011 Boring Locations Exceeding MTCA-A CULs
- Kleinfelder 2005 Boring Locations
- Kleinfelder 2005 Boring Locations Exceeding MTCA-A CULs

ECI & Kleinfelder Subsurface Investigation  
Soil Sample Location Map  
2119 Mildred Street  
Fircrest, Washington

Previous investigations identified perchloroethylene (PCE) exceeding the Washington State Administrative Code (WAC) 173-340 Model Toxic Control Act (MTCA) Method A Soil Cleanup Levels for Unrestricted Land Uses (CUL) of 0.05 milligrams per kilogram (mg/kg) in four borings, B1:5', B13:7', B14:5' and B14:9' at concentrations ranging from 0.087 mg/kg to 0.23 mg/kg. These sample locations were in the same vicinity as the 2005 Kleinfelder sample locations ( Limited Phase II Environmental Site Assessment & Supplemental Phase II Environmental Study – Kleinfelder 2005), near a Freeman Family (property owner through 2012) reported "drainage area" at the southeast corner of the building, extending to the southeast (Figure 3).

The extent of PCE impacted soil was delineated using Kleinfelder's 2005 data obtained from borings B79, B81, B82, B83 and B85, with samples reported below the laboratory method reporting level (MRL). Using the data collected by ECI and reported by Kleinfelder, the impacted area appears to be approximately 25 to 50 feet east-west by 50 to 100 feet north-south ranging from 4 to 10 feet below ground surface (bgs).

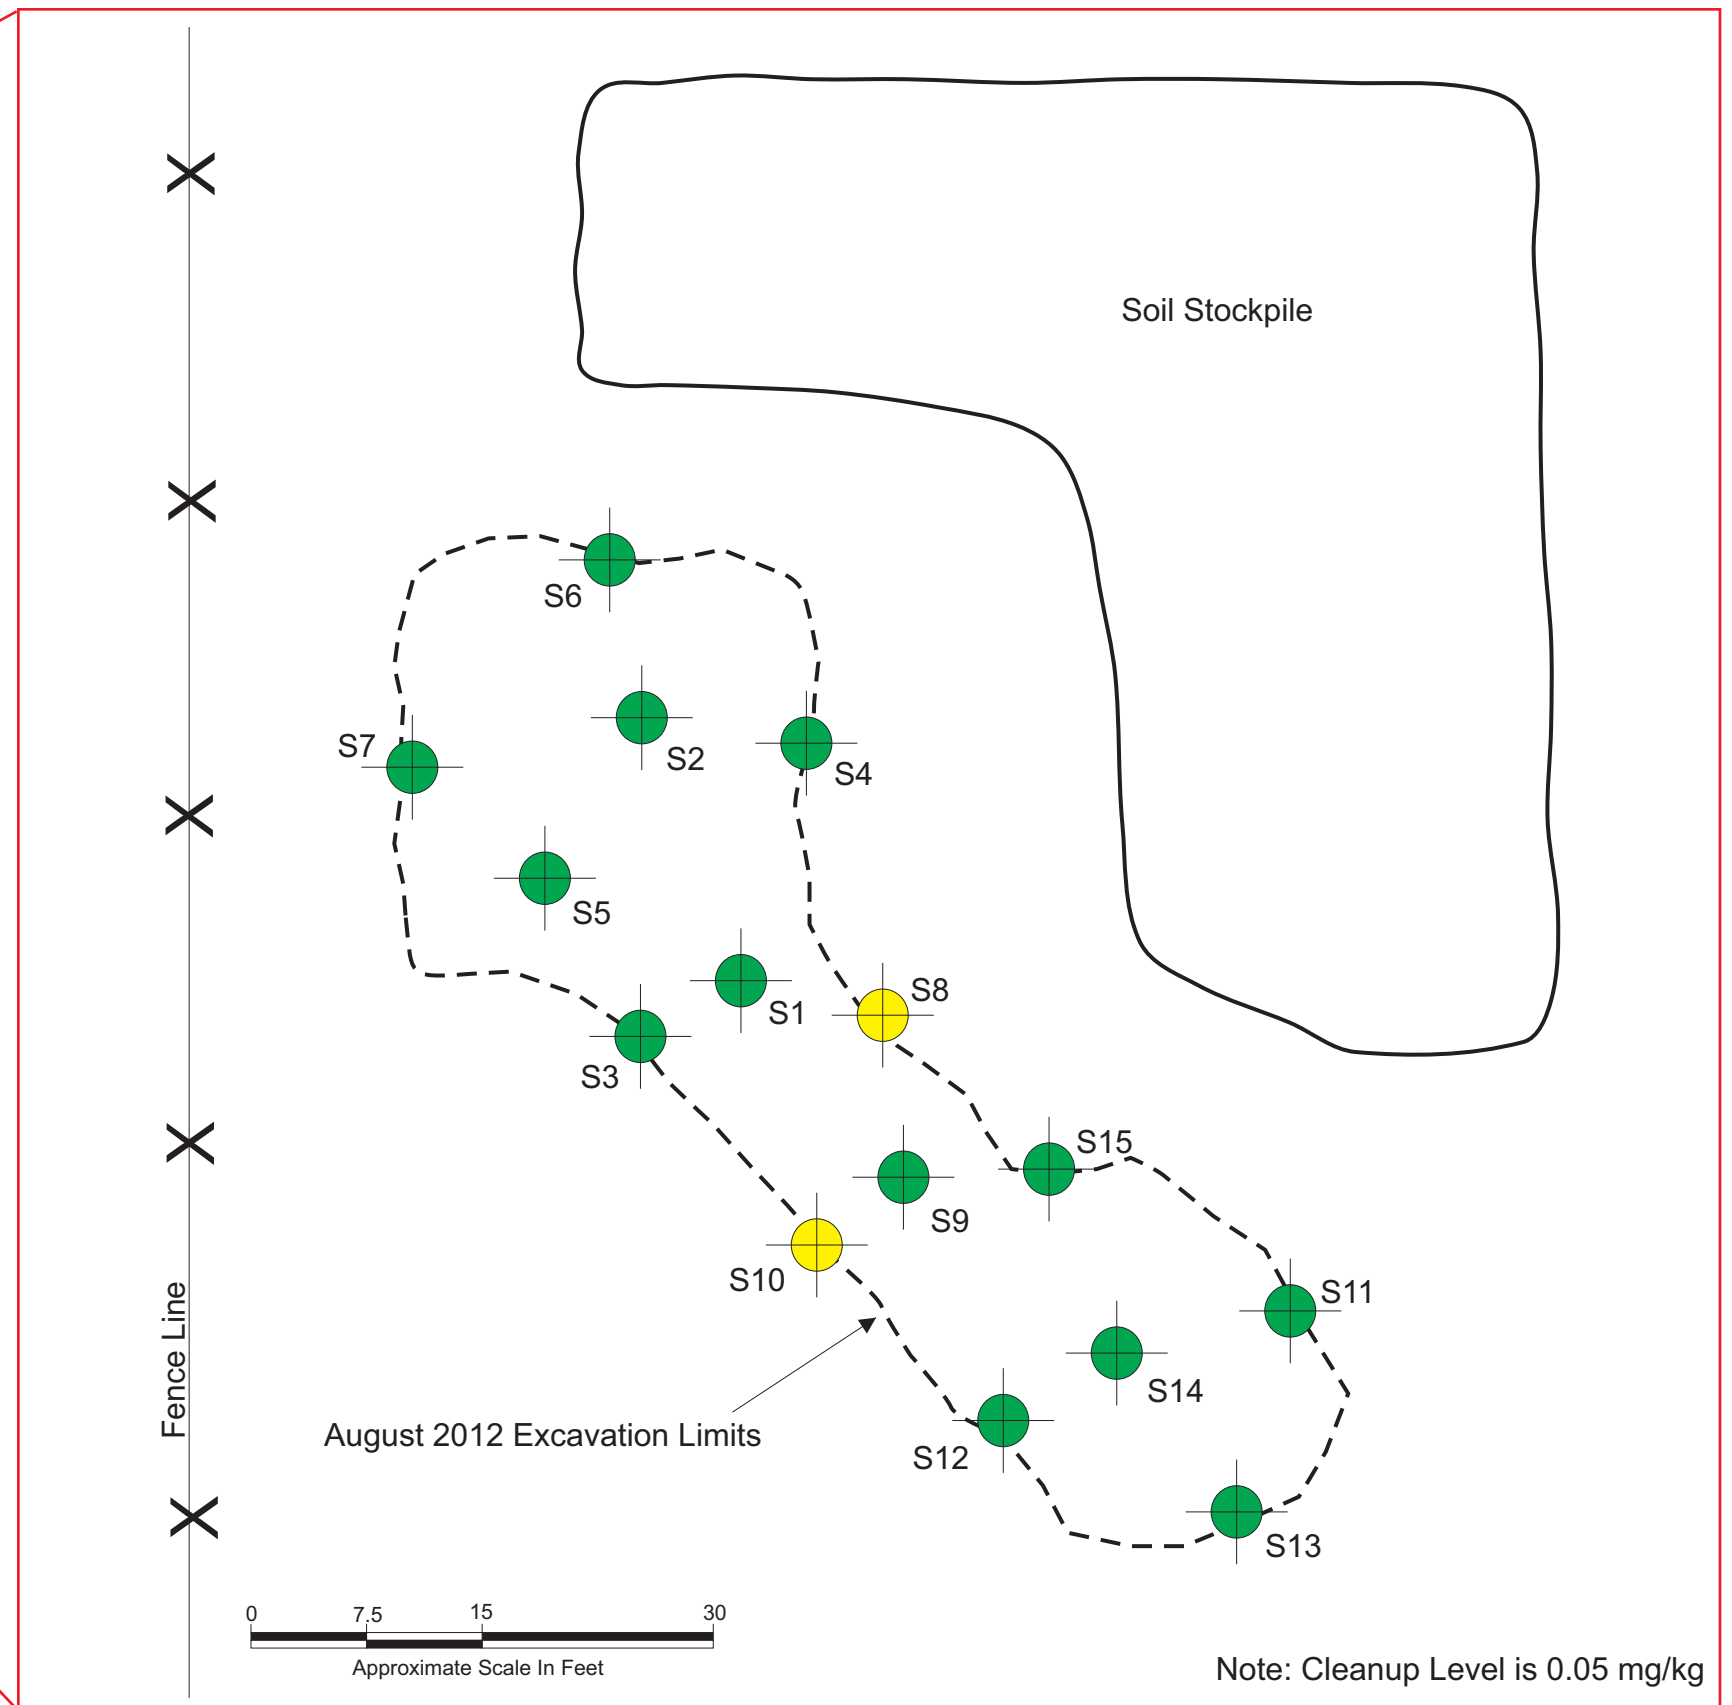
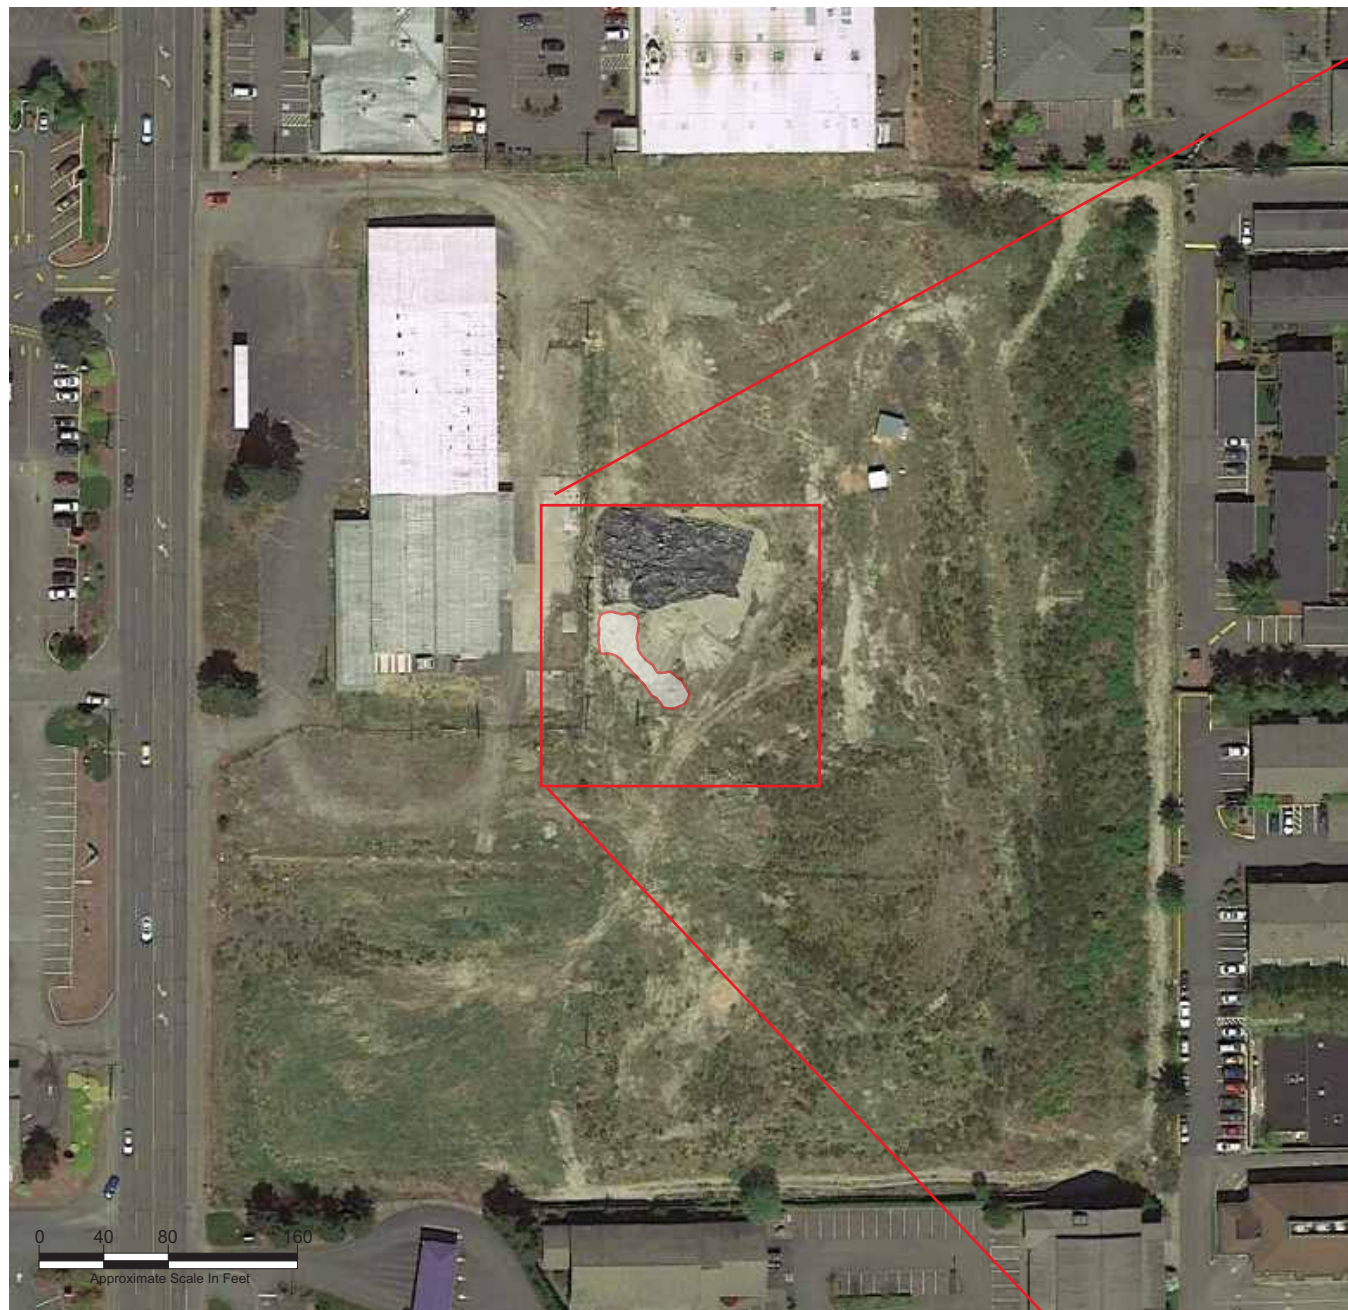
Figure No.: **04**  
 Sheet 04 of 05

Soil sample locations reported below laboratory reporting levels and below MTCA-A Cleanup Levels (CUL)
-

Soil sample locations reported above laboratory reporting levels of 0.02 mg/kg but below the CUL of 0.05 mg/kg

**PCE Soil Sample Location Map**  
 Remedial Excavation  
 2119 Mildred Street  
 Fircrest, Washington

Starting on the north and extending to the south, soil samples were collected at and approximate 10 foot interval along the excavation sidewalls and from the floor of the excavation. Nine soil samples were collected from the perimeter of the excavation at seven to nine feet bgs, and six from the floor of the excavation at elevations ranging from eleven to thirteen feet bgs.

Sample analysis reported each of the confirmation soil samples below the MTCA-A CUL for PCE. Two samples, B8-8-9 and B10-8-9' were each reported containing PCE at 0.021 and 0.027 mg/kg, exceeding the laboratory method reporting limit of 0.02 mg/kg. Additionally, five other volatile organic compounds were analyzed. Each sample was analyzed for Vinyl Chloride (VC), 1,1-Dichloroethene, trans-1,2-Dichloroethene, cis -1,2-Dichloroethene and Trichloroethene (TCE) and reported below the laboratory method reporting level or none-detect.

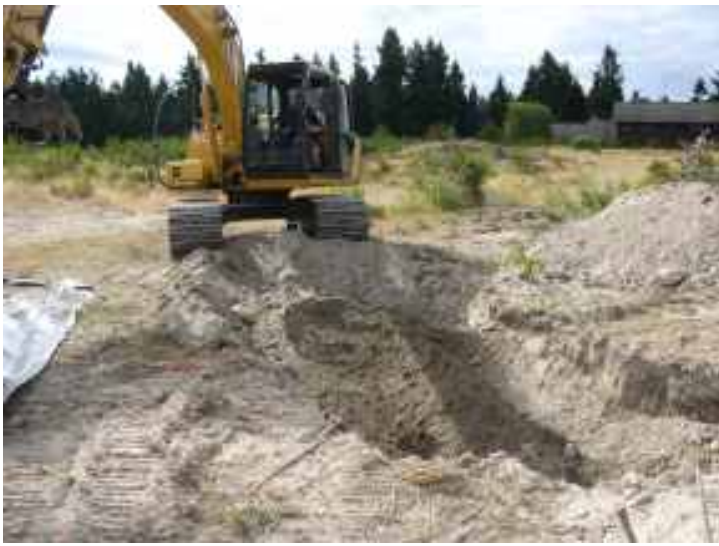
Photograph 01: Excavation area - View east

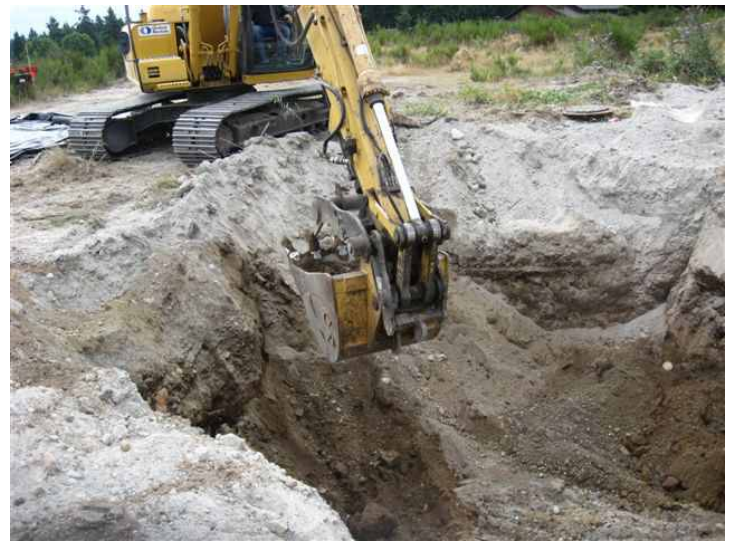
Photograph 02: Excavation of soil

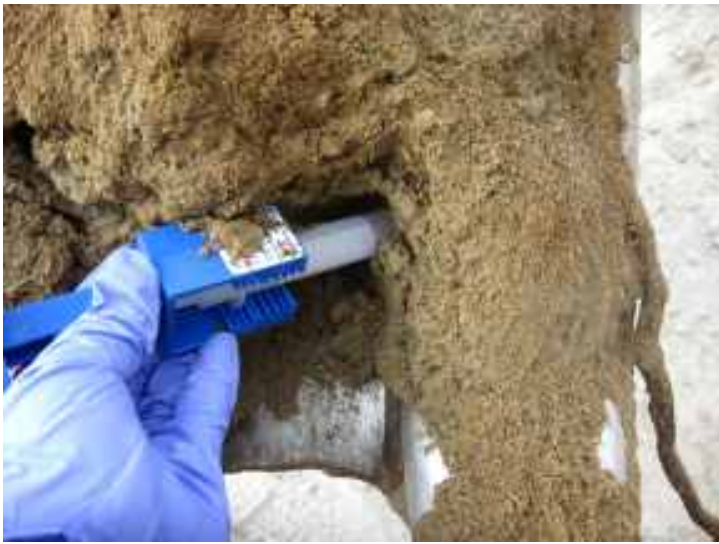
Photograph 03: Soil sample collection - EPA Method 5035

Samples were collected by a properly trained environmental professional using industry standard sampling techniques, including Environmental Protection Agency (EPA) sampling method 5035. Select soil was gathered from the sample locations and placed into Labroatory provided, new analyte specific sample containers. Following collection, each sample was assigned a unique sample identification number and submitted to an onsite environmental laboratory for analysis. Each sample was analyzed for chlorinated volatile organic compounds by EPA Method 8260C.

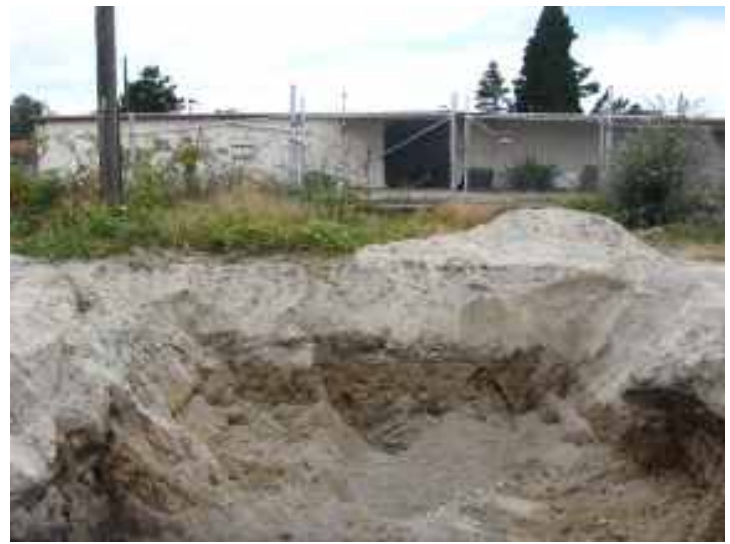
Photograph 04: Excavation area - View West

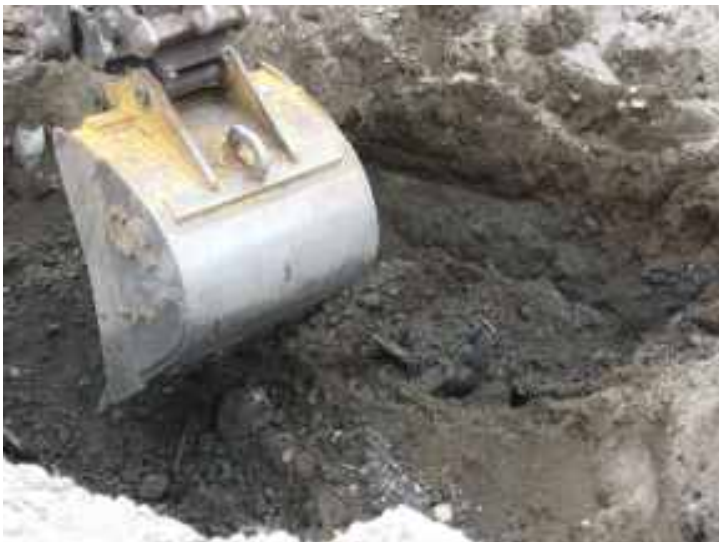
Photograph 05: Continued excavation of soil

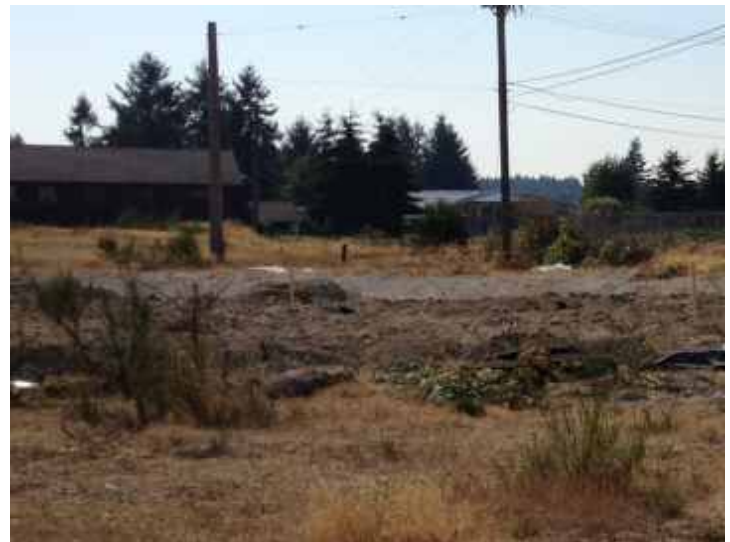
Photograph 06: Soil Stockpile - View South

Soil, previously identified as containing PCE at concentrations exceeding the MTCA-A CUL of 0.05 mg/kg was excavated and stockpiled on 10 millimeter plastic sheeting. Approximately 250 cubic yards of soil was excavated and stockpiled. Soil samples collected from the permitted and floor of the excavation area were each reported below the CUL for PCE.
