PHASE I ENVIRONMENTAL SITE ASSESSMENT

**PROPOSED FIRCREST WINCO
2119 MILDRED STREET WEST
FIRCREST, PIERCE COUNTY, WASHINGTON**

**Project Number: B2087704
Report Date: June 30, 2008**

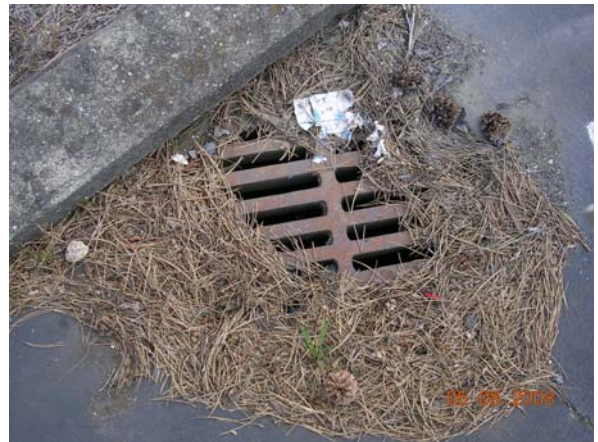
Evidence of seven catch basins were observed onsite during the site reconnaissance. According to Mr. Freeman, the catch basins discharge to the City of Fircrest stormwater system. Surficial staining or odors were not observed on or adjacent to any of the catch basins. The catch basins do not appear to represent RECs.

Photo #2 A catch basin in the parking lot

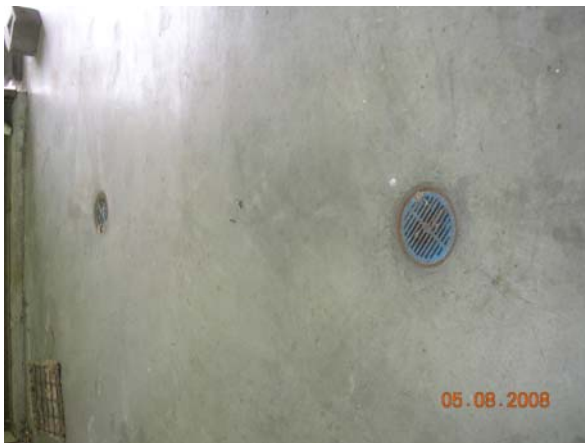
Five interior floor drains were observed in the painting building and two drains were observed on the building pad of the former materials building. According to Mr. Freeman, the floor drains discharge to the two concrete sealed recovery USTs located east of the painting building and paint storage shed. Evidence of staining or other releases to the floor drains were not observed during the site reconnaissance. Potentially hazardous materials did not appear to be stored in the vicinity of the floor drains; however, based on information provided by Mr. Freeman, it appears paints, solvents, and degreasers were discharged through the floor drains. According to a previous report completed by others, a soil sample collected from the bottom of one drain located in the materials building was reported to contain diesel-range TPH at a concentration of 420 mg/kg and heavy oil-range TPH at a concentration of 1,700 mg/kg. Based on information provided by Mr. Freeman and the previous report, these floor drains appear to represent a RECs.

Photo #5 Floor drains in the painting building

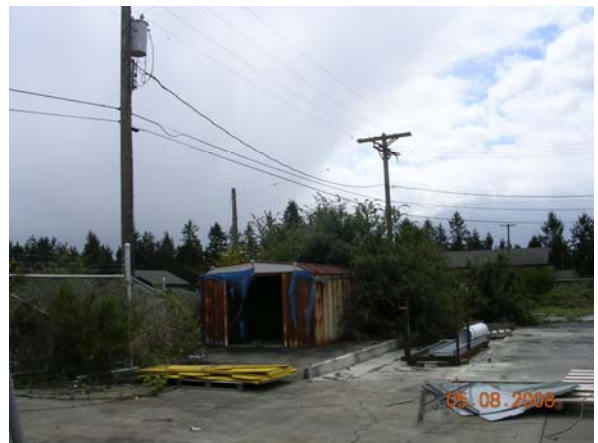
During Terracon's site visit, four pole-mounted transformers, owned and serviced by Puget Sound Energy, were observed; however, no information with regard to PCB content of the transformer fluids was observed. Transformers contain mineral oil which may contain minor amounts of PCB and could be considered "PCB contaminated" (PCB content of 50-500 ppm).

Photo #6 The paint storage building and a power pole with a transformer

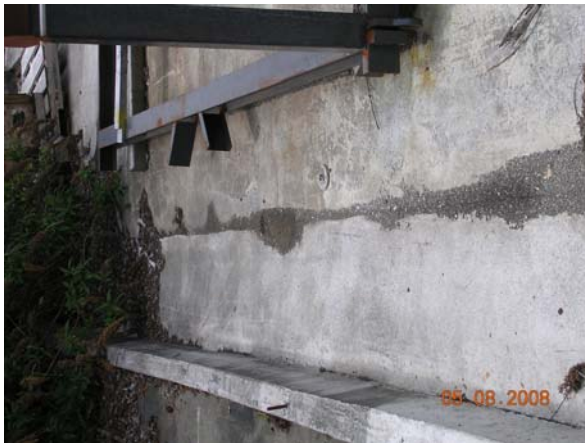
Photo #9 The drum storage area

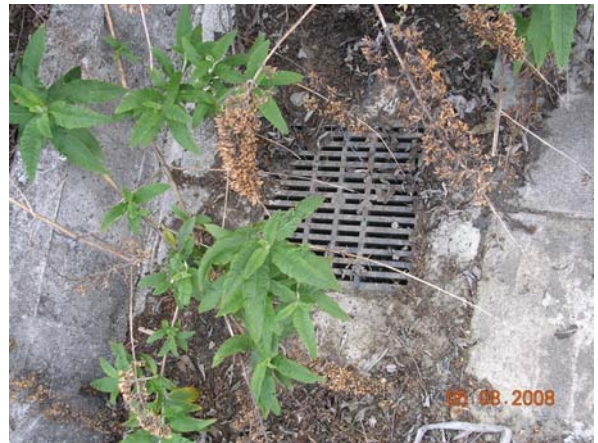
Another catch basin was observed in the former drum storage area. According to Mr. Freeman, this catch basin discharges to the southern sealed recovery UST, located east of the paint storage building. Surficial staining or odors were not observed on or adjacent to the catch basin; however, based on the contents of drums formerly stored in the vicinity of the catch basin, this catch basin appears to represent a REC.

Photo #10 The catch basin in the drum storage area

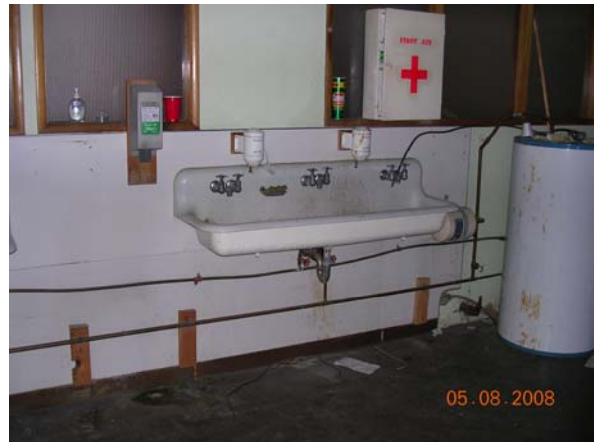
The subject site is equipped with three septic tanks, one located south of the main building and the other two located east of the main building (Figure 3). According to Mr. Freeman, the septic tanks were used exclusively for discharge from the restrooms located in the main building and no hazardous material was discharged to the septic system. Stressed vegetation or noxious odors was not observed in the vicinity of the on-site septic tanks and drain fields. However, based on the substantial historic use of potentially hazardous materials at the site, the septic tanks and leach fields appear to represent a REC.

Photo #14 One of the sinks connected to the septic system

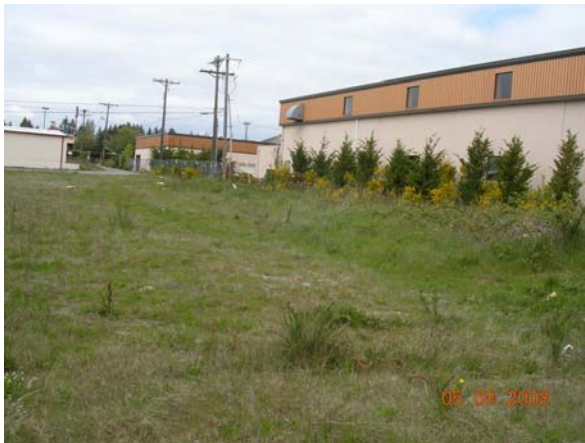
- Pace Industries (Pace) operated a foundry on the property that adjoins the site to the north. A pipe rupture caused a spill of paraffin oil onto unimproved ground in the southern portion of the Pace property and the north-central portion of the subject site. The Freeman family reportedly initiated remediation activities to remove the impacted soil on the site. According to Mr. Freeman, cleanup of the spill on the Pace property was not completed for quite some time. Mr. Freeman was not convinced that the cleanup process on the Pace property was completed correctly and believed that contamination still remained. Mr. Freeman also indicated that the floor within the Pace facility was heavily cracked and that the company commonly disposed of waste material outside the southeastern corner of the building. See Section 3.11 and 4.1 for further details on the Pace facility.

Photo #15 The northern portion of the site with the Pace Industries property in the background

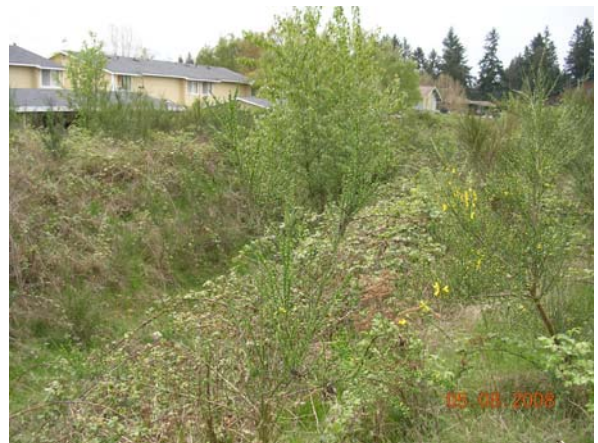
Photo #18 The drainage ditch along the eastern site boundary
