RE: LIMITED PHASE II ENVIRONMENTAL SITE ASSESSMENT, APPROXIMATE 13.4 ACRES
– WALLER ROAD, FREDERICKSON, WASHINGTON

Shannon & Wilson has completed a Limited Phase II Environmental Site Assessment (ESA) to support the Bethel School District's acquisition of the northern approximately 13.4-acre portion (the Property) of Pierce County parcel 0319262004, adjacent to and west of Waller Road East in Frederickson, Washington. This assessment was conducted in accordance with the scope of services presented within the revised proposal dated February 7, 2019.

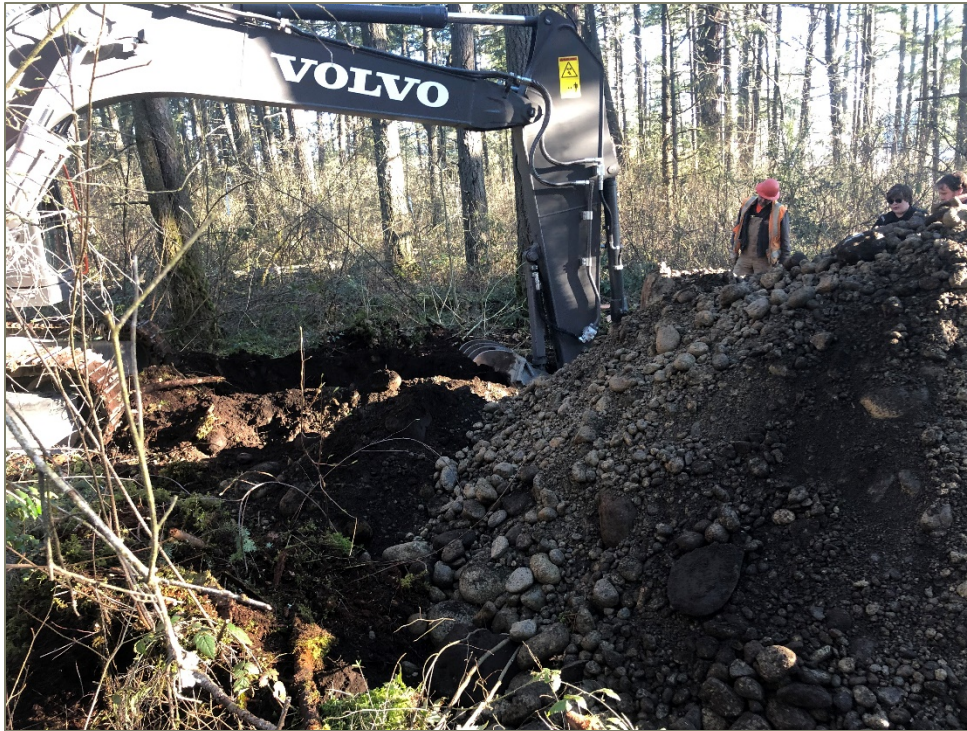
Photograph 1: Excavation of Test Pit 7 (TP-7).

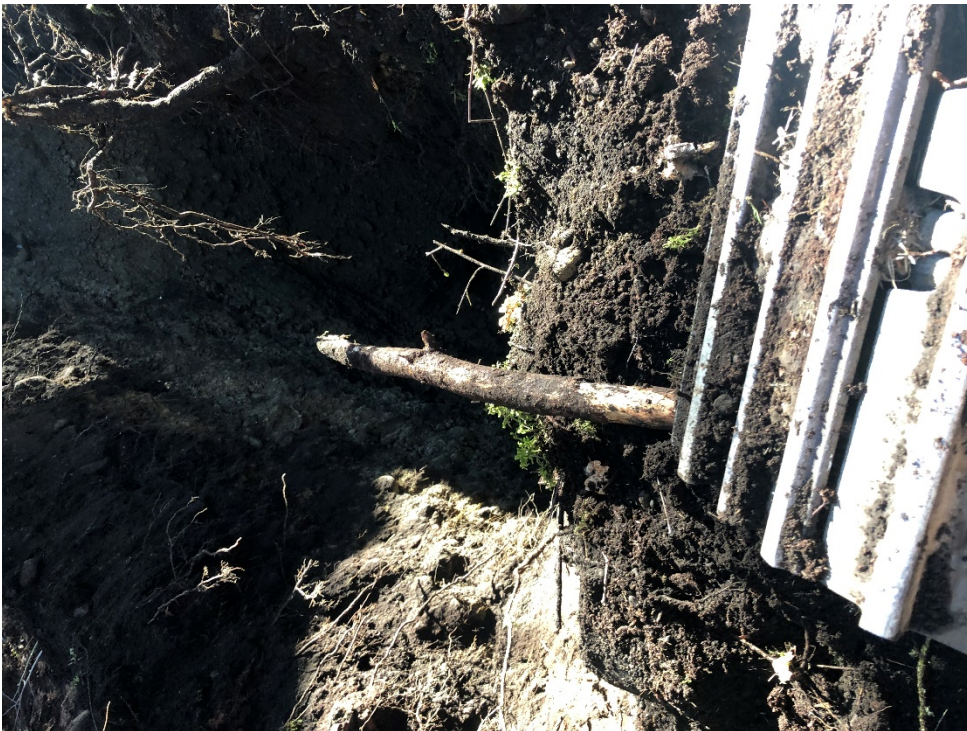
Photograph 2: Excavation of Test Pit 6 (TP-6).

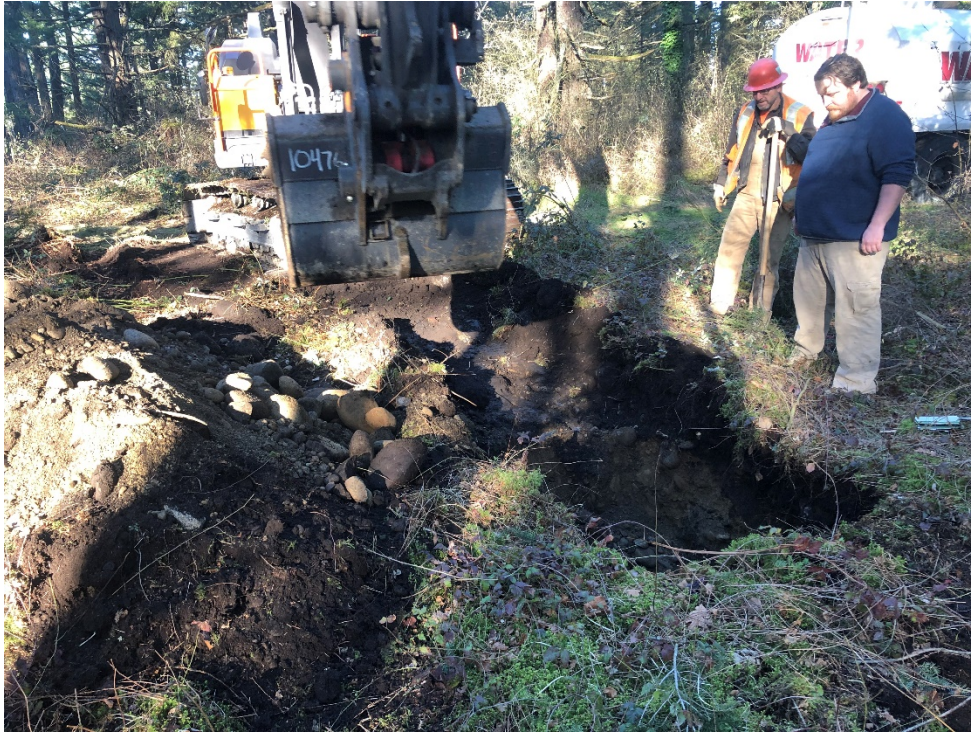
Photograph 3: Excavation of Infiltration Trench 1 (INF-1).

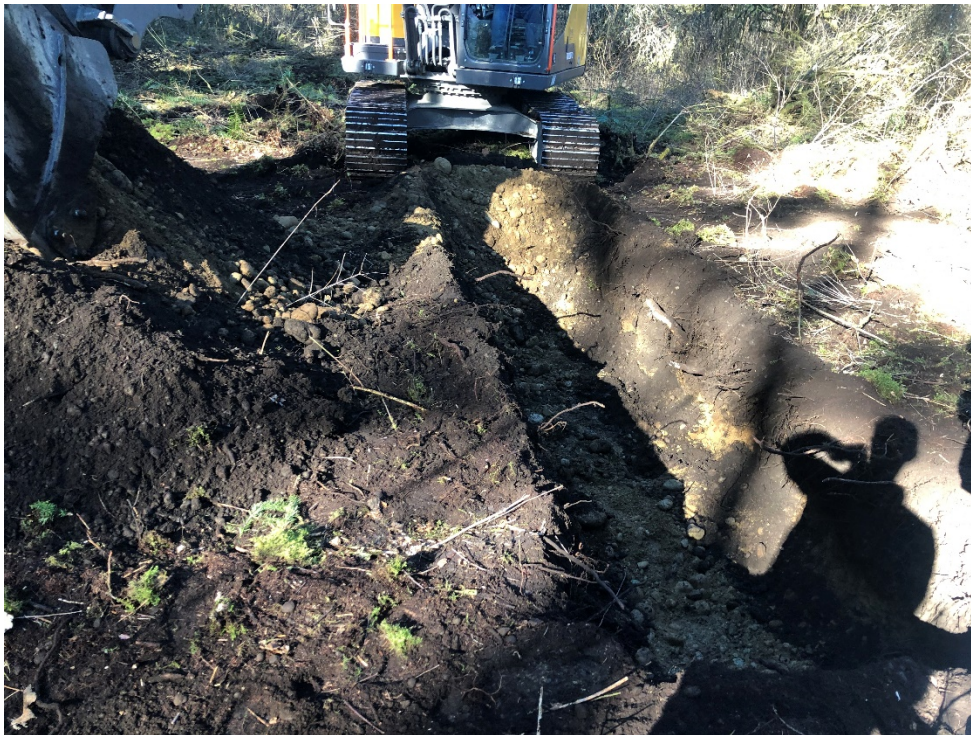
Photograph 4: Excavation of Test Pit 8 (TP-8). Approximately 2feet of brown, poorly graded sand with organics over a foot of weathered outwash over unweathered outwash, extending the bottom of excavation.

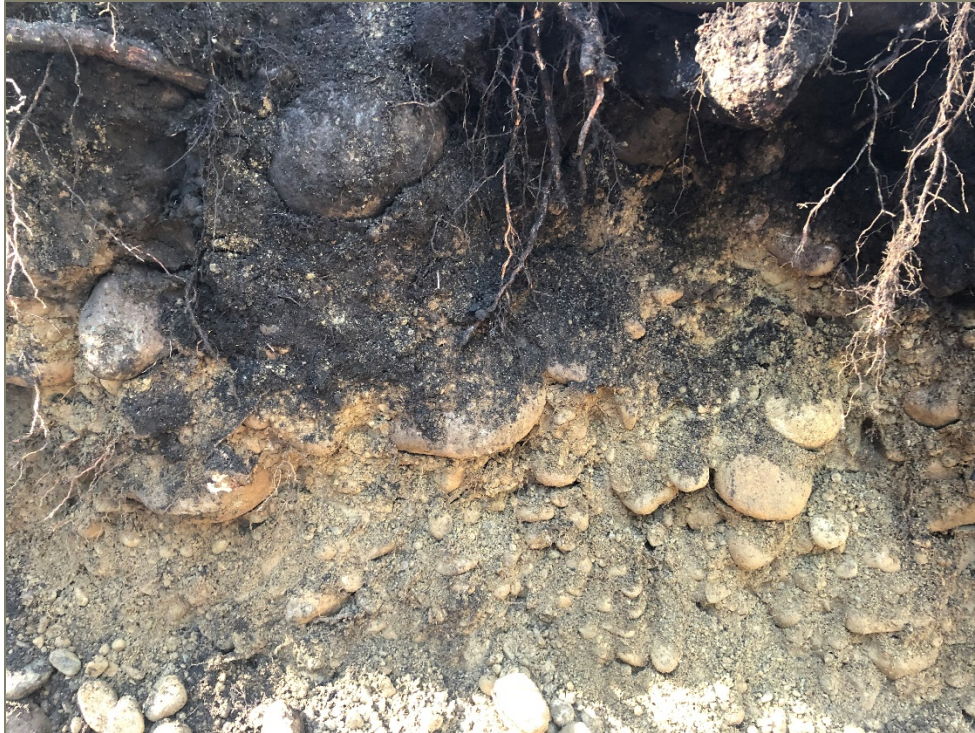
approximately 1 to 2 feet of weathered, medium dense outwash, which was comprised of a gravel with silts, sand, cobbles, and boulders and occasionally roots. Photograph 5 of Appendix B shows the transition between the upper two layers. A dense, unweathered outwash was observed below the weathered layer.

Photograph 5: Transition from brown sand with organics to weathered outwash.

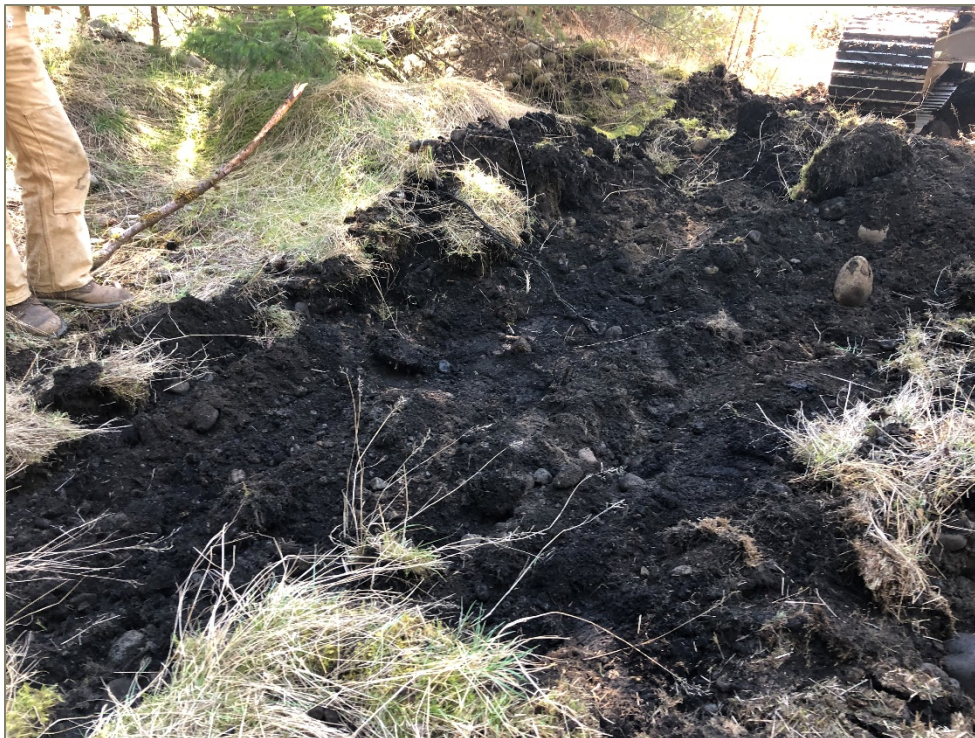
Within TP-9, dumped items including tires, electrical wire, rusted metal (including a crushed and ripped drum of approximately 32-gallon capacity), rubber, foam, concrete block, bricks, and treated wood were observed (Photographs 6 through 9 of Appendix B). The metal debris observed during the Phase I ESA was discovered to be a drum lid and the surrounding soil was observed to be stained blue-gray and had a pungent petroleum odor. The pit was completed to a depth of 8 feet below ground surface (bgs) in an attempt to delineate the impacted depth. The excavation stopped when dense, unweathered outwash was encountered (Photograph 10 of Appendix B). A sample of the stained soil was taken from 2.5 feet bgs and a bottom sample was taken from 8 feet bgs. Following completion of the test pit, the removed soil was replaced in the test pit (Photograph 11 of Appendix B).

Photograph 6: Beginning excavation of Test Pit 9 (TP-9). Electrical wire was uncovered.

Shannon & Wilson recommends that the Bethel School District request that the material encountered at TP-9 be removed by the Road Operations Division prior to the purchase of the Property. Based on the results of the lead TCLP analysis, the material encountered at 2.5 feet bgs is hazardous waste. Further TCLP testing was not completed to determine the extent at which lead was present at hazardous waste levels. Following excavation of the test pit, the material was replaced within the pit. Additional analyses including, but not limited to, polychlorinated biphenyls, volatile organic compounds (full list), and gasoline-range petroleum hydrocarbons may be necessary to support waste disposal characterization.

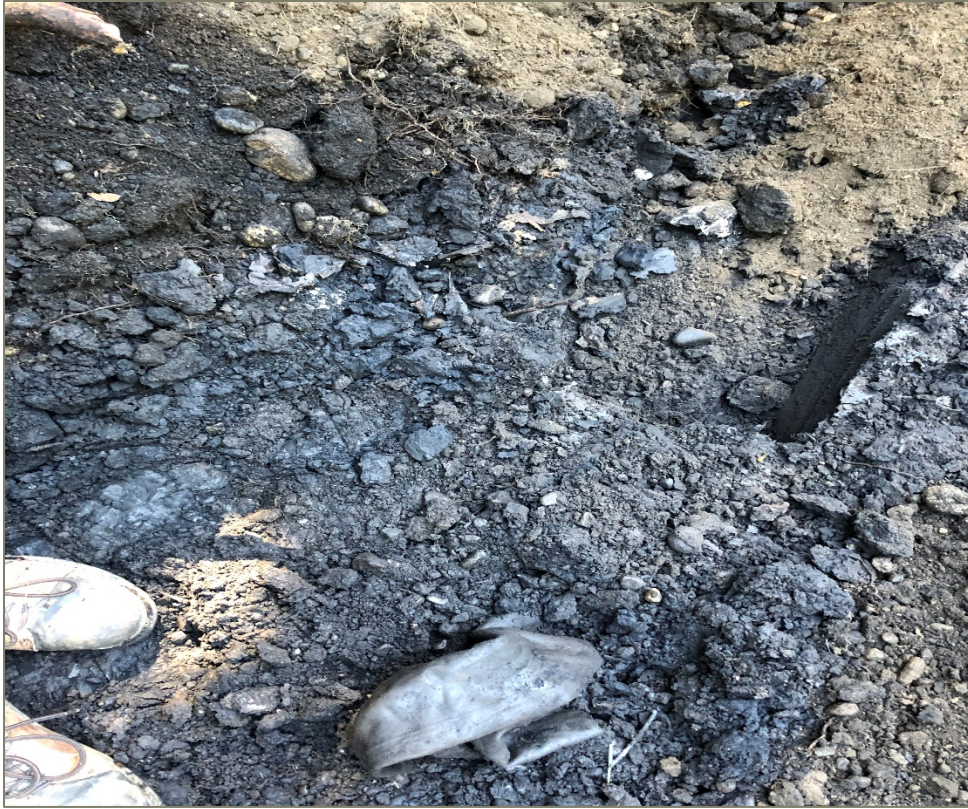
of the test pit (8 feet bgs) contained lube oil and lead at concentrations above MTCA Method A CULs; however, the concentrations were significantly lower than detected values in the sample from 2.5 feet bgs. Based on the analytical results and observations made in the field, it appears that the contamination may be from a dumped drum (possibly an approximately 32-gallon drum) that contained waste oil.

Photograph 7: Rubber tube-tire uncovered at TP-9. Blue-gray soil staining with a pungent petroleum odor.

Confirmation sampling (base and sidewall) should be completed to verify that the full extent of contamination has been removed at TP-9 to below MTCA Method A CULs. It is unknown if groundwater has been contaminated by the detected hydrocarbons and metals.

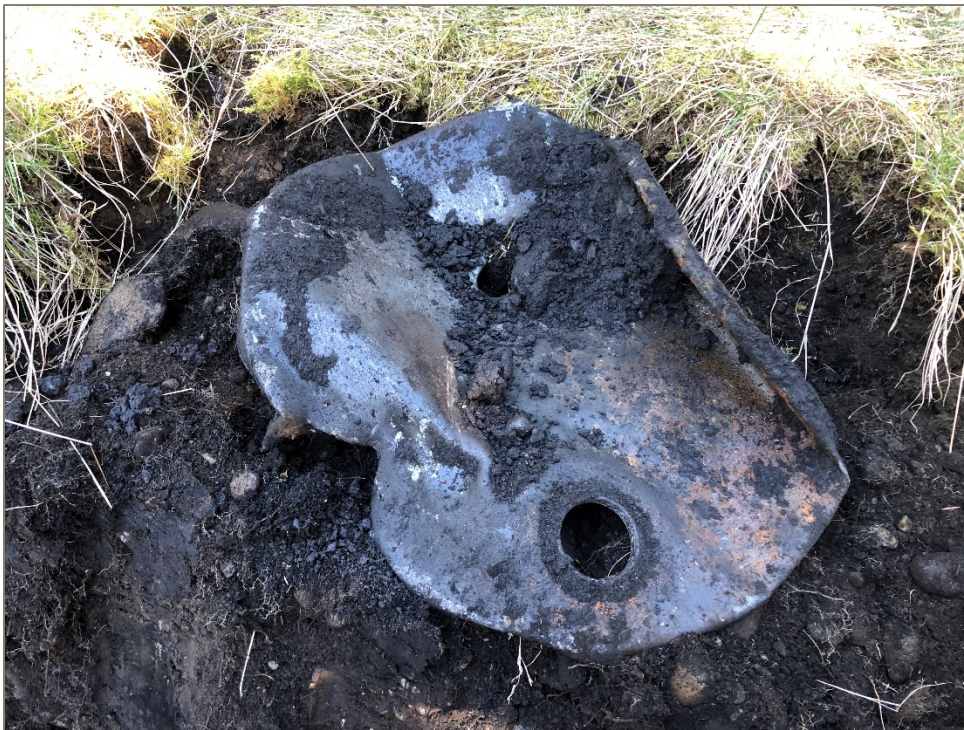
Photograph 8: Steel object uncovered at TP-9. Object appeared to be a drum lid with heavy petroleum odor.

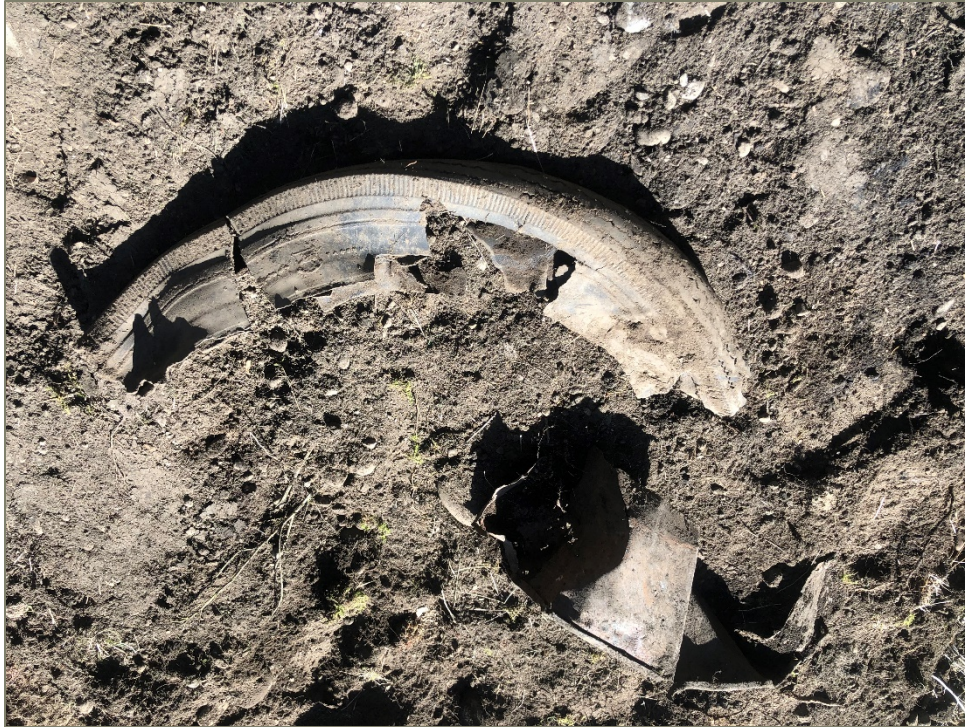
Photograph 9: Rubber tire uncovered at TP-9.

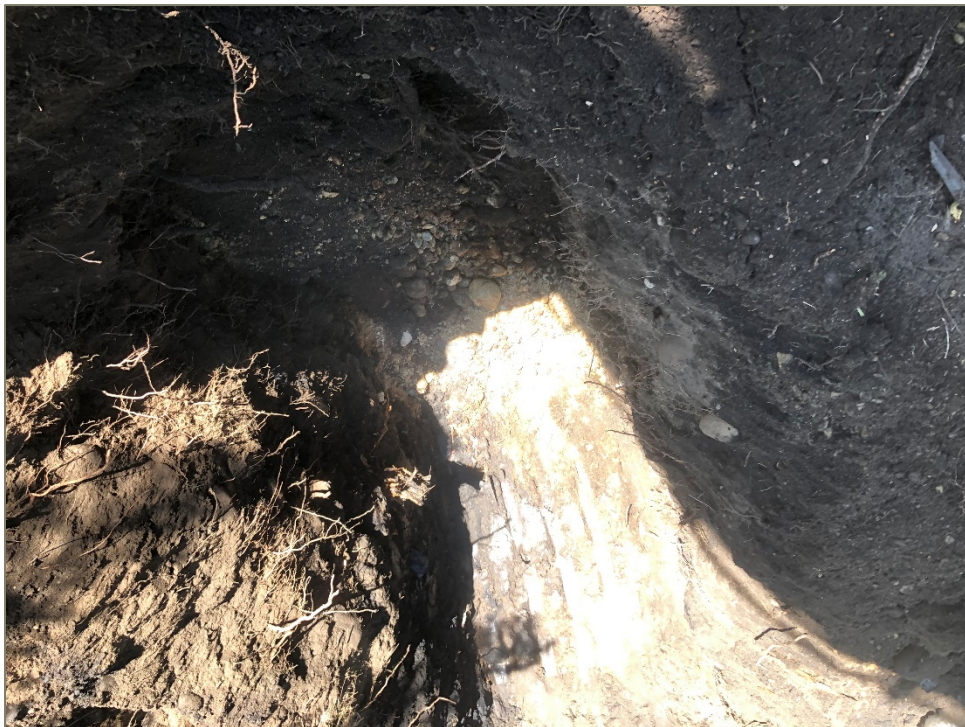
At TP-9, the top silty sand layer was approximately 7 feet thick. Between 7 and 8 feet, native, dense outwash was observed. The reason for the thicker top layer at TP-9 appears to be because the pit was completed within the raised area adjacent to the trench observed near the northern Property boundary. The thicker top layer likely included material, which had historically been excavated to from the trench.

Photograph 10: TP-9 was excavated to 8 feet below ground surface. This is when outwash was observed.

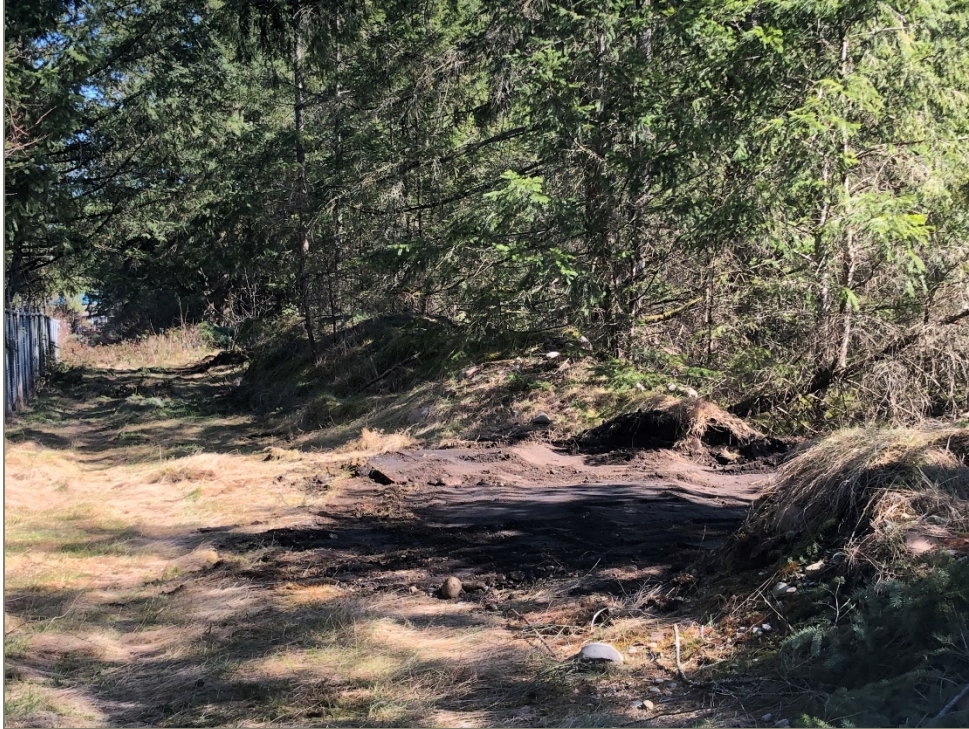
Photograph 11: TP-9 was filled in and can be seen in photo as the dark brown soil in the trees shadows. The northern boundary fence is present on the left side of the photo.

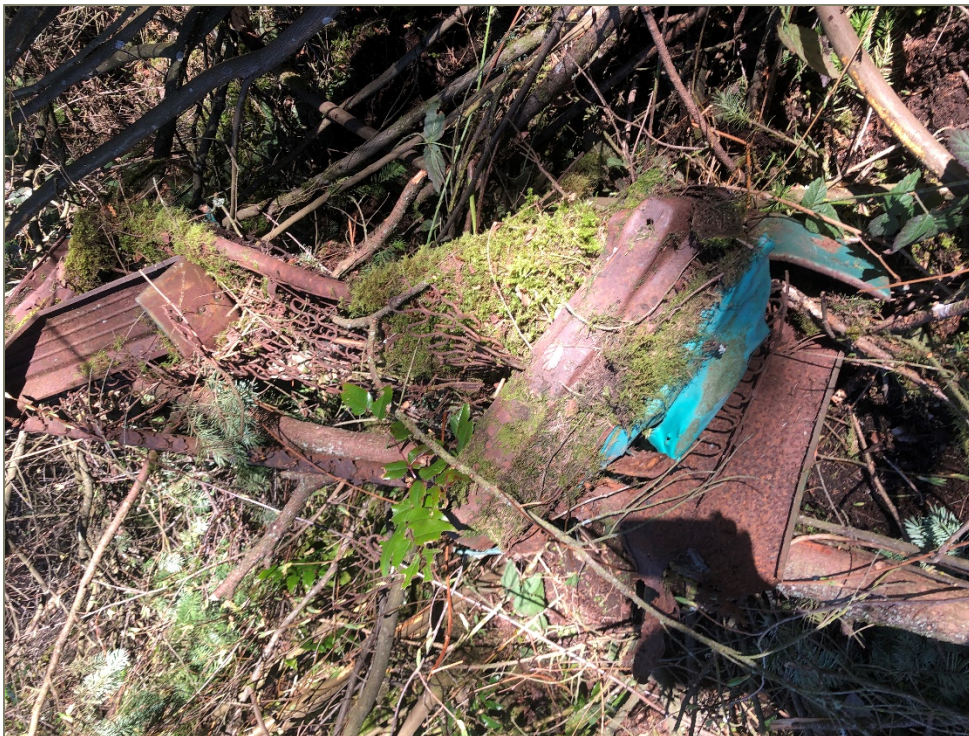
Composite samples were taken from each of TP-1 through TP-8. No signs of dumping or indication of contamination (visual or olfactory) were observed within TP-1 through TP-8. Near TP-4, remnants of an abandoned automobile body were observed above ground (Photograph 12 of Appendix B).

Photograph 12: Remnants of a vehicle were found above-ground near TP-4.

Shannon & Wilson recommends that the Bethel School District request that the abandoned automobile body remnants observed near TP-4 be removed prior to purchasing the Property. A surface and/or near-surface soil sample should be collected following removal to evaluate for contamination (hydrocarbon identification, PAHs, and priority pollutant metals) resulting from fluids potentially left present within the vehicle at the time of dumping. If contaminated soil is detected at the abandoned car location, we recommend the soil is also excavated, disposed off-site, and confirmation samples tested.
