ADDENDUM

***South Lake Union Height
and Density Alternatives EIS***

**520 Westlake Ave. N.
Development**

Master Use Permit No.: 3017466

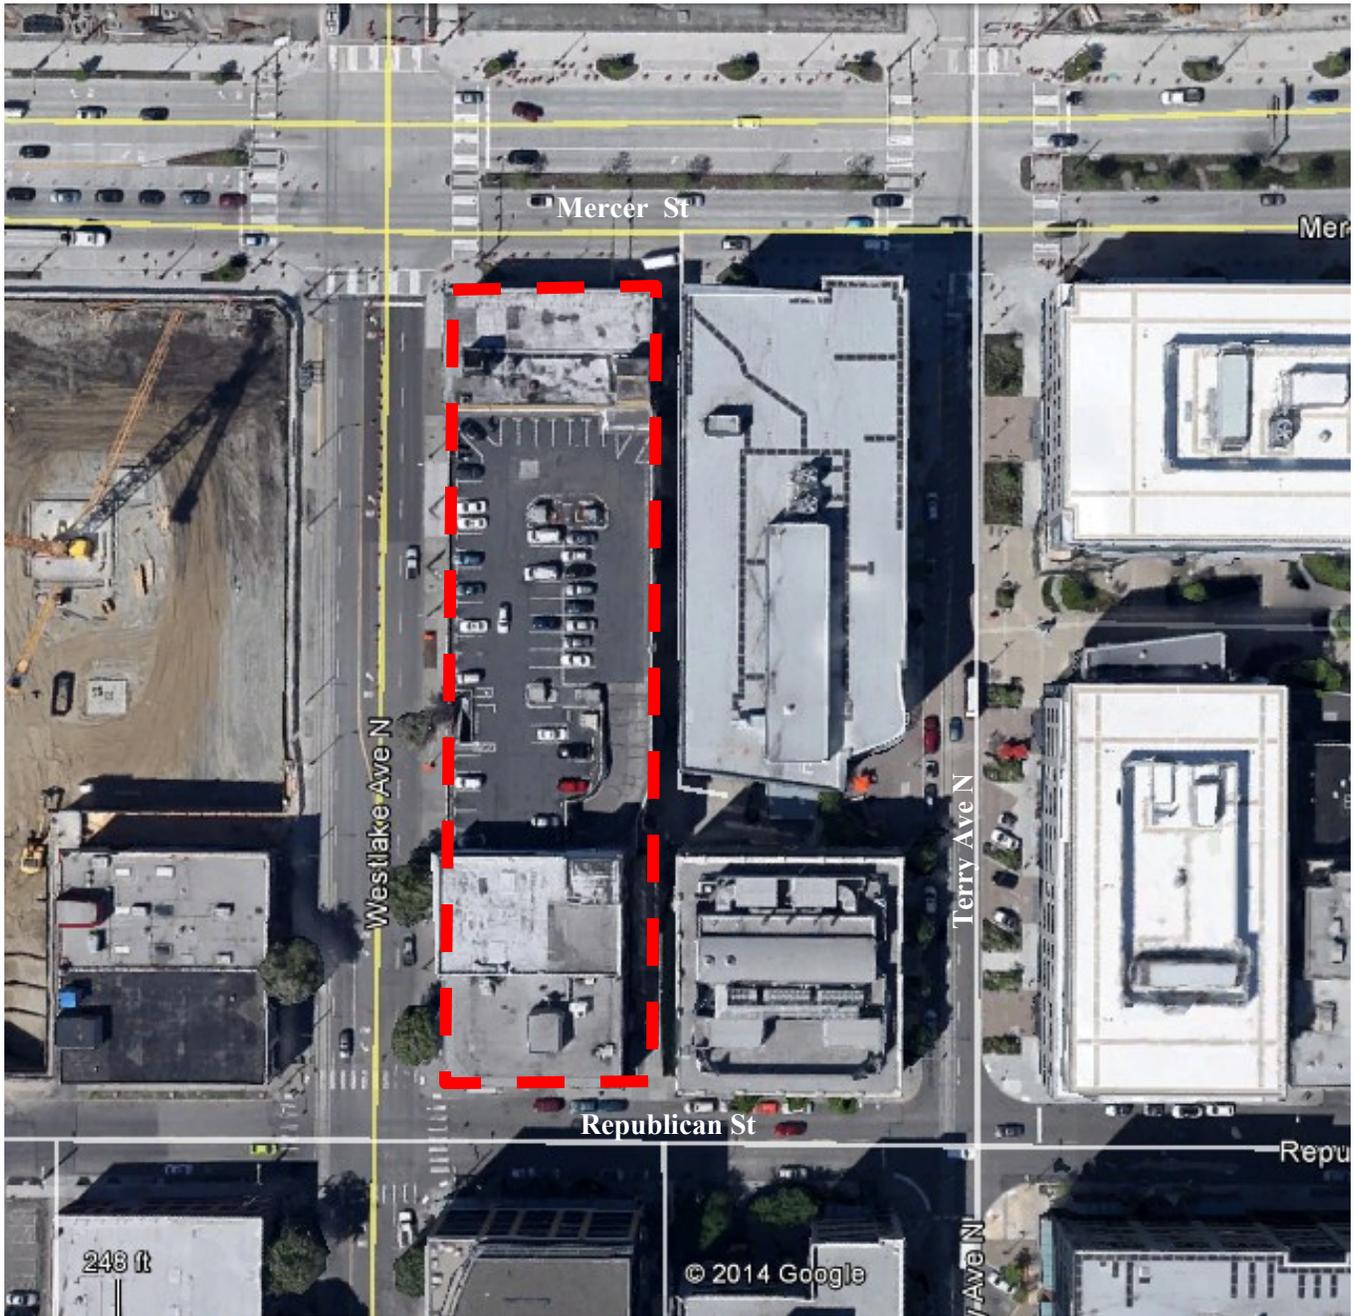
Figure 3
Existing Site Conditions

Currently, the site is entirely developed and contains three buildings, as described below (see **Figure 3** for a map of existing conditions):

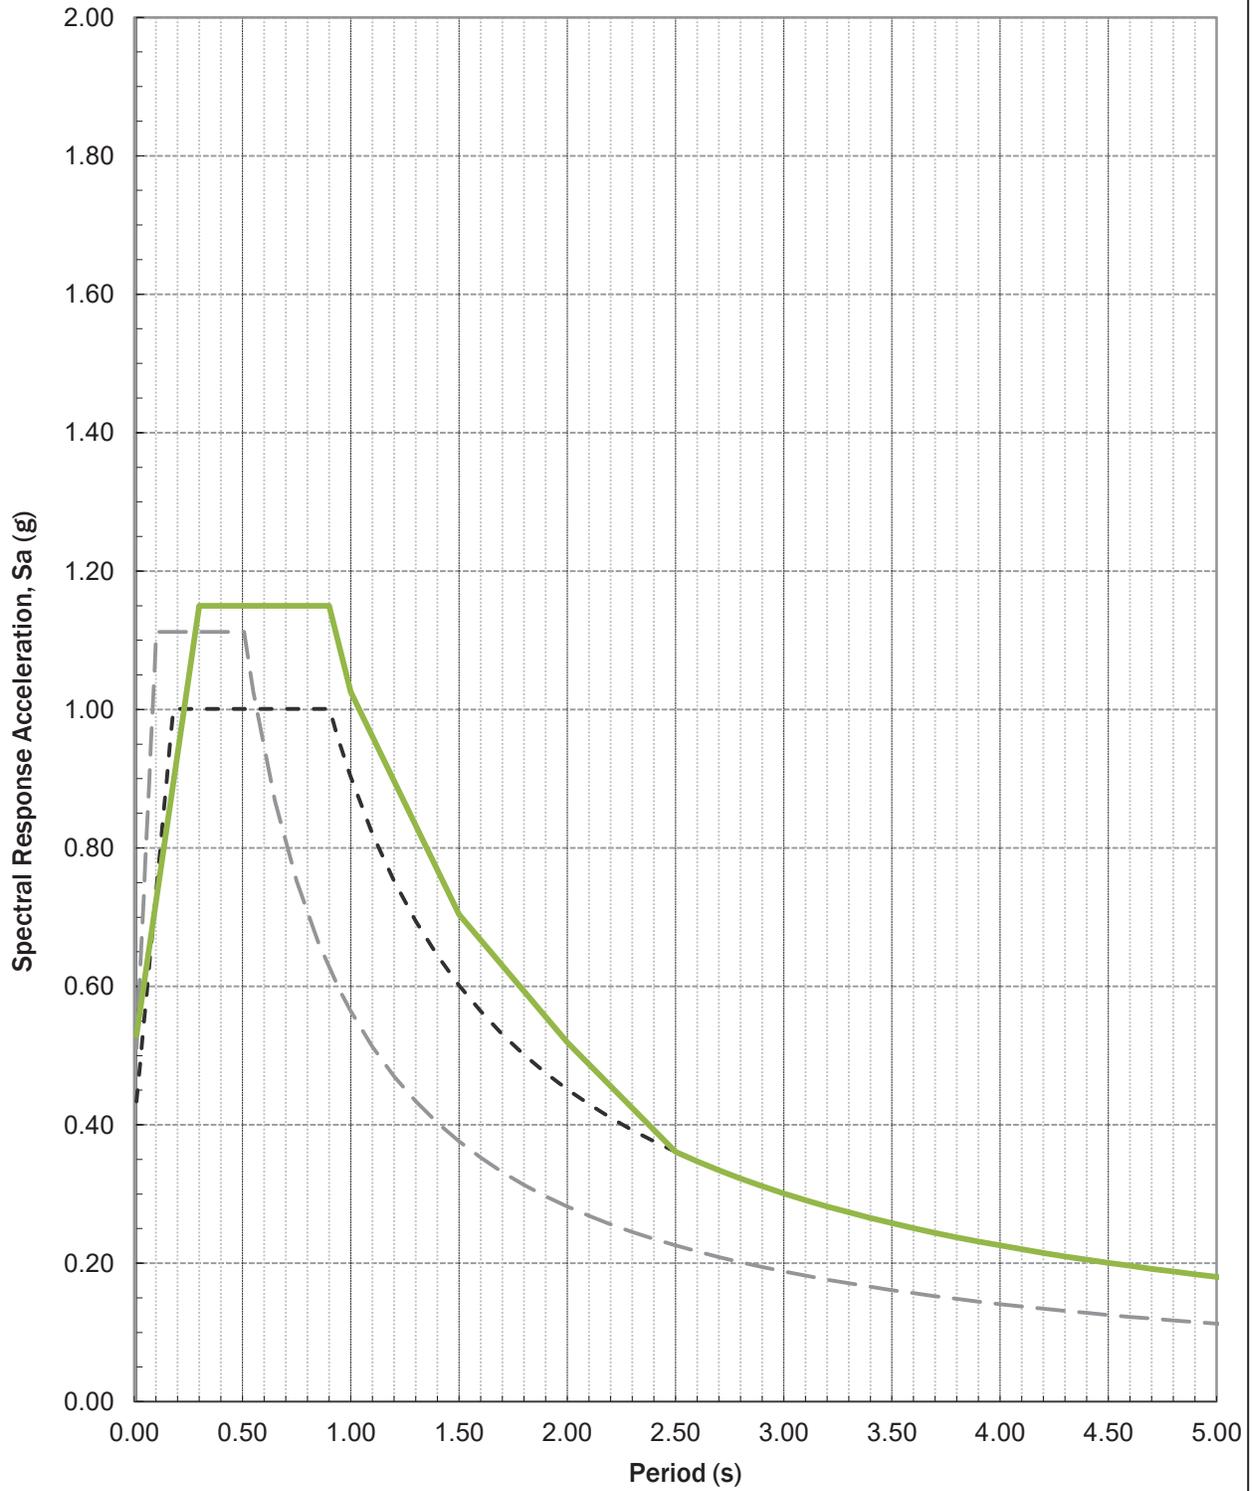
Figure 8

- 0.8 x Site Class D Generalized Response Spectrum (ASCE 7-05)
- - - 0.8 x Site Class E Generalized Response Spectrum (ASCE 7-05)
- Recommended Site Specific MCE Response Spectrum

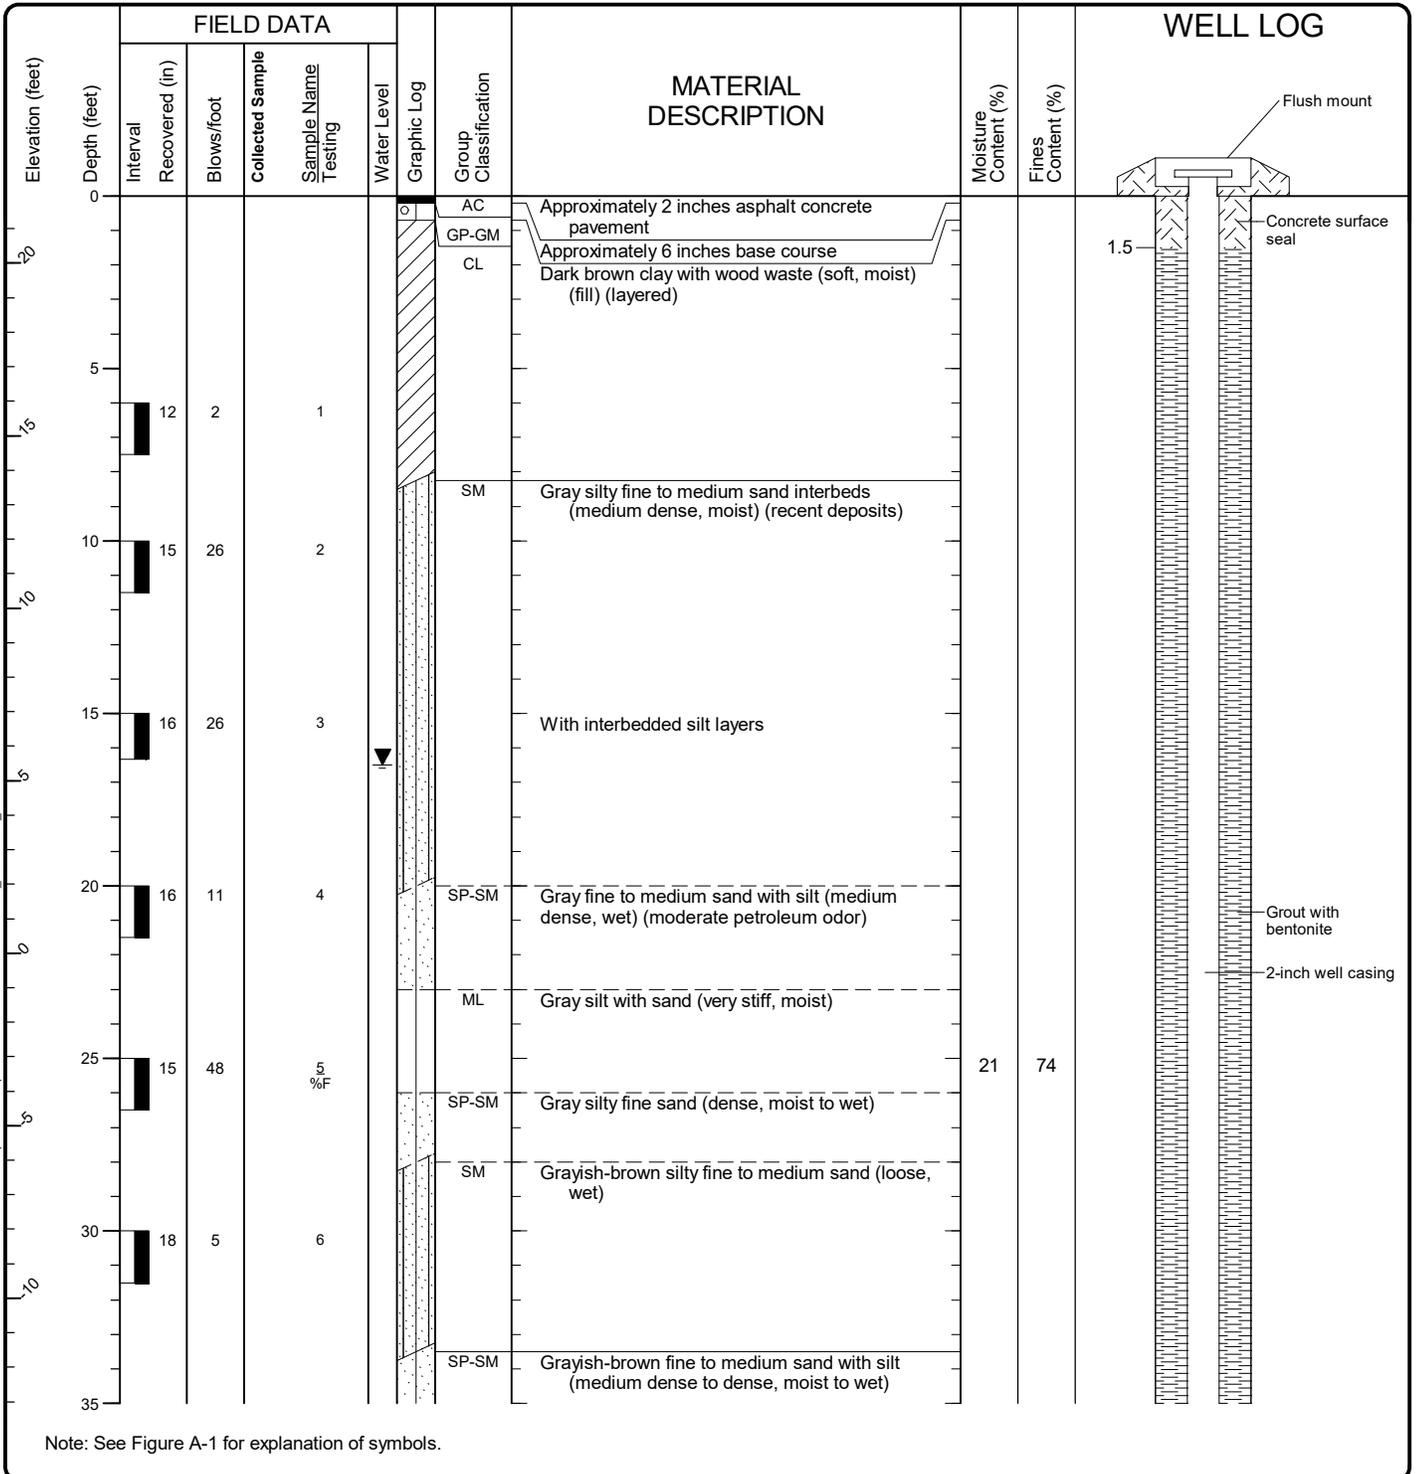
Log of Boring F-MW-130

Start Drilled 7/21/2014	End	Total Depth (ft) 61.5	Logged By Checked By	DTM DPC	Driller Cascade Drilling	Drilling Method Sonic
Hammer Data	Autohammer 140 (lbs) / 30 (in) Drop		Drilling Equipment Boart Longyear V576 Spider		A 2 (in) well was installed on 7/22/2014 to a depth of 55 (ft).	
Surface Elevation (ft) Vertical Datum		21.95 NAVD88	Top of Casing Elevation (ft) 21.58		<u>Groundwater</u> Date Measured 8/8/2014	
Easting (X) Northing (Y)		1269395.886 231129.143	Horizontal Datum NAD83		Depth to Water (ft) 16.5	Elevation (ft) 5.1
Notes: Air knife and vactor to 5.7 feet

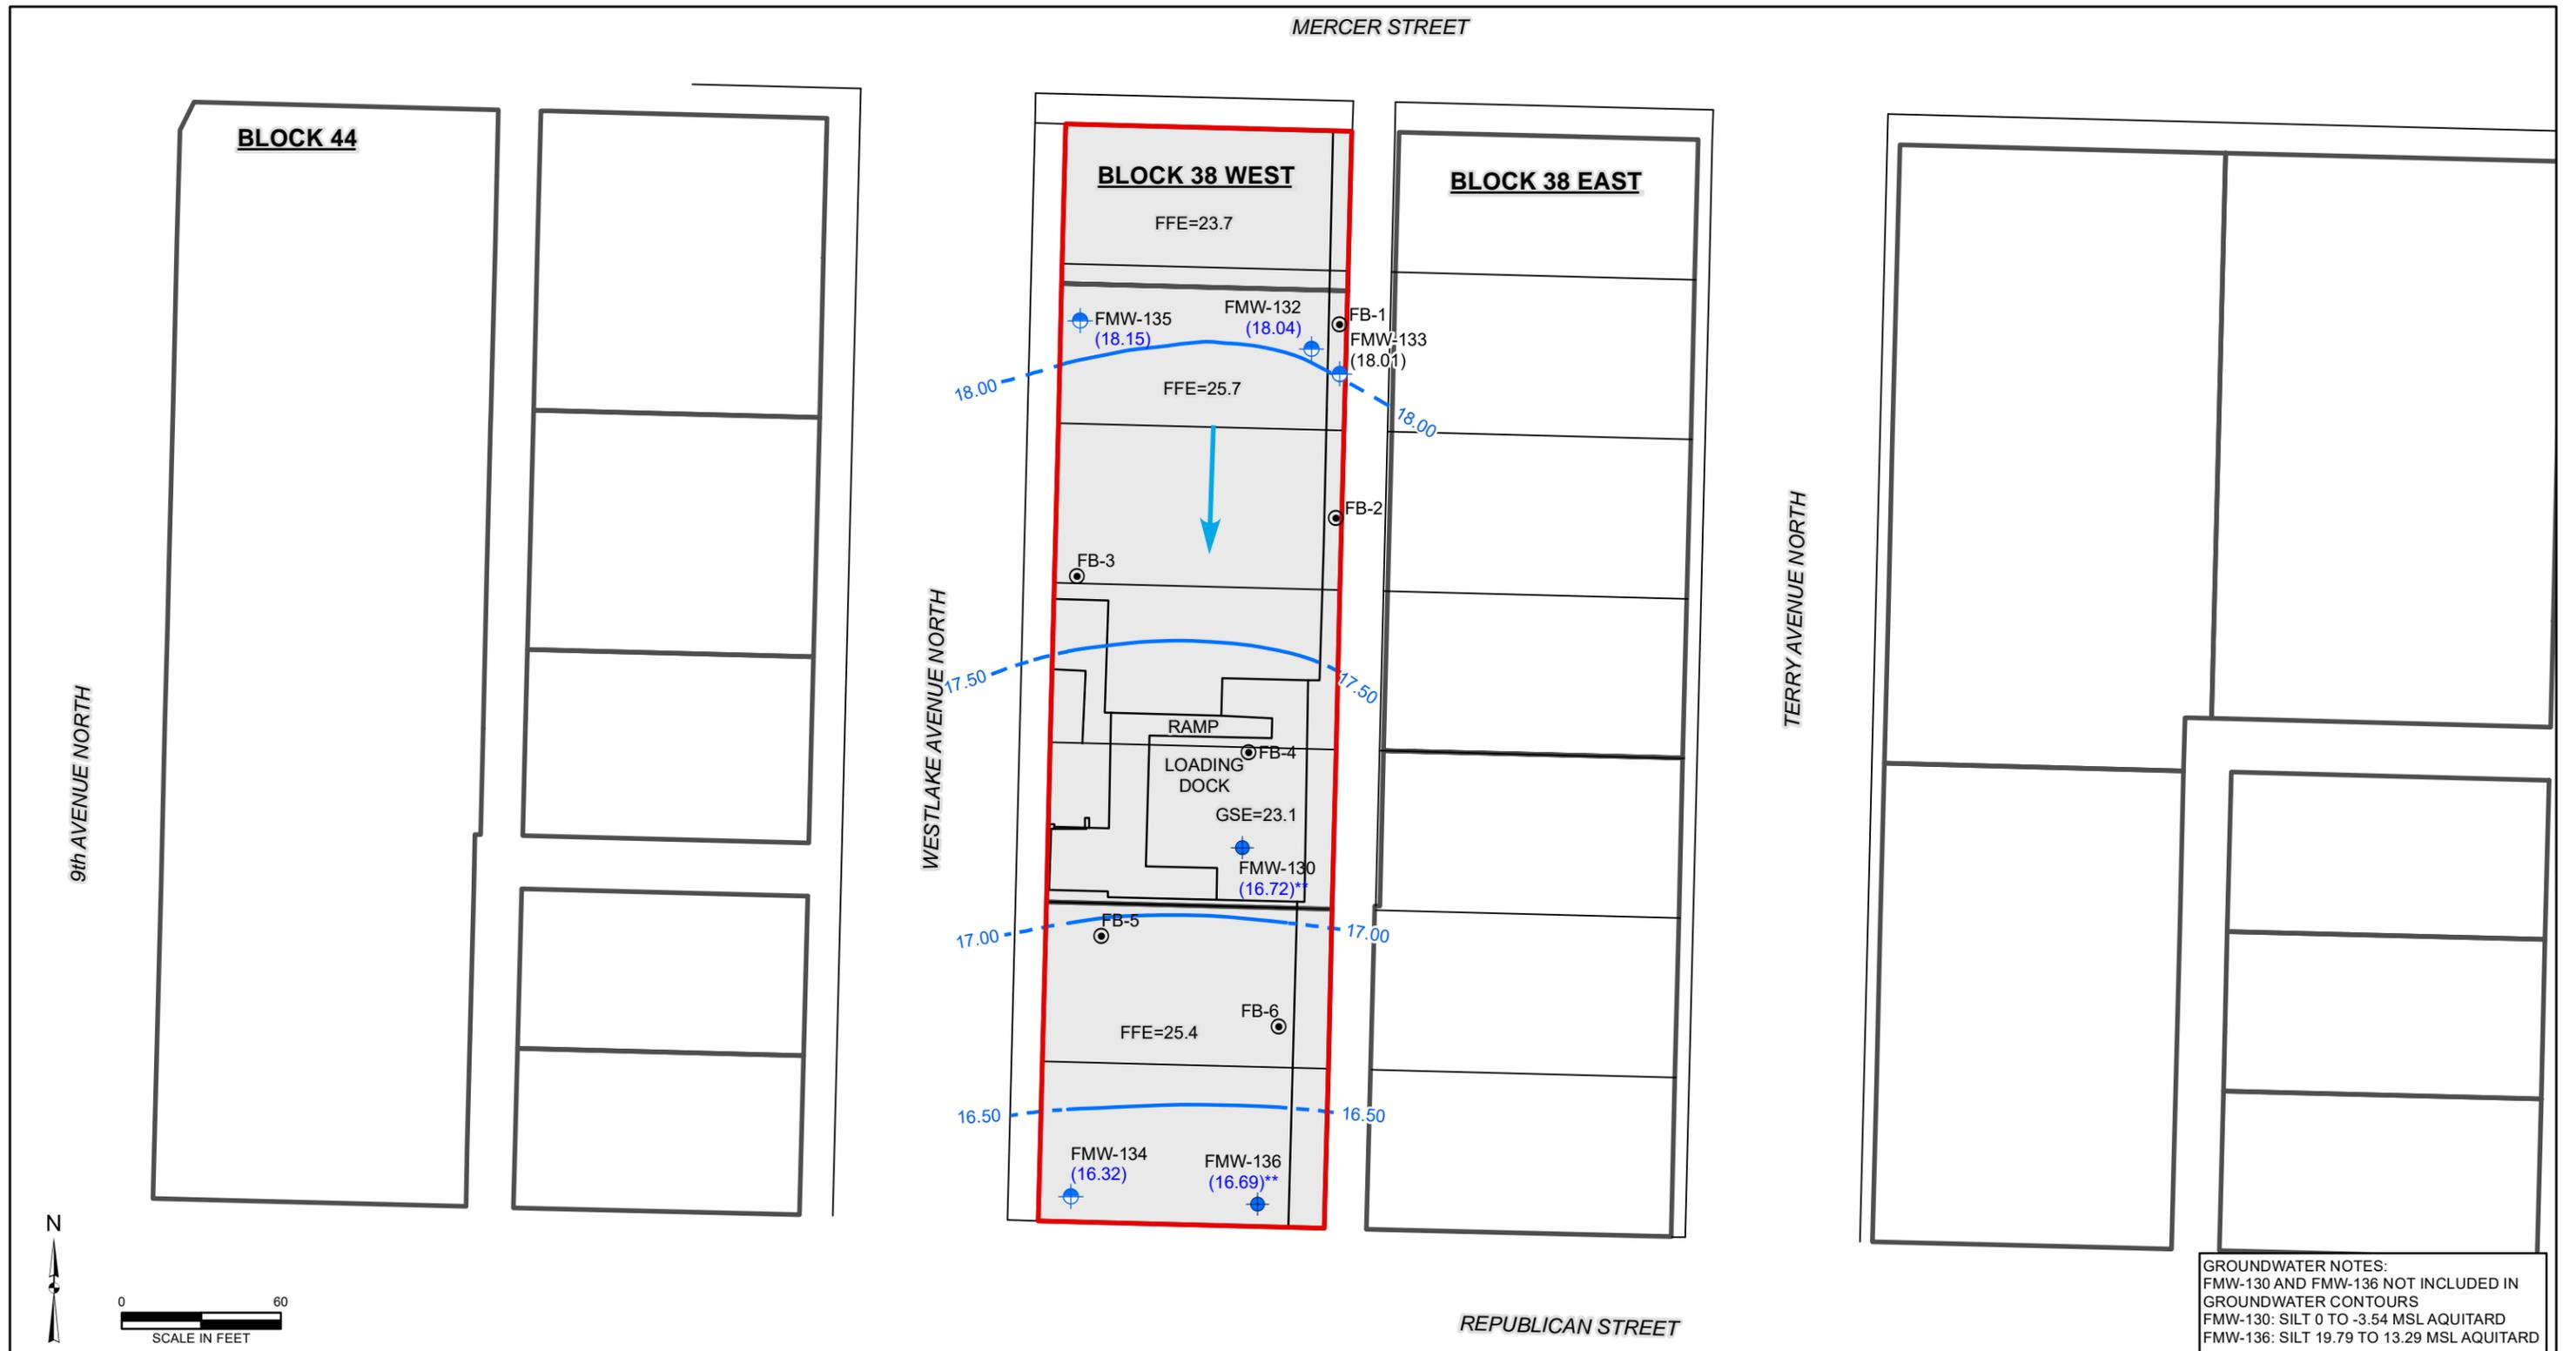
GROUNDWATER NOTES:
 FMW-130 AND FMW-136 NOT INCLUDED IN GROUNDWATER CONTOURS
 FMW-130: SILT 0 TO -3.54 MSL AQUITARD
 FMW-136: SILT 19.79 TO 13.29 MSL AQUITARD

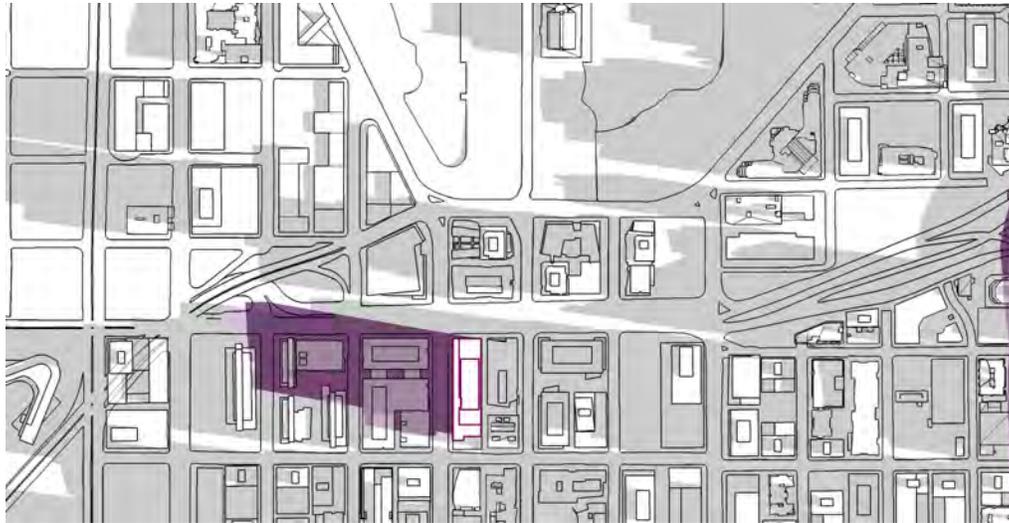
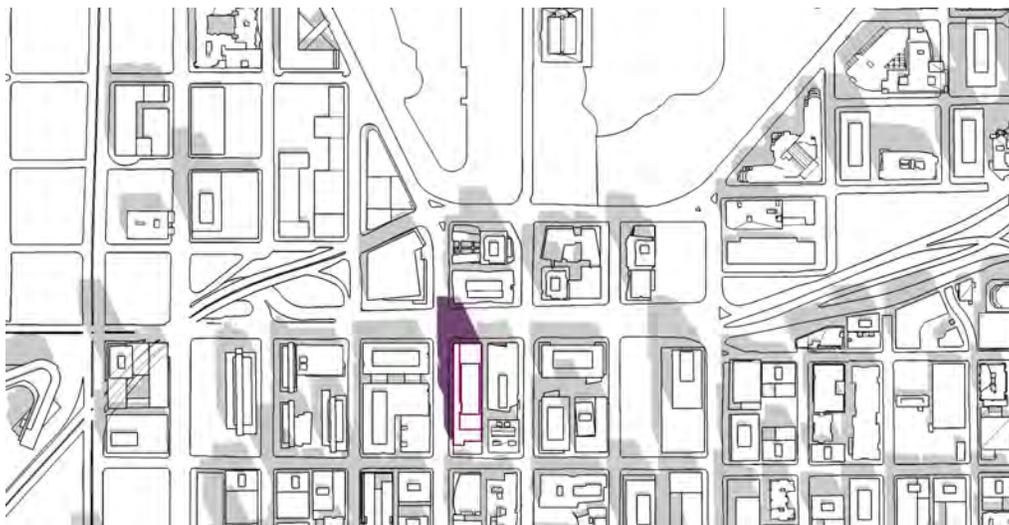
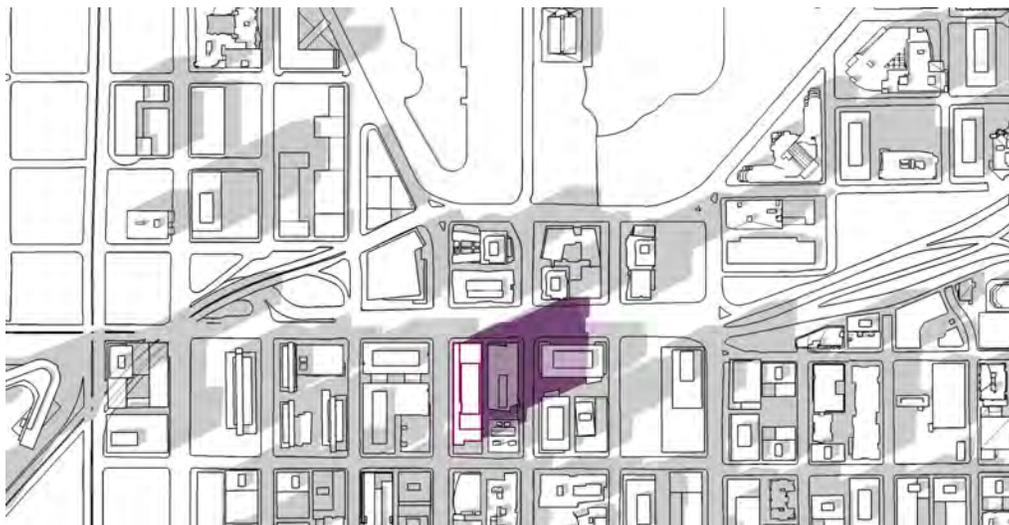
Figure 1
Shadows—Vernal & Autumnal Equinox

8:00 AM

12:00PM

5:00 PM

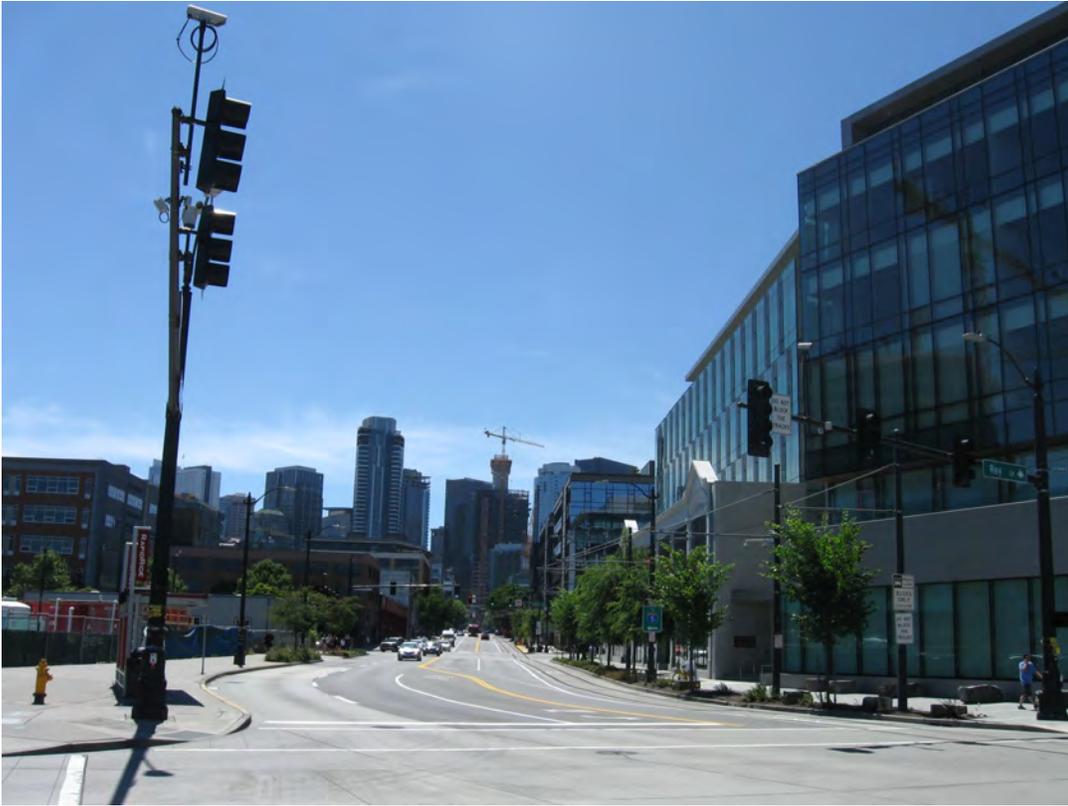
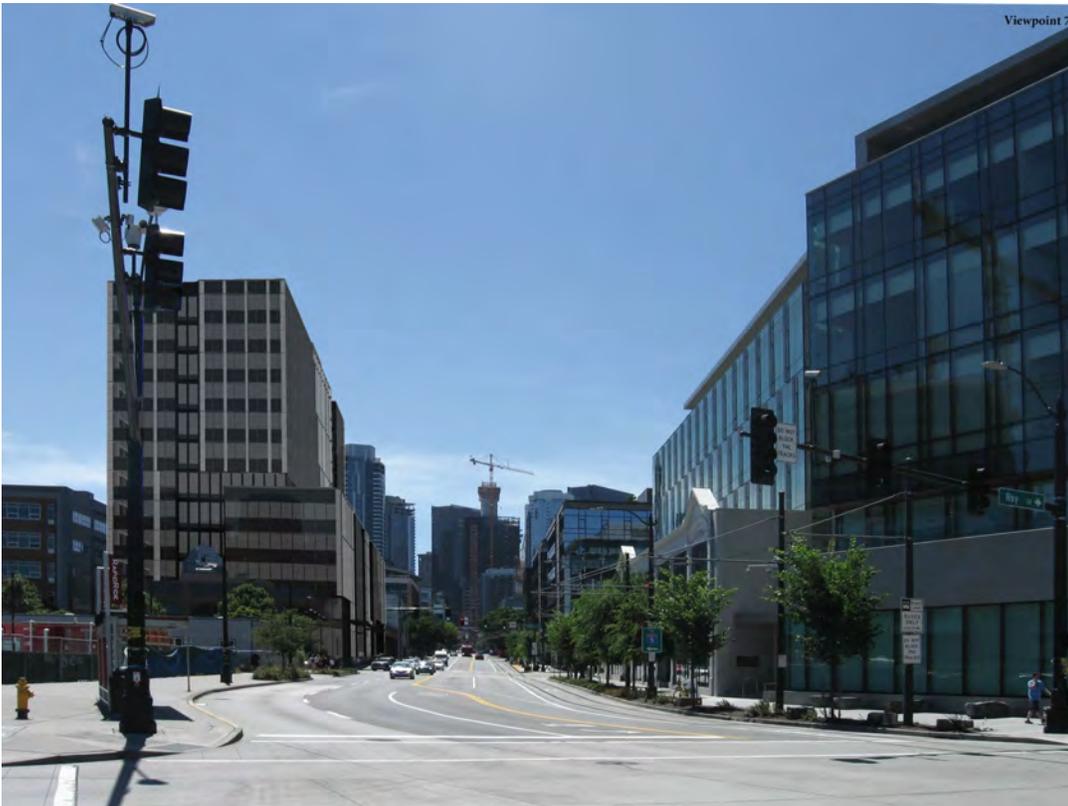
Figure 8
Viewpoint 7—Westlake Ave. N. and Valley St.— Looking South

Existing View

Proposed View

- Viewpoint 7 – Westlake Avenue N. Scenic Route – Figure 8** depicts the view from Westlake Avenue N. and Valley Street, looking south down Westlake Ave. N. towards the project site. **Viewpoint 7** shows the existing and potential view, with the proposed project site on the east (right) side of Westlake Ave. N. Portions of the historic façade of the Pacific-Ford McKay building are partially visible in the foreground to the west (left), which is integrated into the Allen Institute for Brain Science building. Downtown highrise buildings are visible in the distance, at the terminus of and along both sides of Westlake Ave. N. As indicated by **Figure 8**, the proposed 12-story office building would be visible from this viewpoint under the proposed view. The overall visual effect would be a continuation of the existing urban density in the vicinity to the south and further vertical definition of the South Lake Union Neighborhood. No viewshed impacts are anticipated from this scenic route. As well, views of historic Pacific-Ford McKay Landmark would remain the same as under existing conditions. For informational purposes and to provide greater context for how the proposed building will fit into the urban fabric of the South Lake Union neighborhood, one additional photosimulation of the proposed **520 Westlake Ave. N.** building is provided from Lake Union Park (looking south) - **Viewpoint 8**.

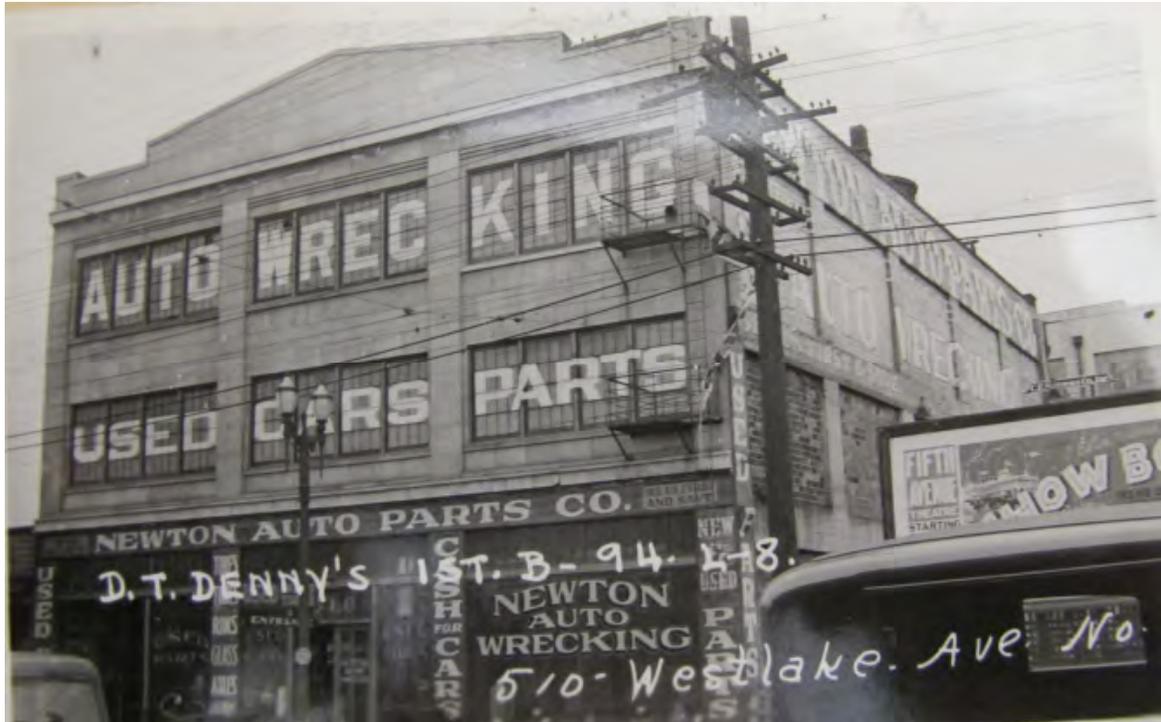
1937 view of west elevation of north portion of building originally constructed in 1919 (510 Westlake) (tax assessor photo). The empty lot to the right is lot 8, where 1947 addition would be built.

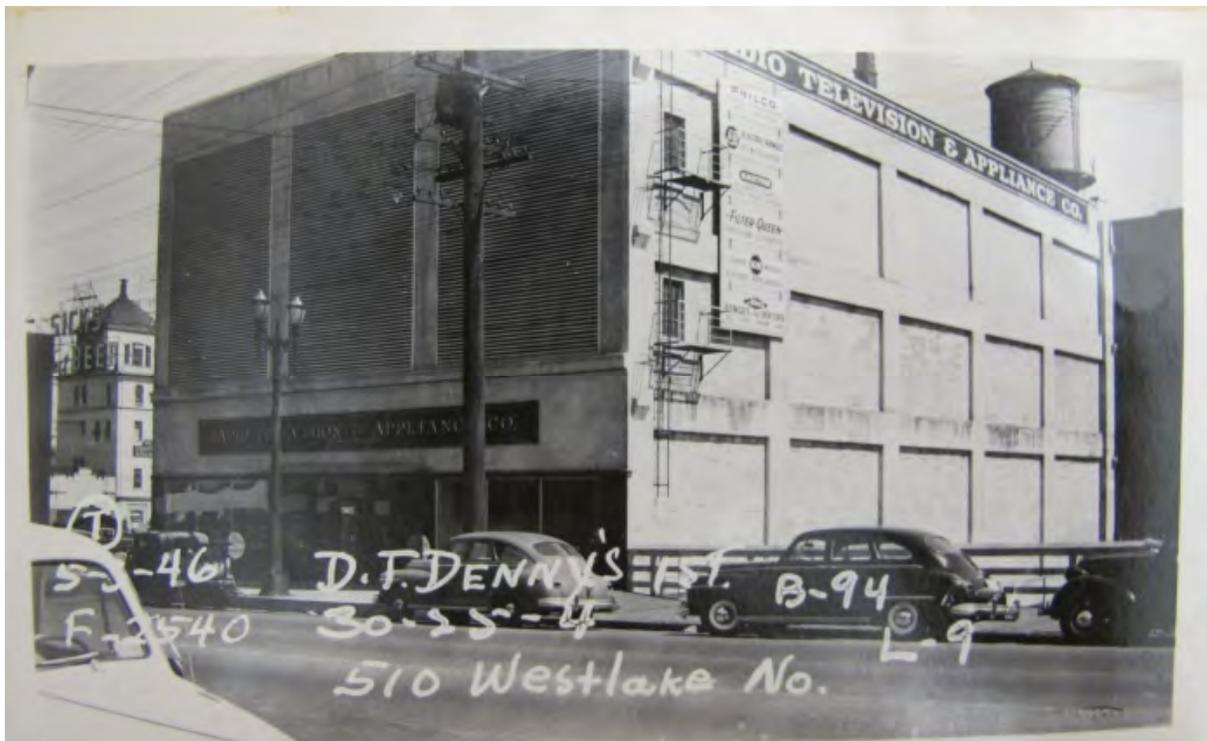
1946 view of the west elevation of building occupying lot 9, with alterations compared to the 1937 photograph. The empty lot to the right is lot 8. Note changes to shaped parapet, upper floor windows, and storefront windows.

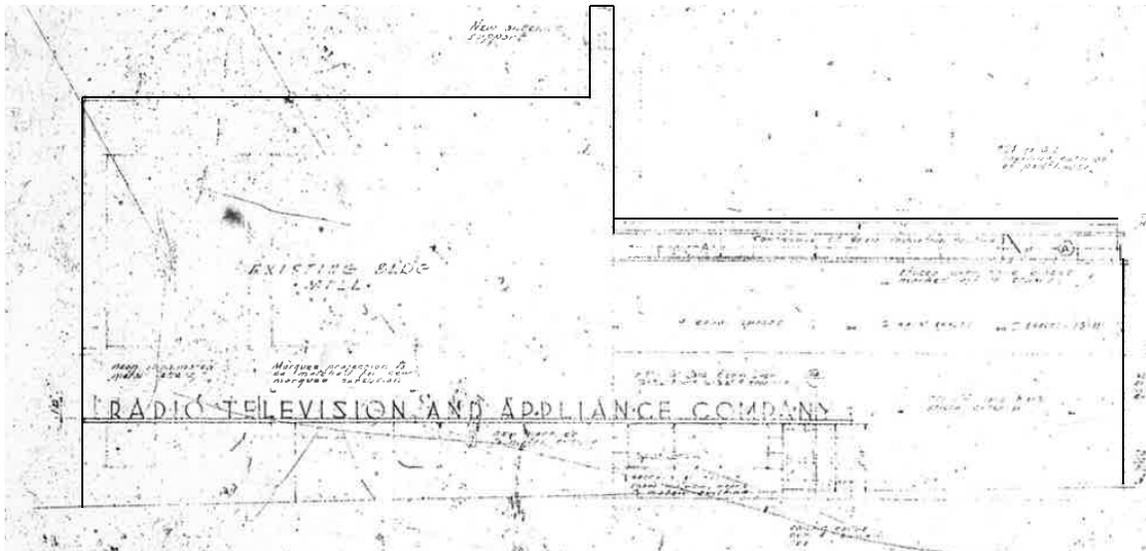
Detail of 1947 architectural drawings (original poor; drawn outline of building added for clarity) by William J. Bain & Associates, showing west elevation. Note wide band of new signage used to unify the entire west elevation of the original portion at left and the 1947 addition at right. The new main entry was located in a recessed entry just below the word “company.” Drawings suggest that the storefront windows of the north portion of the building (at left in this image) were either made smaller or removed, as compared to their 1946 condition (compare to 1946 photo).

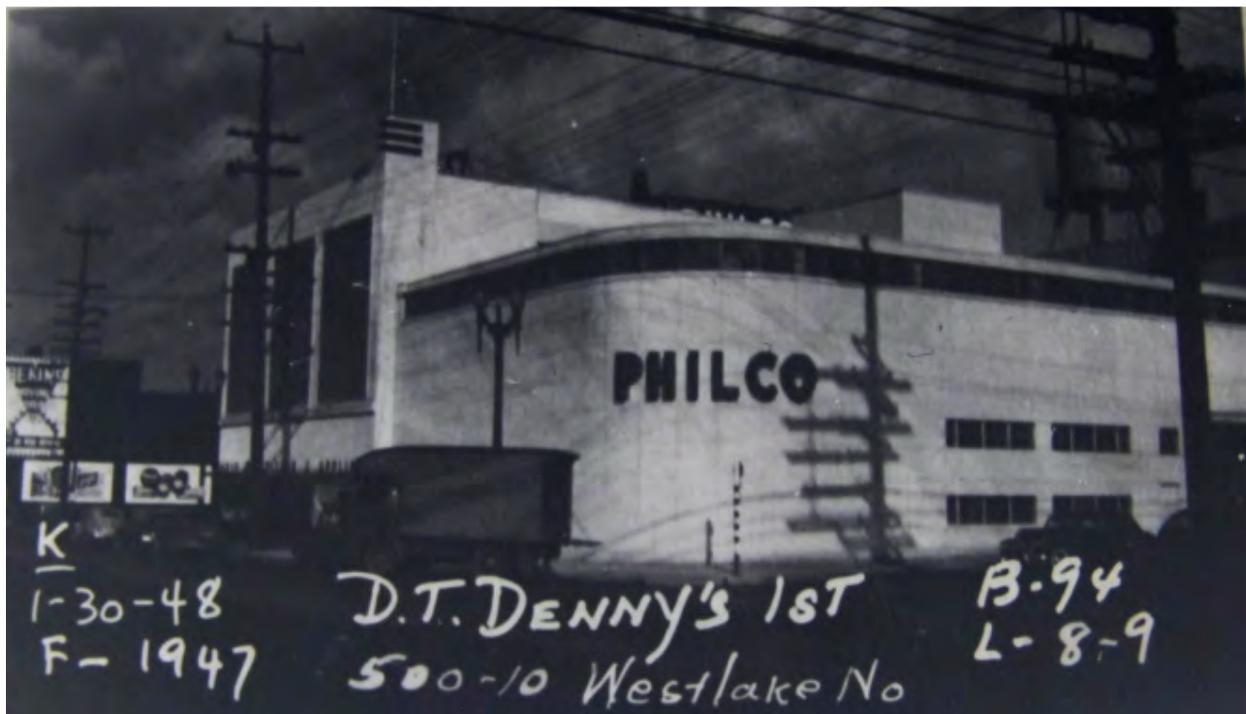
1948 image of west and south elevations of the original 1919 portion (at left) and the 1947 addition (at right). The 1919 portion was renovated and modernized on the exterior in 1946, just before the construction of the 1947 addition. A truck (just above the letters “D.T.”) blocks the view of the west elevation at street level, where the new main building entry was located.

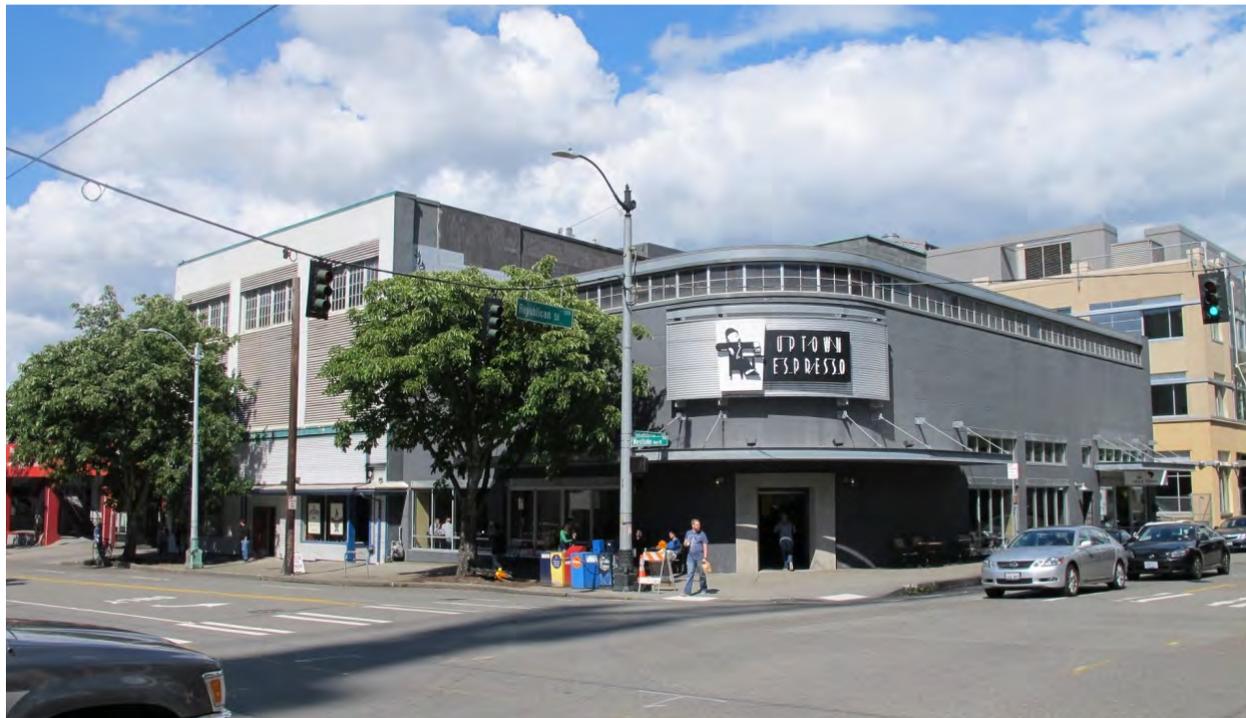
2014 view of west and south elevations. Original 1919 north portion of building at left, and 1947 south portion of building on right. At right, the continuous strip window at roof and scored cement cladding finish date to 1947. Window openings in 2003 were enlarged at the two street level windows at the center of the south elevation, at right (compare pre-2003 tax assessor photo above). All window sash at first floor, galvanized awning, signage, and sheet metal “headers” at windows are all non-original, dating to 2003. Corner entry dates to some time before 2003 but after 1968, based on photographic evidence.

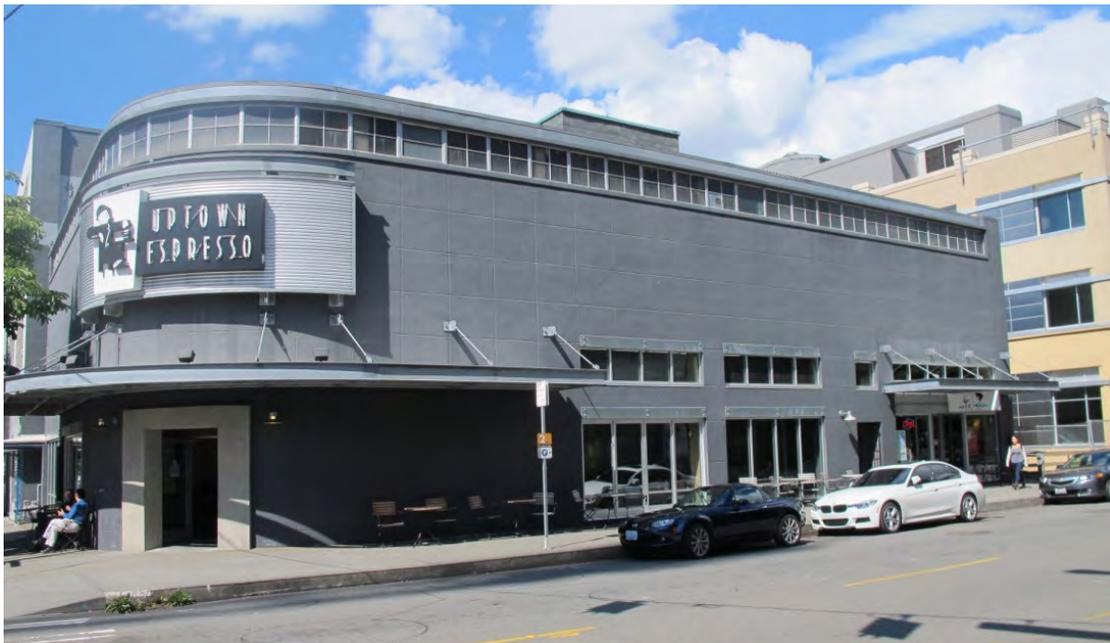
2014 view of south elevation (Republican Street). Canopy, signage, and window alterations from 2003 remodeling. Entrance to Uptown Espresso at left, Blue Moon Burgers at far right (Blue Moon fenestration was originally a garage entrance, see drawings above). Continuous strip window at roof and scored cement cladding finish date to 1947. Window openings in 2003 were enlarged at the two street level windows at the center of the south elevation (compare pre-2003 tax assessor photo above). All window sash at first floor, galvanized awning, signage, and sheet metal “headers” at windows are all non-original, dating to 2003. Corner entry dates to some time before 2003 but after 1968, based on photographic evidence.

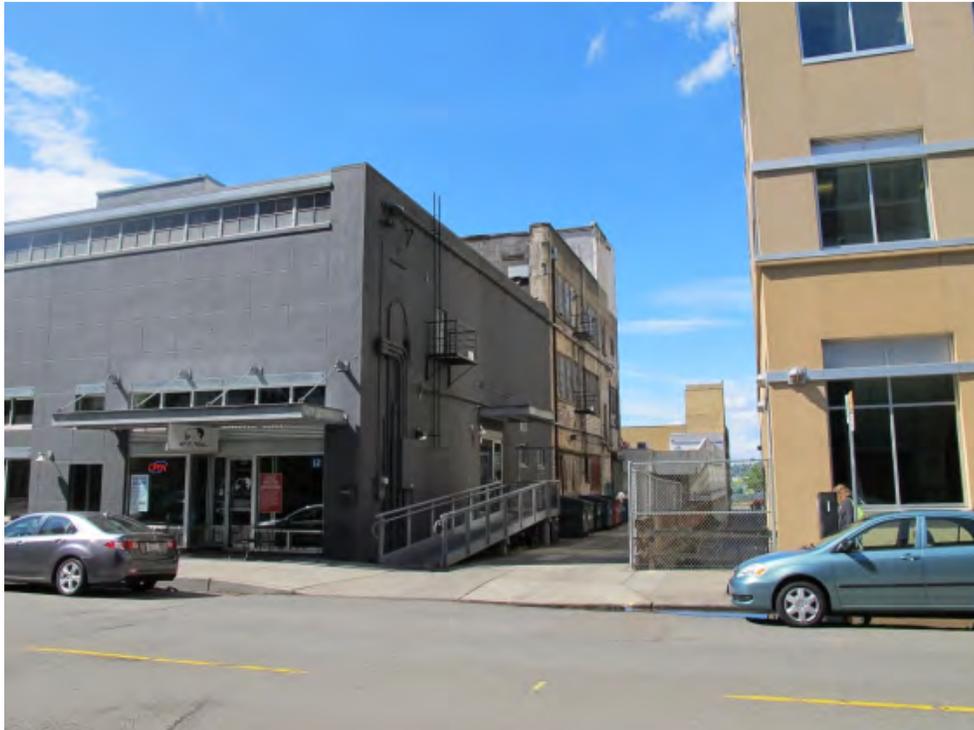
2014 view of alley and east elevations of the building. Steel access ramp at alley added in 2003.

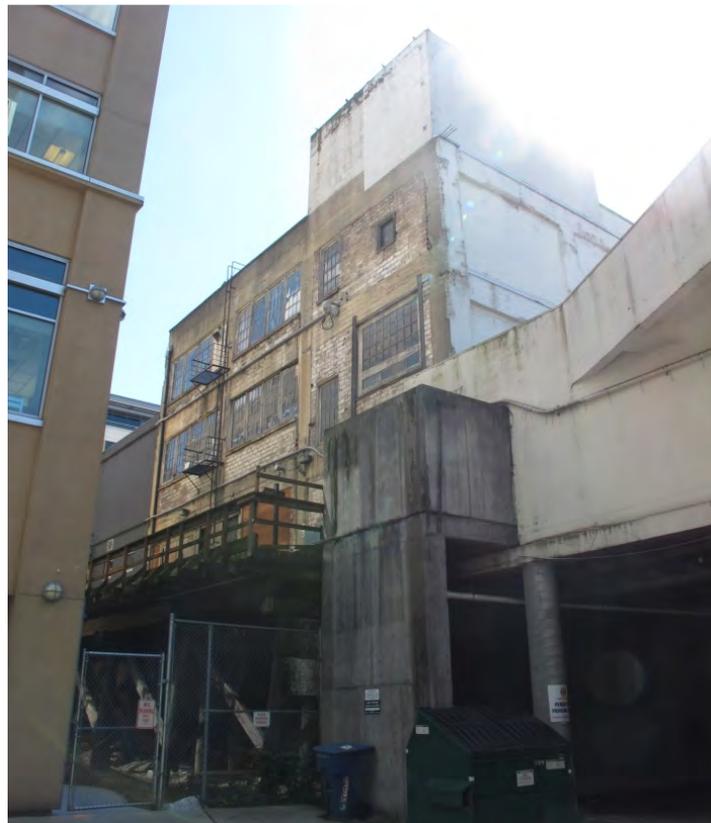
2014 view of east and north façade of 1919 (north) portion of building (510 Westlake). Alley windows appear to retain original sash.

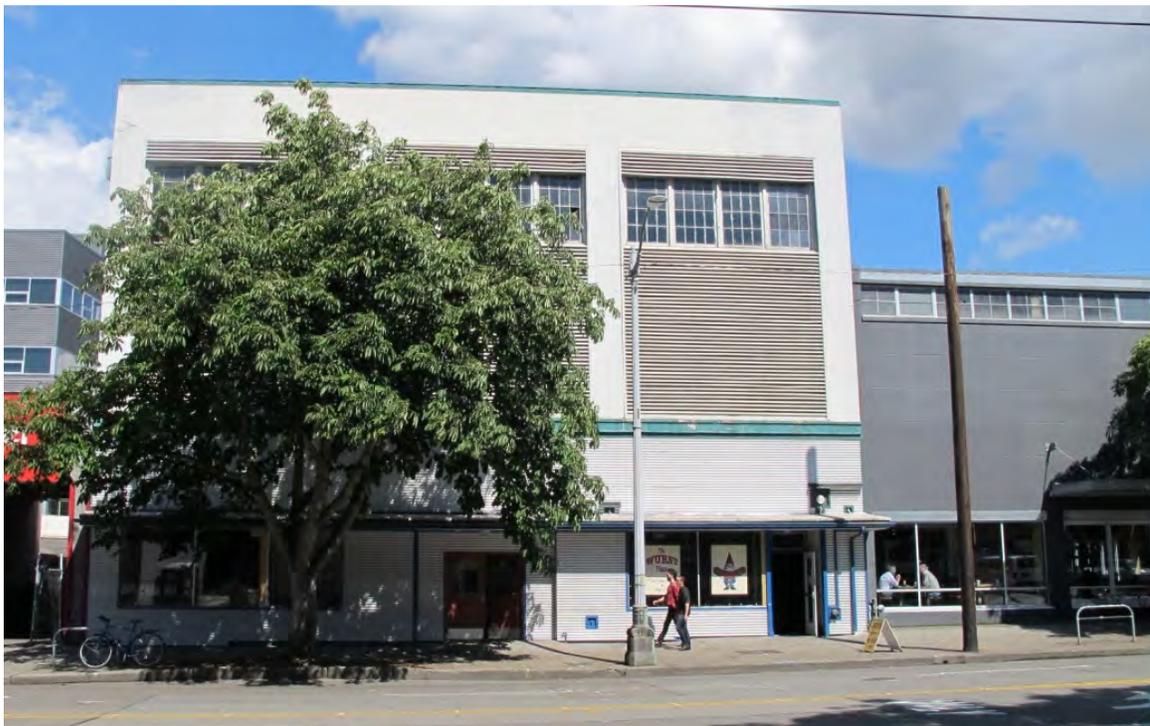
2014 view of west elevation (Westlake Avenue) of north portion of building. Louvers dating from 1946 may cover additional original 1919 windows at the second floor. Drawings suggest that the storefront windows of the north portion of the building (at left in this image) were either made smaller or removed, as compared to their 1946 condition (compare to 1946 photo; see images pp. 8-9). Corrugated metal siding at street level is not original but was installed at an unknown date, probably in recent decades.

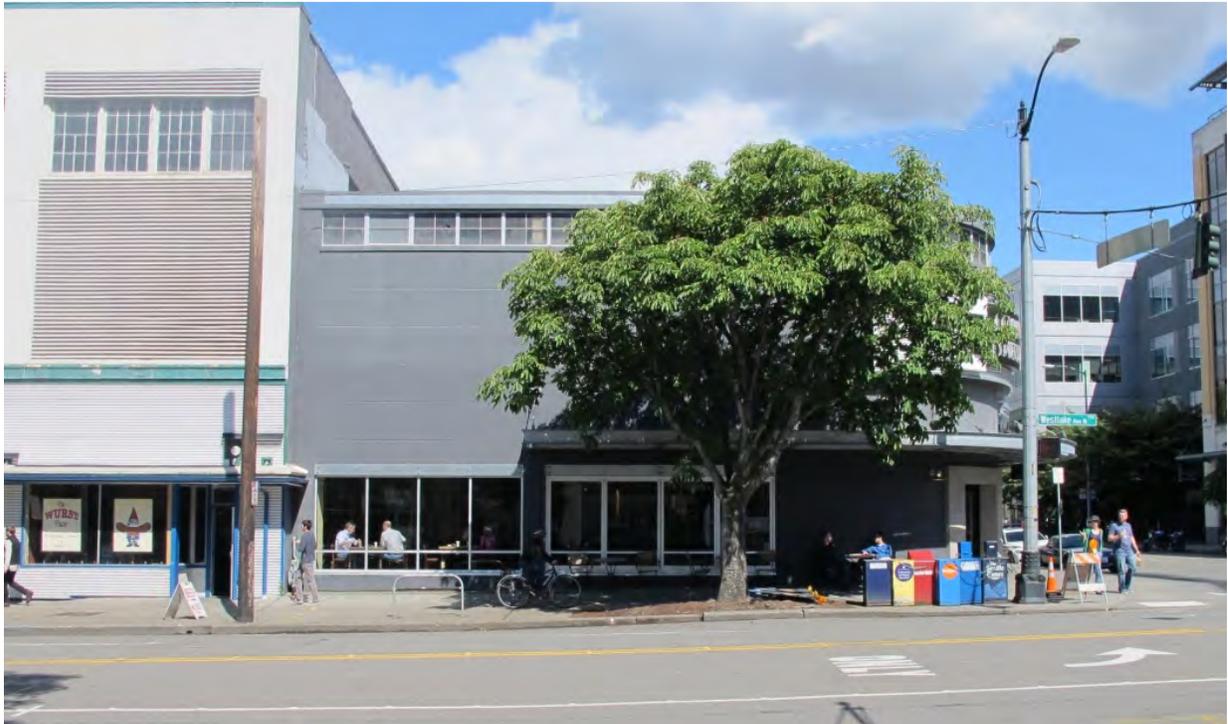
2014 view of west elevation (Westlake Avenue) of south portion of building, originally constructed as an addition in 1947. Windows at roof line retain original 1947 sash; storefront window sash is modern and dates to 2003; corner entry at right is not original and dates to some time between 1968 and 2003.

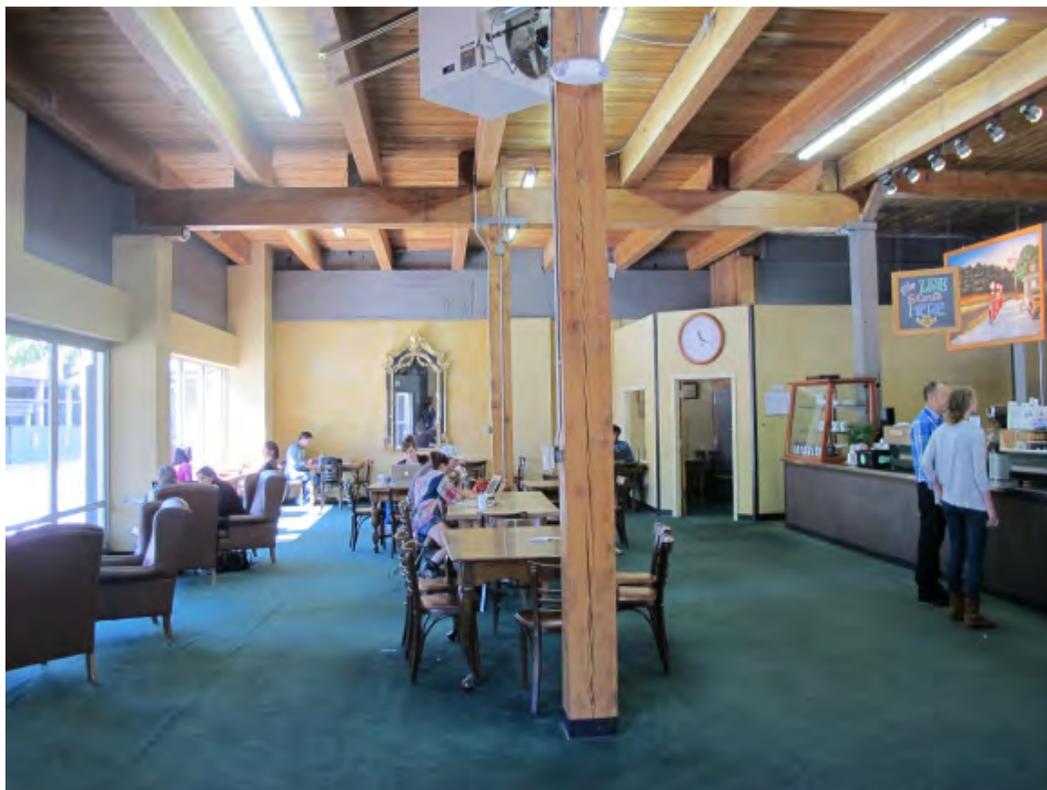
Interior of Uptown Espresso, first floor store space. Original heavy timber framing can be seen.
