ADDENDUM

***South Lake Union Height
and Density Alternatives EIS***

**520 Westlake Ave. N.
Development**

Master Use Permit No.: 3017466

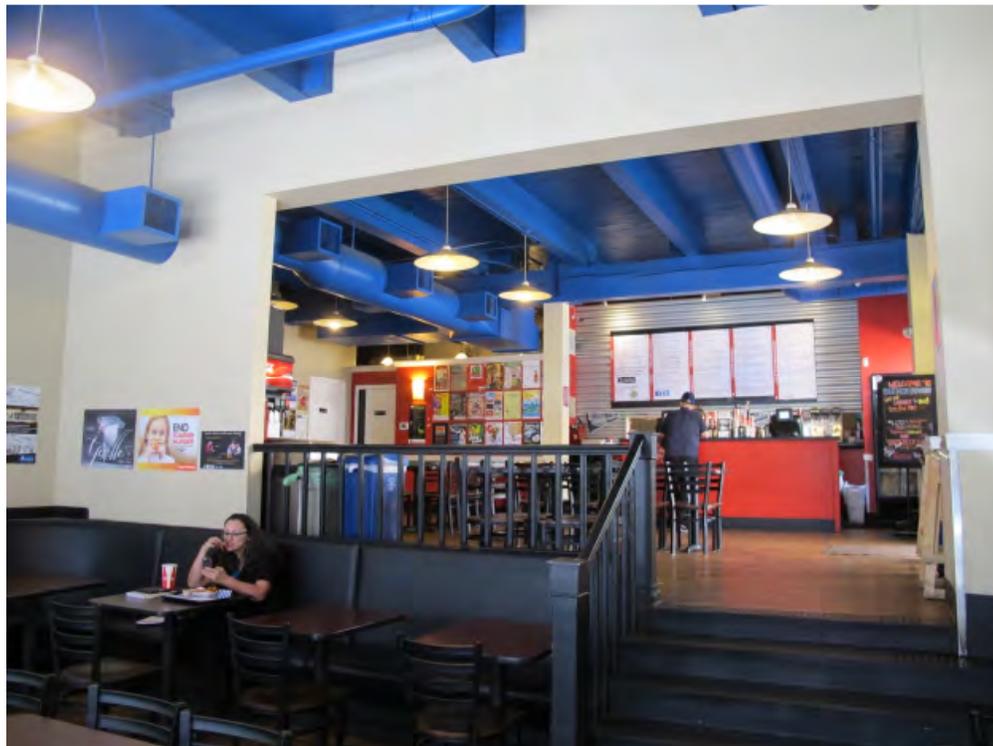
Interior of Blue Moon Burgers, located in south portion of building (originally constructed in 1947), accessed from Harrison Street. Original heavy timber beams can be seen, painted in blue. Interior altered in 2003 for restaurant use.

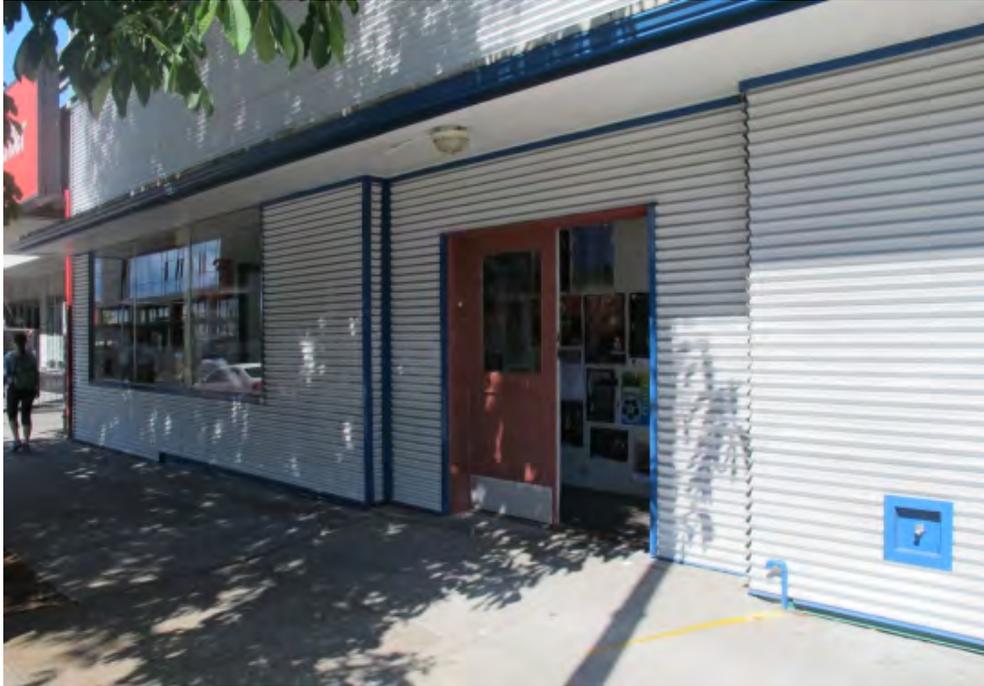
2014 storefront view of north portion of building (510 Westlake) originally constructed in 1919, showing entrance to The Wurst Place, a restaurant. Non-original corrugated metal siding at first floor was installed at an unknown date. First floor windows may date from 1947 renovation to building. Entry door is recent and not original.

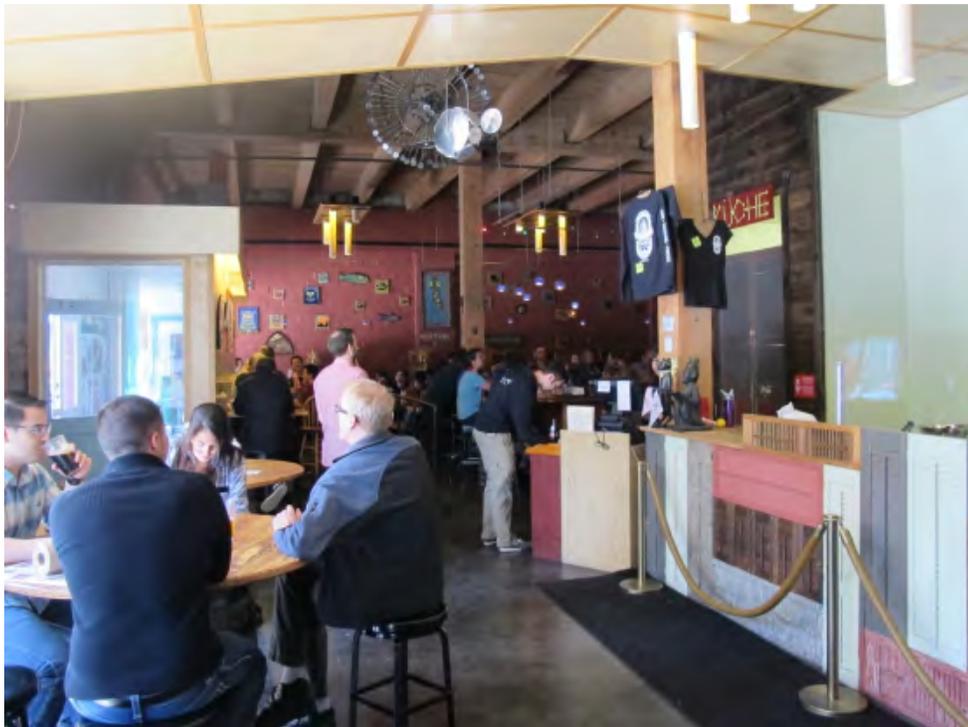
Interior view in north portion of building originally constructed in 1919, now occupied by The Wurst Place, a restaurant. Original 1919 heavy timber framing visible, original brick exterior wall visible.

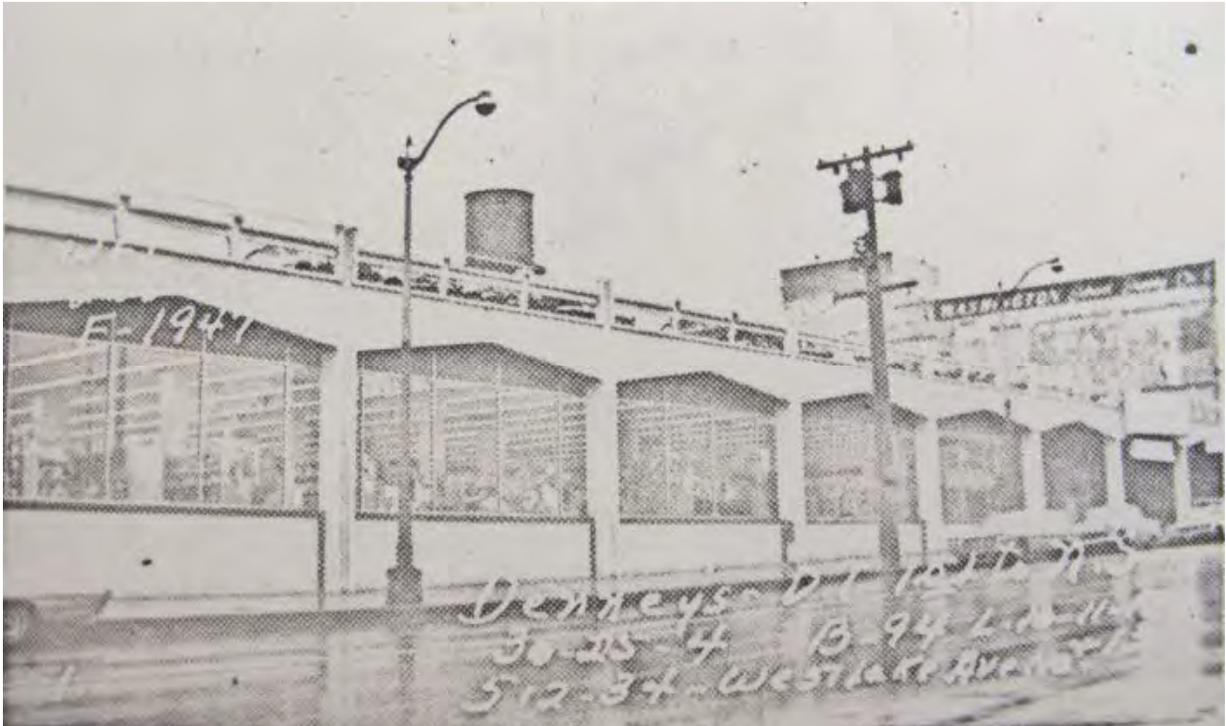
1964 tax assessor image. Note that storefront window width below the horizontal muntin is entirely glazed; compare to current windows.

Additionally, a comparison of the 1964 tax photo with current conditions show that the storefront window system in 1964 was entirely glazed in width below the horizontal muntin, while today's window features marblecrete outermost panels in the storefront system. Additionally, the current glazing features additional vertical muntins; the date of these alterations to the storefront system are unknown.

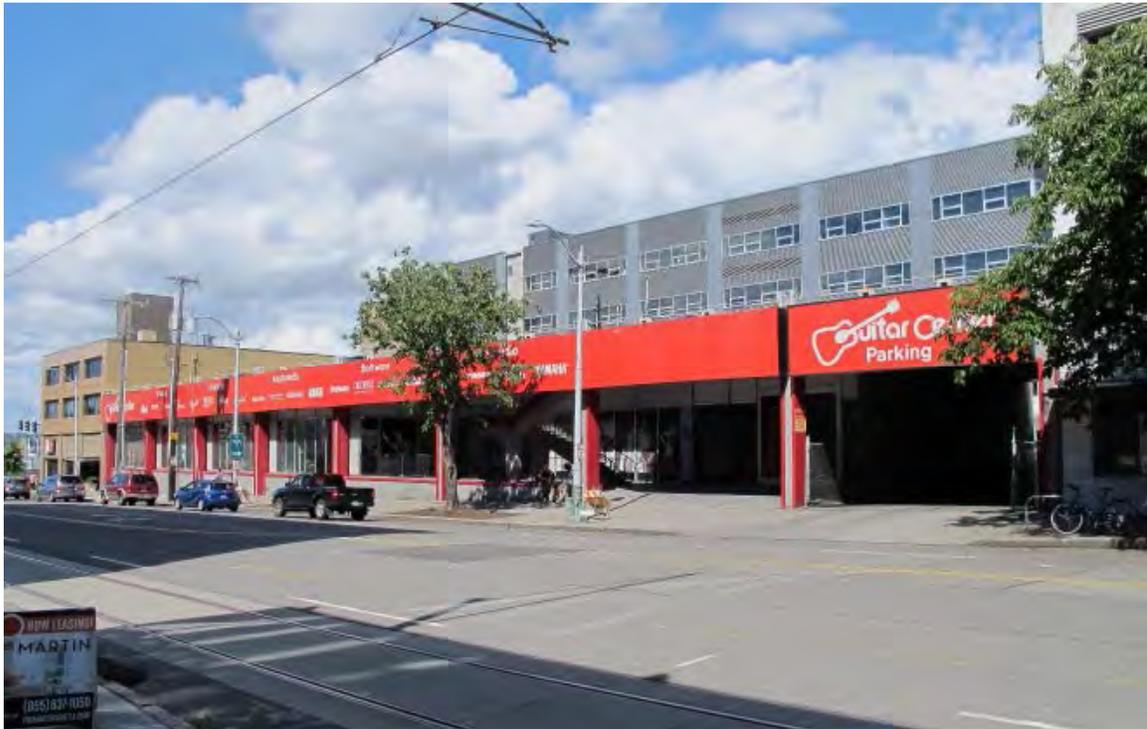
West elevation. Pointed arches remain under current awnings. Note that current storefront windows have intermediary muntins at glazing (compare to 1964 tax photo), and that the outermost portion of the storefront window system consists of marblecrete panels (of indeterminate age). The date of these alterations to the windows is unknown.

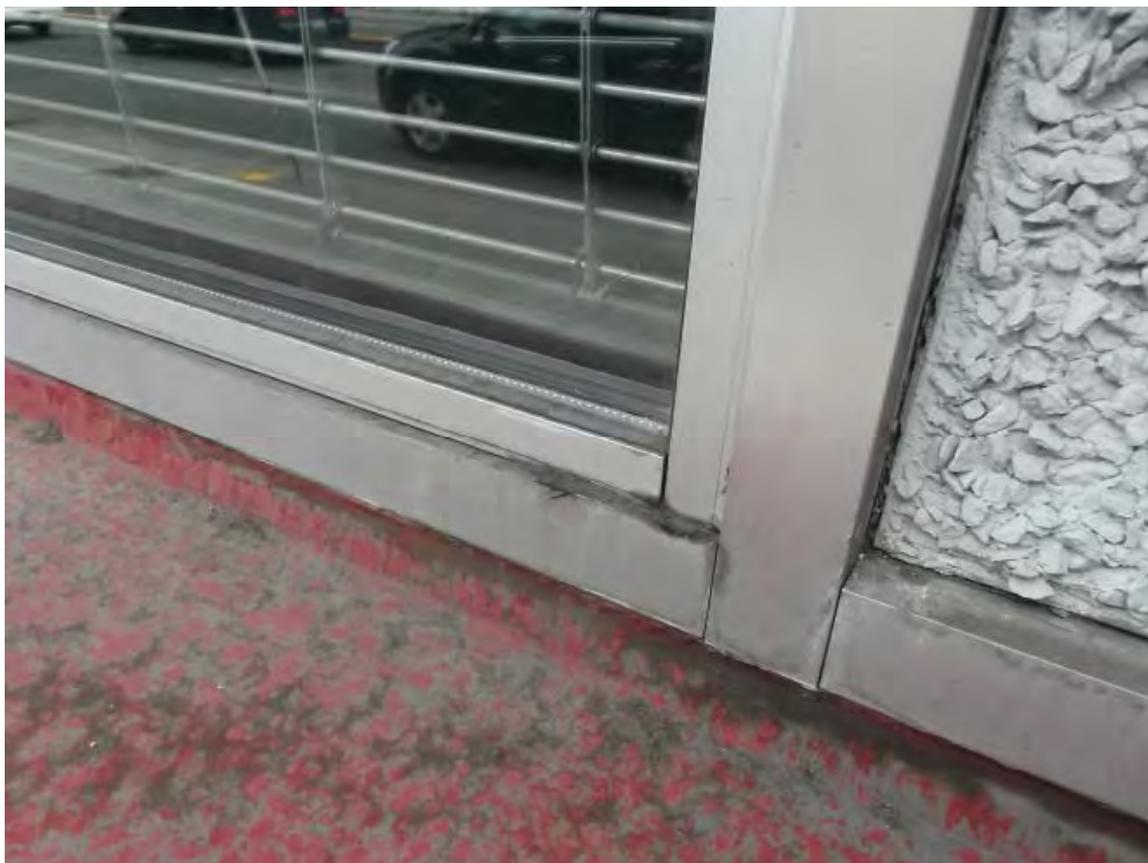
Detail of storefront window system along sidewalk at fourth bay (located by arrow above); note marblecrete panel at right. Date of current window system with marblecrete panels is unknown, but after 1964 and before 1997.

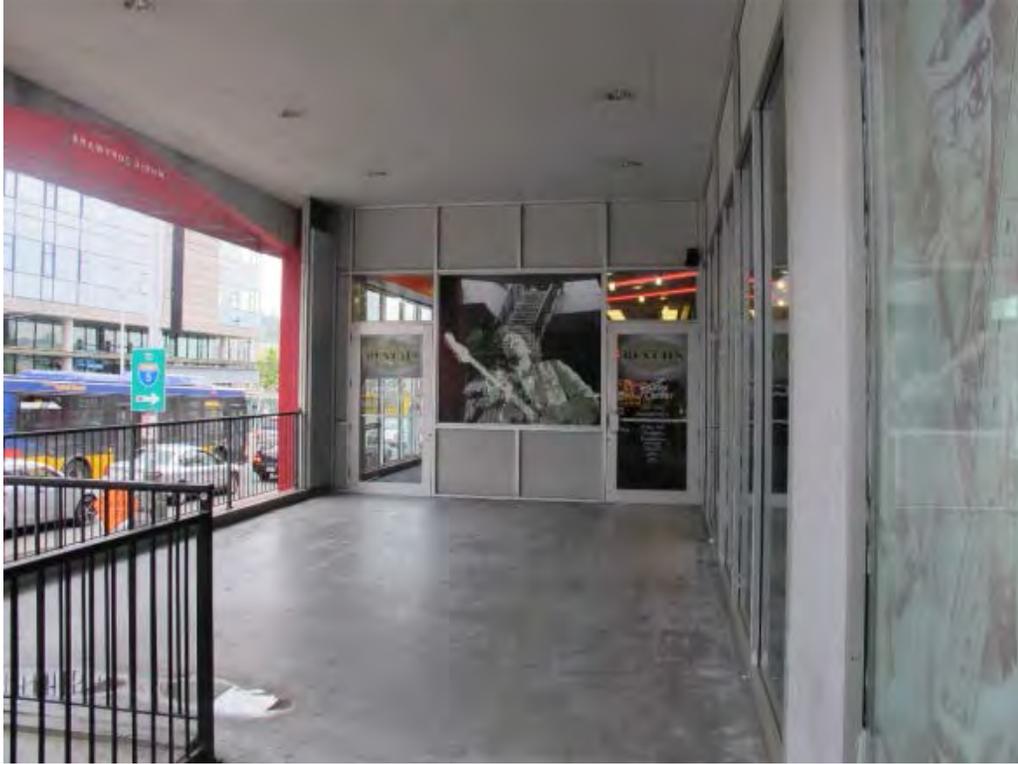
Exterior entry court, open to street. Note pointed arch form visible behind awning.

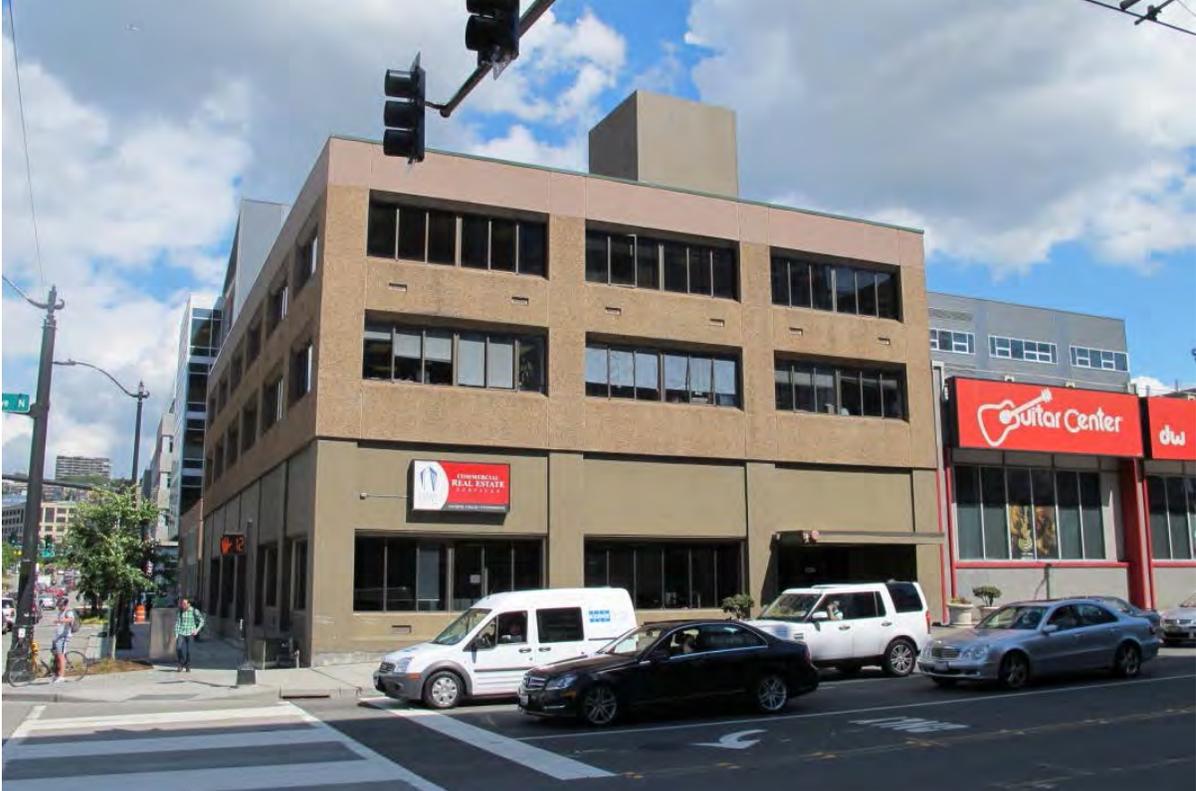
2014 view of west elevation along Westlake Ave N. Current appearance dates to 1968 renovation. (Stucco and marblecrete façade) Original stair core can be seen in the back right above the building.

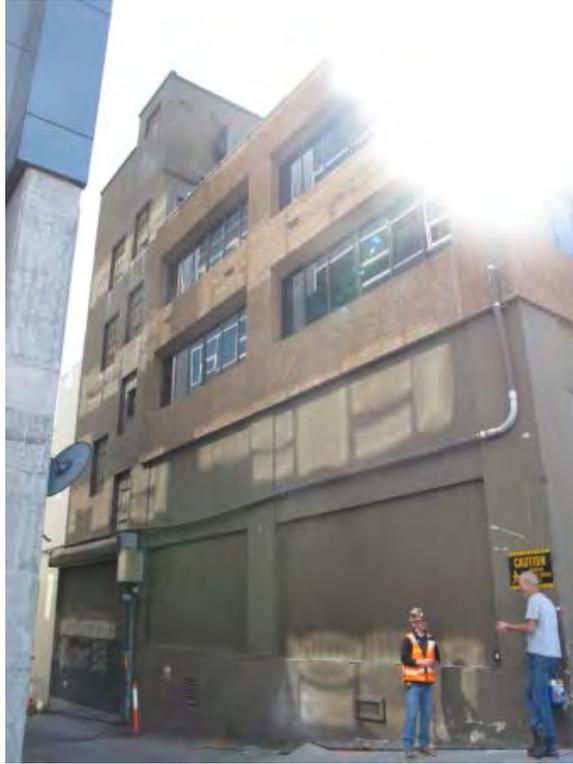
2014 view of east elevation/rear of building (alley). Original 1920 staircase can be seen on the left with steel sash windows which have been painted over.

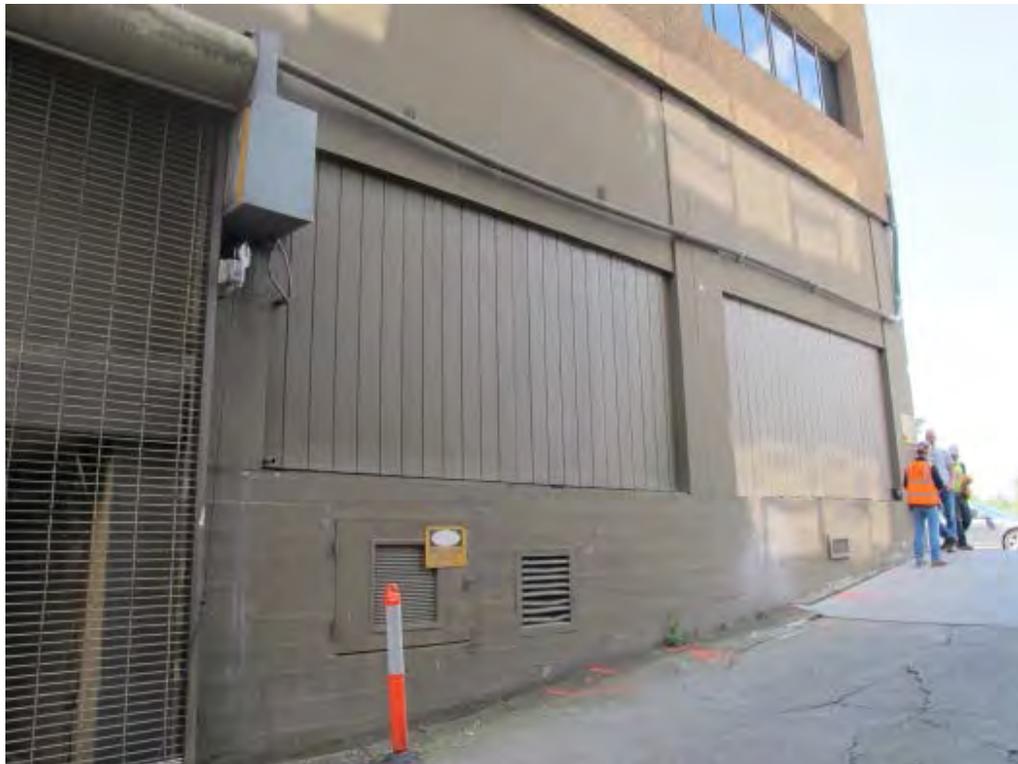
2014 detail view of east elevation (alley) with windows from 1968 renovation boarded.

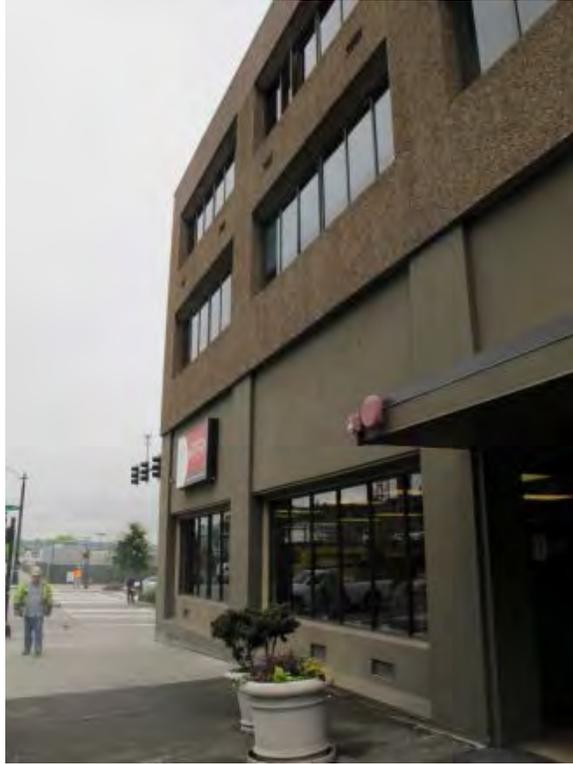
2014 view of western façade, stucco first level, marbled concrete second and third levels, and storefront marquee.

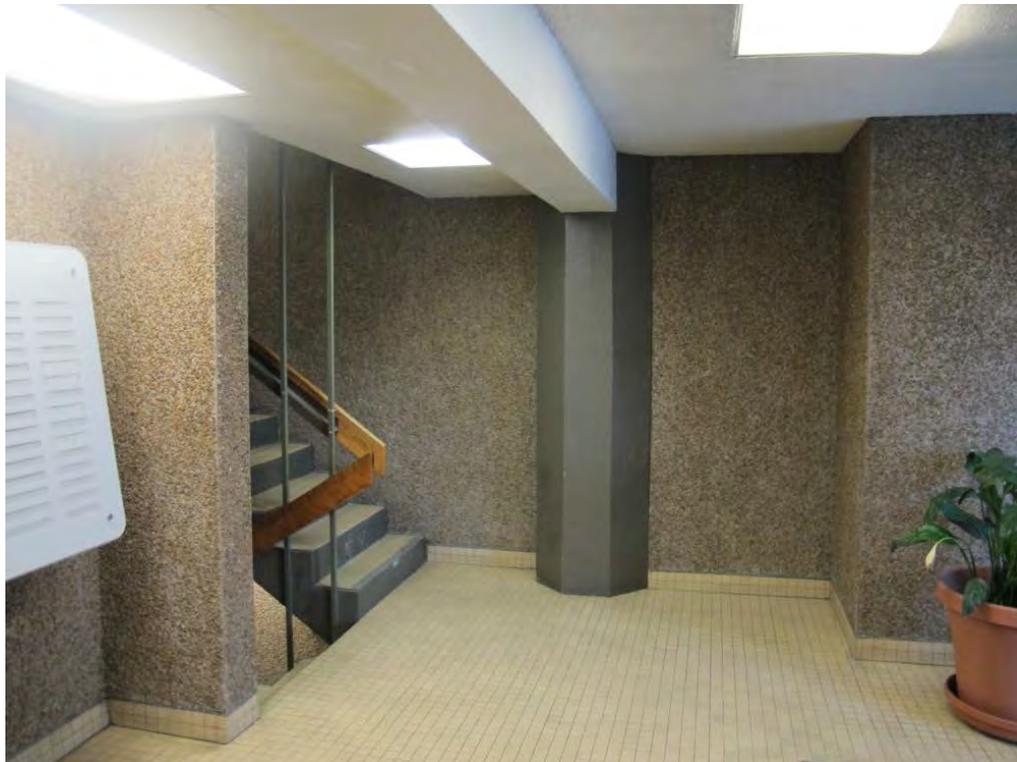
Interior-first level, lobby space, showing marbled concrete walls, tile flooring, wooden railing on staircase, low suspended ceilings of acoustic tile.

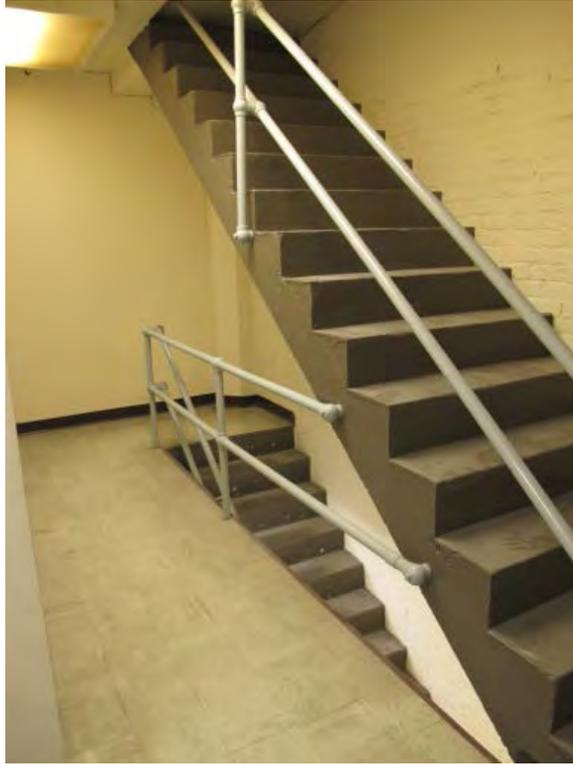
Interior- staircase with steel railing. Brick exterior wall can be seen.

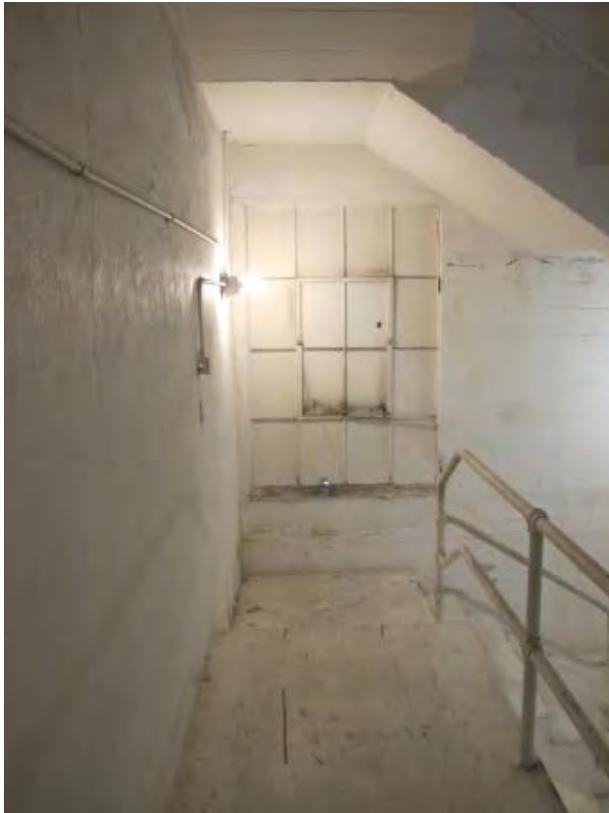
Interior- original 1920 stair core, windows painted over, as well as entire space.

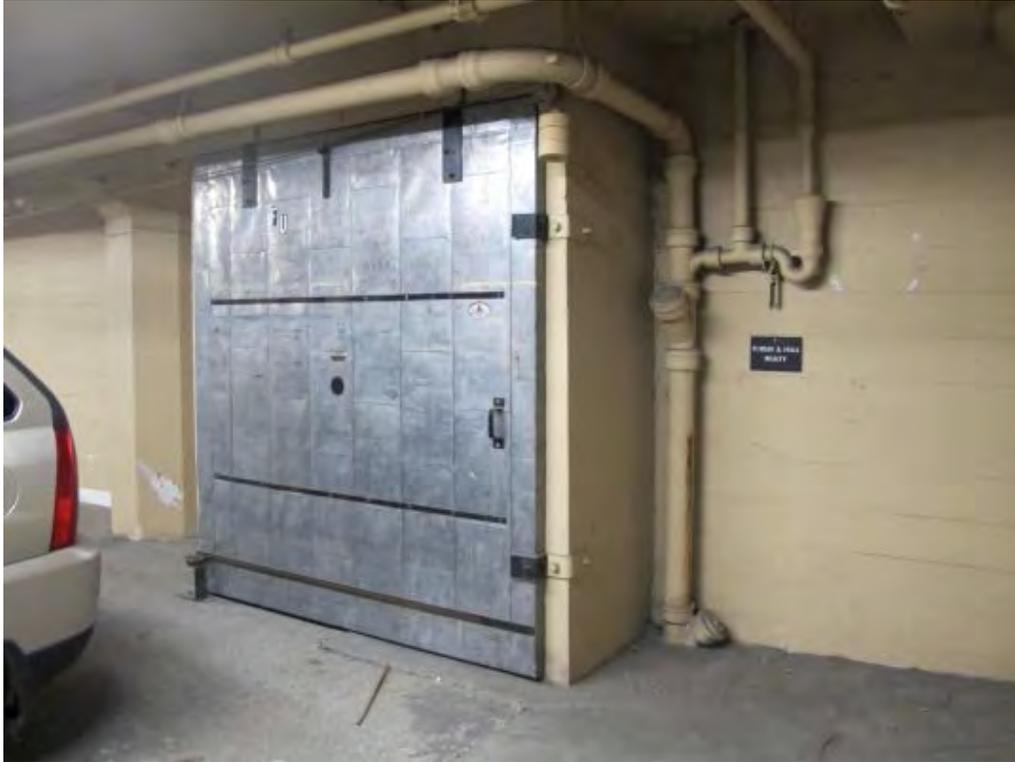
Interior- basement, garage portion, fire door detail.
