Cedar Hills Regional Landfill – EPZ Phase I Interim Actions - Infrastructure Upgrades Technical Memorandum

CEDAR HILLS REGIONAL LANDFILL – EPZ PHASE I INTERIM ACTIONS - INFRASTRUCTURE UPGRADES TECHNICAL MEMORANDUM

Project No. 130088 • August 31, 2018 • Final

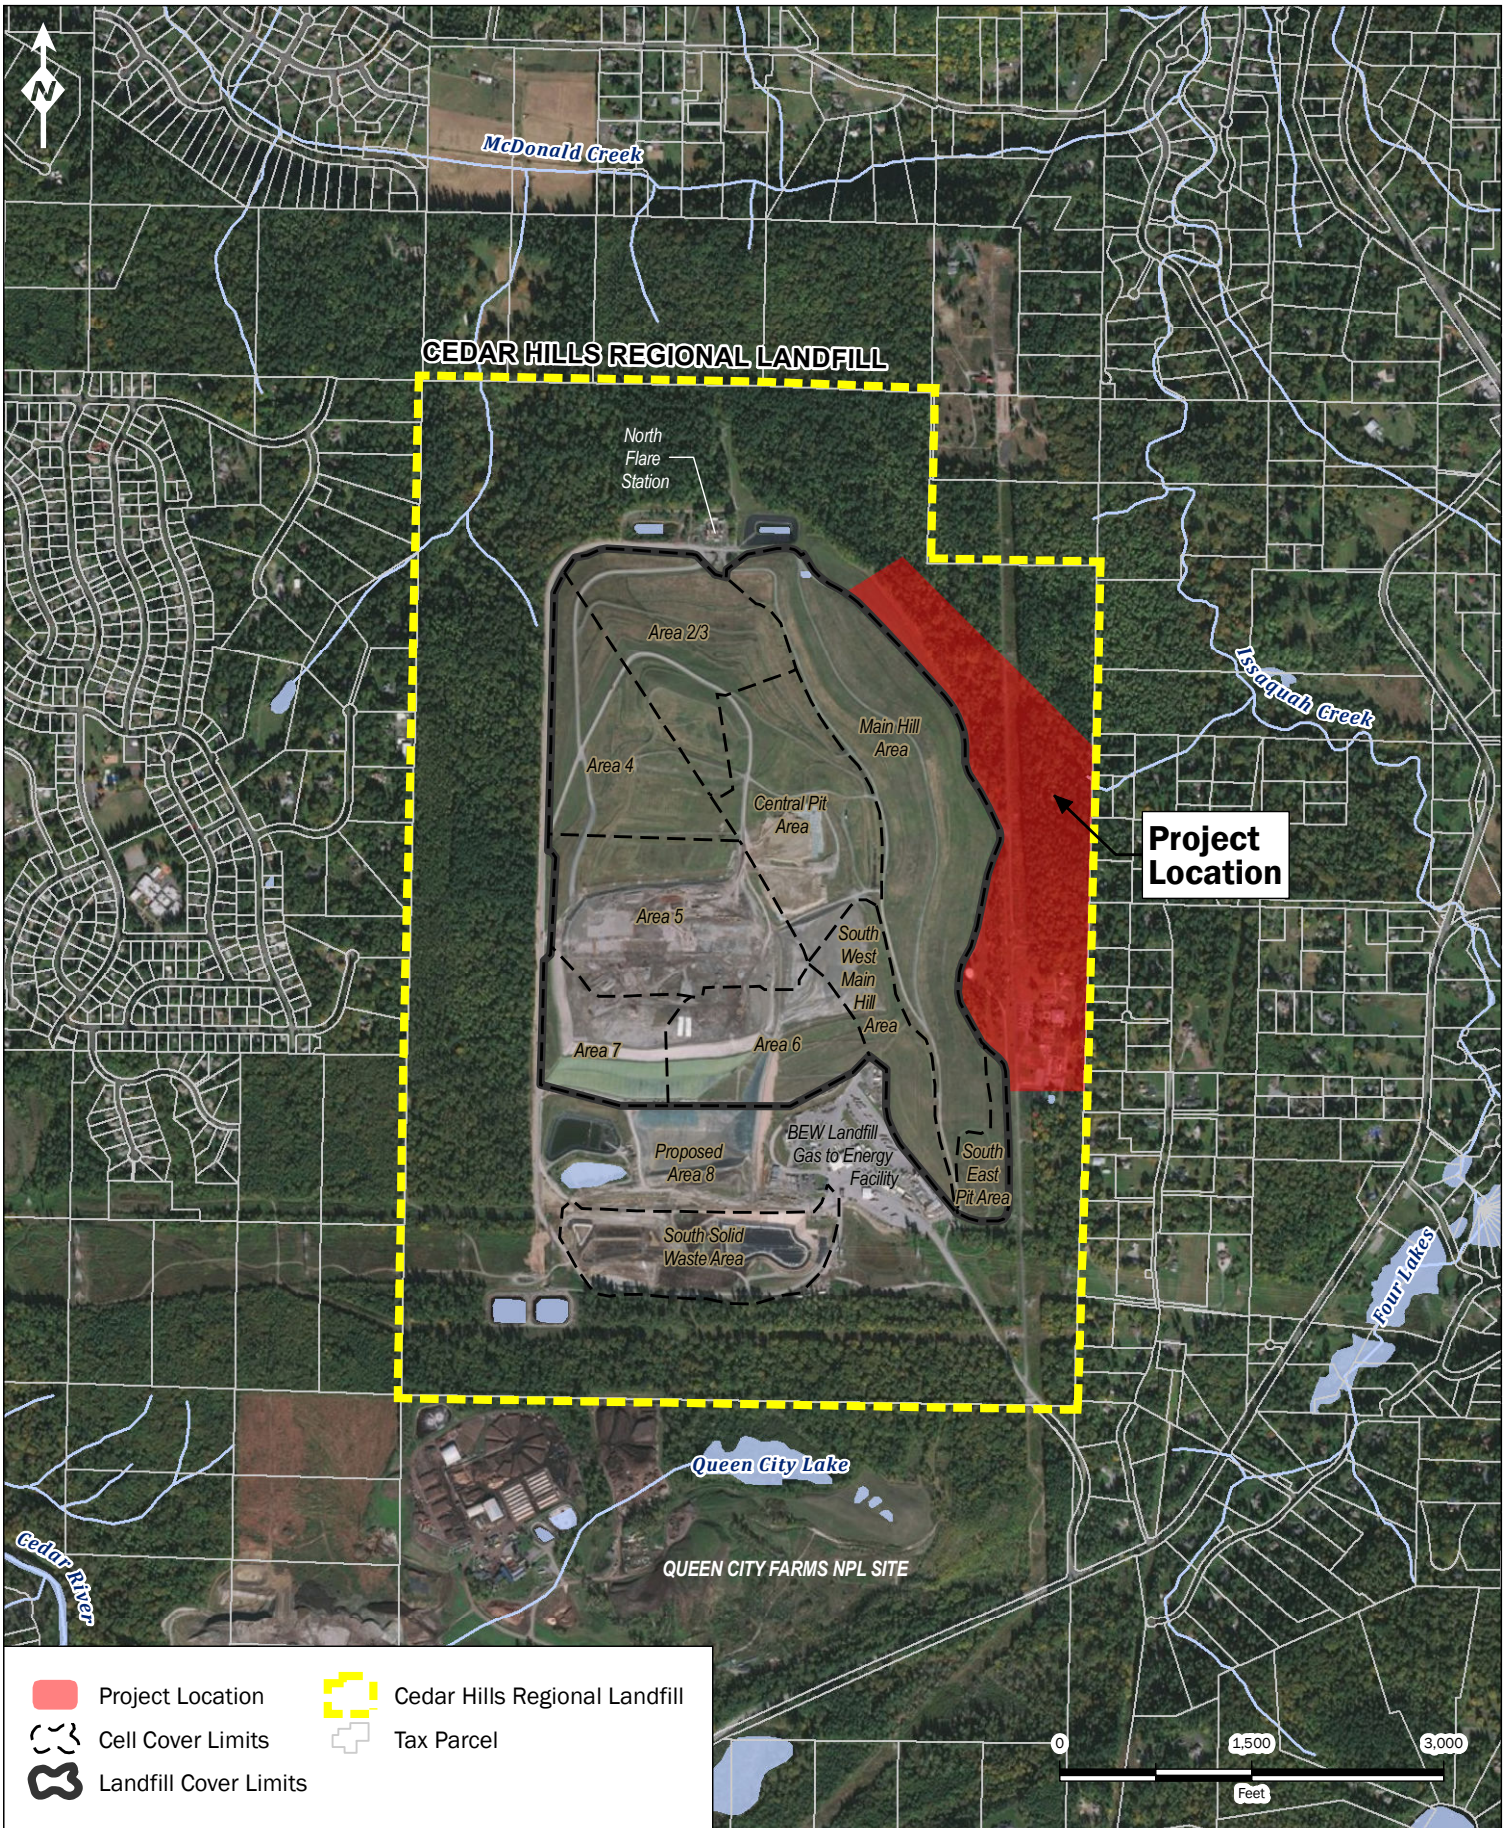
Project Location	  Cedar Hills Regional Landfill
  Cell Cover Limits
