## TECHNICAL MEMORANDUM

Re: Port Gamble Cleanup Project (NWS-2013-1270) – Year 3 Voluntary Eelgrass Transplant Memorandum

## **YEAR 3 VOLUNTARY EELGRASS TRANSPLANT AS-BUILT TECHNICAL MEMORANDUM**

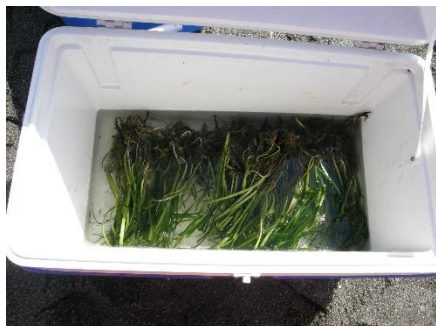
During eelgrass harvesting, divers will work in pairs to collect and count eelgrass turions, which will be stored in mesh dive bags carried by the divers. Turions will be harvested by gently agitating the substrate beneath the turions by hand to expose the rhizomes. Rhizomes and turions together will be pulled from the substrate, taking care not to break the turions from the rhizomes.

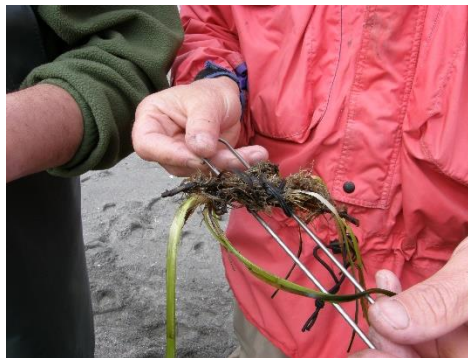
After returning to shore, Grette staff will begin processing the eelgrass turions into planting units (PUs). Staff will tie four eelgrass turions onto landscape staples with paper-coated twist ties and jute twine. The heavy gauge landscape staples will be a minimum of 9 inches long with a minimum 1-inch crown. The turions will be crossed on the staples, with two turions facing one direction and two facing the other, such that paired blades extend from either side of the staple.
