# Draft Data Summary Report

Simplot Grower Solutions  
J.R. Simplot Company

*Sunnyside, Washington*  
August 2019

**Prepared by:**  
HDR Engineering, Inc.  
412 East Parkcenter Blvd, Ste 100  
Boise, Idaho 83706

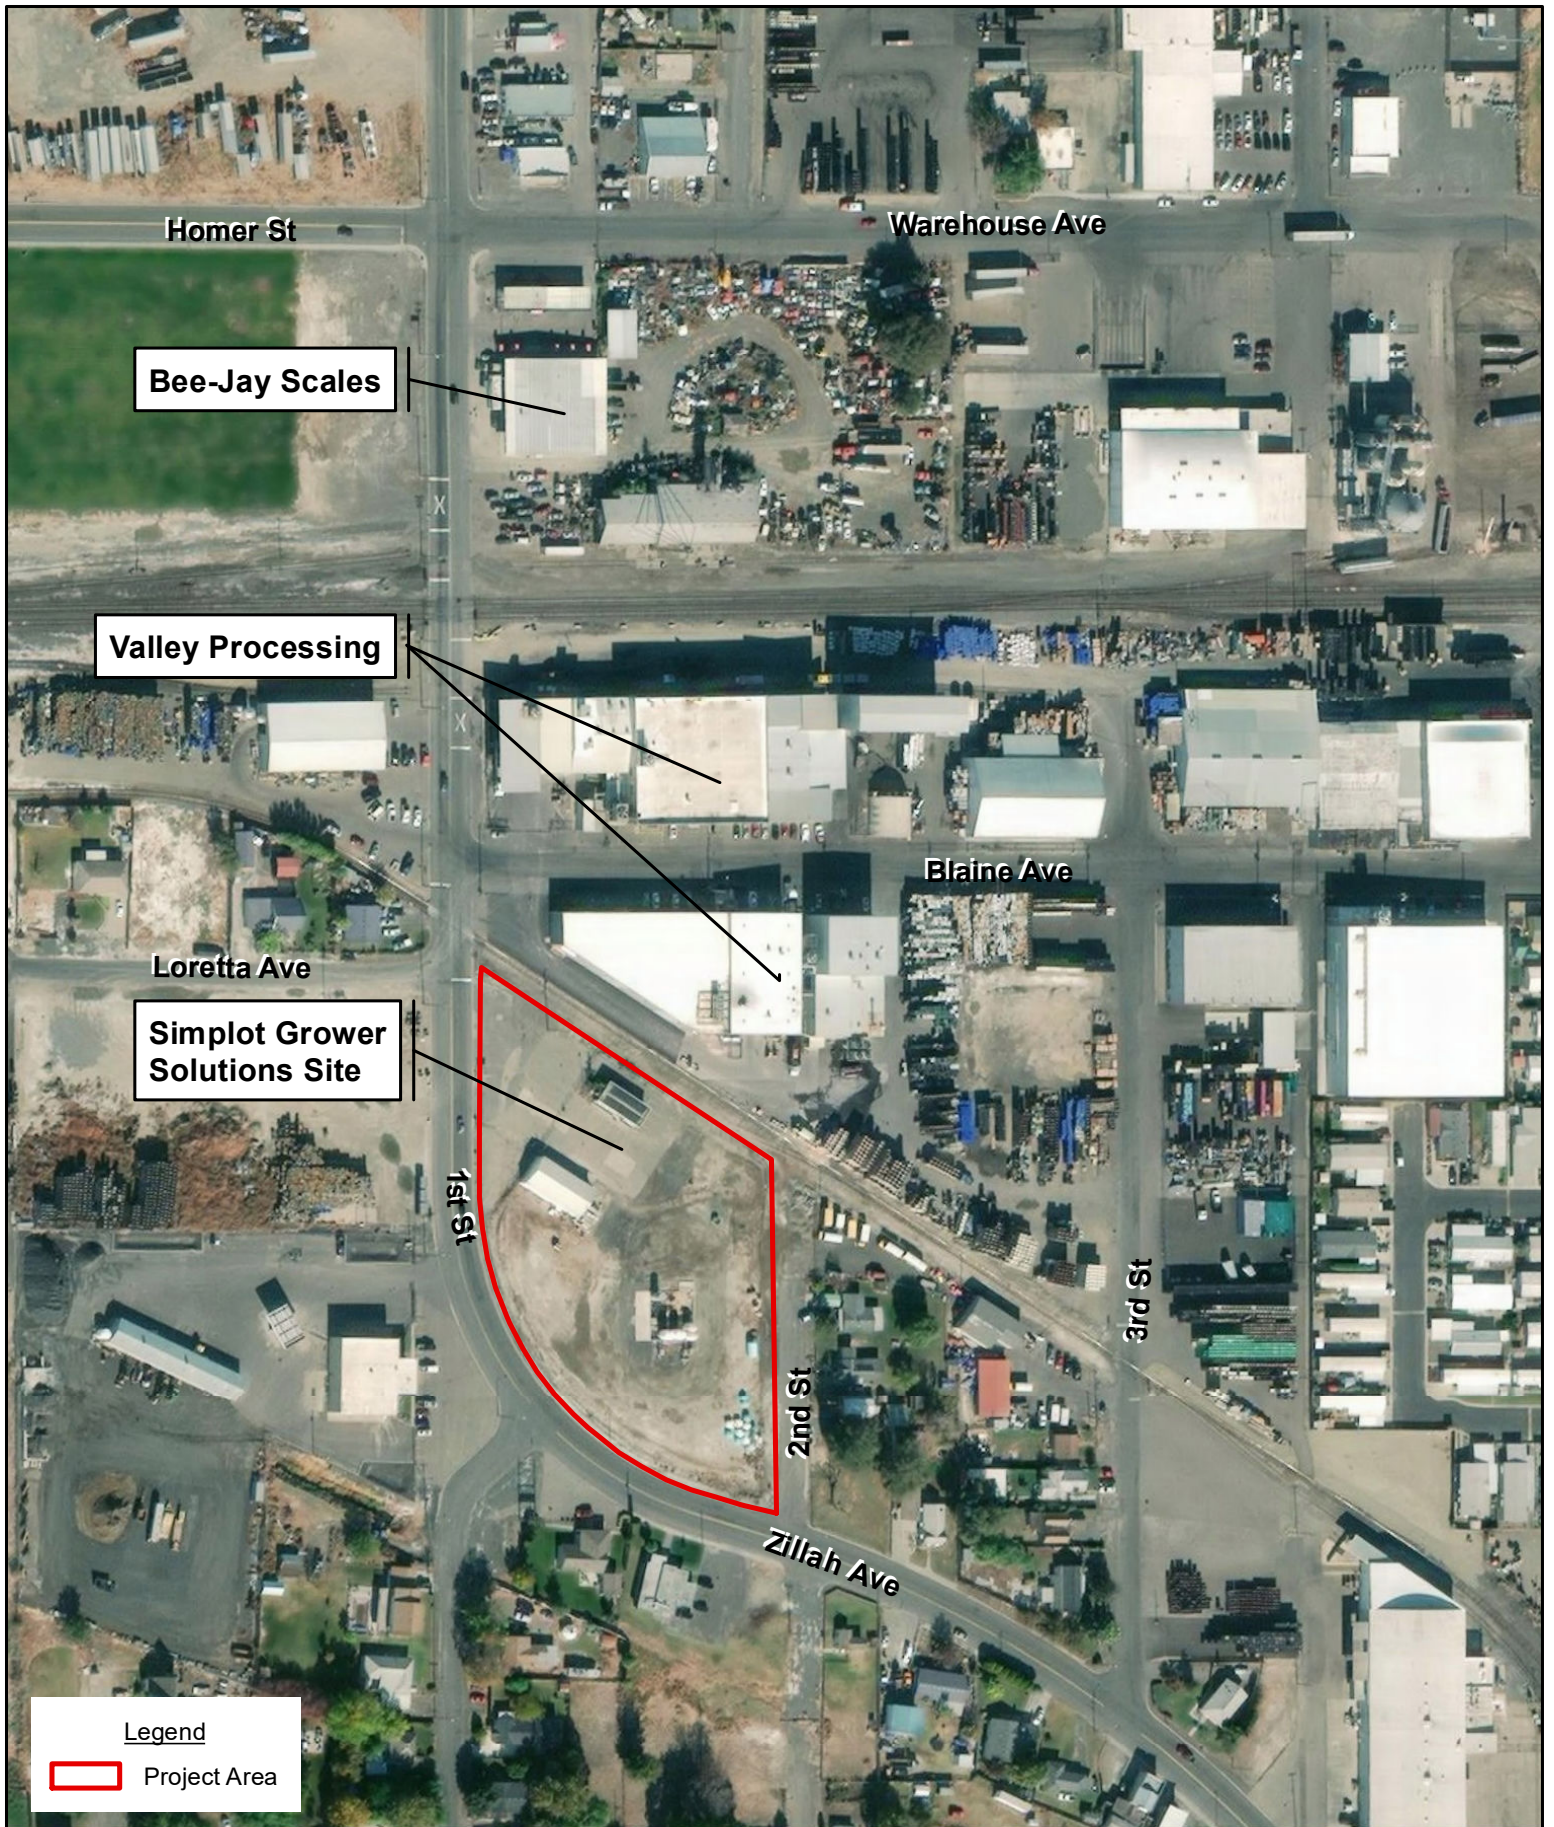
**Figure 2: Site Map 2018**  
**Simplot Grower Solutions, Sunnyside, WA**

In 2011, Simplot removed the main warehouse, office building, fertilizer storage tank area, and associated containment systems, and replaced them with a new office and concrete basin containment structure. A maintenance shop also remains on site. **Figure 2** illustrates site conditions in 2006 prior to reconfiguring the buildings and **Figure 3** illustrates current site conditions.

As described above, Simplot replaced the original office/warehouse building in 2011 with a smaller office on the north portion of property (**Figure 3**) and built a new tank area (middle of property). The original shop building remains.

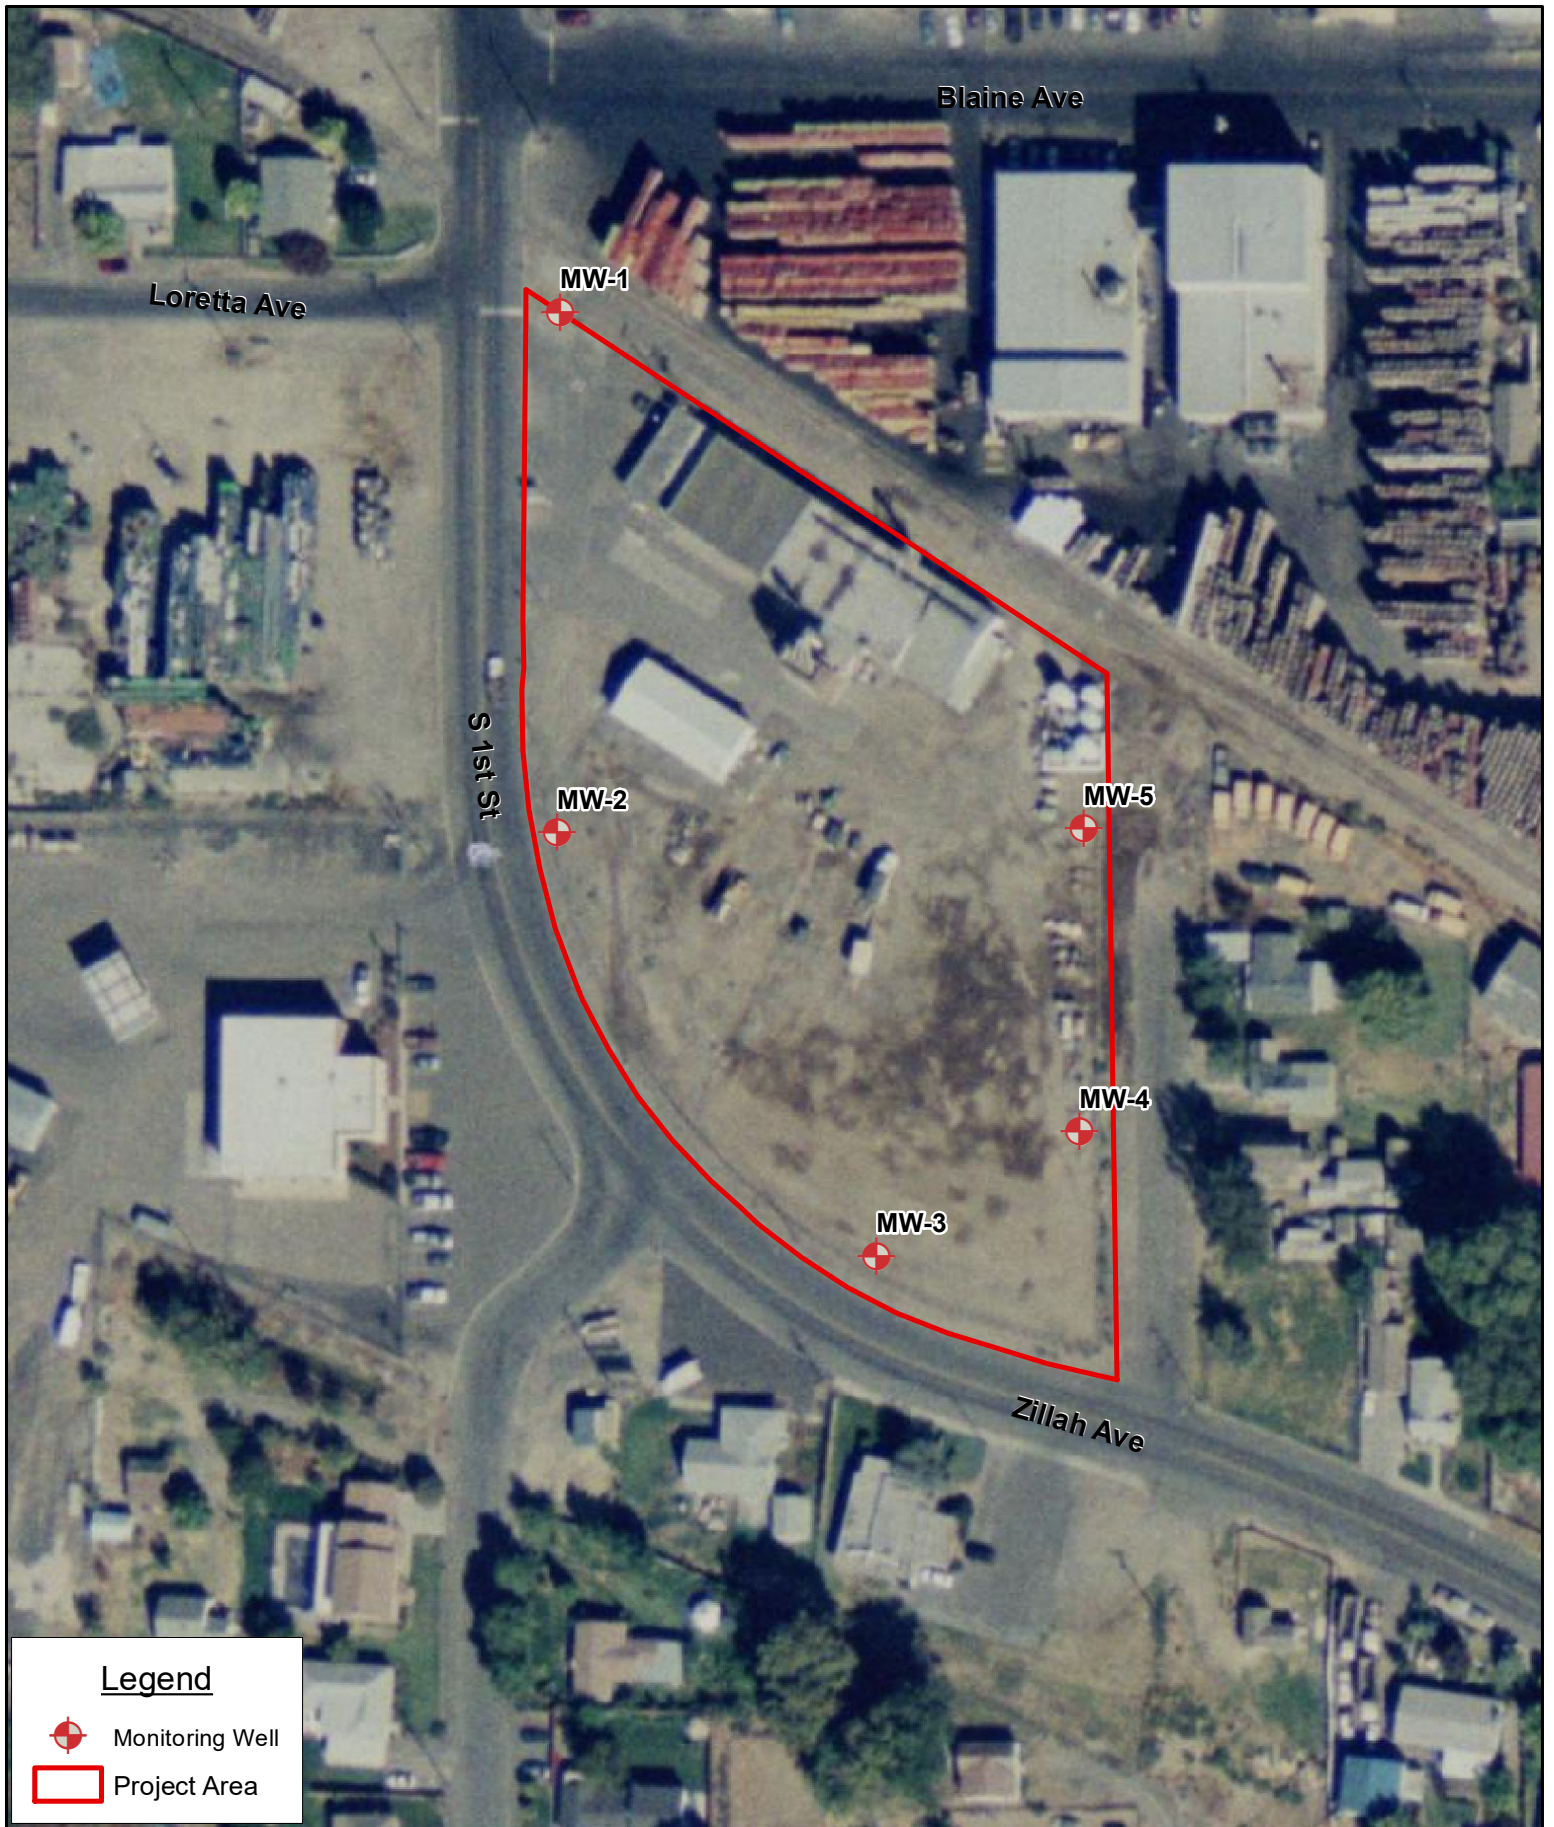
Based on the Bee-Jay Scales site investigation, groundwater flow was anticipated to be toward the east to southeast. One objective of installing the monitoring wells was to assess groundwater flow direction and seasonal changes over four quarters. Because of the uncertainty in groundwater flow direction (at that time), five monitoring wells were proposed. Monitoring well locations are presented in **Figure 7** (note that this is the monitoring well network in 2011 with modification in 2012).

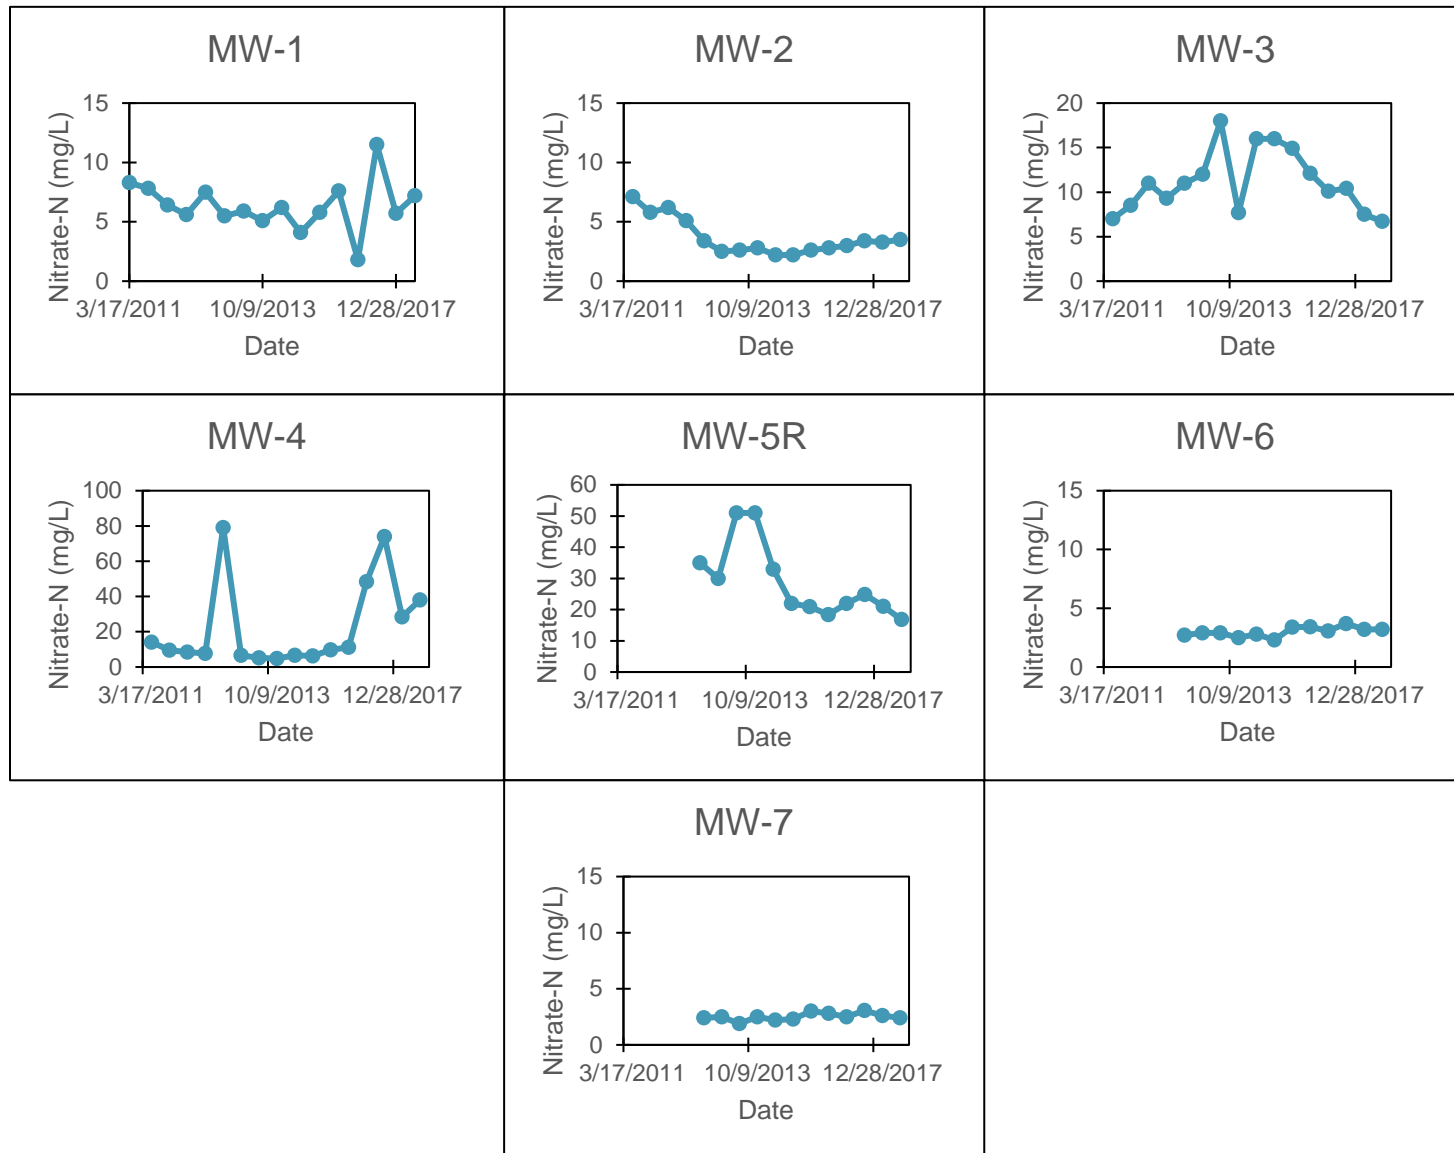
Figure 14. Trend Plots for Nitrate-N in Groundwater Monitoring Wells

- MW-5R (downgradient well) – was constructed following source area removal in 2012. Nitrate-N in this well has shown a decreasing trend since 2014, though nitrate-N concentrations remain above 10 mg/L.

- MW-6 and MW-7 (downgradient and off-site wells) – show nearly identical nitrate-N concentrations and have been below 10 mg/L with an average nitrate-N concentration of 2.8 mg/L in December 2017. While nitrate concentrations in MW-7 during the April 2018 sampling event rose above 10 mg/L (15.7 mg/L), those concentrations were down to 2.4 mg/L when MW-7 was sampled again in June 2018. Therefore, the April MW-7 data is considered suspect and the June data is used in this report.

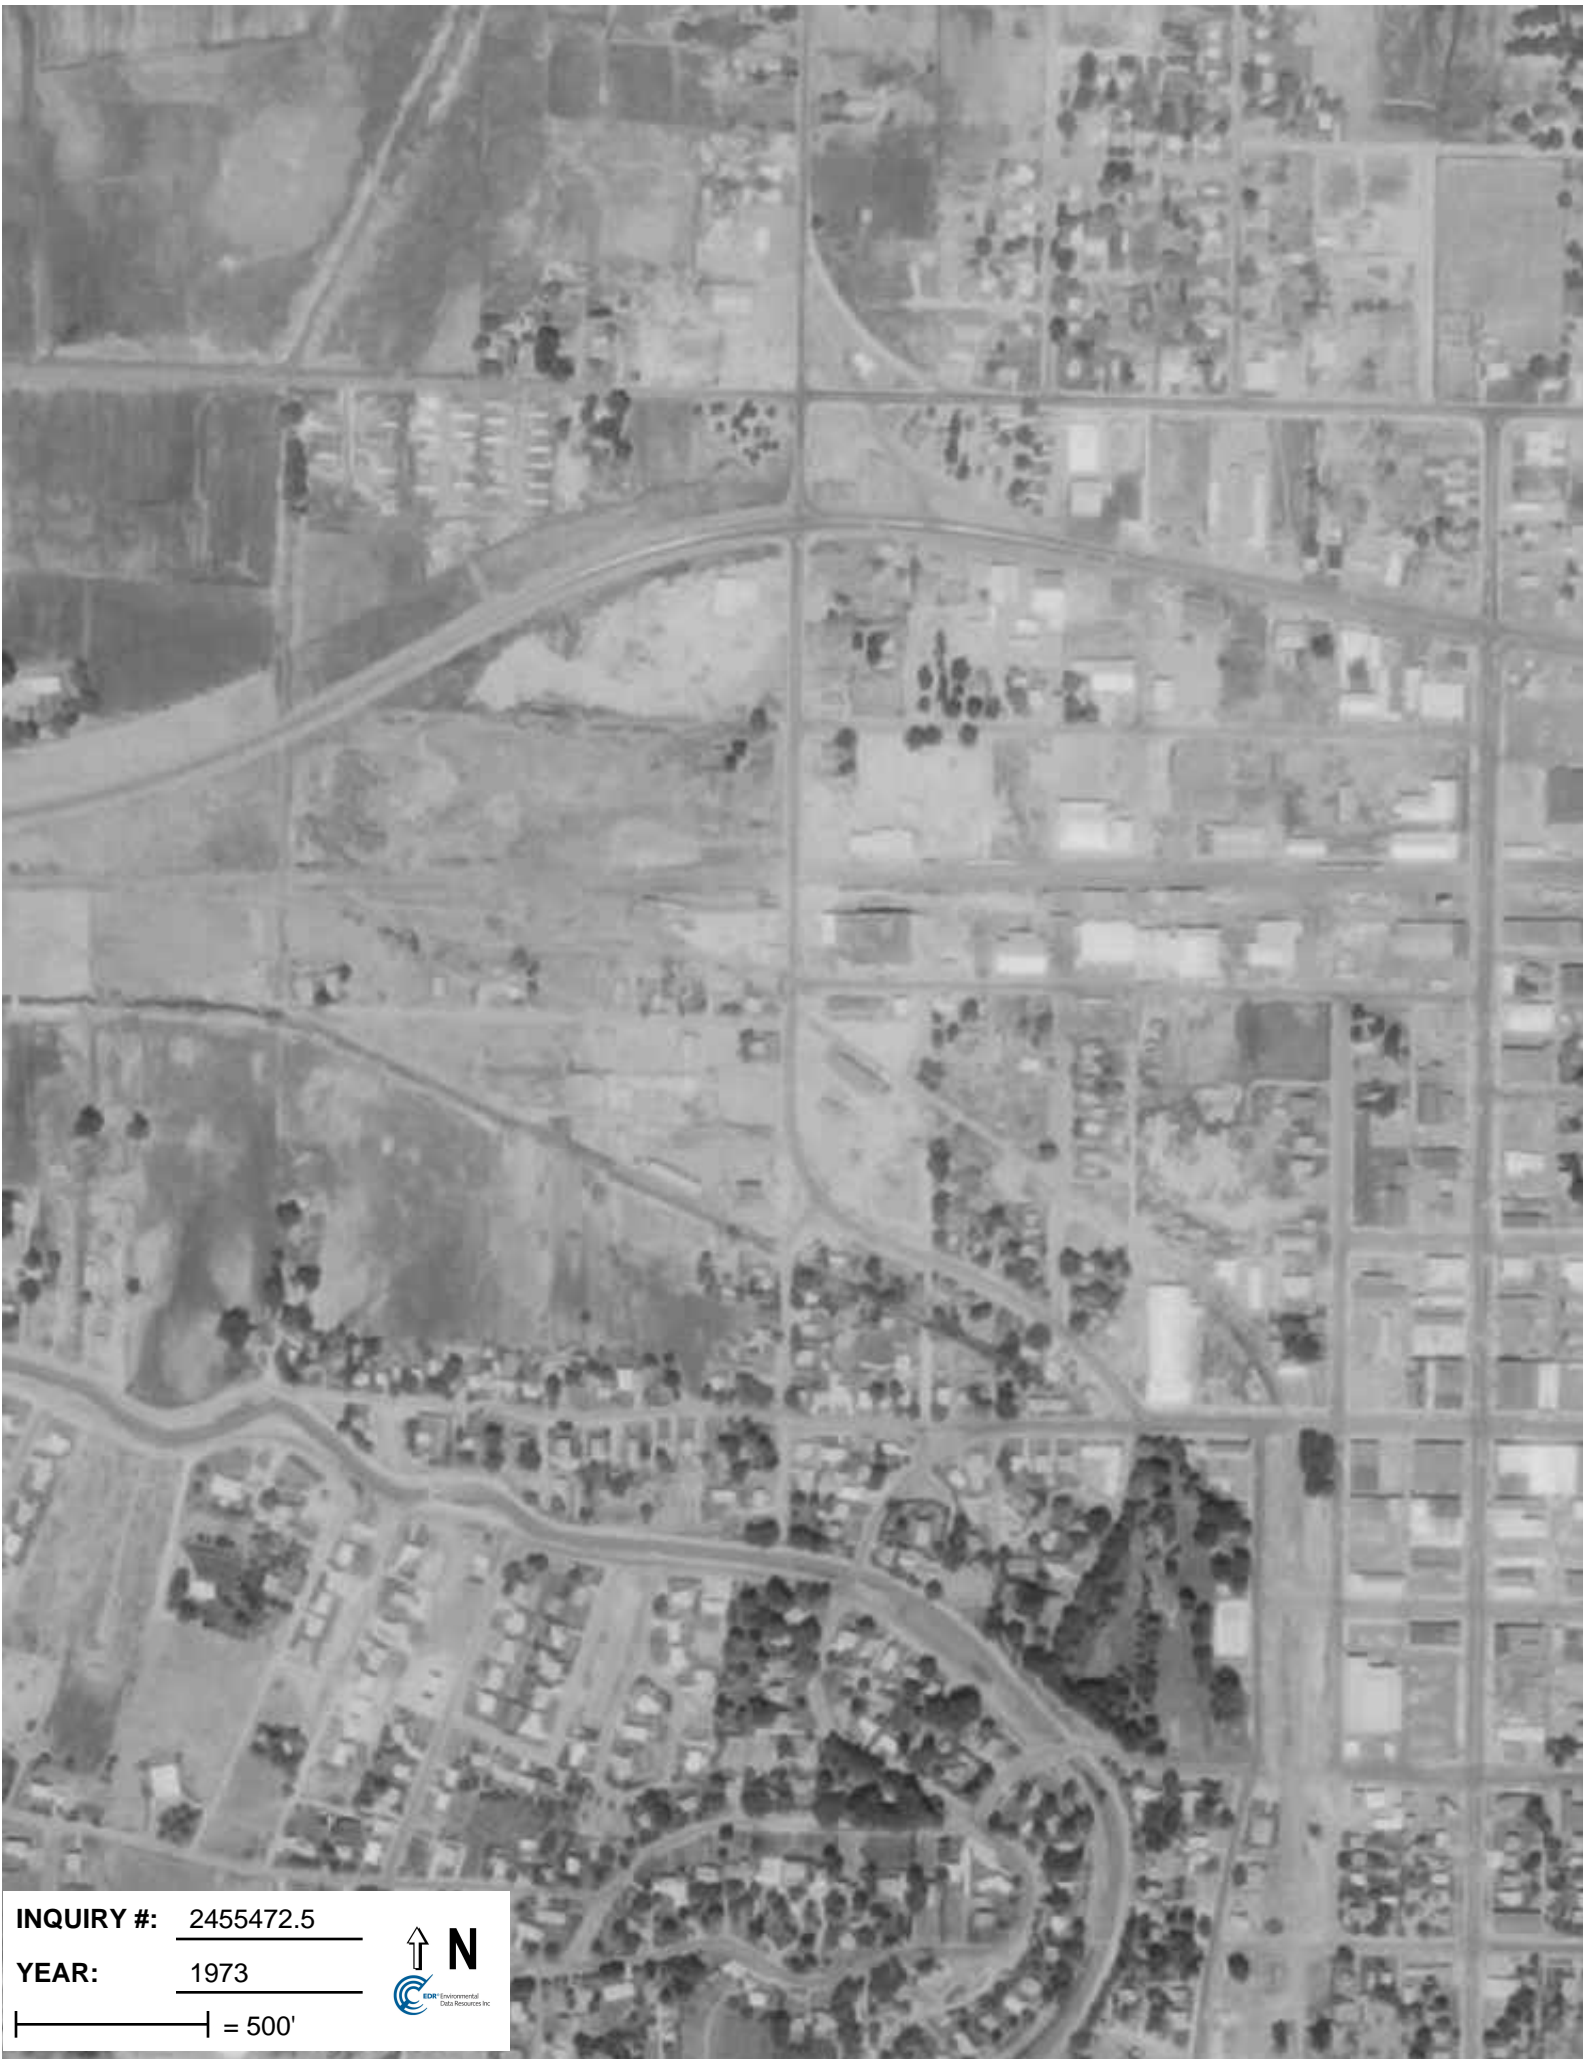
**YEAR:** 1973

<u>Year</u>	<u>Scale</u>	<u>Details</u>	<u>Source</u>
1973	Aerial Photograph. Scale: 1"=500'	Panel #: 2446120-C1/Flight Date: July 01, 1973	EDR
1982	Aerial Photograph. Scale: 1"=1000'	Panel #: 2446120-C1/Flight Date: August 17, 1982	EDR
1990	Aerial Photograph. Scale: 1"=1000'	Panel #: 2446120-C1/Flight Date: June 20, 1990	EDR
1996	Aerial Photograph. Scale: 1"=750'	Panel #: 2446120-C1/Flight Date: June 29, 1996	EDR
2006	Aerial Photograph. Scale: 1"=535'	Flight Year: 2006	EDR

A review of historic records for the Simplot Grower Solutions Sunnyside facility found information dating back to 1965. Based on a 1965 historic topographic map, the Simplot site had one building and the site was outside the corporate city limits of Sunnyside (City). Historic aerial photographs from 1973, 1982, 1990, 1996, and 2006 (Appendix A) are summarized in **Table 2-2**.

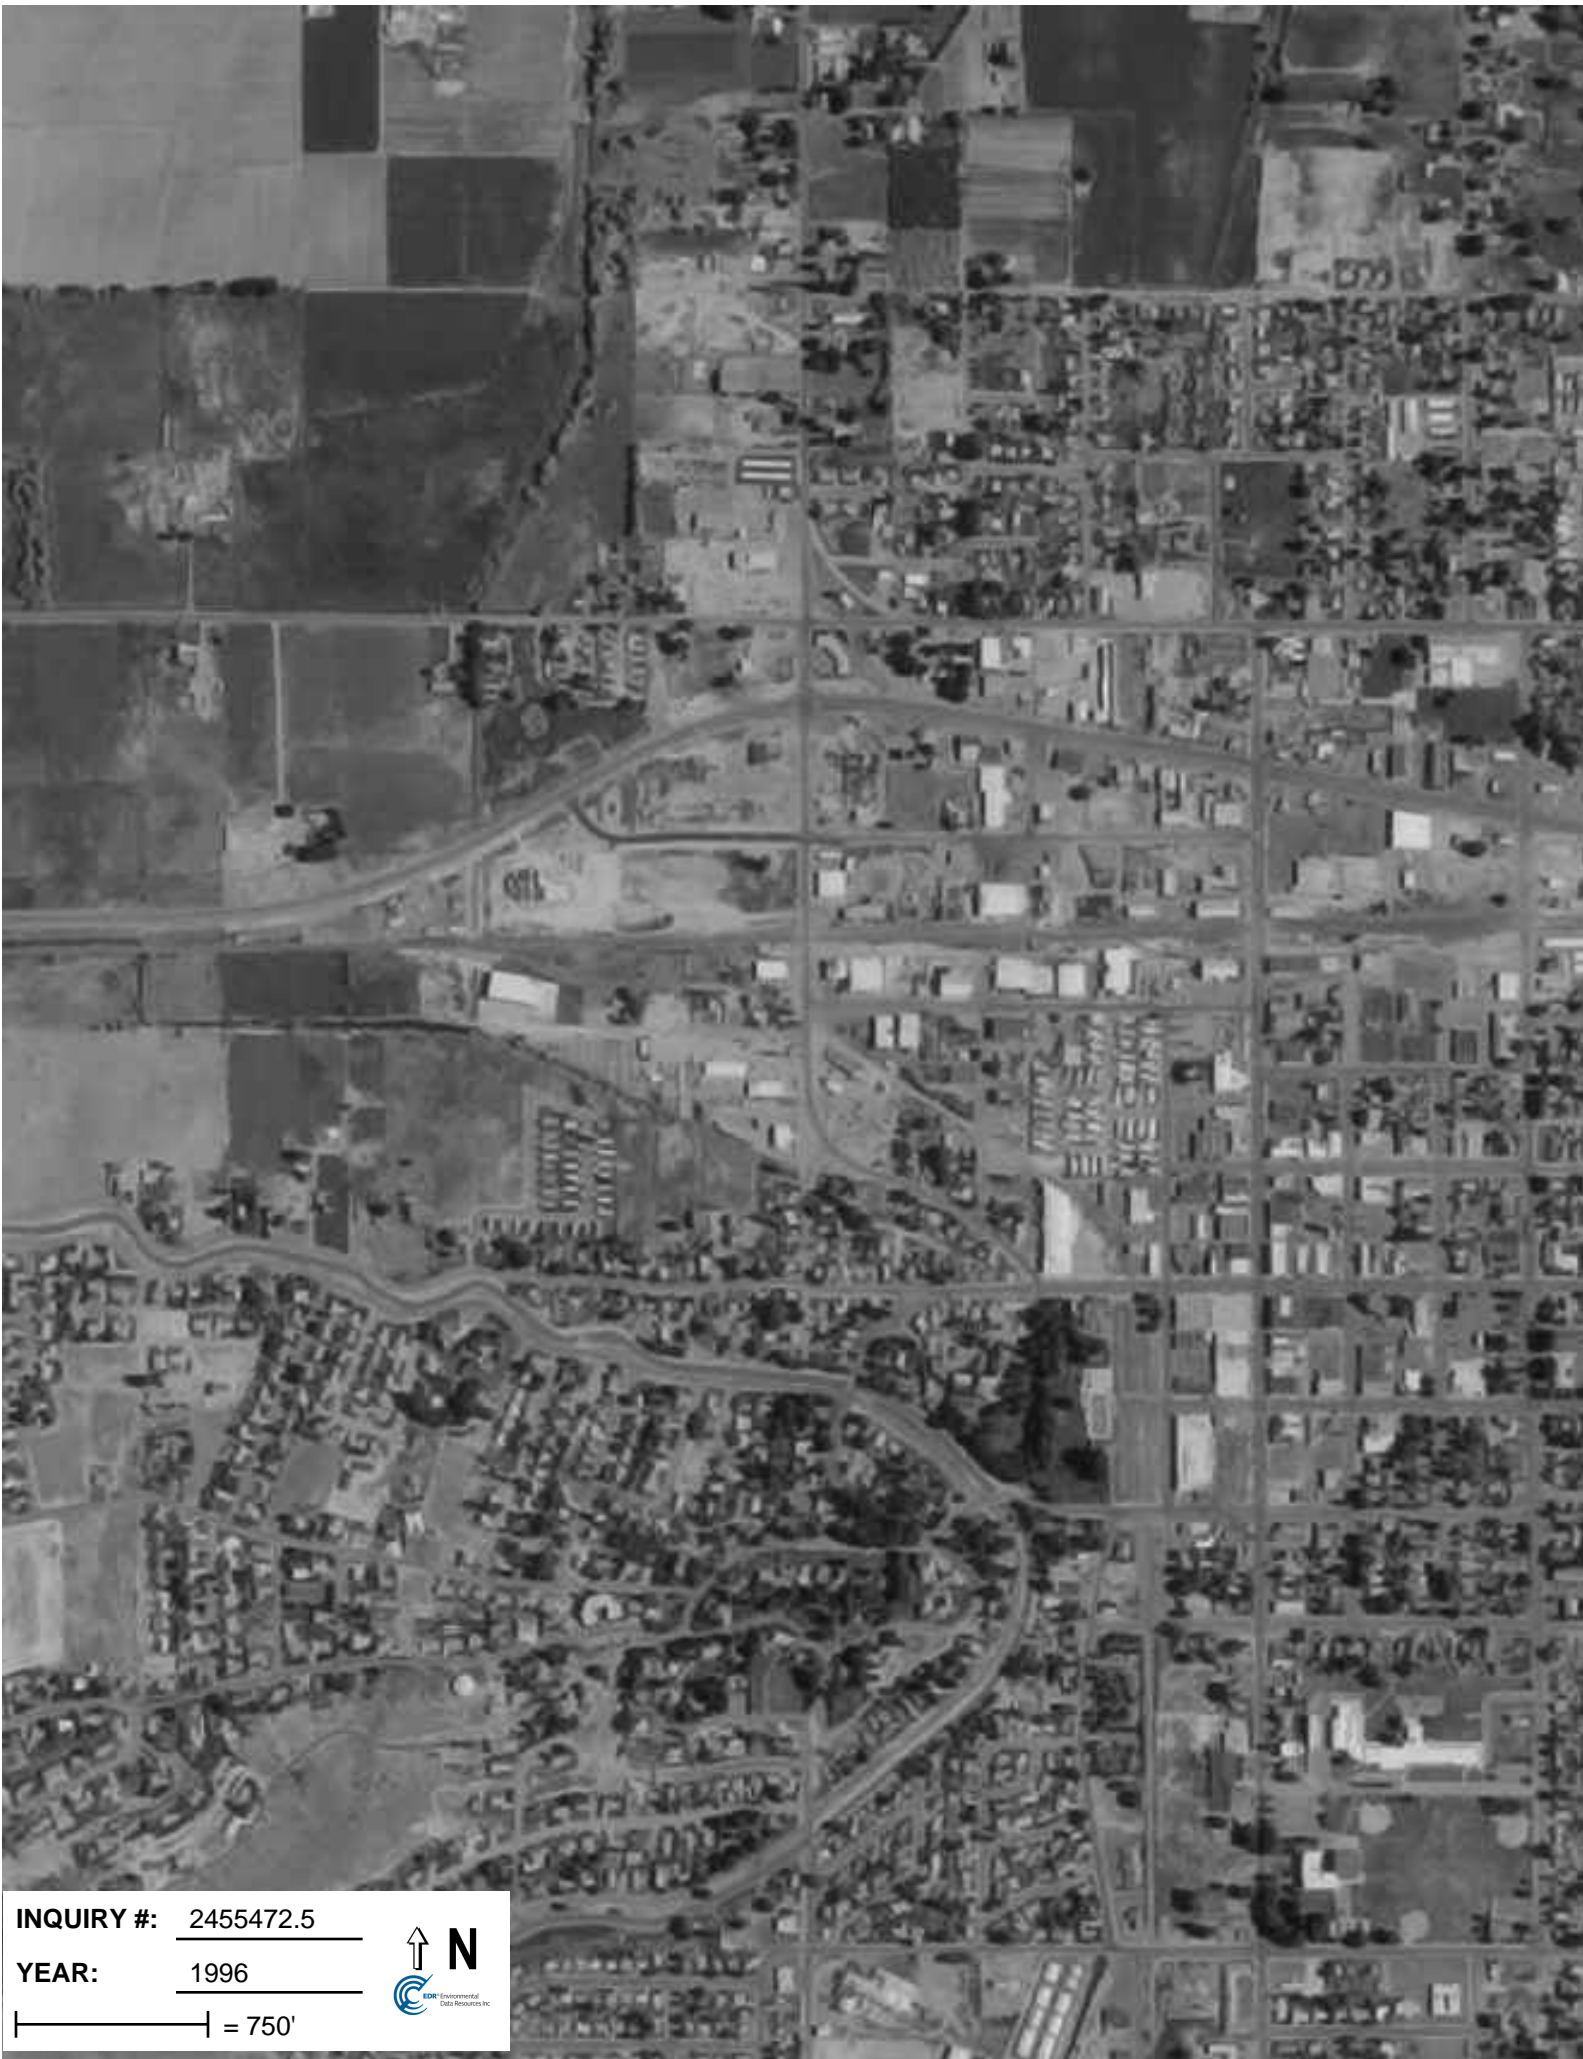
**YEAR:** 1996

Aerial Photograph <sup>1</sup>	Description
1996 (1:9000)	Consistent with 1973 photographs. A structure is present near the northeast corner of the site that corresponds to the current day above ground storage tanks. These tanks hold liquid fertilizer.
2006 (1:6420)	Consistent with previous aerials, warehouse and office building shop, and tank farm present and illustrated in Figure 2.
Figure 3	In 2011, Simplot removed the main warehouse, office building, fertilizer storage tank area, and associated containment systems, and replaced them with a new office and concrete basin containment structure. The shop remains.

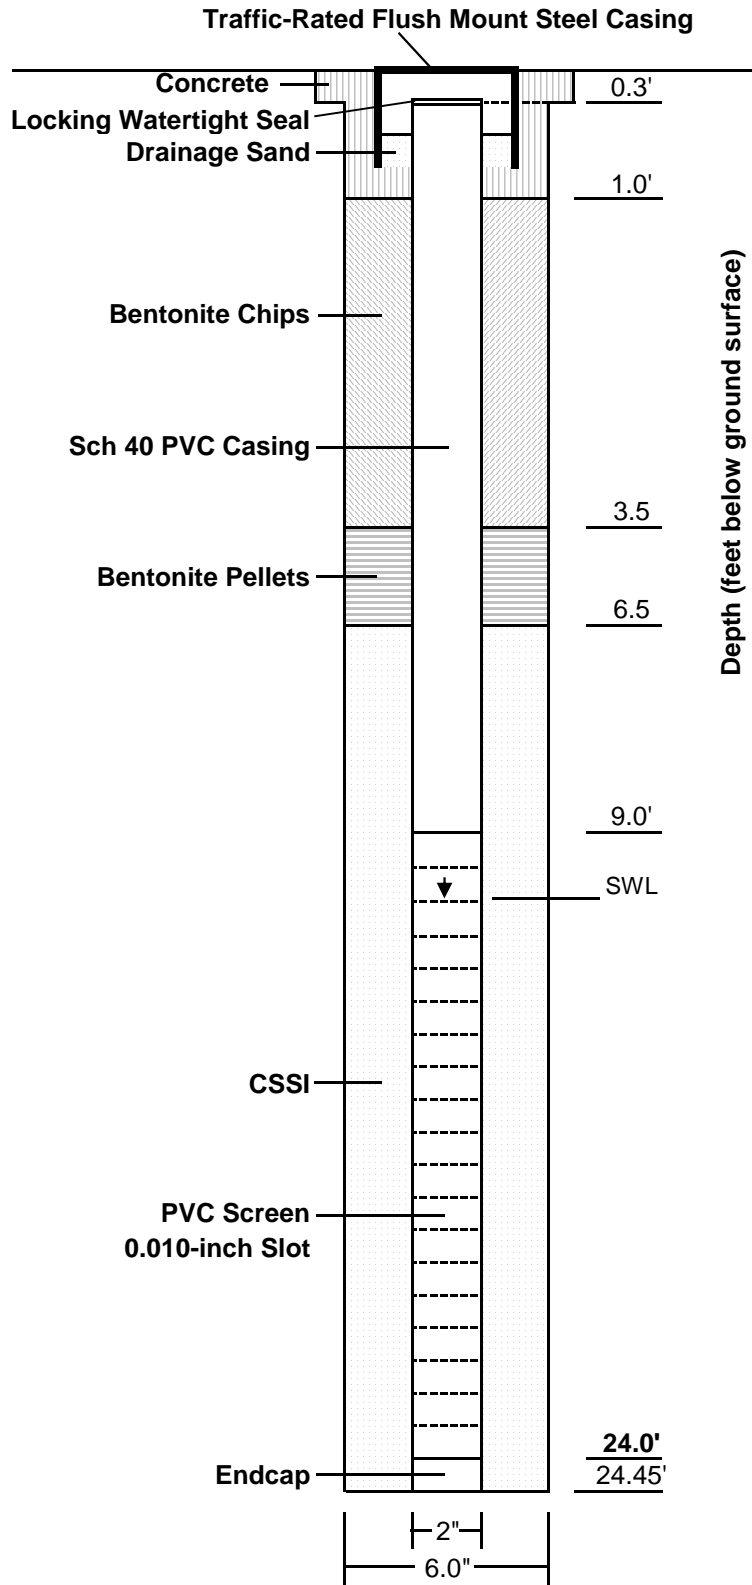
MW-7

Top of Steel Plate = 743.43 MSL  
 Top of PVC = 743.06 MSL

SILT(ML): Dark Gray Brown (10YR 4/2);  
 soft; moderate plasticity; moist; no odor.
