Phase I Environmental Site Assessment

BHP Billiton Canada Inc.

21 July 2017

Phase I Environmental Site Assessment Proposed Grays Harbor Potash Export Facility Port of Grays Harbor, Hoquiam, Washington BHP Document No. 40600-HS-RPT-55034

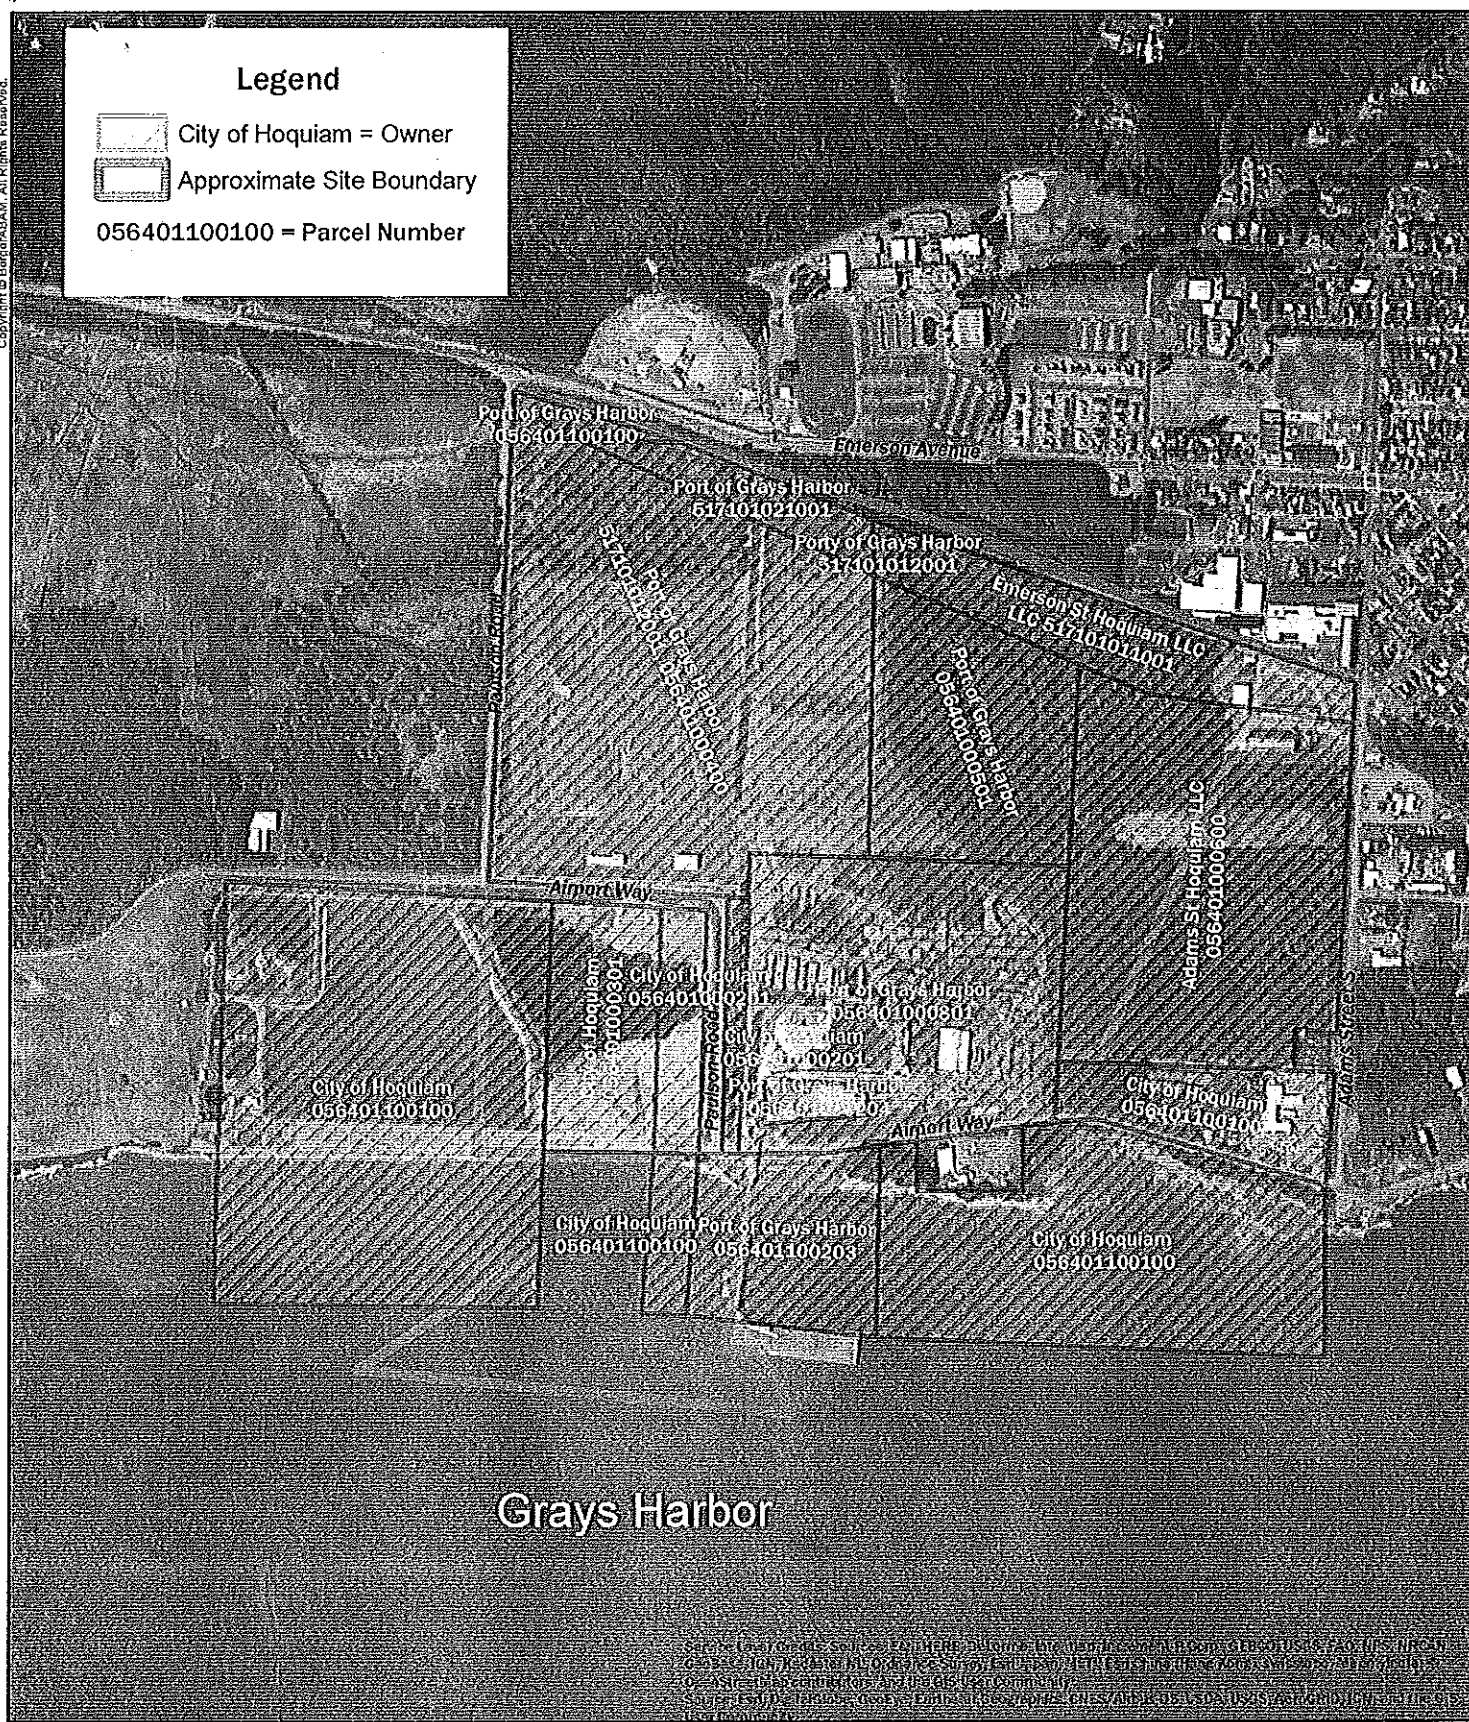
Figure 2-Parcel Map

City of Hoquiam = Owner
Approximate Site Boundary
056401100100 = Parcel Number

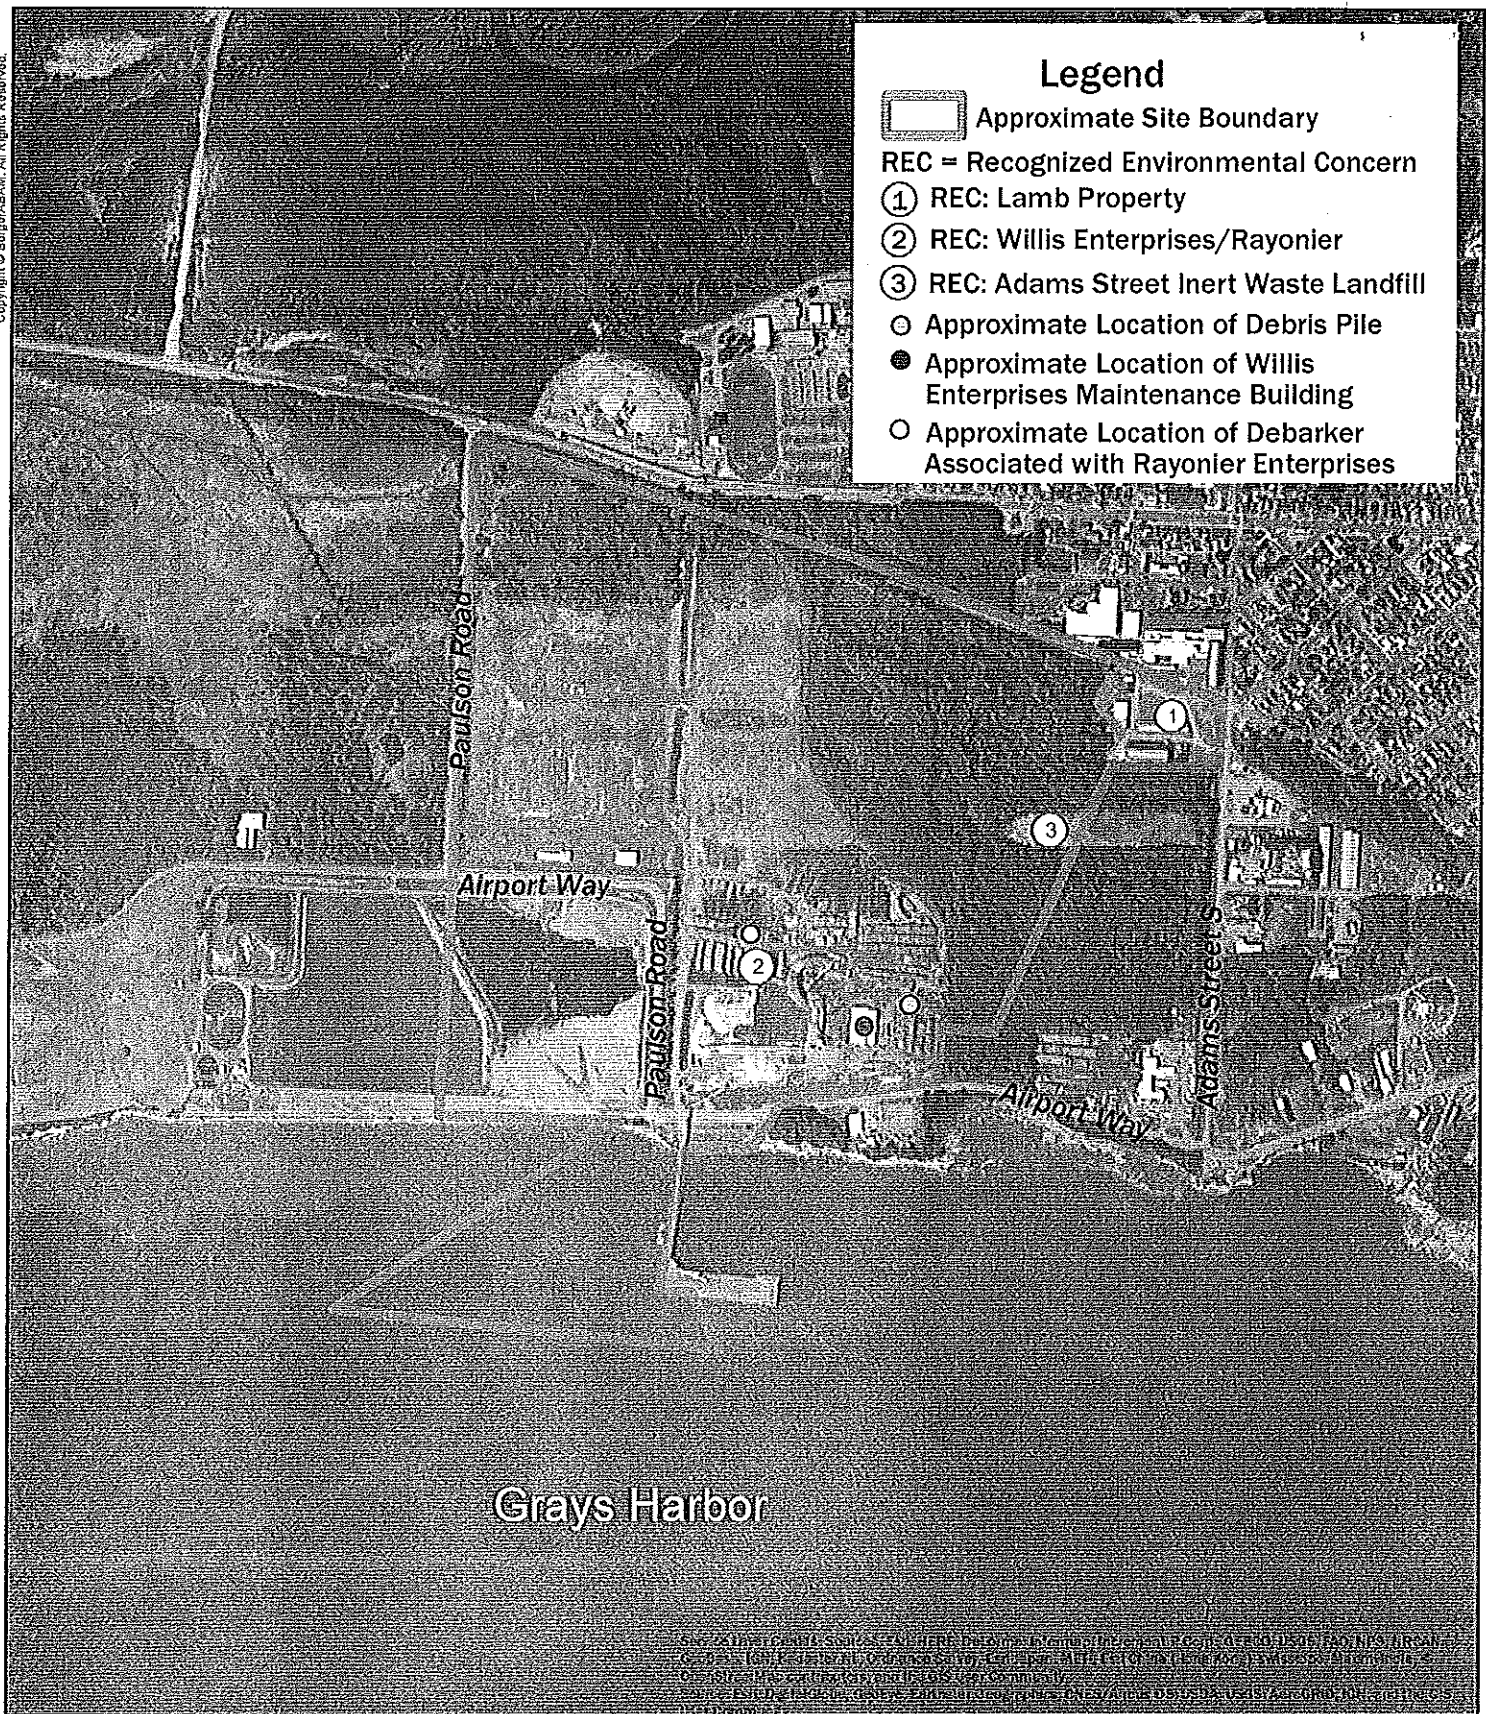
- Approximate Site Boundary
- REC = Recognized Environmental Concern
- ① REC: Lamb Property
- ② REC: Willis Enterprises/Rayonier
- ③ REC: Adams Street Inert Waste Landfill
- Approximate Location of Debris Pile
- Approximate Location of Willis Enterprises Maintenance Building
- Approximate Location of Debarker Associated with Rayonier Enterprises

A representative of BergerABAM performed a visual reconnaissance of the subject site on 10 May 2017. The subject site is generally flat, ranging from Elevations +7 to +23 feet mean lower low water (MLLW). The approximately 240-acre site (including an existing berth and intertidal area) is occupied by approximately 4.3 acres of wetland near the northwest corner, 1.6 acres of wetlands on the west and southwest portions of the site, and 77 acres of wetland on the east portion of the property. These wetland areas are approximated from previous studies³. The subject site and surrounding properties are shown on Figures 2 and 3.

The Lamb parcels represent a potential REC due to the known contamination at the former foundry facility, lack of characterization of material disposed at the City-leased landfill, and the parcel locations on and adjacent to the subject property.
