**RE: Remediation System Decommissioning  
Phillips 66 Facility No. 255353 (AOC #1396)  
600 Westlake Ave North  
Seattle, Washington  
ATC Project No. Z076000073  
Washington Department of Ecology Facility ID 46445373  
Washington Department of Ecology VCP #NW1714**

ATC Group Services LLC (ATC) is pleased to submit this letter report to Phillips 66 Company (Phillips 66) for the above referenced facility (Site) documenting the above ground remediation system component decommissioning activities that were completed in April 2019.

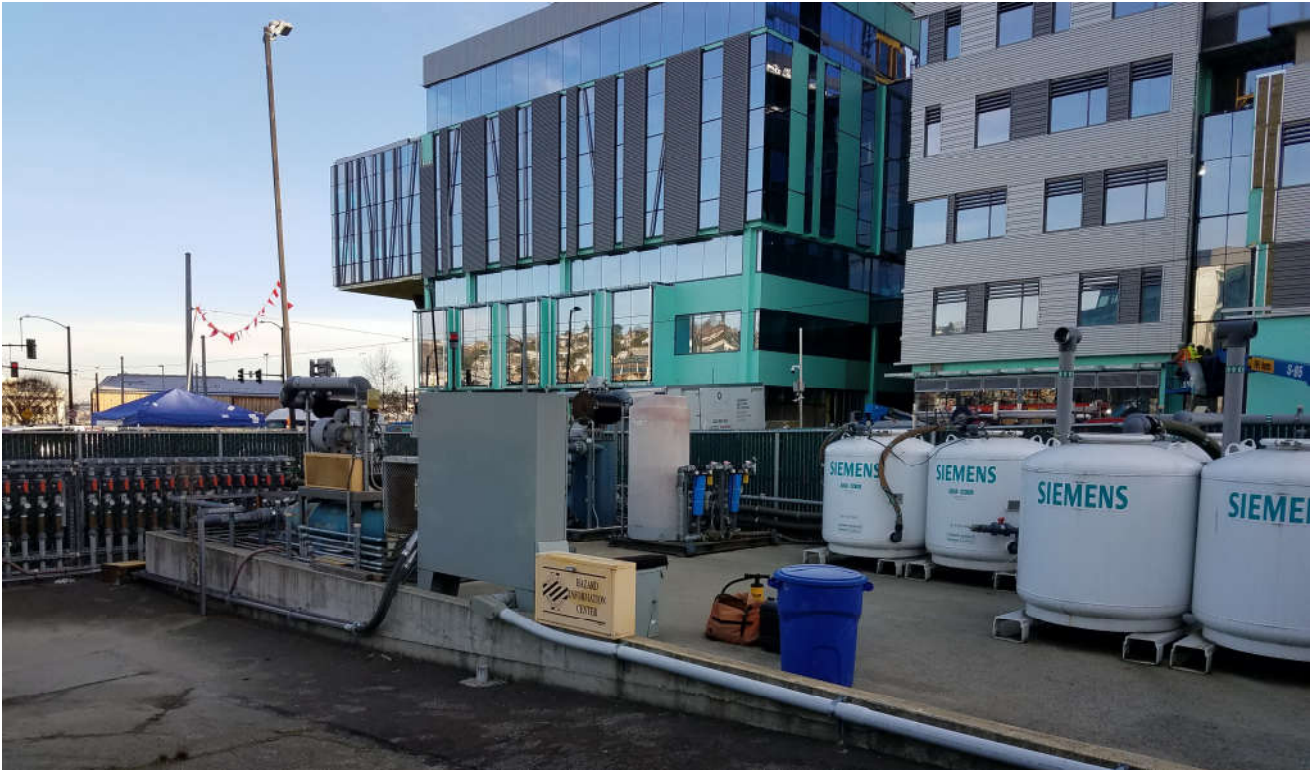
Photograph 1: View to the northeast – Former remediation system compound prior to removal.

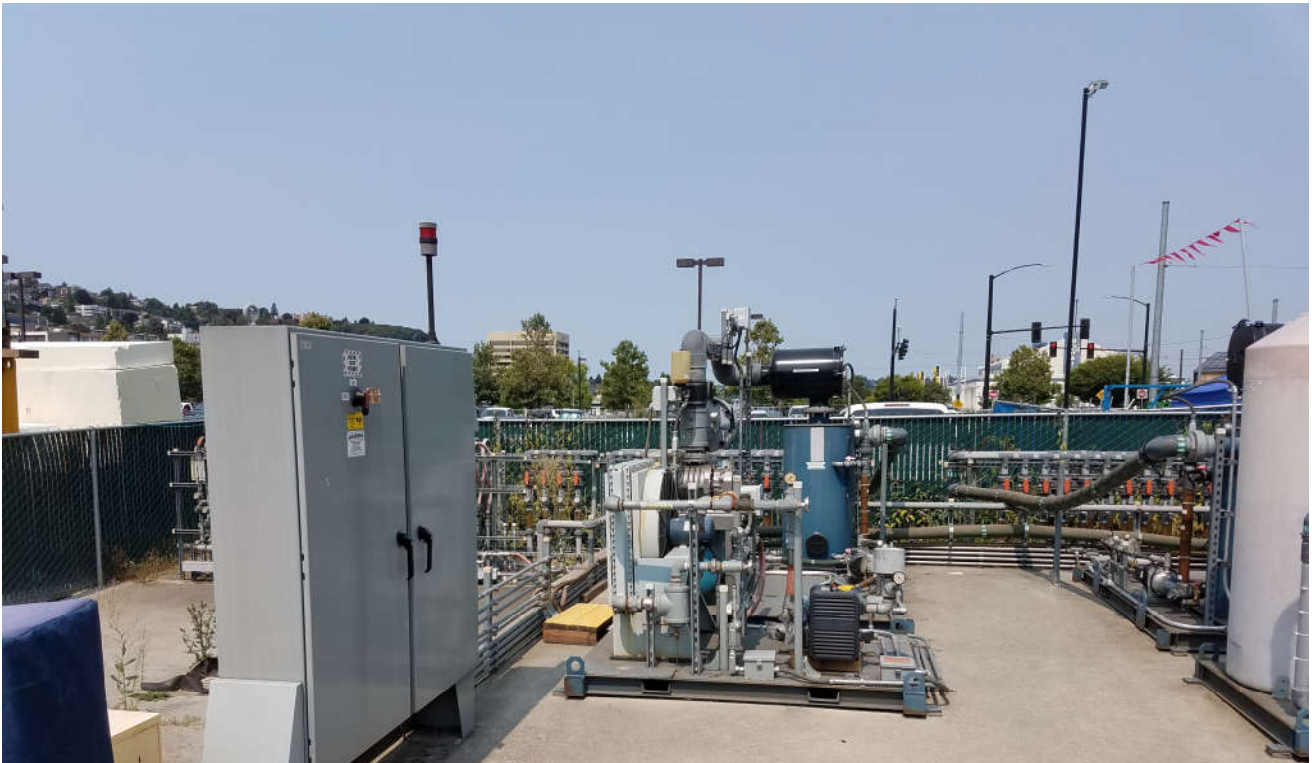
Photograph 2: View to the north – Former remediation system compound prior to removal.

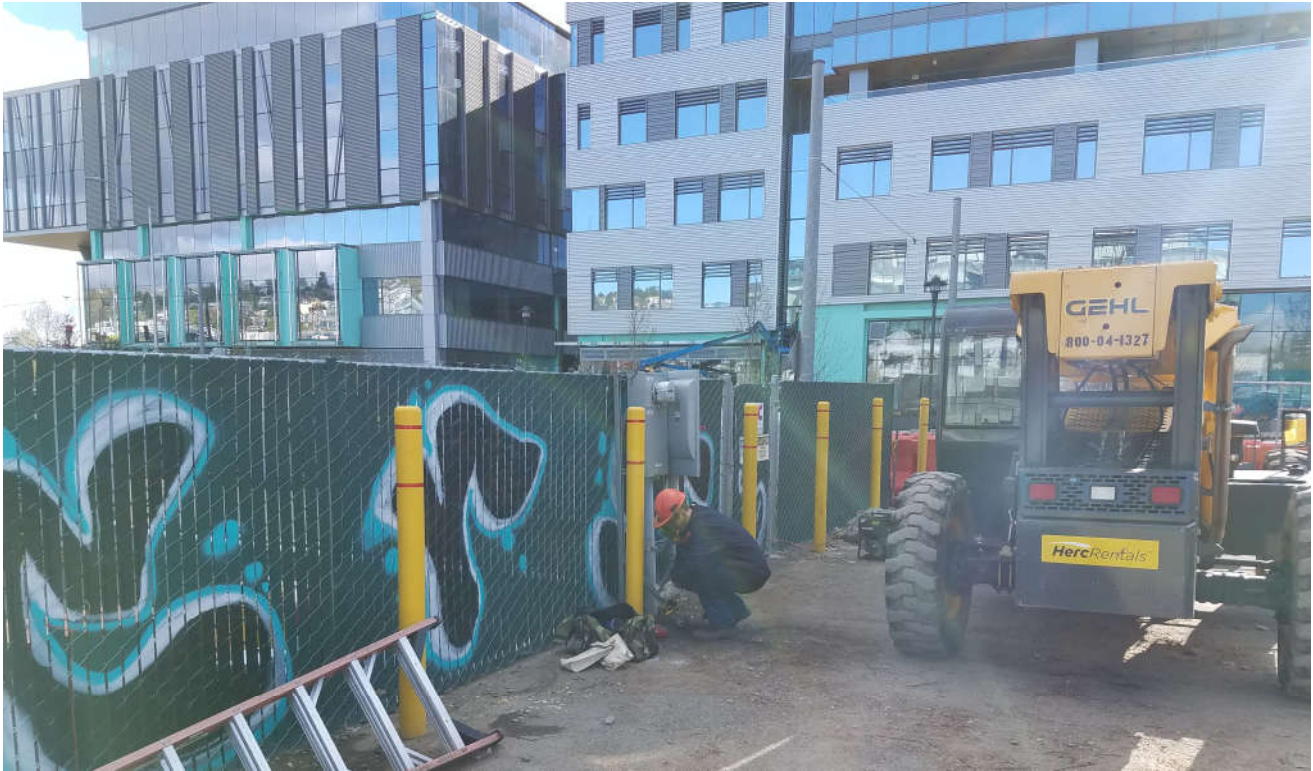
Photograph 3: View to the east – Electrician performing power disconnect at main system breaker.

Following Emerald's activities, SHJ Electric Company, Inc. (SHJ), under the supervision of Clearcreek, de-energized the main breaker to the system (located at the south end of the remediation compound) and disconnected power to the breaker panel. SHJ then verified that power to the system control panel was inactive and all system components were de-energized.

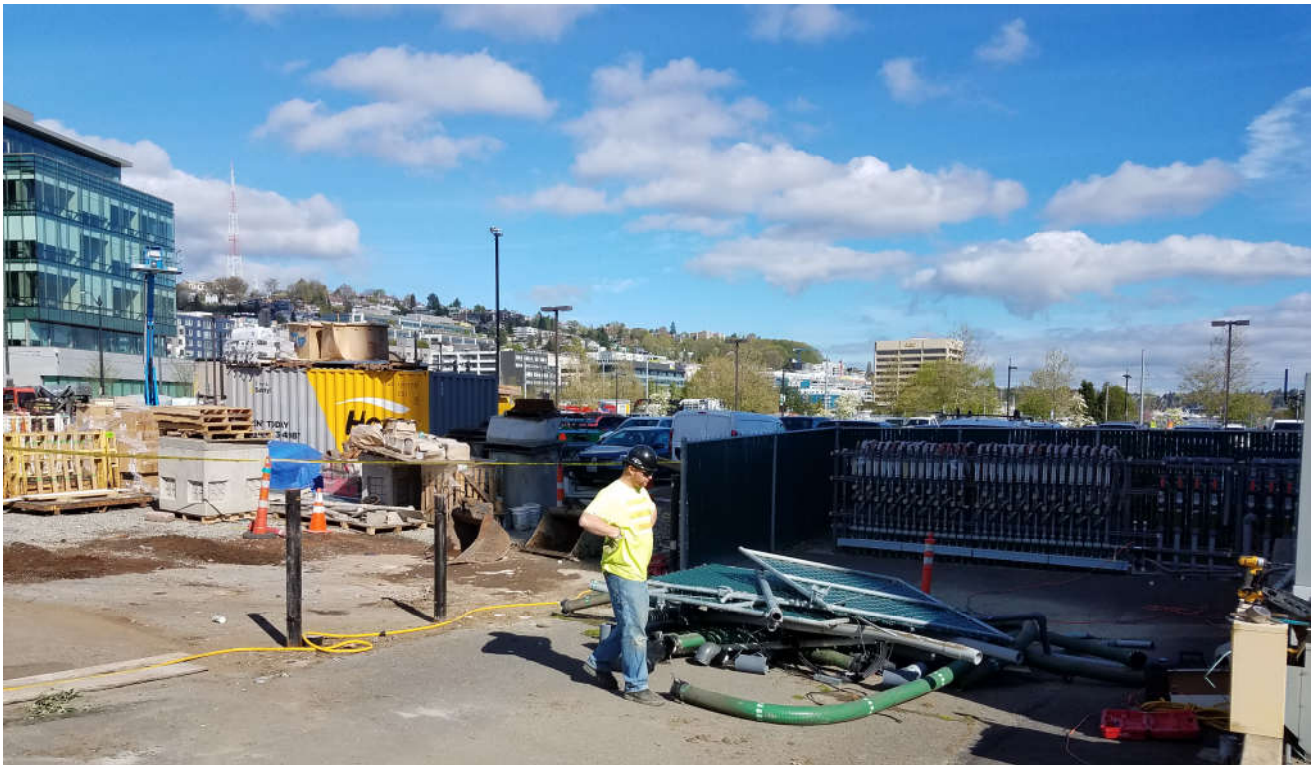
Photograph 4: View to the north – Removal of system fencing and conveyance piping.

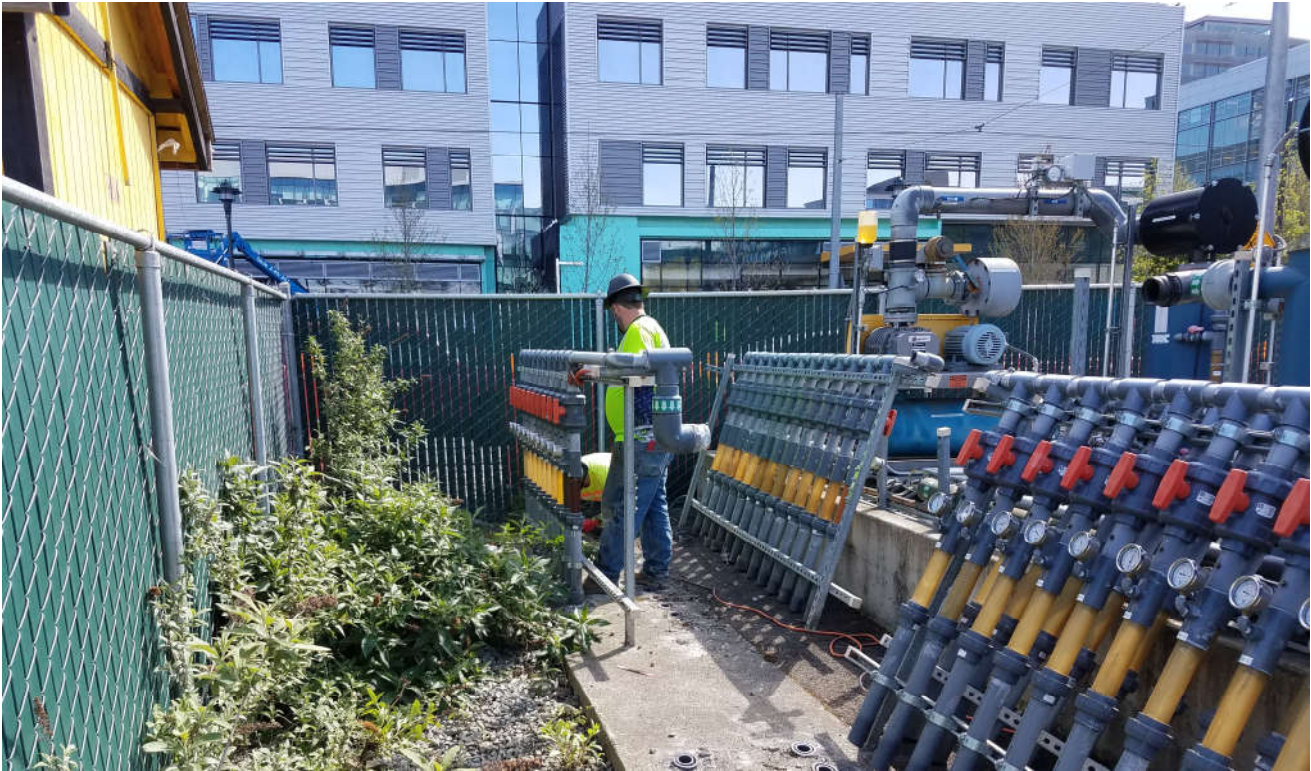
Photograph 5: View to the east – Removal of SVE manifolds.

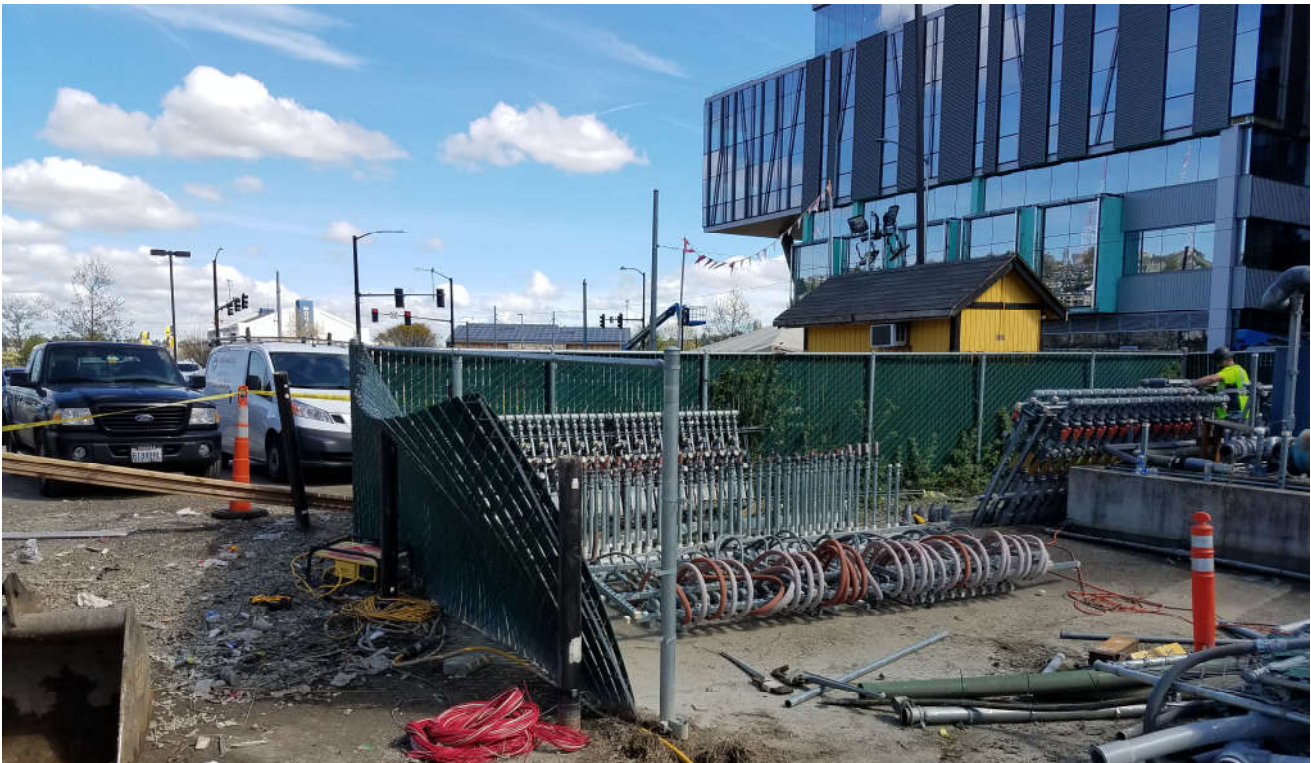
Photograph 6: View to the northeast – Removal of air sparge manifolds.

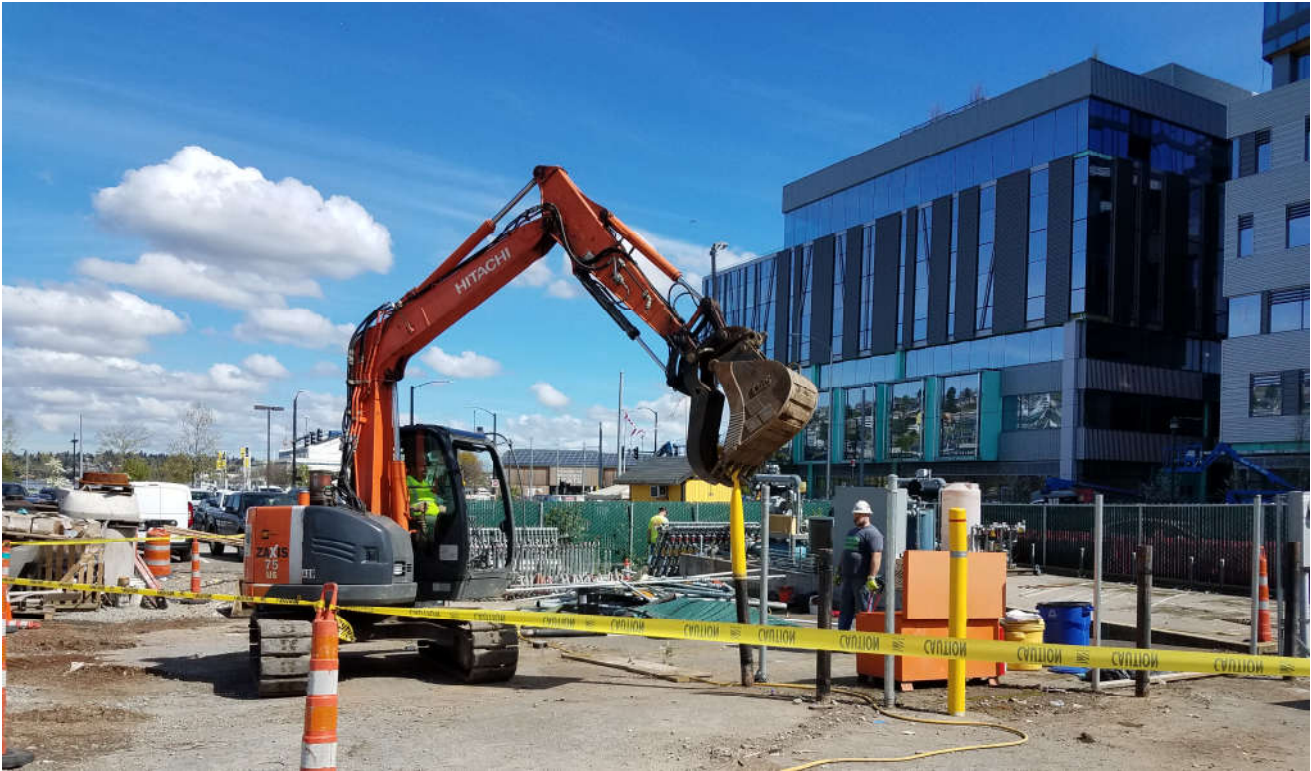
Photograph 7: View to the northeast – Removal of bollard posts.

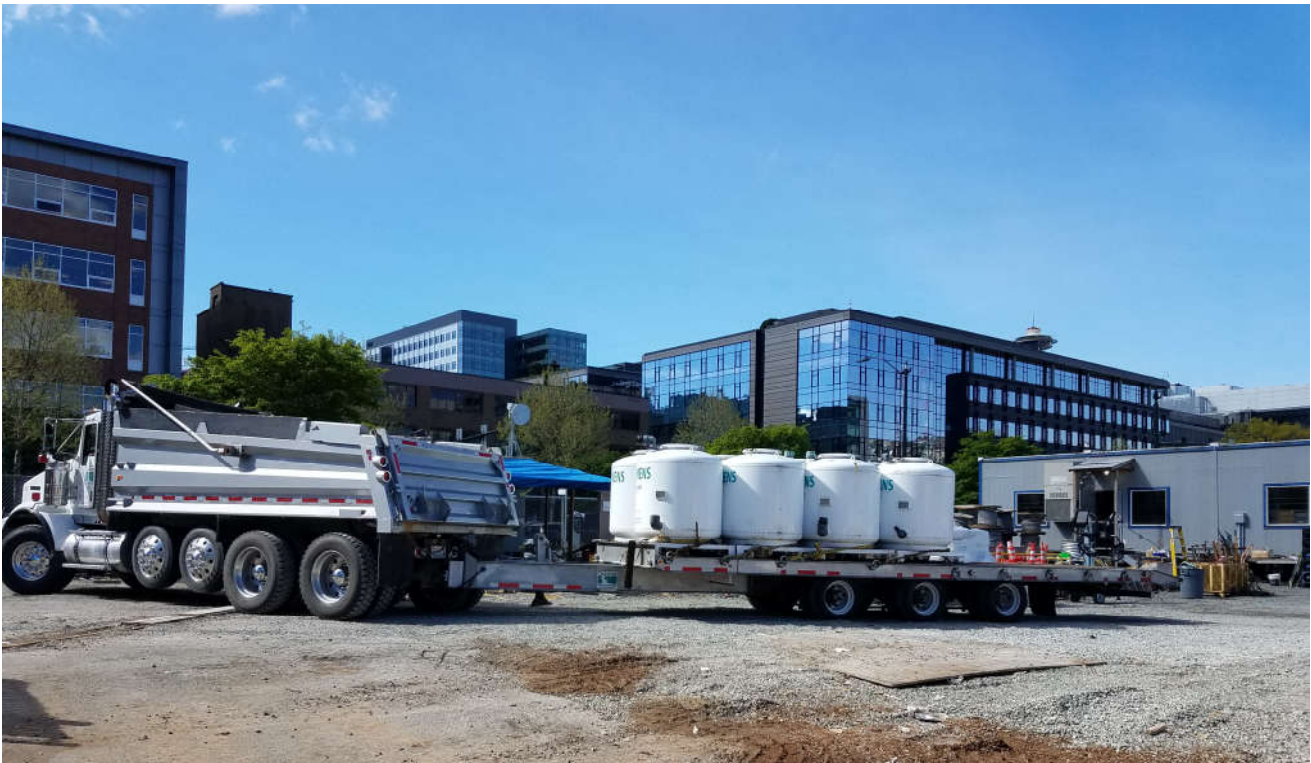
Photograph 8: View to the southwest – Carbon vessels loaded onto trailer for removal from site.

ATC subsequently observed Clearcreek complete the following remediation system decommissioning activities from April 15-16, 2019: Disconnected connections to and between the two liquid and six vapor phase granular activated carbon (GAC) vessels and removed the vessels from the site. Removed the air sparge and SVE manifolds and cut all manifold piping flush with the surrounding site grade. Removed all hoses, conveyance piping, conduits and unistrut members on and around the secondary containment slab. Removed compound fence and bollards from the perimeter of the remediation compound. Loaded and hauled off the equipment skids and control panel cabinet. Cut off bolts protruding from the secondary containment slab flush with surrounding slab surface and removed any remnant pieces of unistrut from the slab. Grouted all air sparge and SVE manifold piping stubs at ground surface grade. Grouted subsurface water conveyance piping at ground surface (piping connection to catch basin in system compound). Performed a general cleanup of residual debris from the former system area. Photographs of the system prior to, during and after decommissioning are provided in **Attachment A – Remediation System Decommissioning Photographic Log**.

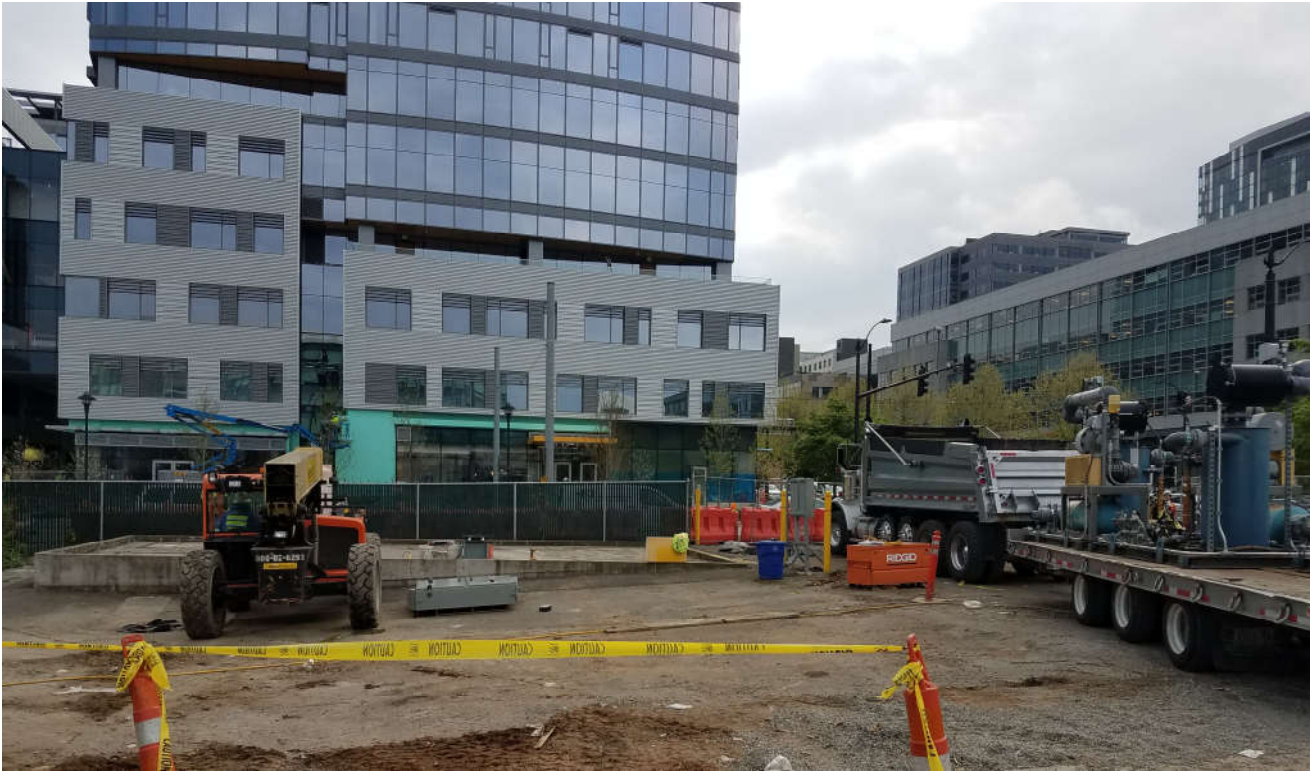
Photograph 9: View to the southeast – System equipment being loaded onto trailer for removal from site.

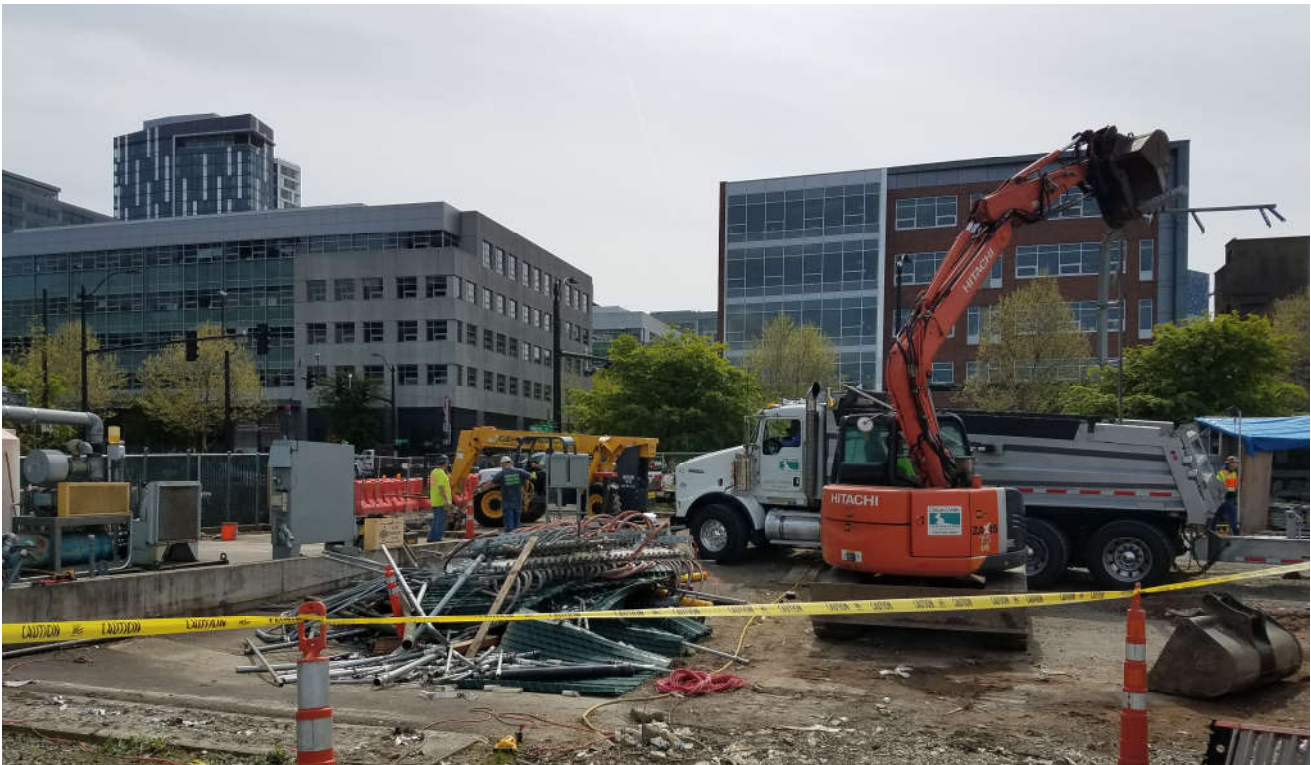
Photograph 10: View to the south – Loading system materials to truck for off site disposal.

With the exception of system components viable for reuse (carbon treatment vessels, air sparge and SVE equipment skids, control panel cabinet and equalization tank), the majority of the system components/materials were hauled from the site as non-hazardous construction debris by Clearcreek. Clearcreek transported the debris back their facility in Marysville, Washington, where it was placed in their construction debris dumpster. The dumpster is managed by Waste Management, and the contents are emptied on a weekly basis for disposal at a Waste Management facility.

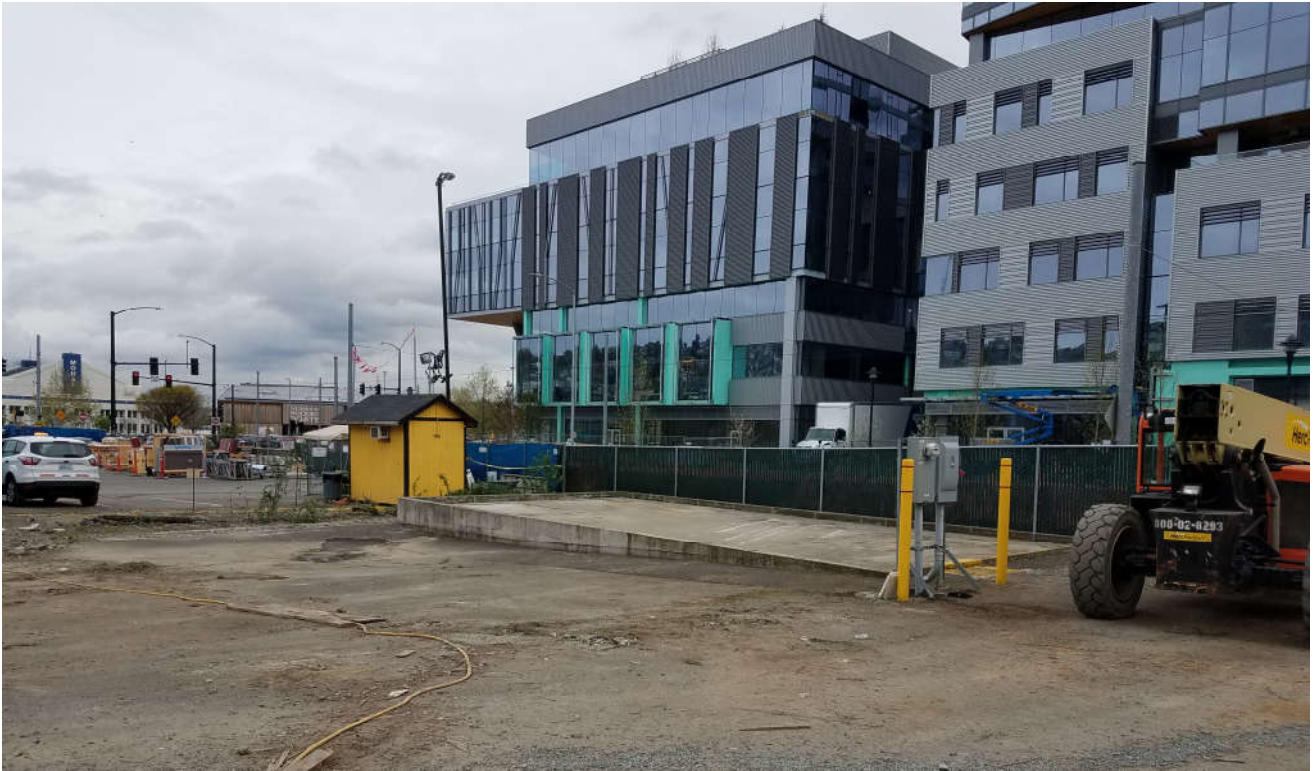
Photograph 11: View to the northeast – Former system compound area following completion of system removal.

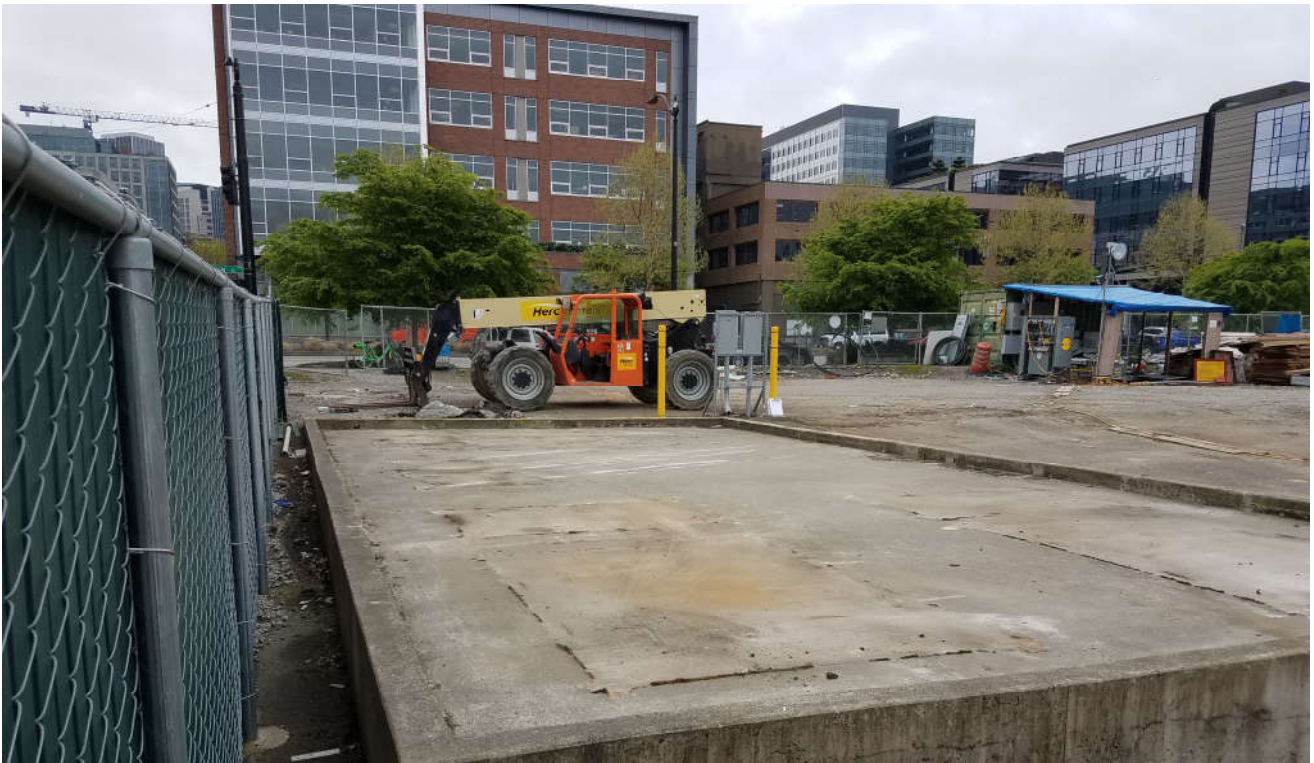
Photograph 12: View to the south – Former system compound area following completion of system removal.

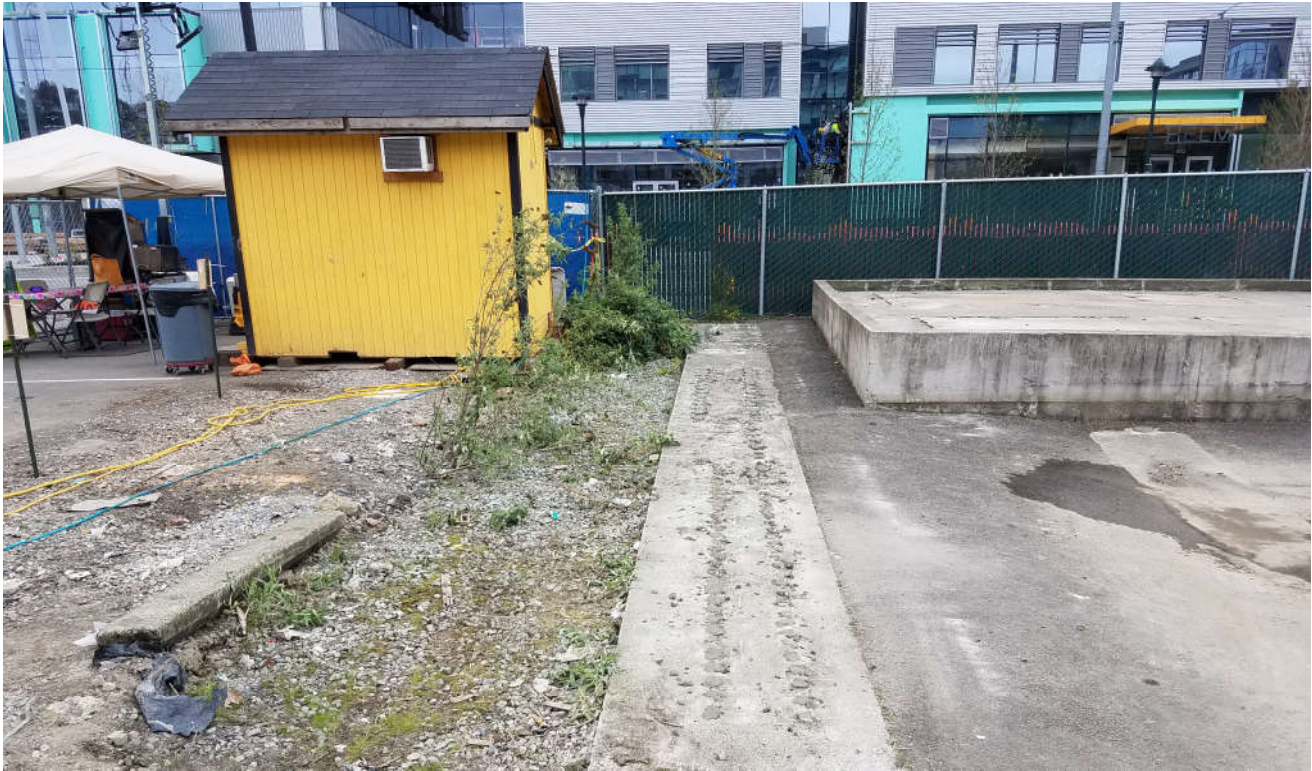
Photograph 13: View to the east – Grout sealed manifold piping.
