**REPORT  
OF**

**UNDERGROUND STORAGE TANK REMOVAL PROJECT  
LIMITED ENVIRONMENTAL SITE ASSESSMENT  
UPTOWN SHOPPING CENTER**

**Richland, Washington**

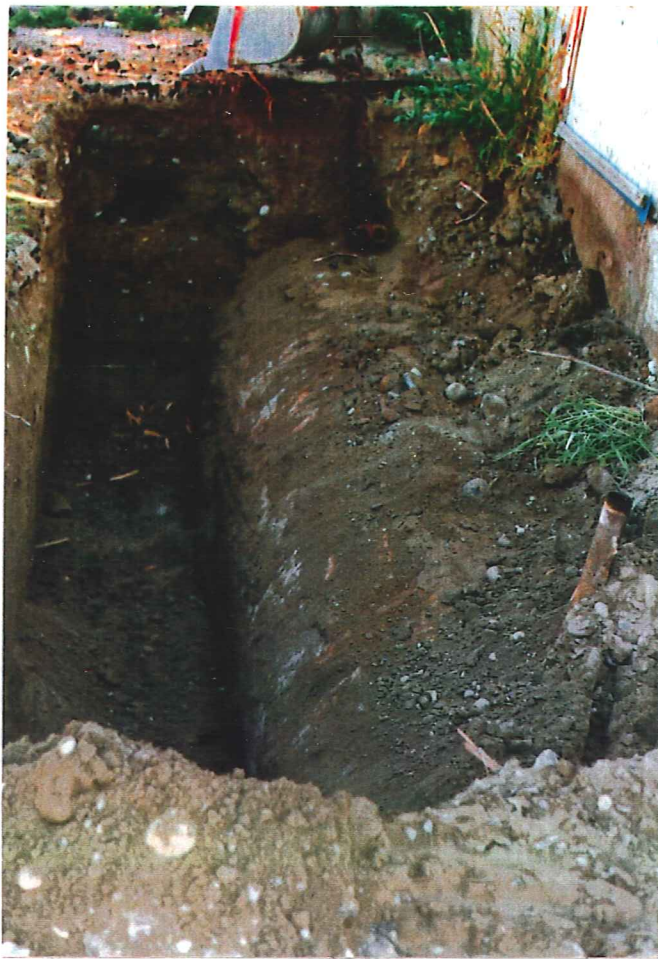
**PHOTOGRAPHED BY:** Dan Uldall  
**DATE:** 8/10/93  
**VIEW:** Tank #1 location behind @  
1317 George Washington Way  
(GWW).

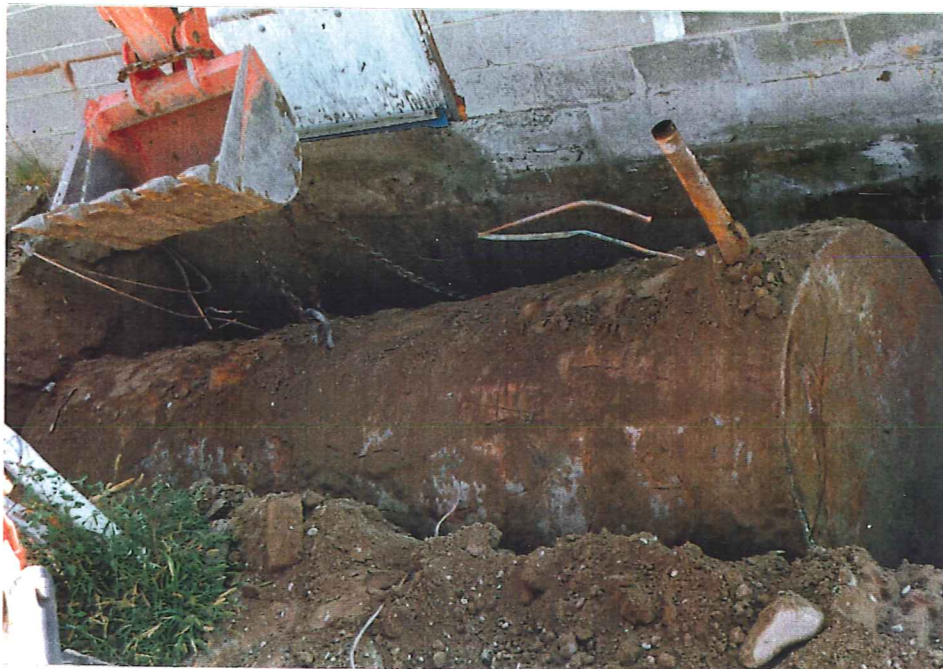
**PHOTOGRAPHED BY:** Dan Uldall  
**DATE:** 8/10/93  
**VIEW:** Tank #1 being removed.

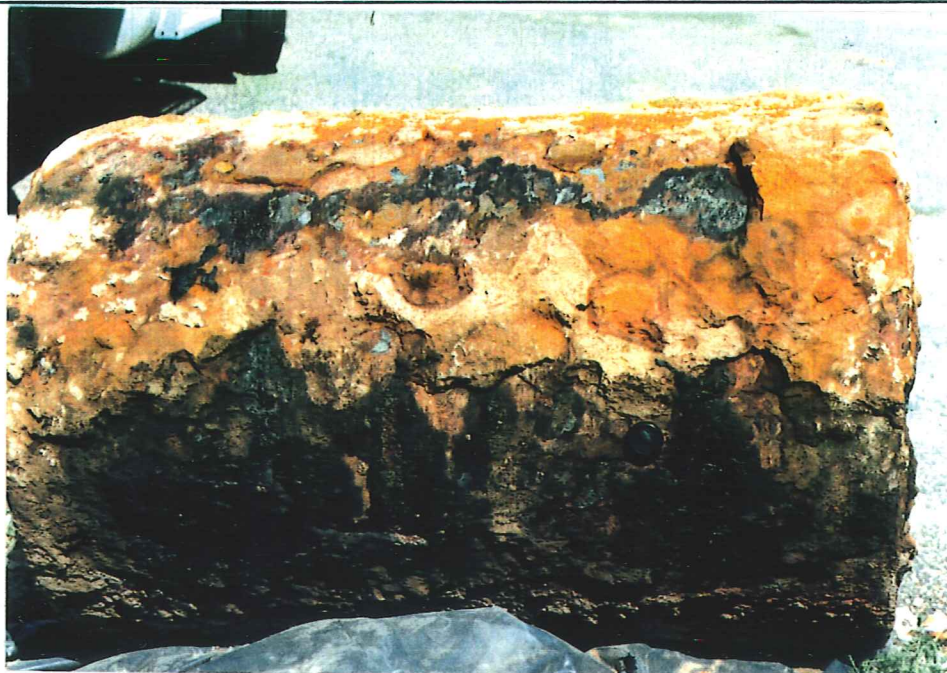
**PHOTOGRAPHED BY:** Dan Uldall  
**DATE:** 8/10/93  
**VIEW:** Rust and pitting on bottom of Tank #2.

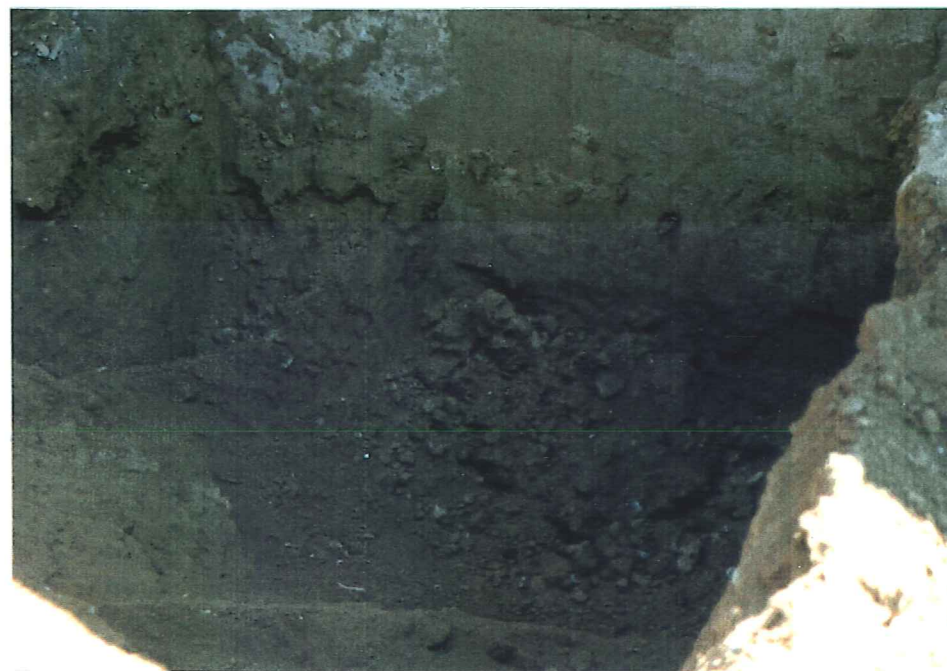
**PHOTOGRAPHED BY:** Dan Uldall  
**DATE:** 8/10/93  
**VIEW:** Tank #2 excavation behind 1319 George Washington Way.

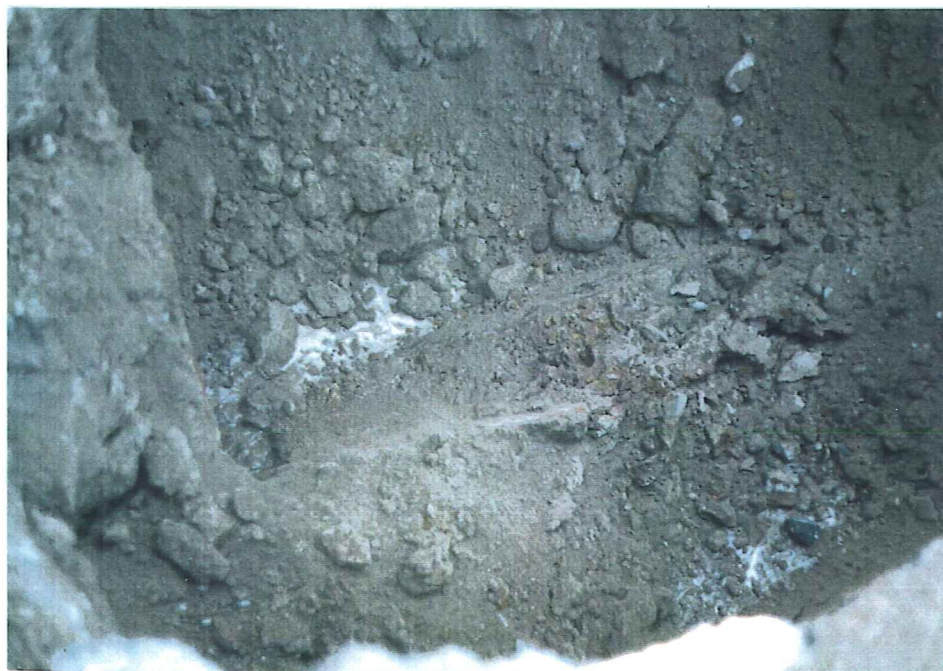
**DATE:** 8/09/93  
**VIEW:** Tank #3 excavation behind 1319 George Washington Way. Some PCS visible. Water from broken sewer lateral leaking in at left (north).

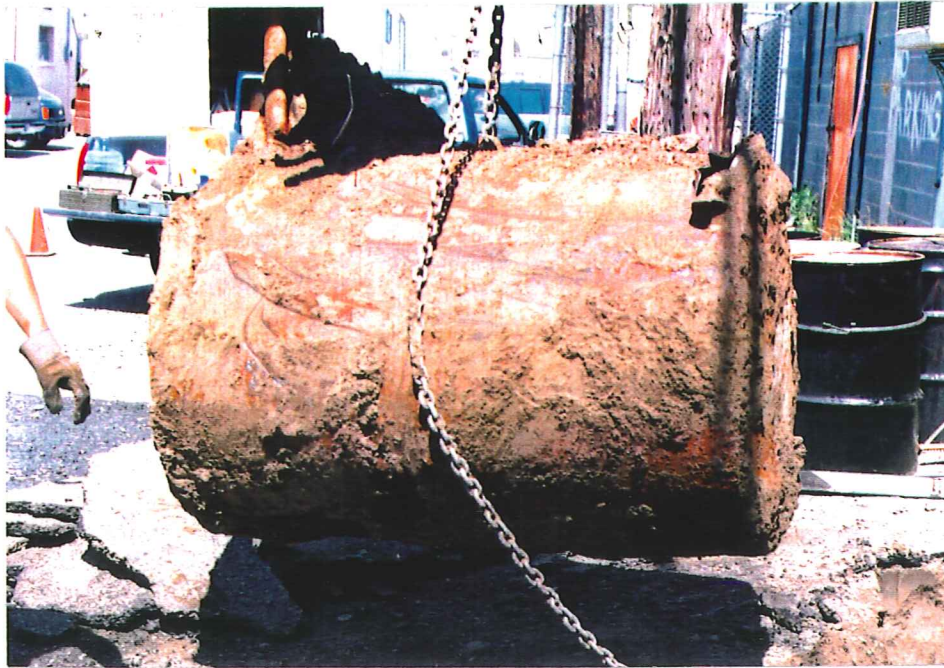
**PHOTOGRAPHED BY:** Dan Uldall  
**DATE:** 8/10/93  
**VIEW:** Tank #4 with rust and pitting  
on bottom.

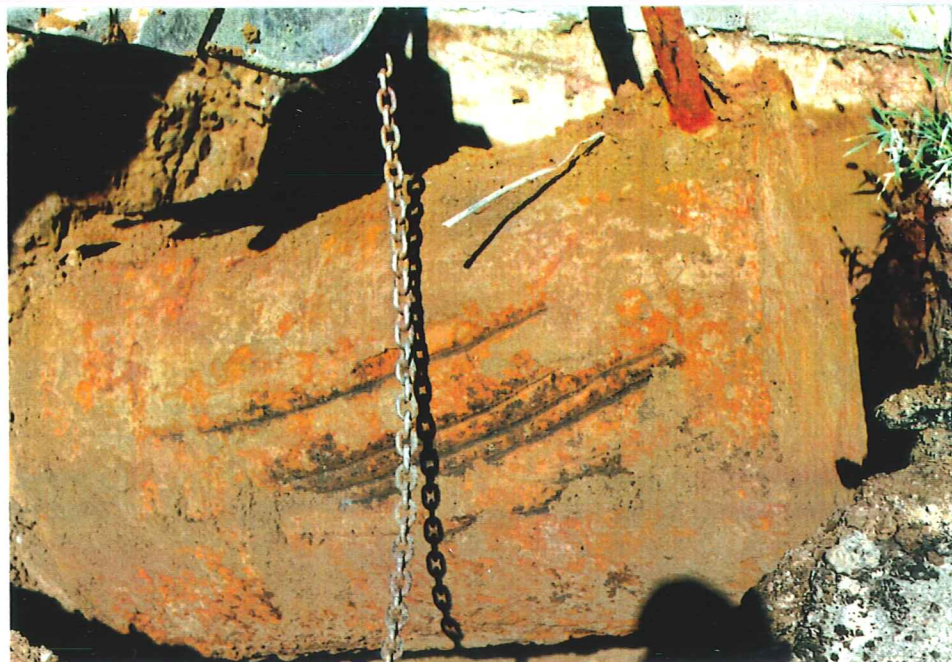
**PHOTOGRAPHED BY:** Dan Uldall  
**DATE:** 8/10/93  
**VIEW:** Tank #5 being removed from excavation behind 1325 George Washington Way.

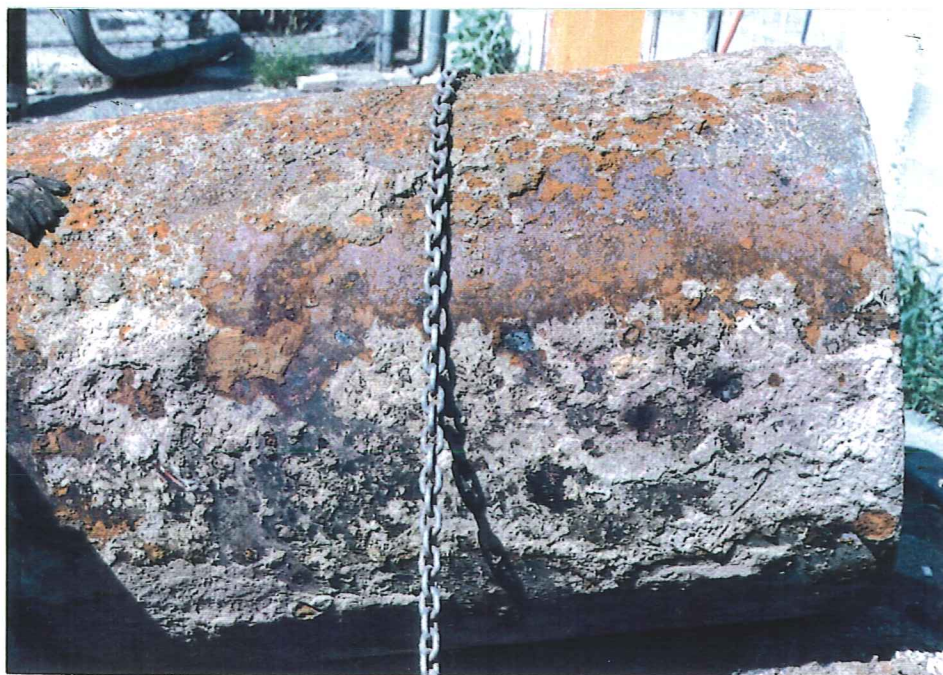
**PHOTOGRAPHED BY:** Dan Uldall  
**DATE:** 8/10/93  
**VIEW:** Rust, pitting and staining visible on bottom of Tank #5.

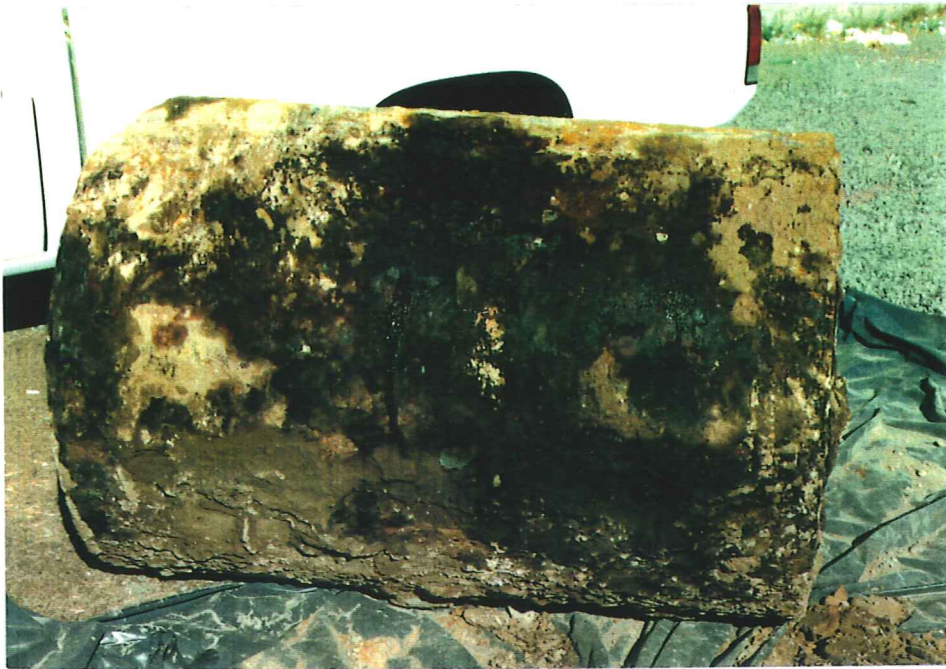
**PHOTOGRAPHED BY:** Dan Uldall  
**DATE:** 8/11/93  
**VIEW:** Rust, pitting and leakage visible staining on bottom of Tank #6.

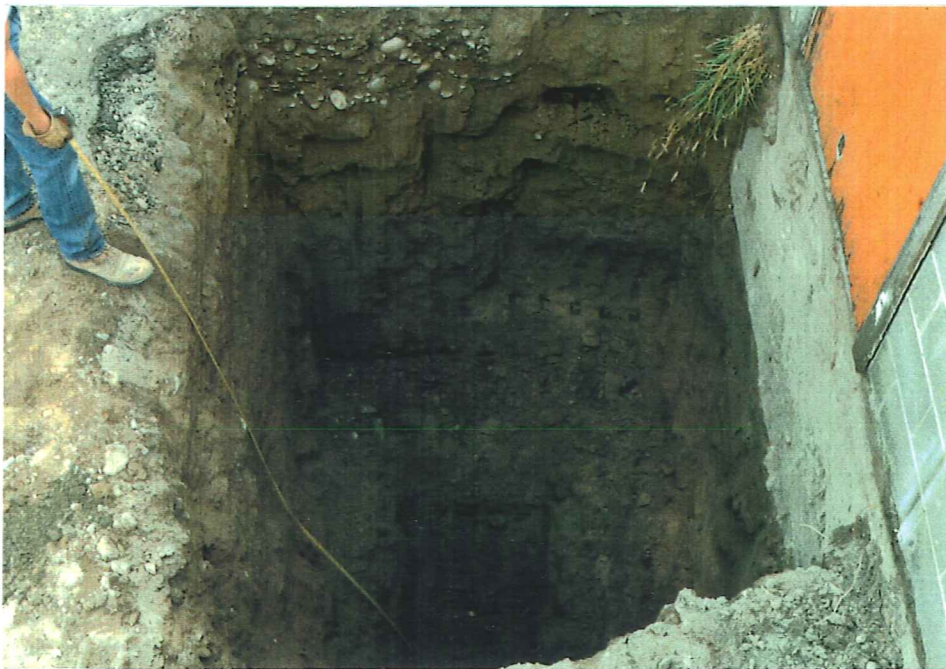
**PHOTOGRAPHED BY:** Dan Uldall  
**DATE:** 8/13/93  
**VIEW:** Tank #6 excavation behind 1327 George Washington Way.

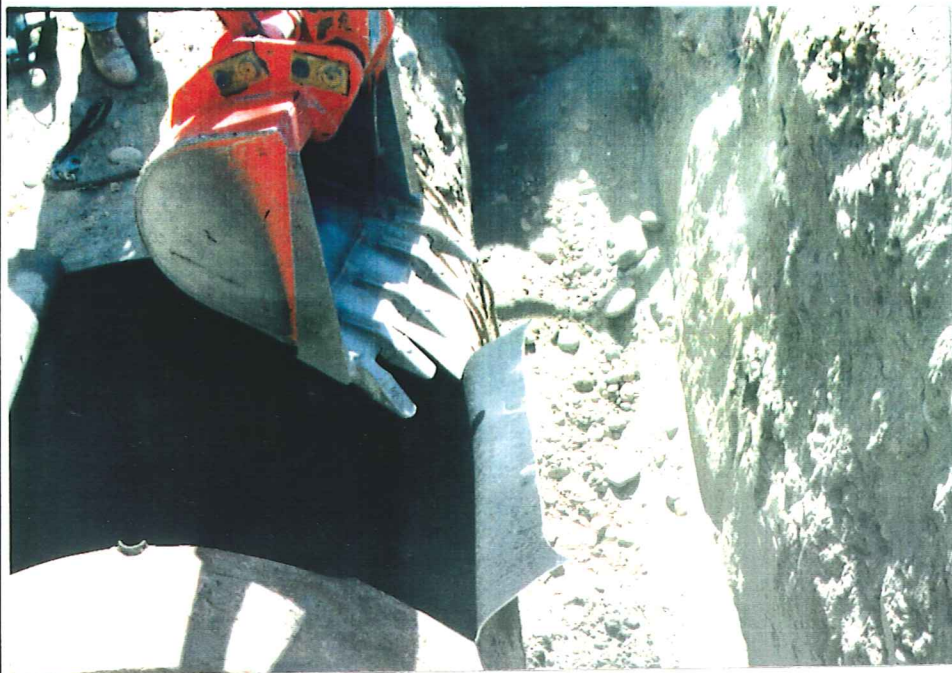
**PHOTOGRAPHED BY:** Dan Uldall  
**DATE:** 8/12/93  
**VIEW:** Tank #7 and excavation behind  
1365 George Washington Way.

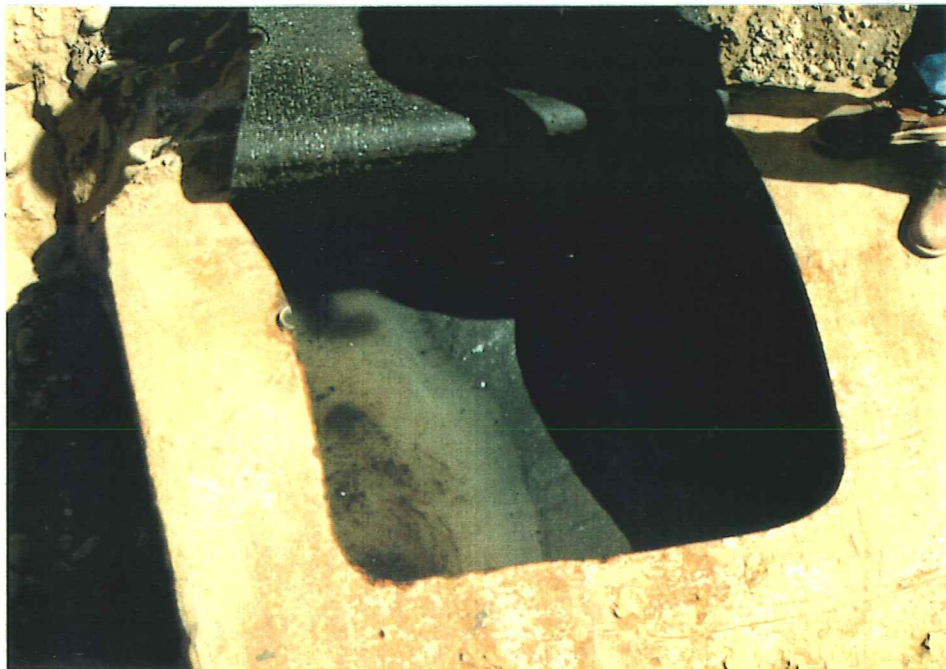
**PHOTOGRAPHED BY:** Dan Uldall  
**DATE:** 8/12/93  
**VIEW:** Contents of Tank #7 as  
observed after opening access  
hole. Small amount of residual  
fuel visible at left after fuel was  
previously pumped. Remainder  
of material consists mostly of  
saturated sandy PCS.

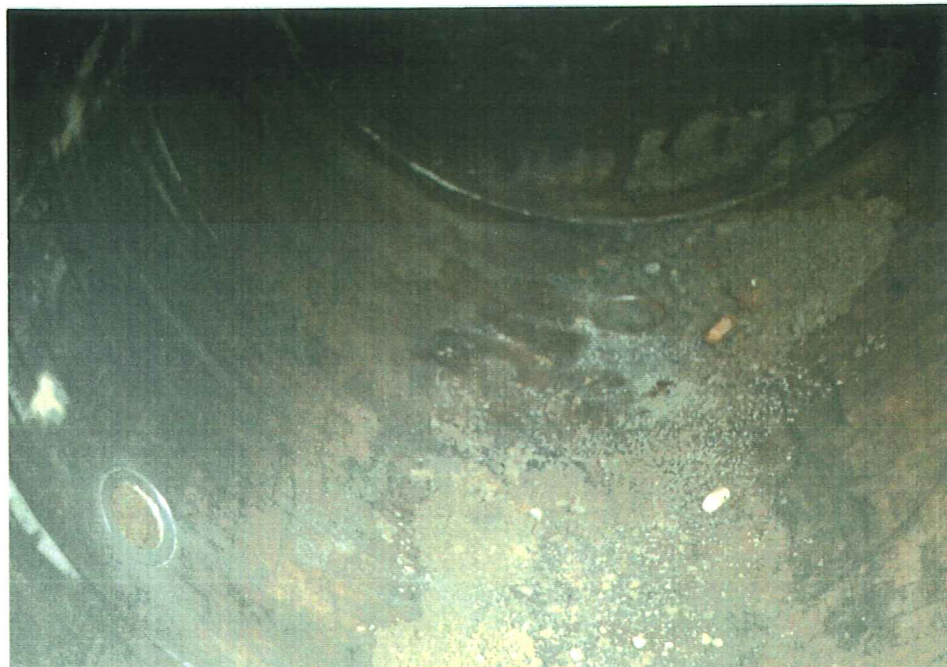
**PHOTOGRAPHED BY:** Dan Uldall  
**DATE:** 8/13/93  
**VIEW:** Tank #7 sample access holes:  
South base - right. East  
sidewall - left. Interior  
appearance is sound.

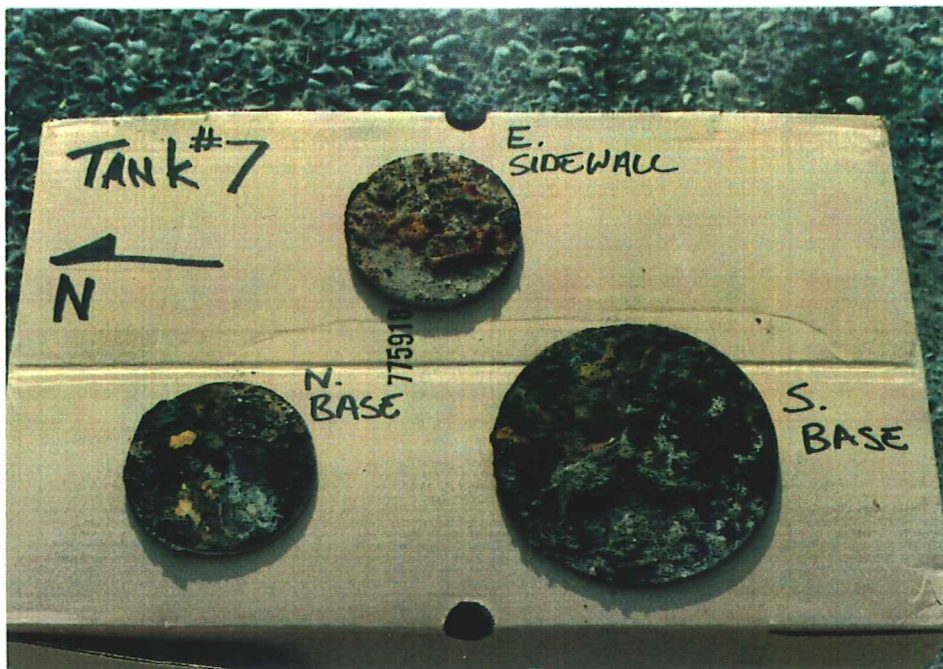
PHOTOGRAPHED BY: Dan Uldall  
DATE: 8/13/93  
VIEW: Condition of Tank #7 exterior at sample locations. Base of tank appears rusted stained and pitted.

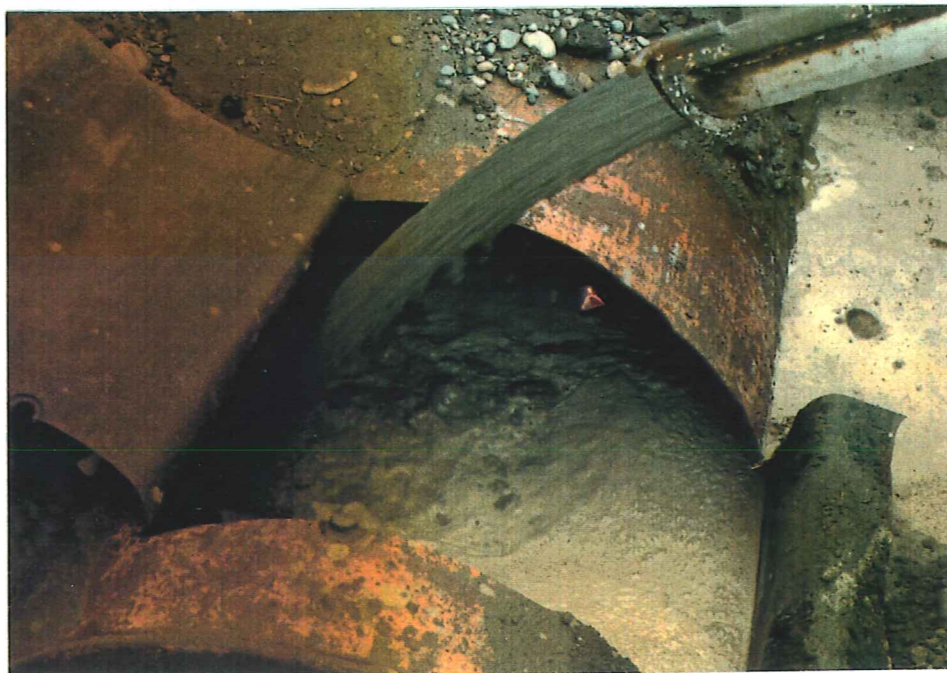
PHOTOGRAPHED BY: Dan Uldall  
DATE: 8/19/93  
VIEW: Grouting of Tank #7 during abandonment in place procedures.

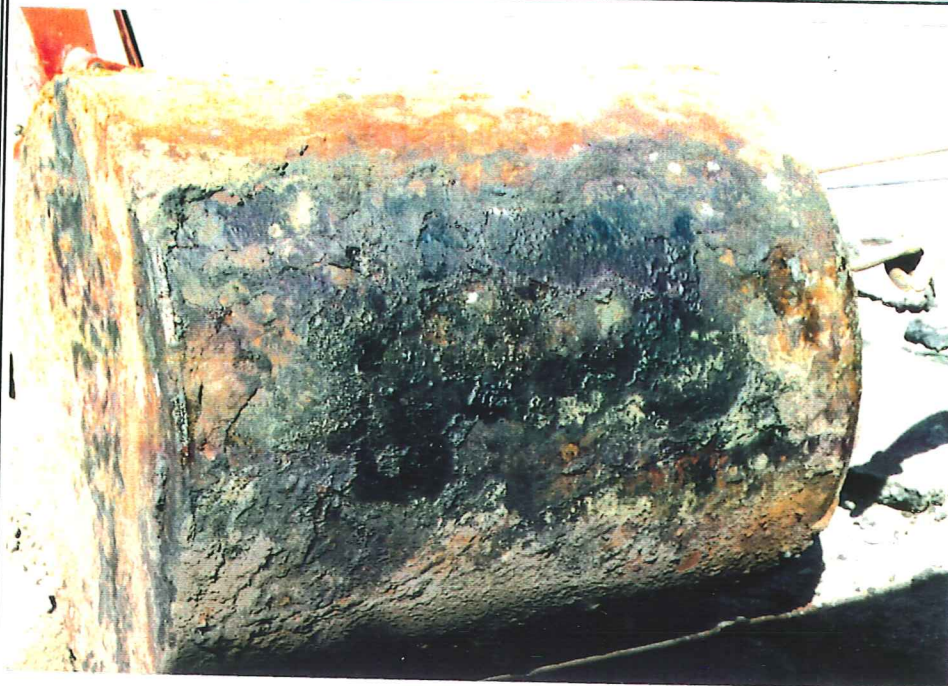
PHOTOGRAPHED BY: Dan  
 DATE: 8/11/93  
 VIEW: Tank #8 with visible rust,  
 pitting, staining and leakage on  
 bottom.

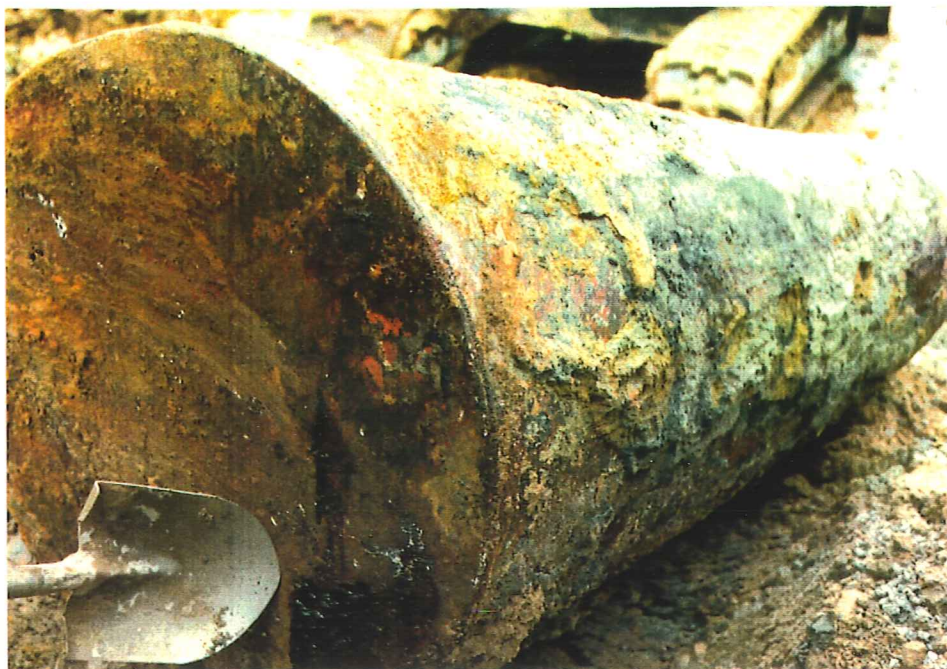
**PHOTOGRAPHED BY:** Dan Uldall  
**DATE:** 8/16/93  
**VIEW:** Tank #10 with staining, rust and pitting on bottom. Removed from south side of 1398 Jadwin Avenue.

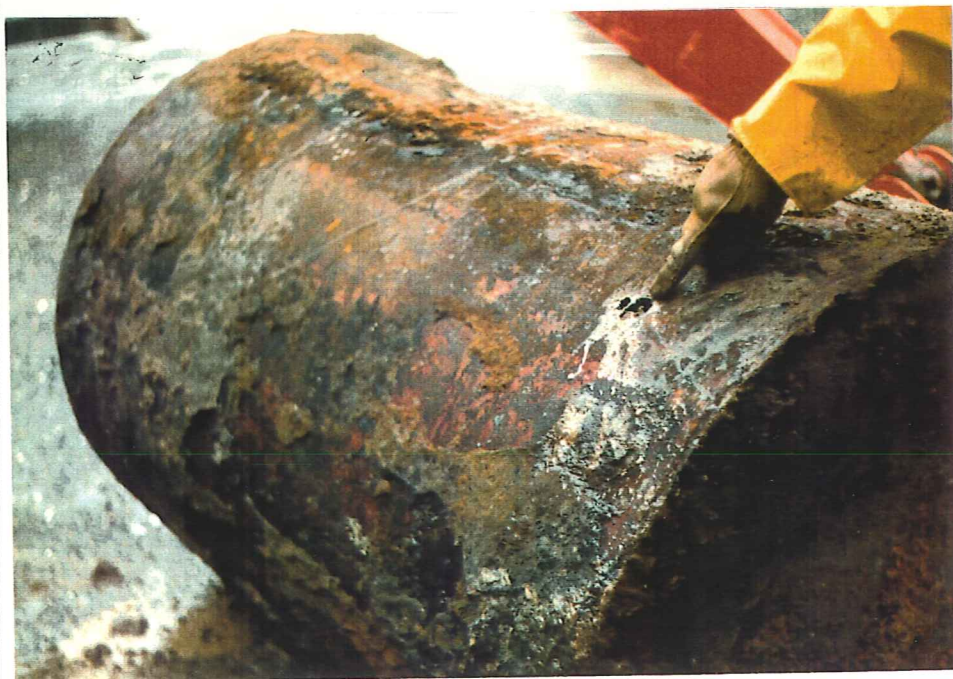
**PHOTOGRAPHED BY:** Dan Uldall  
**DATE:** 8/16/93  
**VIEW:** Tank #13 showing rust, staining, pitting and perforations on bottom. Removed from north side of 1386 Jadwin Avenue.

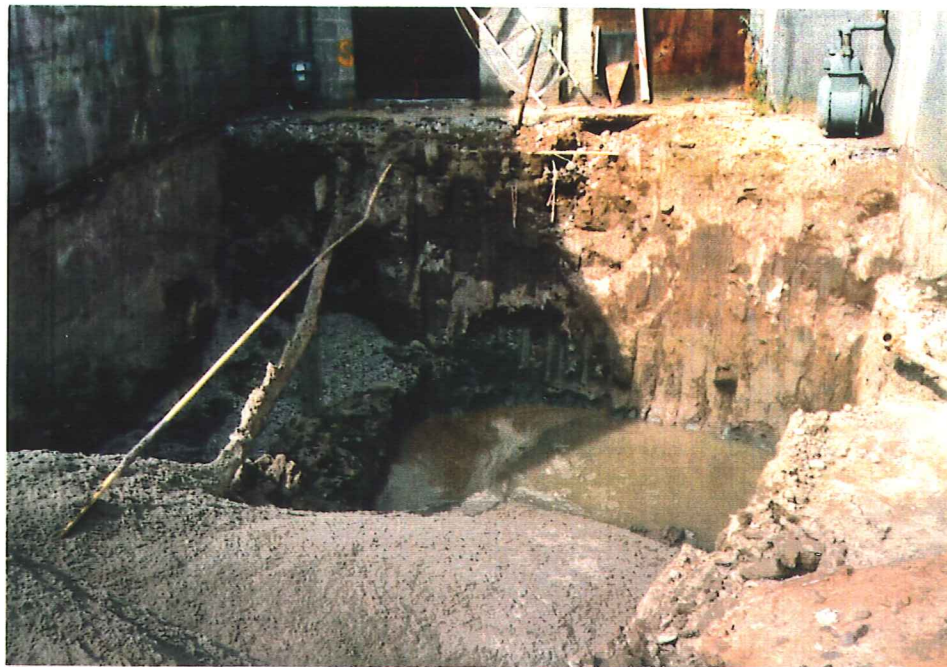
**PHOTOGRAPHED BY:** Dan Uldall  
**DATE:** 8/20/93  
**VIEW:** Partially backfilled excavation from which Tanks #10-#16 have been removed. Groundwater visible with floating product to the left. Gasoline and sewer lateral crossing excavation on left half of photo. Greenish gray PCS visible near water. Excavation is in alcove bounded by 1386, 1388 and 1398 Jadwin Avenue.

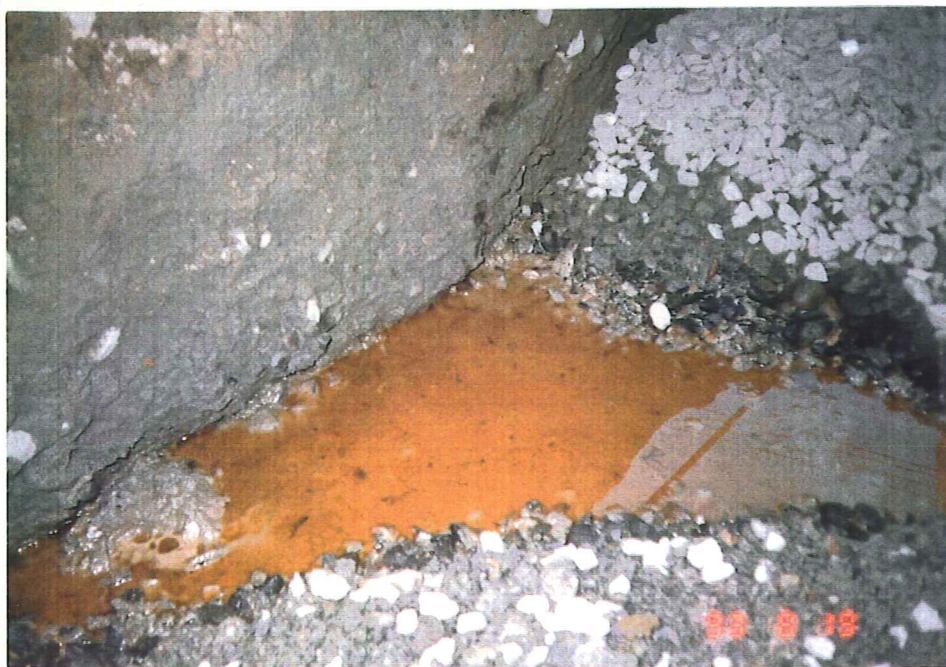
**PHOTOGRAPHED BY:** Dan Uldall  
**DATE:** 8/19/93  
**VIEW:** Floating product on groundwater on south side of tank #10-#16 excavation. Gravelly backfill visible at top and bottom of photo - discolored PCS visible at left under footing.

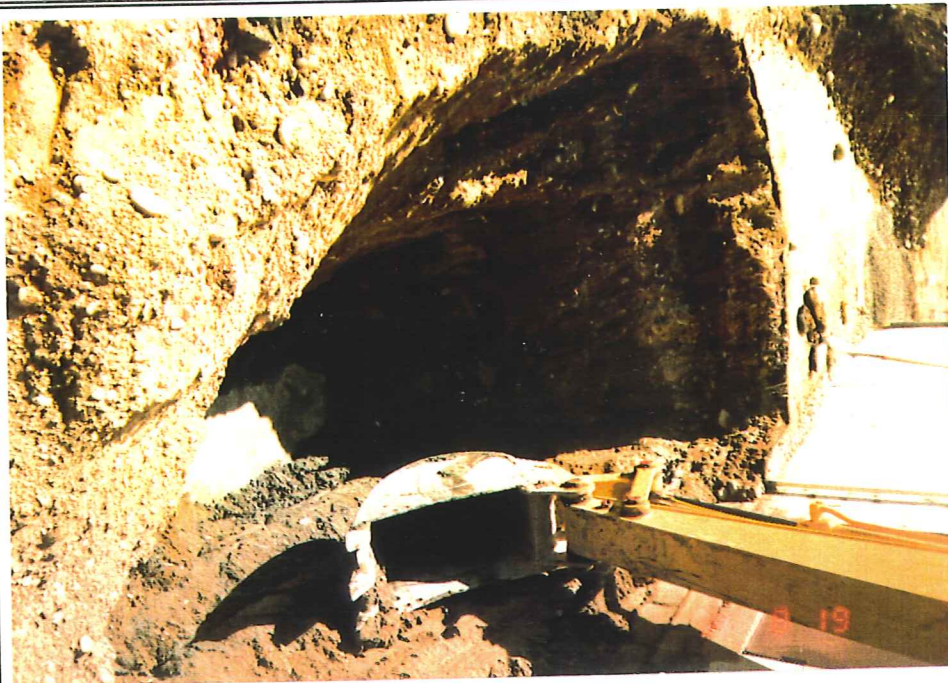
PHOTOGRAPHED BY: Dan Uldall  
DATE: 8/19/93  
VIEW: Excavation adjacent to Tanks #19 and #20 (under building at 1364 Jadwin Avenue). Groundwater visible in base. The tanks were not removed.

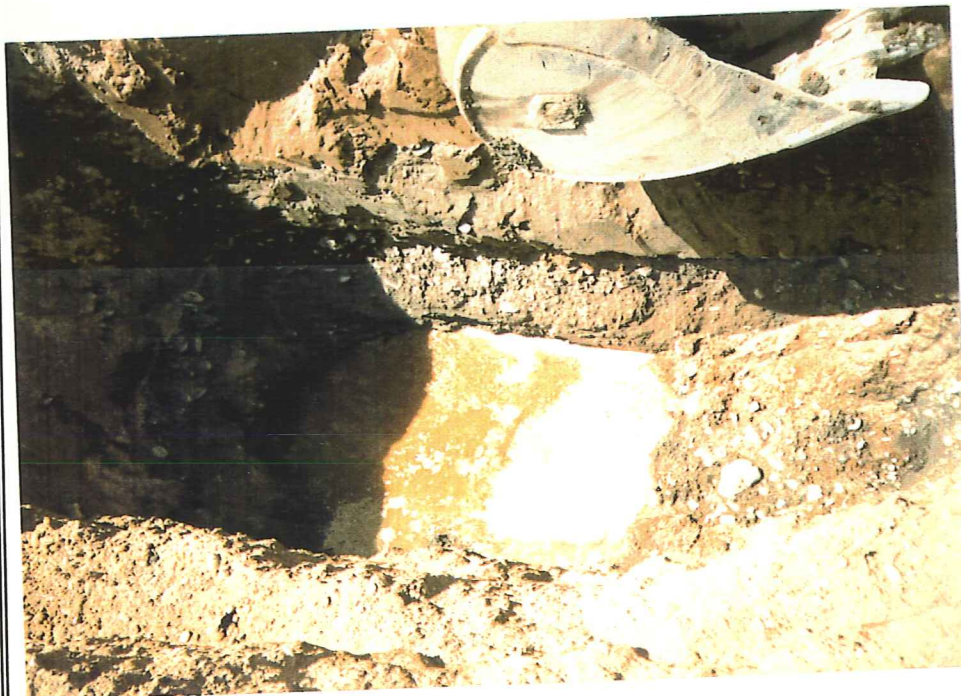
PHOTOGRAPHED BY: Dan Uldall  
DATE: 8/19/93  
VIEW: Visible (yellow) free product on groundwater and greenish PCS in tank #19 & #20 excavation. The product measured a thickness of 1/4 inch.

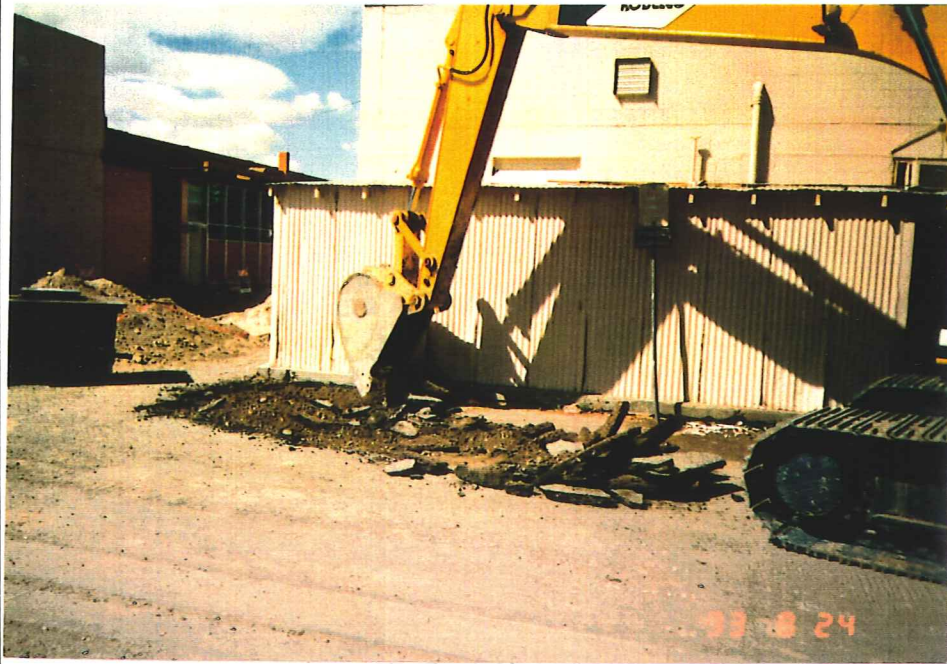
**PHOTOGRAPHED BY:** Paul Danielson  
**DATE:** 8/24/93  
**VIEW:** Excavation in progress at Tank #24 location. Tank located beneath galvanized shed in background at 1342 Jadwin Avenue. Note vent pipe on masonry wall behind street sign. Tank left in place.

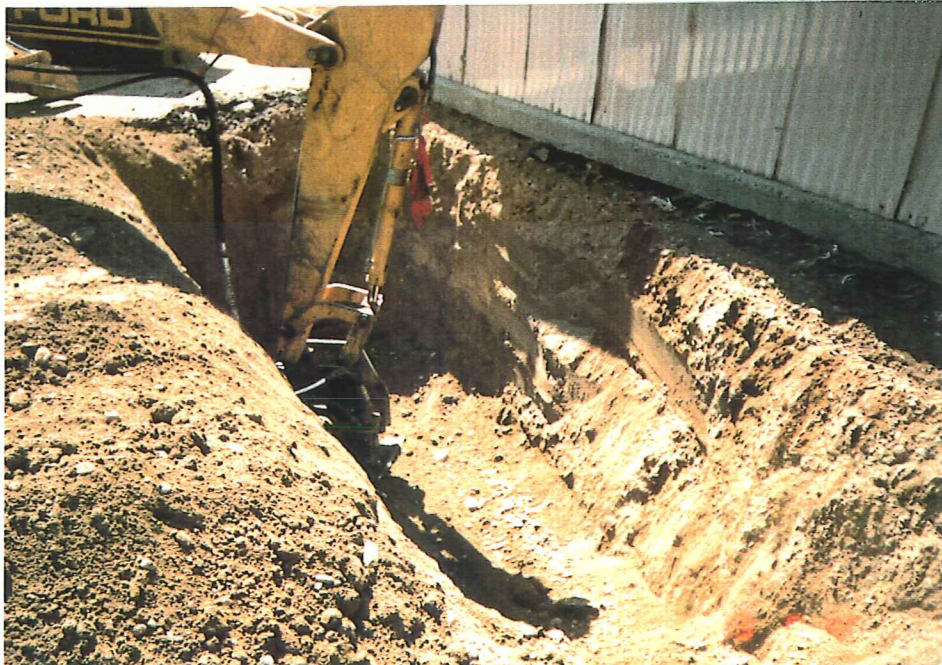
**PHOTOGRAPHED BY:** Paul Danielson  
**DATE:** 8/24/93  
**VIEW:** Backfilling and compaction of Tank #24 excavation. No free product or PCS soils were observed.

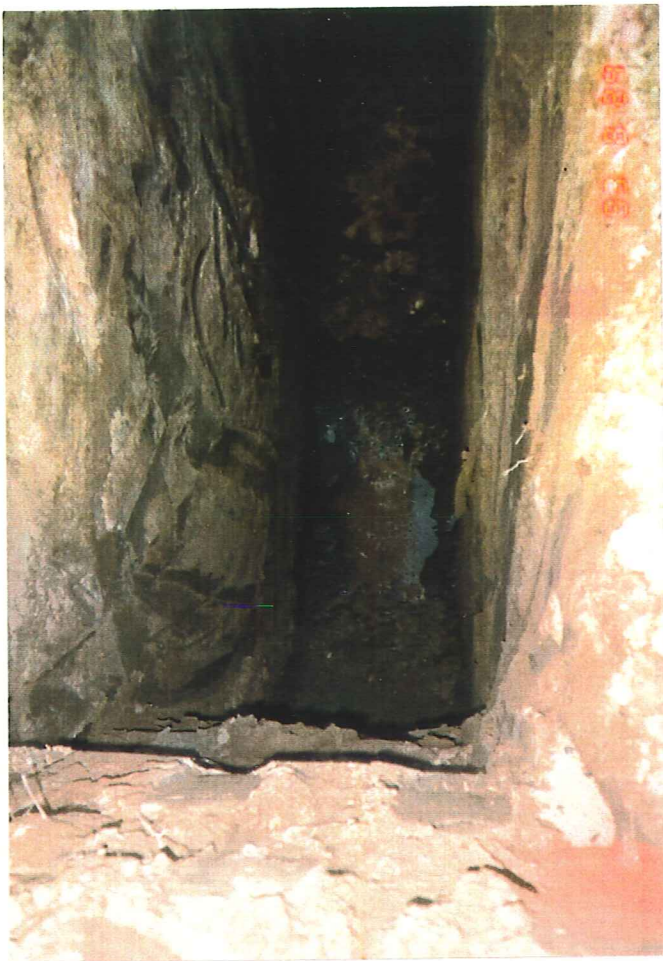
**VIEW:** Excavation completed adjacent to Tank #25 at 1340 B Jadwin Avenue before owners decision to remove foyer to access tank. Groundwater visible in base.

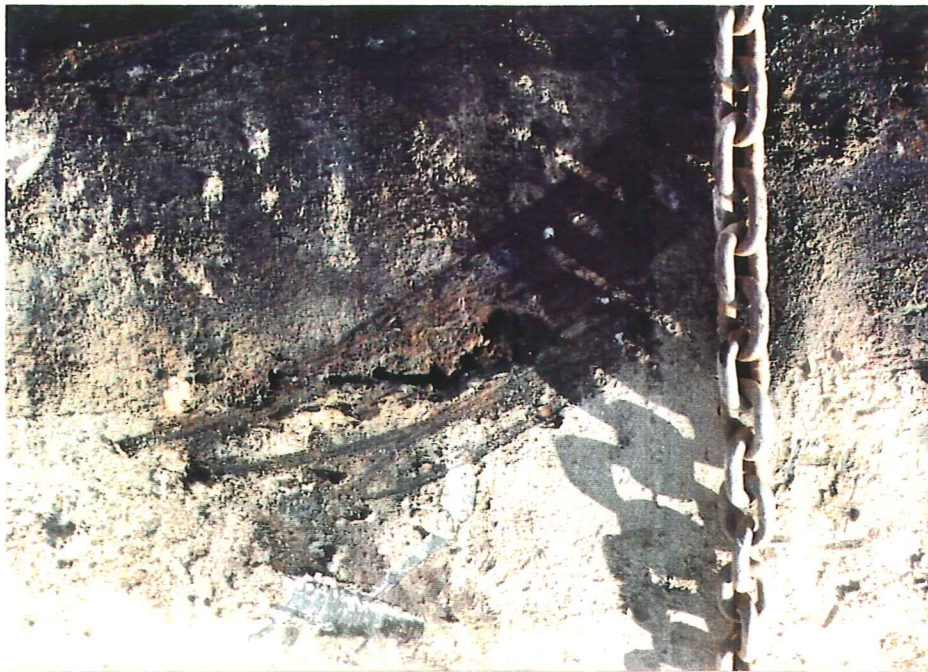
**PHOTOGRAPHED BY:** Dan Uldall  
**DATE:** 8/30/93  
**VIEW:** Rust and perforations visible on bottom of Tank #25.

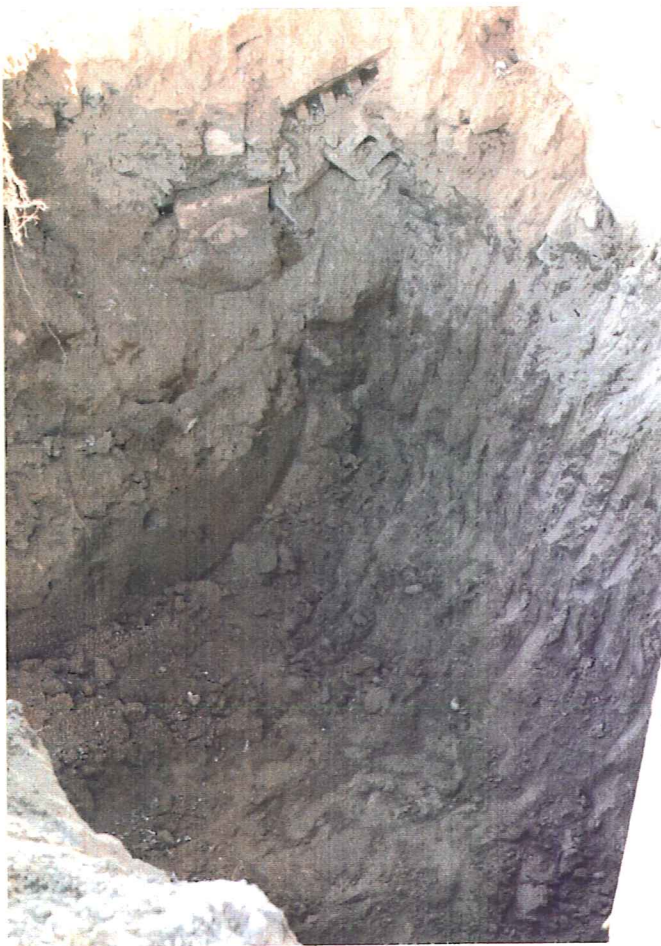
**PHOTOGRAPHED BY:** Dan Uldall  
**DATE:** 8/30/93  
**VIEW:** Tank #25 excavation slight discoloration of soil visible in bottom half.

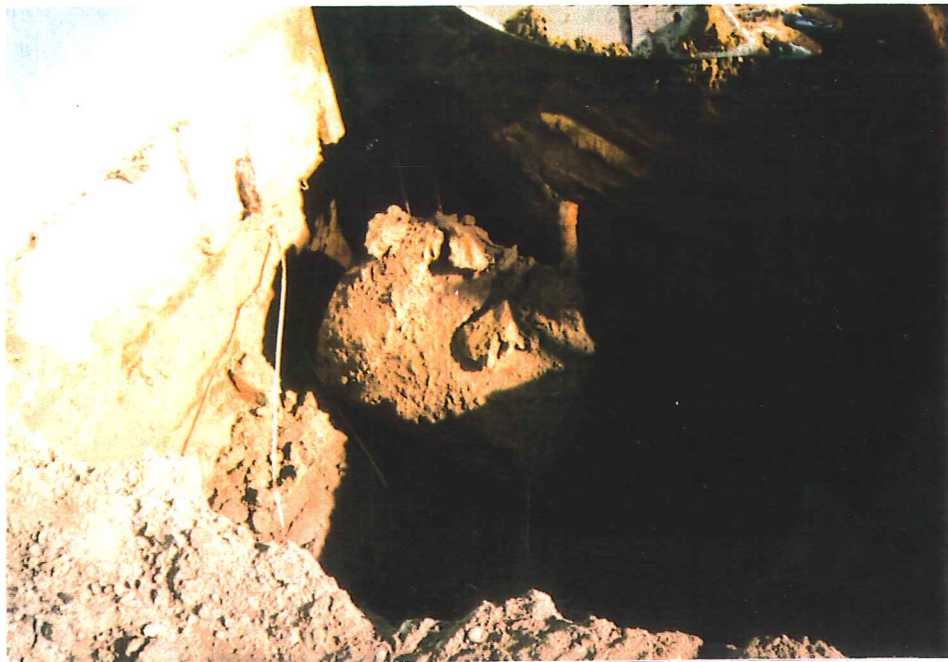
**VIEW:** Tank #26/#27 excavation  
behind 1332 Jadwin Avenue  
with Tank #26 being removed.

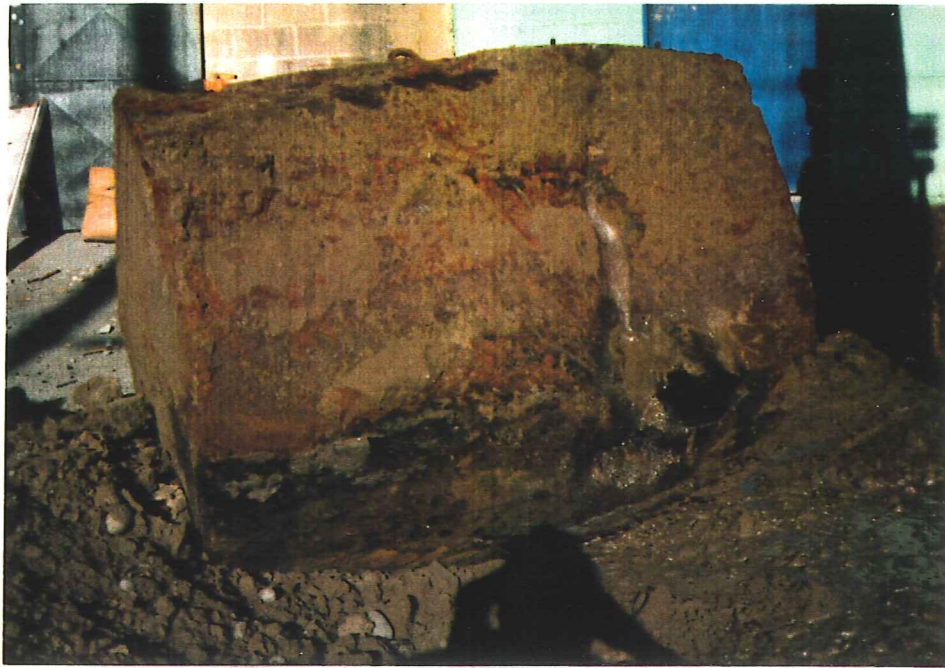
**VIEW:** Tank #27 with rust, staining and pitting visible on bottom. Hole on bottom right opened during removal watery liquid leaked out of hole during removal.

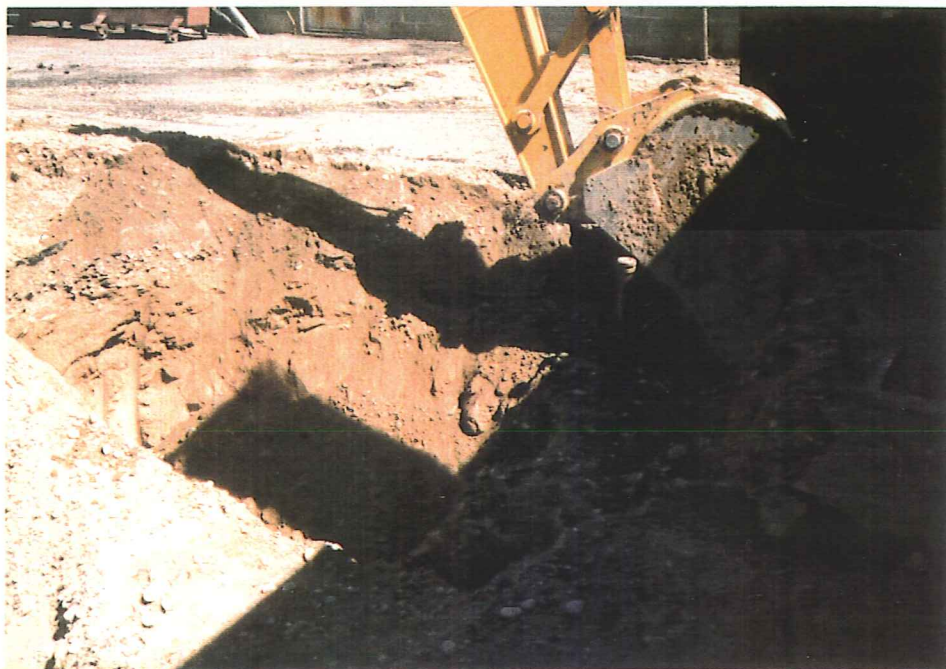
**PHOTOGRAPHED BY:** Paul Danielson  
**DATE:** 8/23/93  
**VIEW:** Excavation of Tank #30 in  
progress at 236 Williams Blvd.

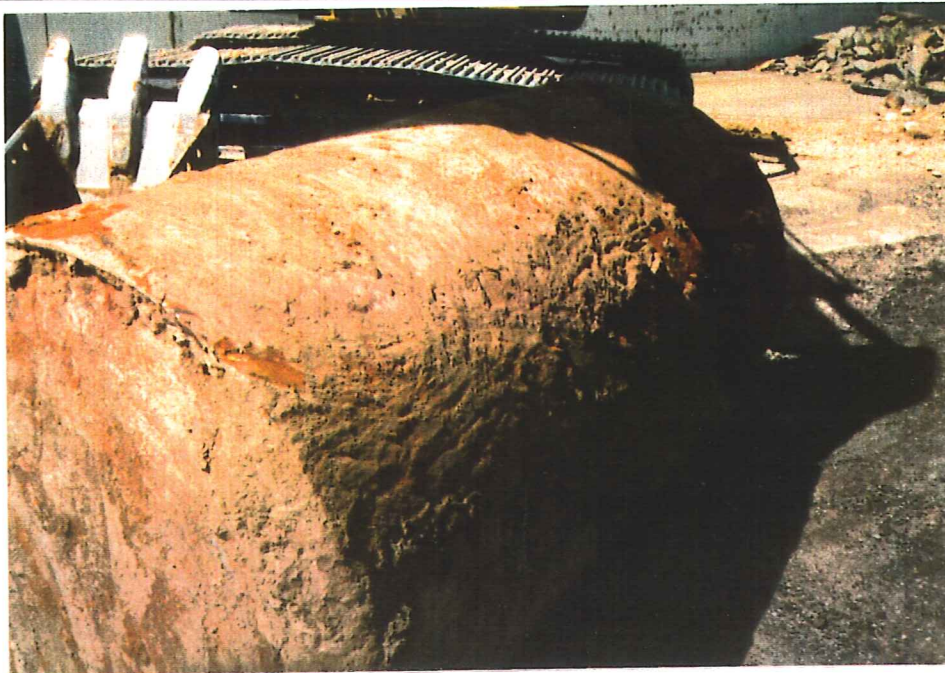
**PHOTOGRAPHED BY:** Paul Danielson  
**DATE:** 8/23/93  
**VIEW:** Bottom of Tank #30. Rust and slight pitting visible. No perforation or stains observed.

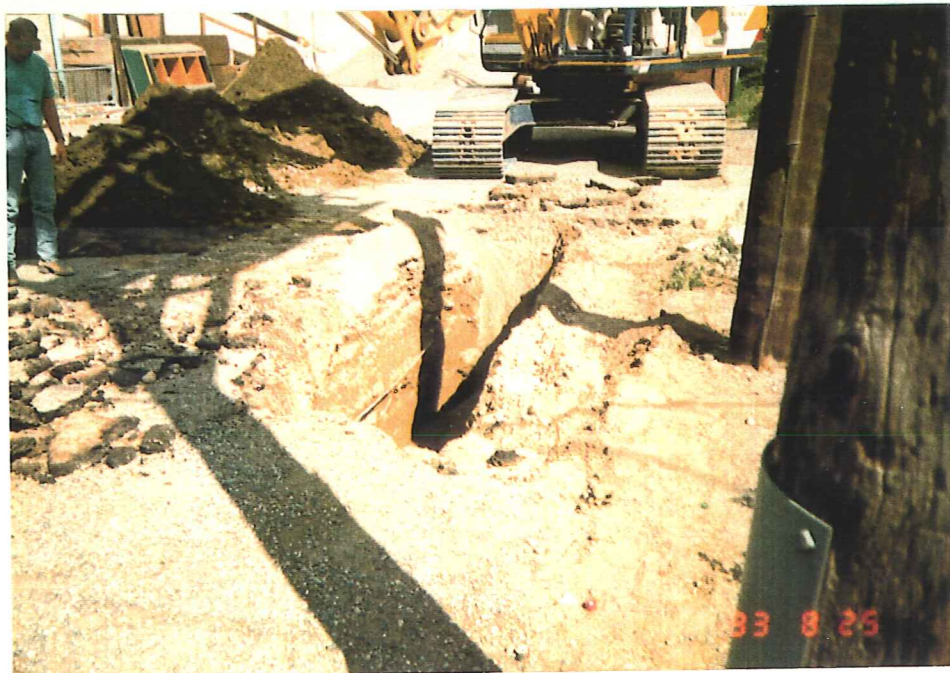
**PHOTOGRAPHED BY:** Dan Uldall  
**DATE:** 8/25/93  
**VIEW:** Trench adjacent to Tank #32 behind 1375 George Washington Way to evaluate potential PCE groundwater contamination.
