**CSID No. 3512 Avista Service Center Garage
Monitoring Well Installation and
July 31, 2019 Groundwater Monitoring Report**

Spokane Service Center Garage
1411 East Mission Avenue
Spokane, Washington

for
Avista Utilities

September 13, 2019

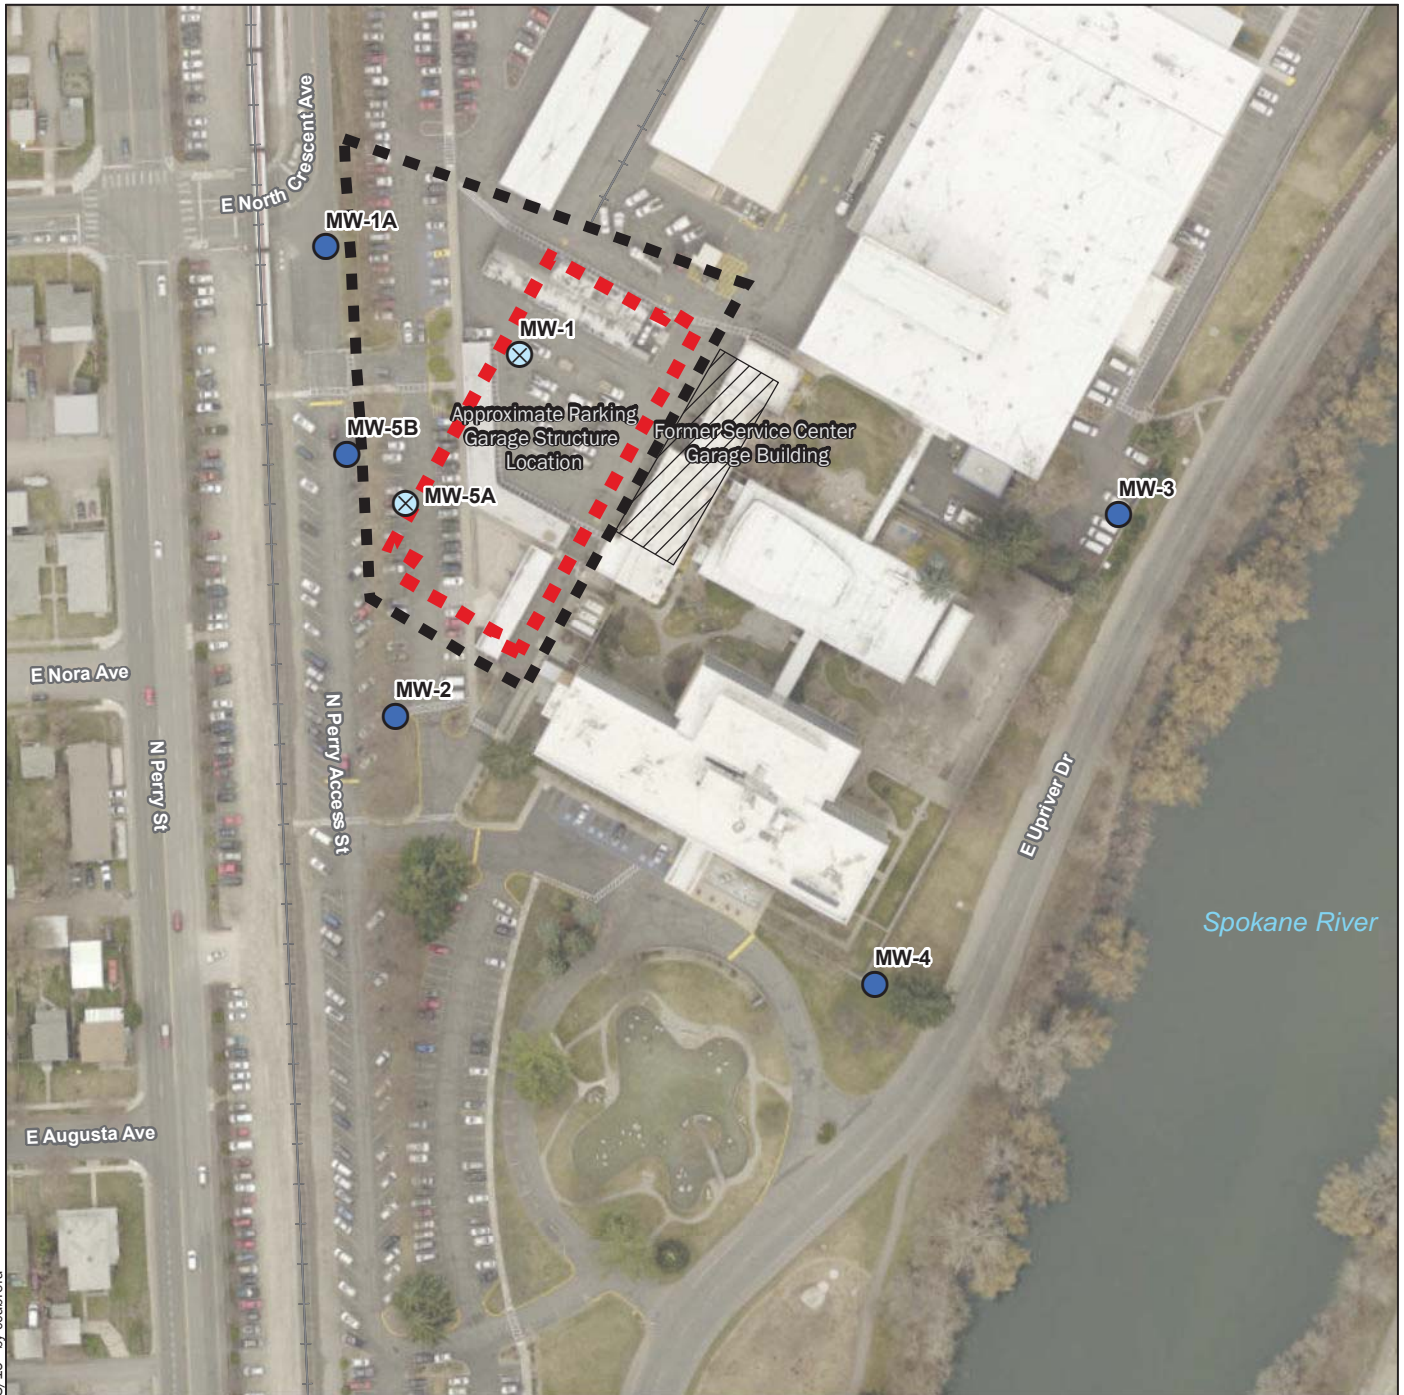
Site Plan	
Avista - Service Center Garage Monitoring Well Installs and Groundwater Monitoring Report Spokane, Washington	
	Figure 2

Proposed monitoring well locations were marked in the field and a one-call utility locate was requested before equipment was mobilized to the site. A private utility locator (Advanced Underground Utility Locating, LLC) was also contracted to locate site utilities near proposed drilling locations before drilling activities commenced. Able Cleanup Technologies (ACT) air-knifed the boring locations due to utilities in the boring locations. Soil borings, well construction and well development activities were conducted by Environmental West. Photographs of the well installations are depicted in Figures 4 and 5. Locations of the groundwater monitoring wells were established in the field using a hand-held iPad with global positioning system (GPS) software before drilling commenced. The horizontal accuracy of the hand-held unit is within about 10 feet. Former monitoring well locations, new well locations and site features are shown on Figure 2.

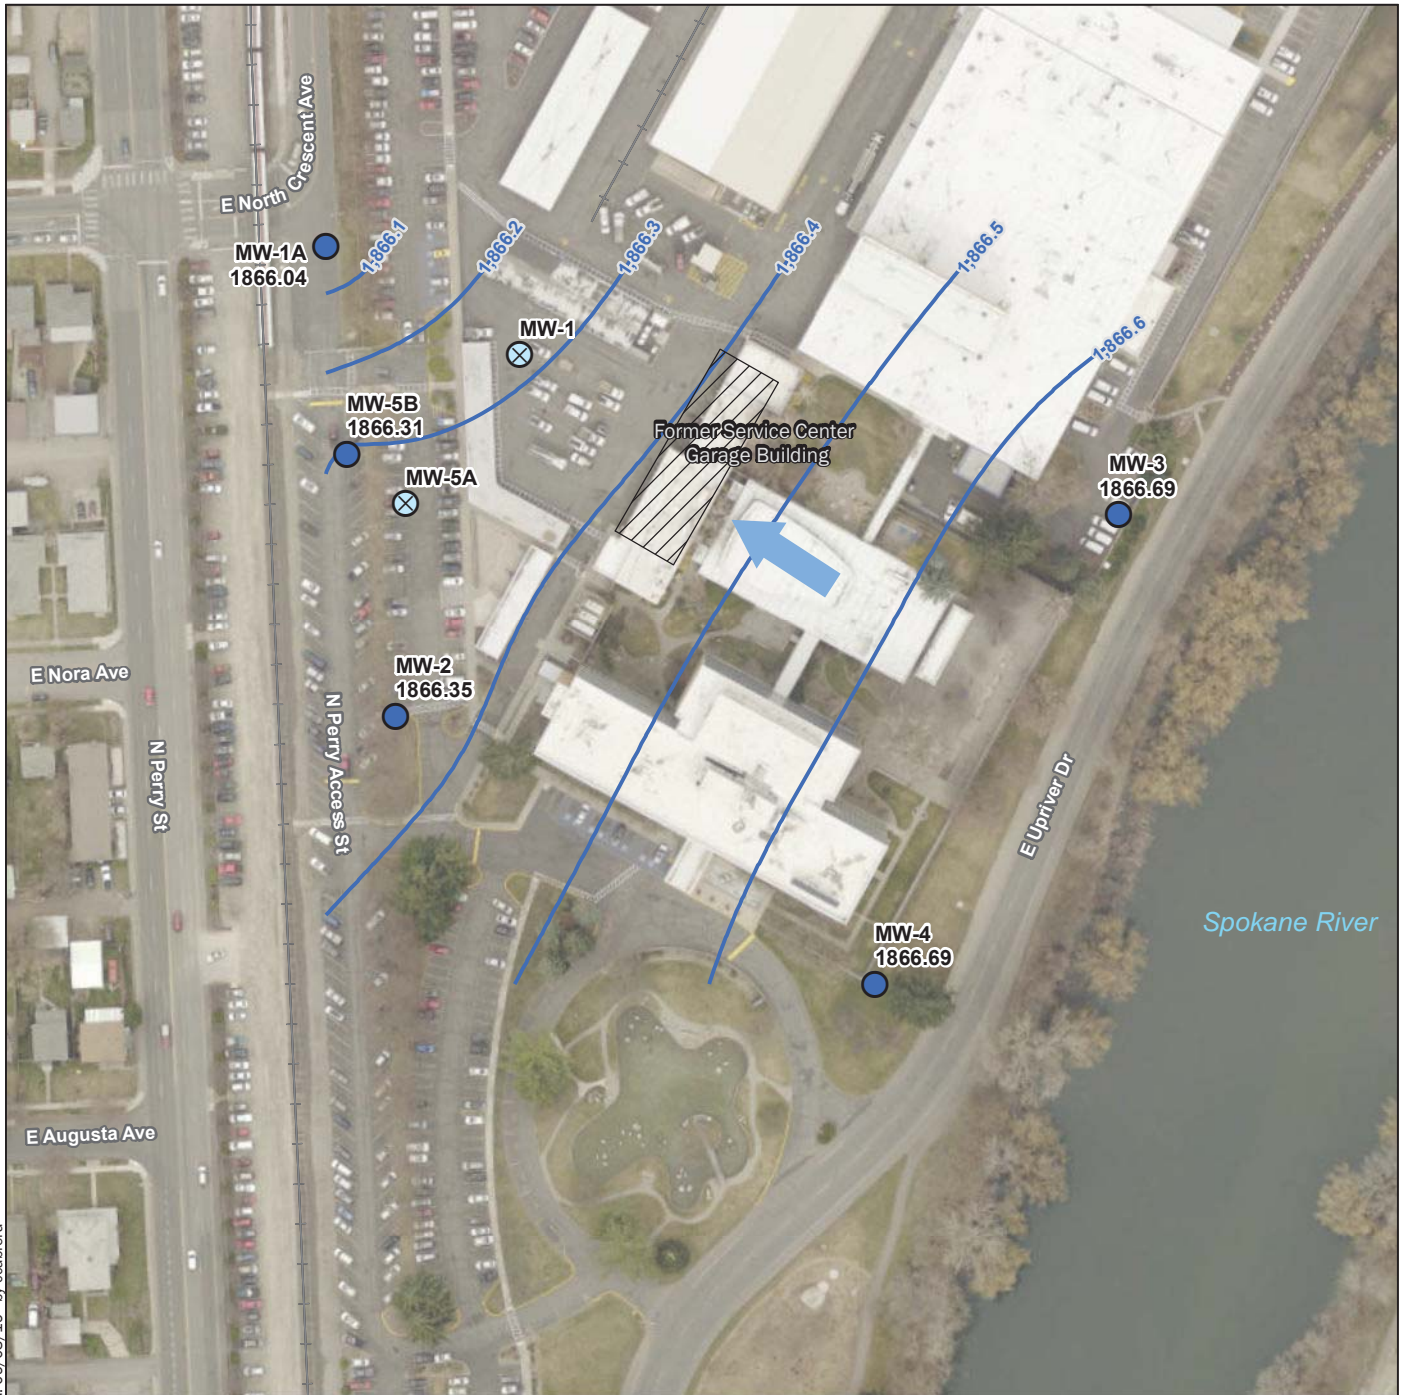
Groundwater Elevation and Interpreted Flow Direction, July 31, 2019	
Avista - Service Center Garage Monitoring Well Installs and Groundwater Monitoring Report Spokane, Washington	
GEOENGINEERS	Figure 3

Static depth to groundwater was measured in the five site groundwater monitoring wells using an electronic water level indicator. Depth to groundwater ranged from 20.88 feet (MW-3) to 40.92 feet (MW-1A) below

the top of well casing, as shown in Summary of Groundwater Level Measurements, Table 1. Groundwater elevations ranged from about 1887.57 feet in MW-3 to 1906.96 feet relative to the Washington State Plane System, NAD83, North Zone.

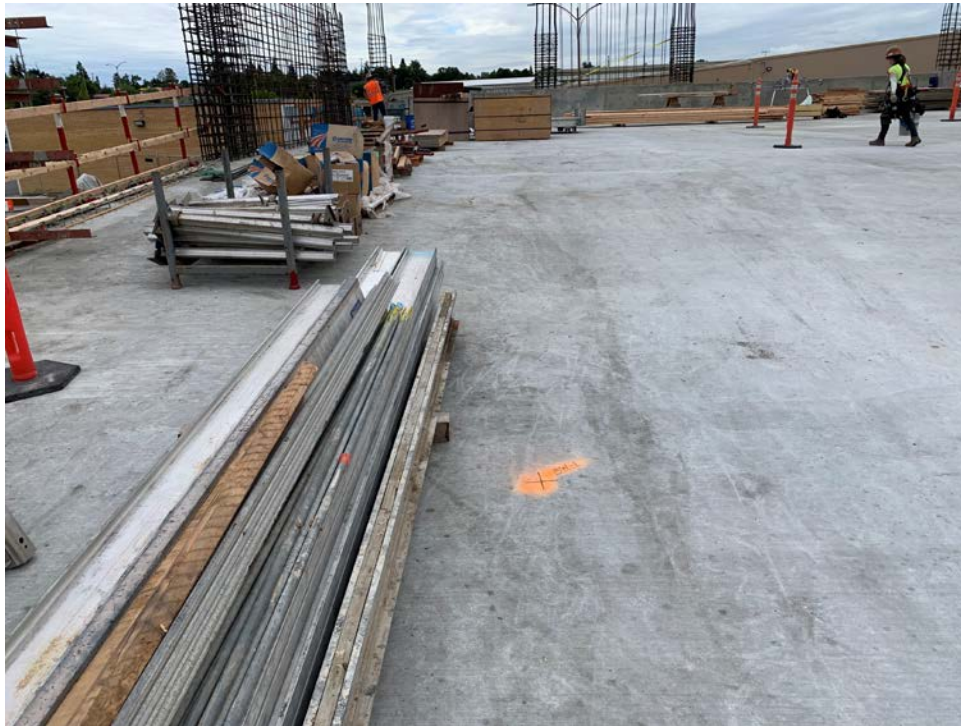
The previous location of MW-1 was located within the footprint of the parking garage structure and was not found. Figure 4 displays the location of MW-1 within the parking garage structure. MW-1 was destroyed or damaged by the contractor during construction of the parking garage structure. The location of MW-5A also appeared near the parking structure footprint in the location of a footing. Drone photogrammetry was utilized to more precisely locate the monitoring well location. Drone photogrammetry (measurements from drone imagery) placed MW-5A inside of the parking garage structure which is depicted in Appendix D. On August 8, 2019 Avista and Able Cleanup Technologies visited the site to excavate near the parking garage footing for the remains of MW-5A, but a bank of new conduits was located in the area and the excavation was cancelled. Former monitoring wells MW-1 and MW-5A were destroyed or damaged by the contractor during construction of the parking garage structure.

Approximate location of destroyed monitoring well MW-1 within parking garage structure.

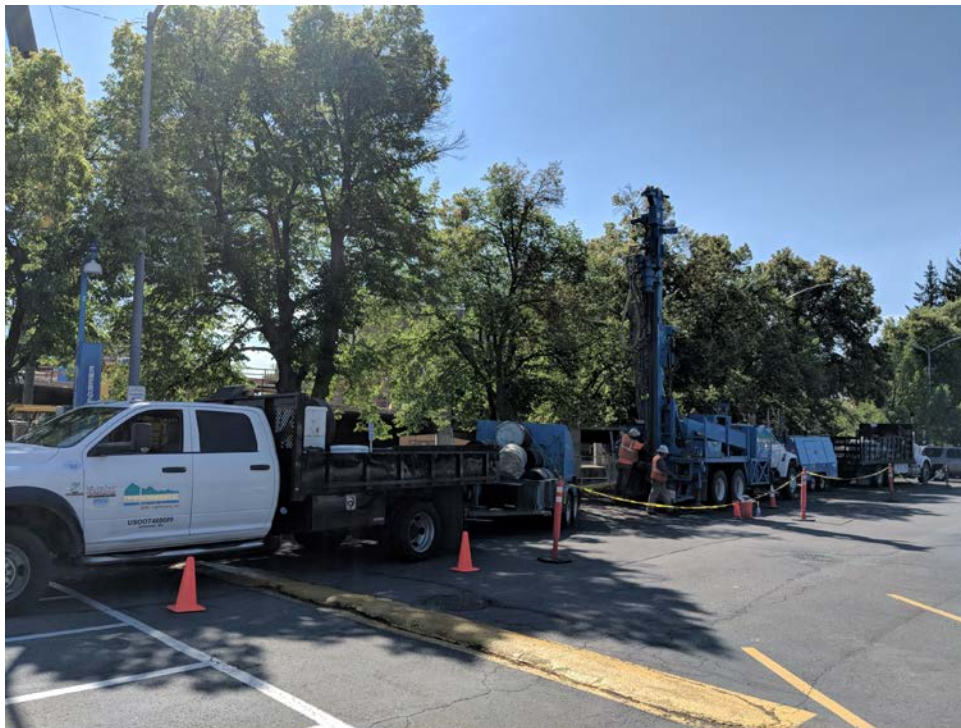
MW-5B was air-knifed to 6 feet bgs and drilling advanced the boring to a total depth of 45 feet bgs. During drilling activities, water was encountered at approximately 36 feet and MW-5B was screened from about 31 to 41 feet bgs.

Environmental West Exploration Drilling installing MW-5B using air rotary drilling.

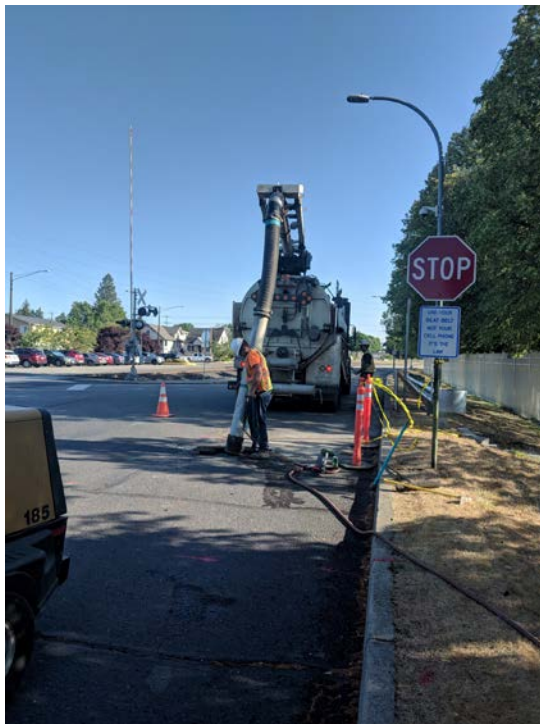
MW-1A was air-knifed to 4.5 feet bgs and drilling advanced the boring to a total depth of 45 feet bgs. During drilling activities, water was encountered at approximately 41 feet and MW-1A was screened from about 35 to 45 feet bgs.

Able Cleanup Technologies air knifing monitoring well MW-1A. (view looking north)

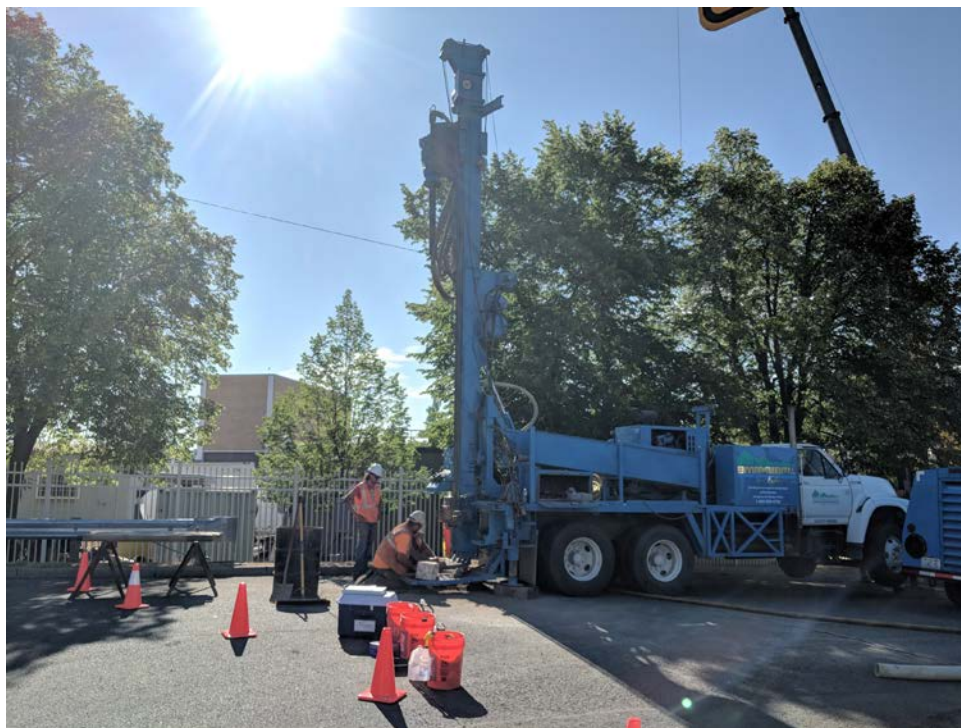
Environmental West Exploration drilling monitoring well MW-1A using air rotary drilling. (view looking east)

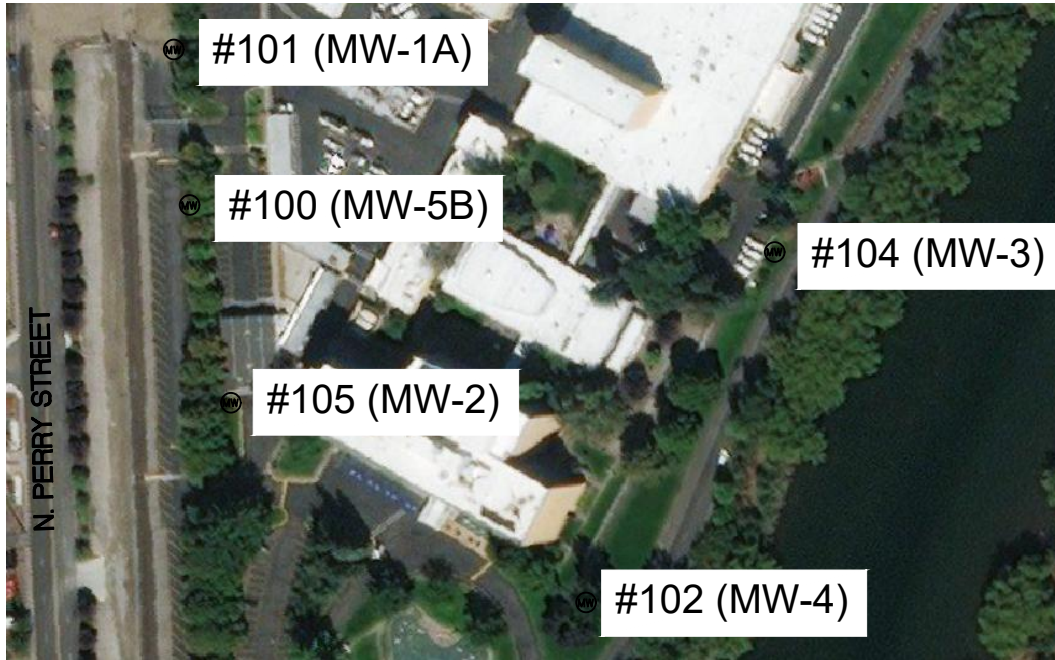
POINT #	NORTHING	EASTING	ELEVATION	DESCRIPTION
100	264905.69	2488511.35	1901.72	MON WELL
101	265067.59	2488494.68	1906.96	MON WELL
102	264491.90	2488924.04	1888.10	MON WELL
104	264856.99	2489120.26	1887.57	MON WELL
105	264699.98	2488554.31	1897.60	MON WELL

1. FIELD SURVEY COMPLETED AUGUST 7, 2019. UPDATED AUGUST 26, 2019
2. ELEVATIONS TAKEN ON THE NORTH SIDE OF MONITORING WELL CASING.

The site monitoring wells were surveyed by Coffman on August 7 and August 26, 2019. The north edge of the top of the PVC casings were surveyed for horizontal and vertical coordinates relative to North American Datum of 1988 (NAD83) Washington North Zone. GeoEngineers marked the north side of each well casing for future depth to groundwater measurements. Well survey information is provided in Appendix B.
