**Phase I Environmental Site Assessment
Motel Property
4610 36th Avenue SW
Seattle, WA 98126**

October 30, 2007

**G-Logics Project 01-0524-A
Copyright 2007 G-Logics, Inc.
All Rights Reserved**

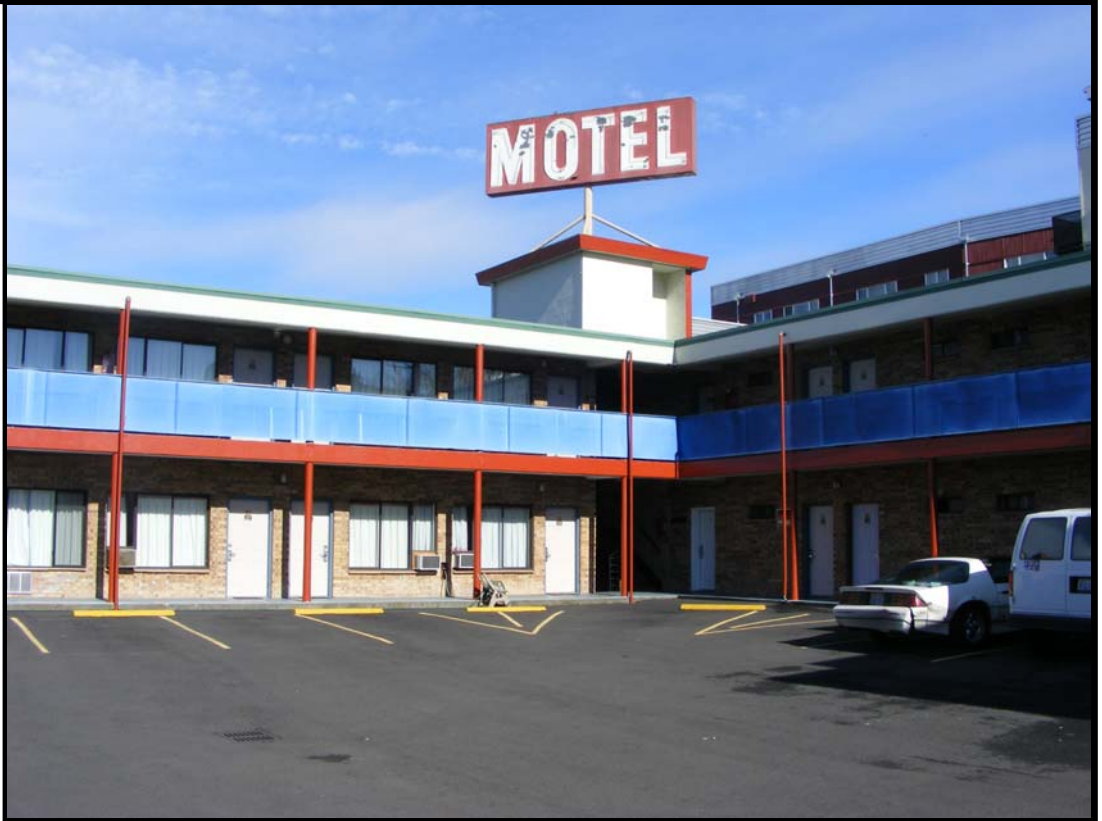
1

Description: Subject property motel looking north from the center of the property.

Comments: The north end of the motel was constructed in 1967 and includes a basement.

The subject property contains a 2-story motel (Photo 1). The north half of the motel includes a basement-level that is aboveground at the lower northeast corner of the property (Photo 2). The buildings are heated by electric baseboard units and cooled by window-mounted air conditioners. No visual indications of USTs (vent pipes or fill ports) were observed.

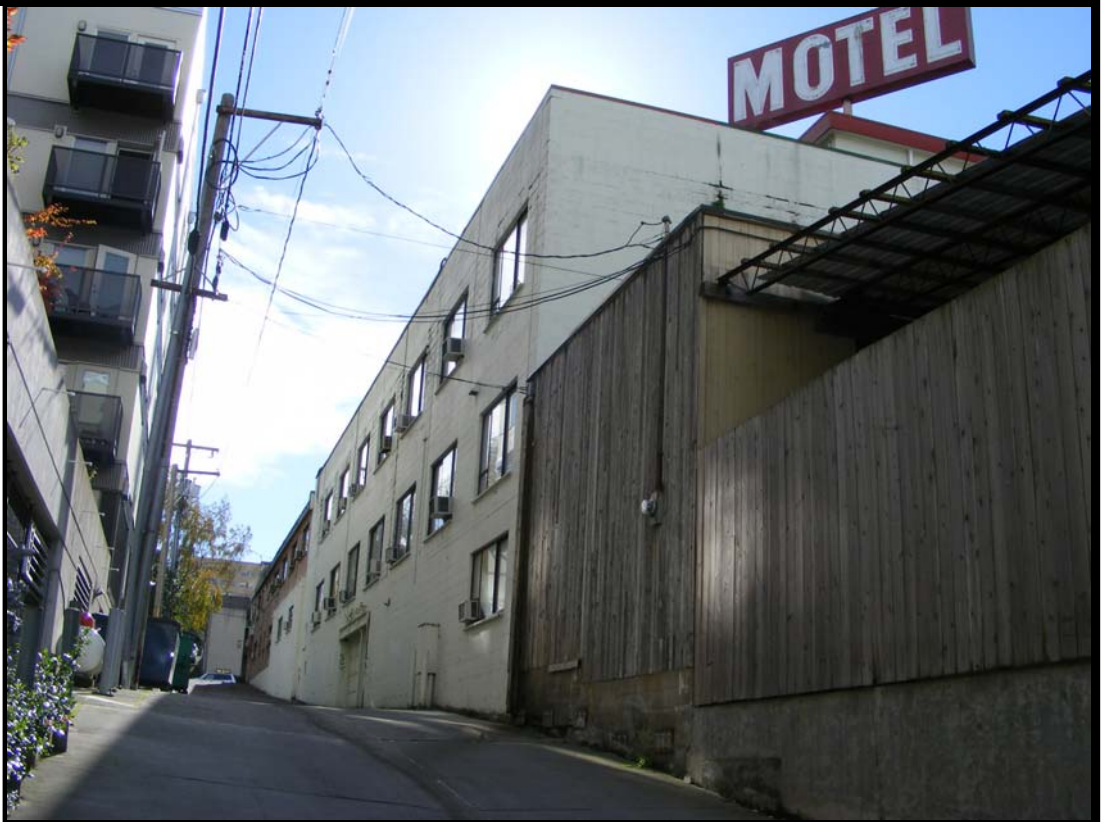
2

Description: Northeast end of the subject property looking south from an adjacent alley.

Comments: The basement level is above grade due to the sloping hillside. The adjacent property Jones Building is shown on the left.

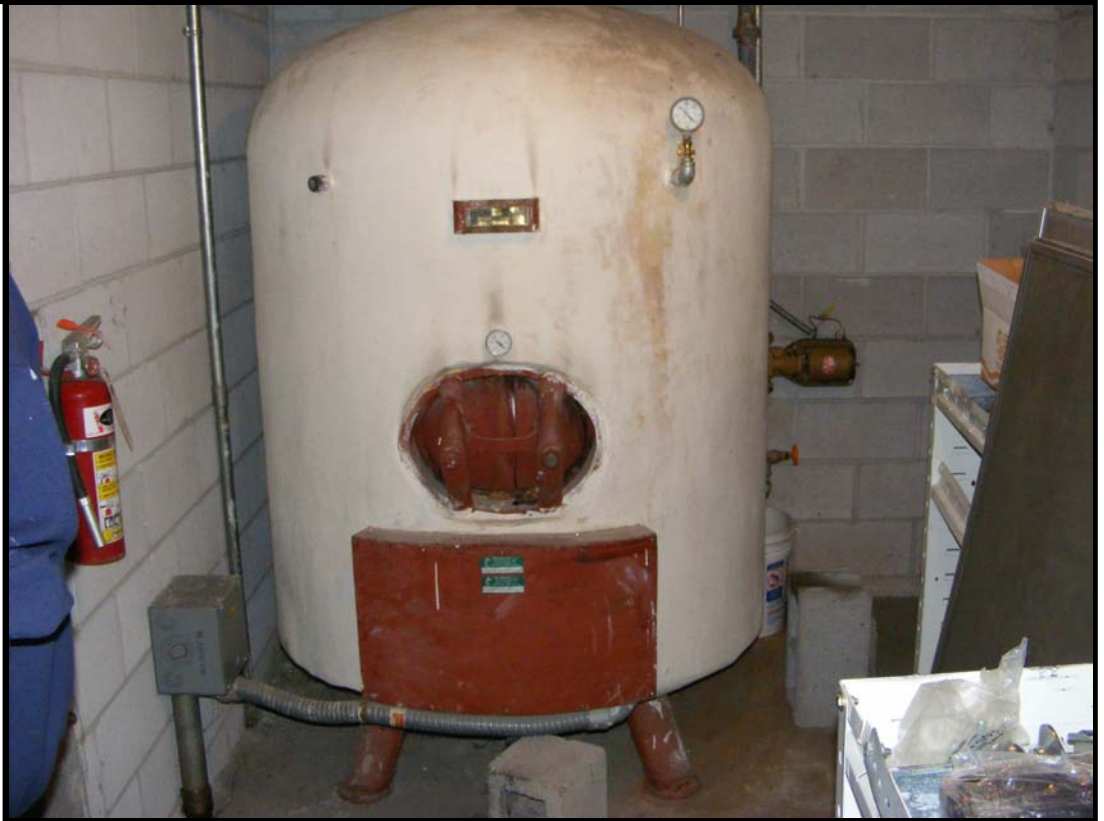
3

Description: Electric boiler located in the basement.

Comments: The boiler appears to be covered with asbestos insulation.

Given the age of the building construction (1959 to 1967), the presence of asbestos and lead paint is likely. Potential asbestos-containing materials observed by G-Logics were boiler insulation, spray-applied “popcorn” ceilings in the guest rooms, ceiling tile mastic in the banquet room, and tar-based roofing. However, samples were not collected during this assessment to confirm this expectation.

If disturbance of possible asbestos containing materials is planned at some future date through either demolition or renovation activities, various regulations regarding the handling of asbestos must be followed. Asbestos removal must be performed by properly trained and certified workers. The Puget Sound Clean Air Agency regulations state that asbestos-containing materials must be removed from a building prior to demolition or their disturbance by renovation activities. If either of these activities are planned for the on-site buildings, G-Logics recommends that representative samples of building construction-materials be collected and analyzed to confirm the presence and location of asbestos containing material. Asbestos Hazardous Emergency Response Act (AHERA) requirements
