Re: No Further Action at the following Site:

- **Site Name:** L & E Auto Sales
- **Site Address:** 227 Naval Ave & 2101 Burwell Pl, Bremerton, WA 98312
- **Facility/Site No.:** 14170
- **VCP Project No.:** NW2785
- **Cleanup Site No.:** 11943

Description and Diagrams of the Site

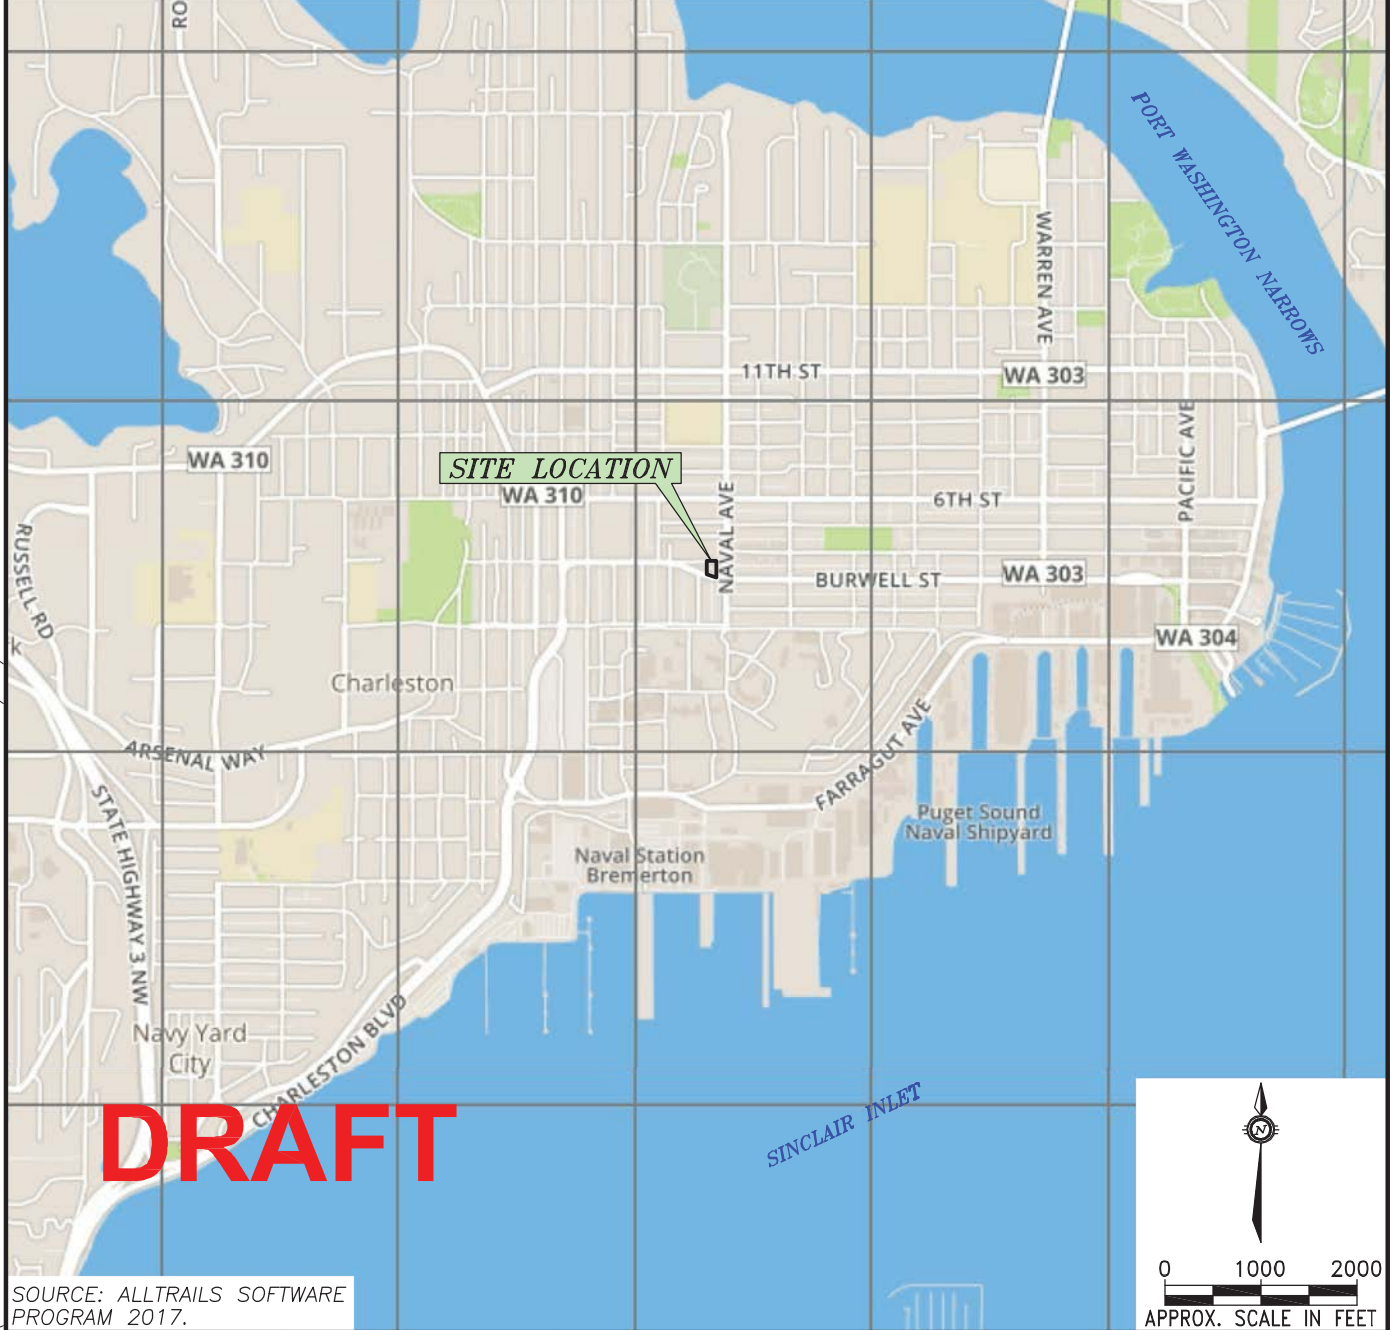
Enclosure A, Figure 1

SITE LOCATION MAP

Area and Property Description: The Property is located within an area of mixed commercial and residential properties. The Property is located west of Naval Avenue, south of Burwell Place, and north of Burwell Street in Bremerton, Washington, see **Figure 1**. Single family residences are located west and south of the Property. A cafe and a pub are located north and east of the Property, respectively.

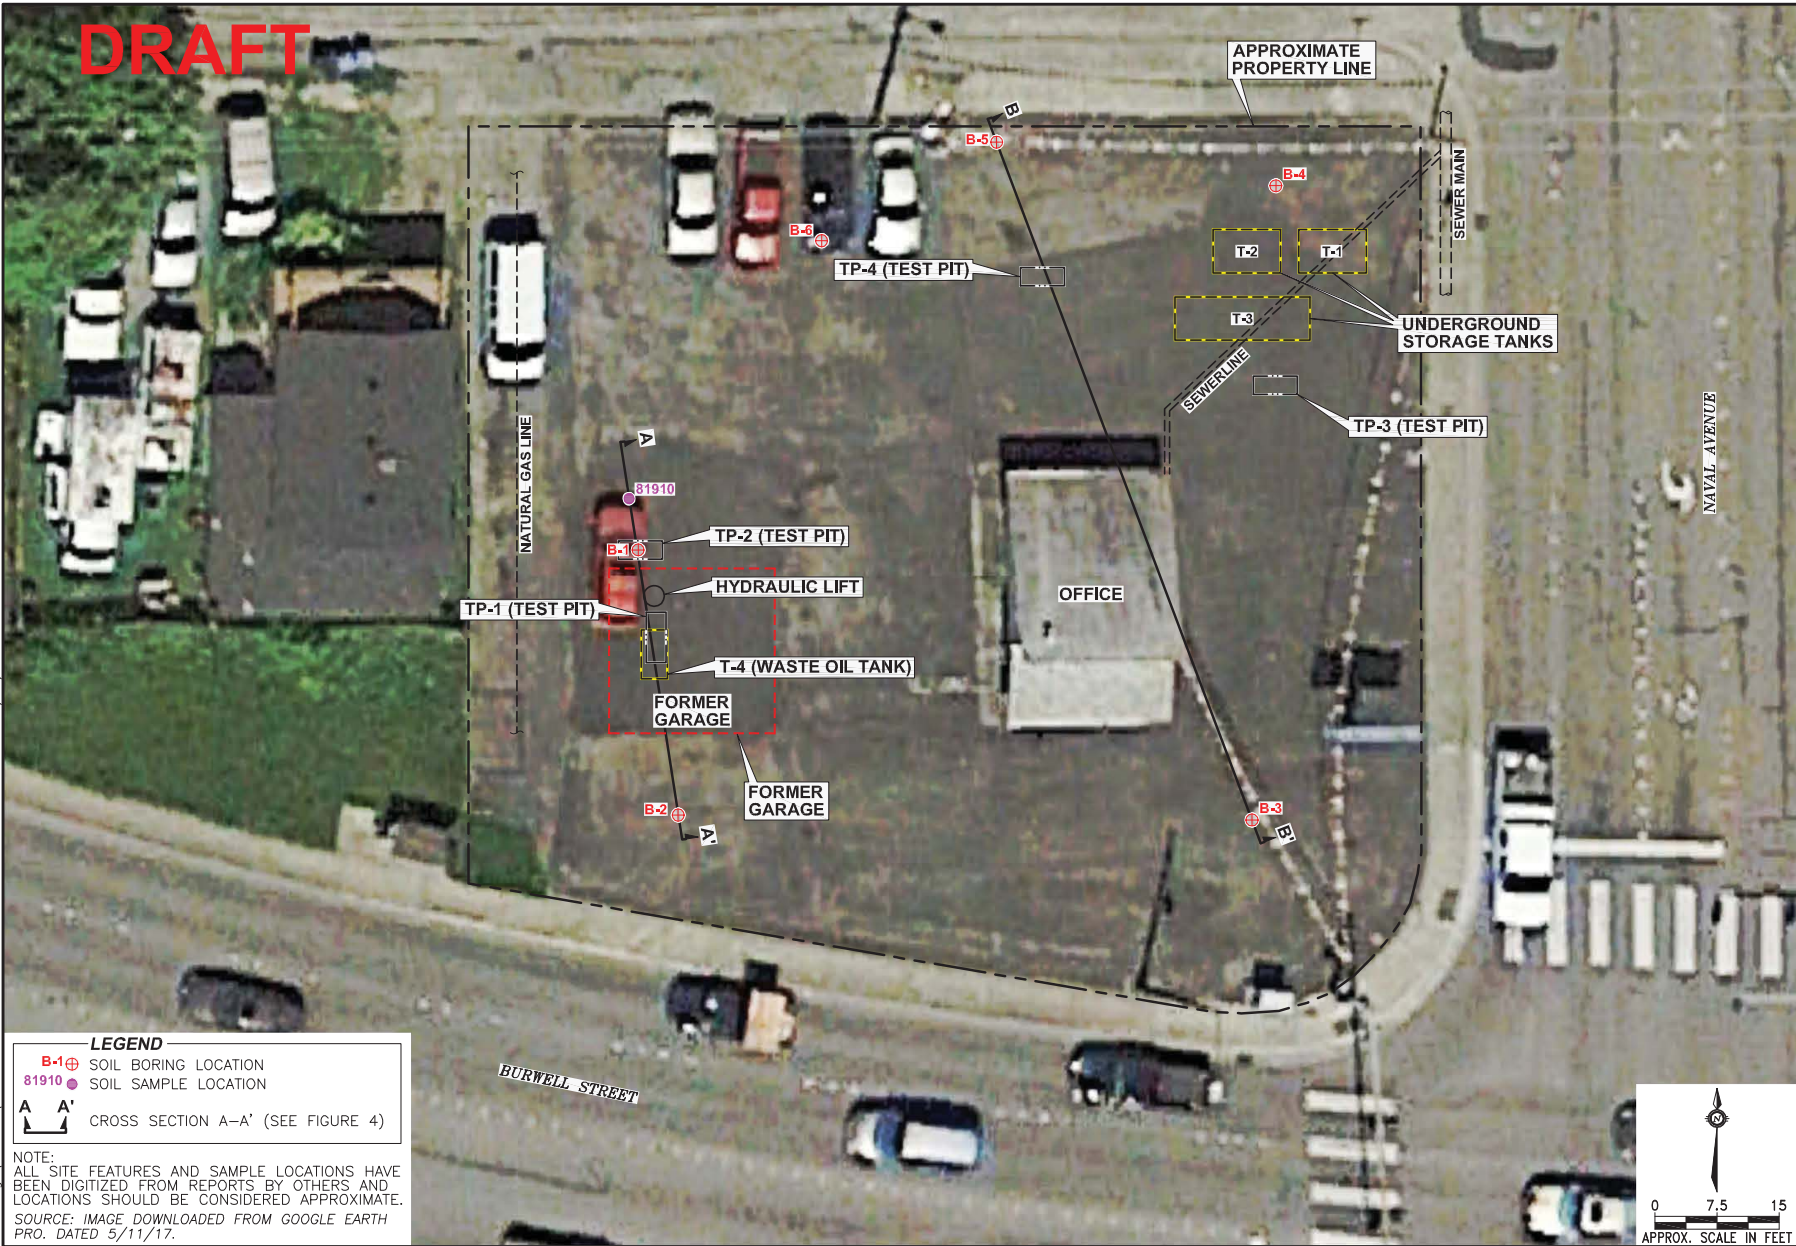
Enclosure A, Figure 2

SITE DETAIL AND SAMPLING LOCATIONS

- B-1 ⊕ SOIL BORING LOCATION
- 81910 ⊕ SOIL SAMPLE LOCATION
- A A' CROSS SECTION A-A' (SEE FIGURE 4)

Site History and Current Use: The Site is noted to have been previously used as a taxi cab stand, but the dates of this use are unknown. Historical aerial photograph review in 2010 indicated the former presence of three pump islands at the northeastern portion of the Property. Concurrent Kitsap County file review indicated that three USTs were present at the Property. Four USTs were removed from the Property in 2010. These included two 1,000-gallon steel tanks and one 2,000-gallon steel tank believed to have been used for gasoline storage, and one 250-gallon steel UST used to store waste oil. One hydraulic lift was also identified near the former waste oil tank. The Property has one building that is reportedly vacant and a gravel parking area. Locations of Site features are shown on **Figure 2**.

Release and Extent of Contamination: In 2010, historical research identified three likely dispenser island locations and the potential presence of three USTs at the Site. Six borings advanced at the Site indicated that TPHo was detected at concentrations greater than MTCA Method A soil cleanup levels at location B-1 (**Figure 2**).

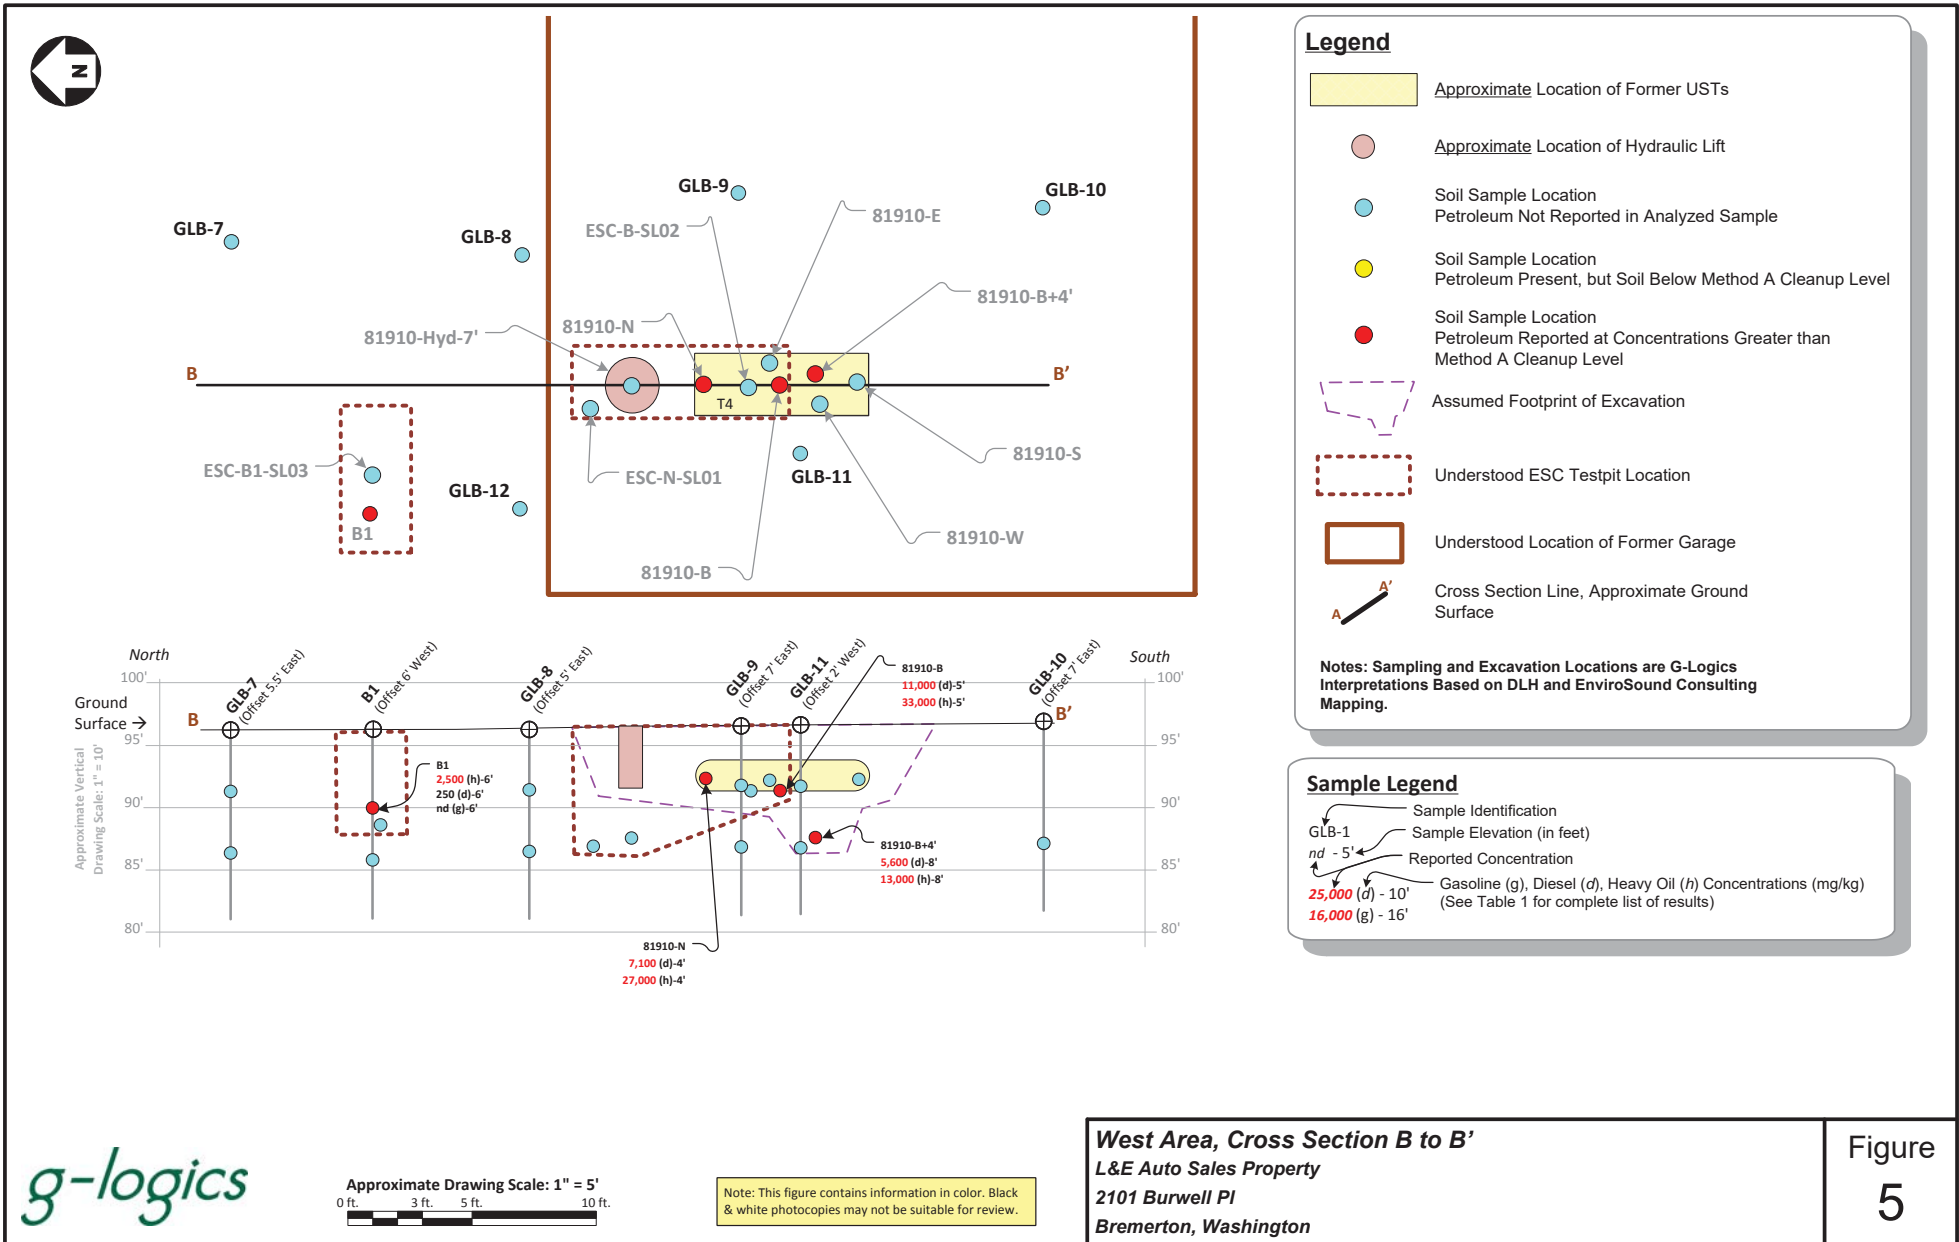
Enclosure A, Figure 6

West Area, Cross Section B to B'
L&E Auto Sales Property
 2101 Burwell PI
 Bremerton, Washington

Soil borings were drilled at the Site in 2019 to address data gaps in the prior Site characterization work (see **Figures 5 and 6**). Soil samples collected from these borings confirmed that petroleum concentrations in soils remaining at the site are below Method A cleanup levels.
