SUBJECT Remedial Investigation Report
Swindahl Properties LLC aka Modutech Marine Inc
2218 Marine View Drive
Tacoma, Washington 98422
VCP Project No.: SW1653

REMEDIAL INVESTIGATION REPORT

Performed at:
**Swindahl Properties LLC
aka Modutech Marine Inc.**
2218 Marine View Drive
Tacoma, Washington 98422

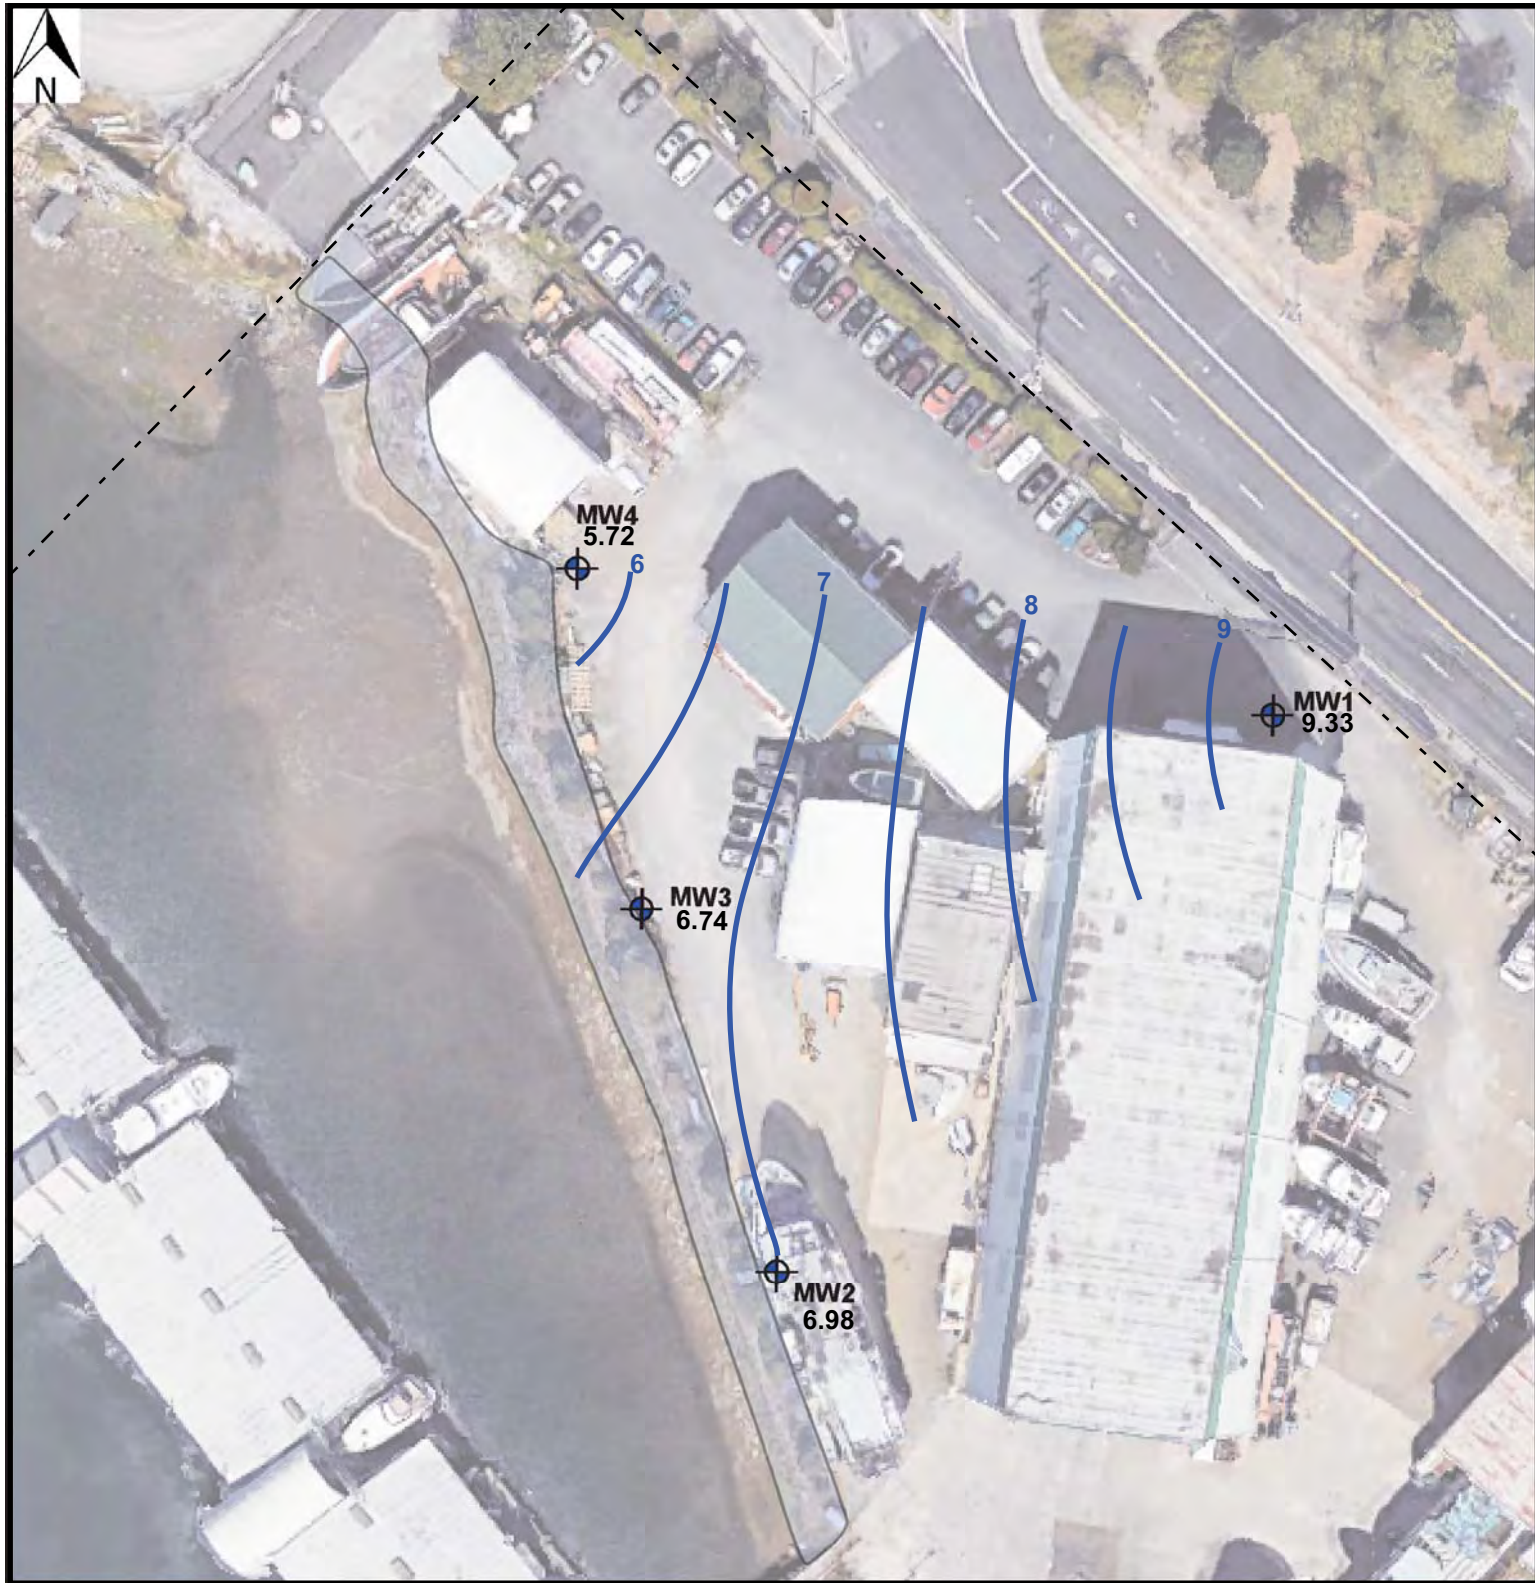
Calculated Groundwater Flow Direction and Gradient:

Hydraulic Gradient is
expressed in ft/ft
