**GROUNDWATER MONITORING  
REPORT:  
Fourth Quarter**

*Performed at:*  
**Swindahl Properties LLC**  
2218 Marine View Drive  
Tacoma, Washington 98422

***AEROTECH***  
*Environmental Consulting Inc.*

**RE: Groundwater Monitoring Report – Fourth Quarter**  
Swindahl Properties LLC  
2218 Marine View Drive  
Tacoma, Washington 98422

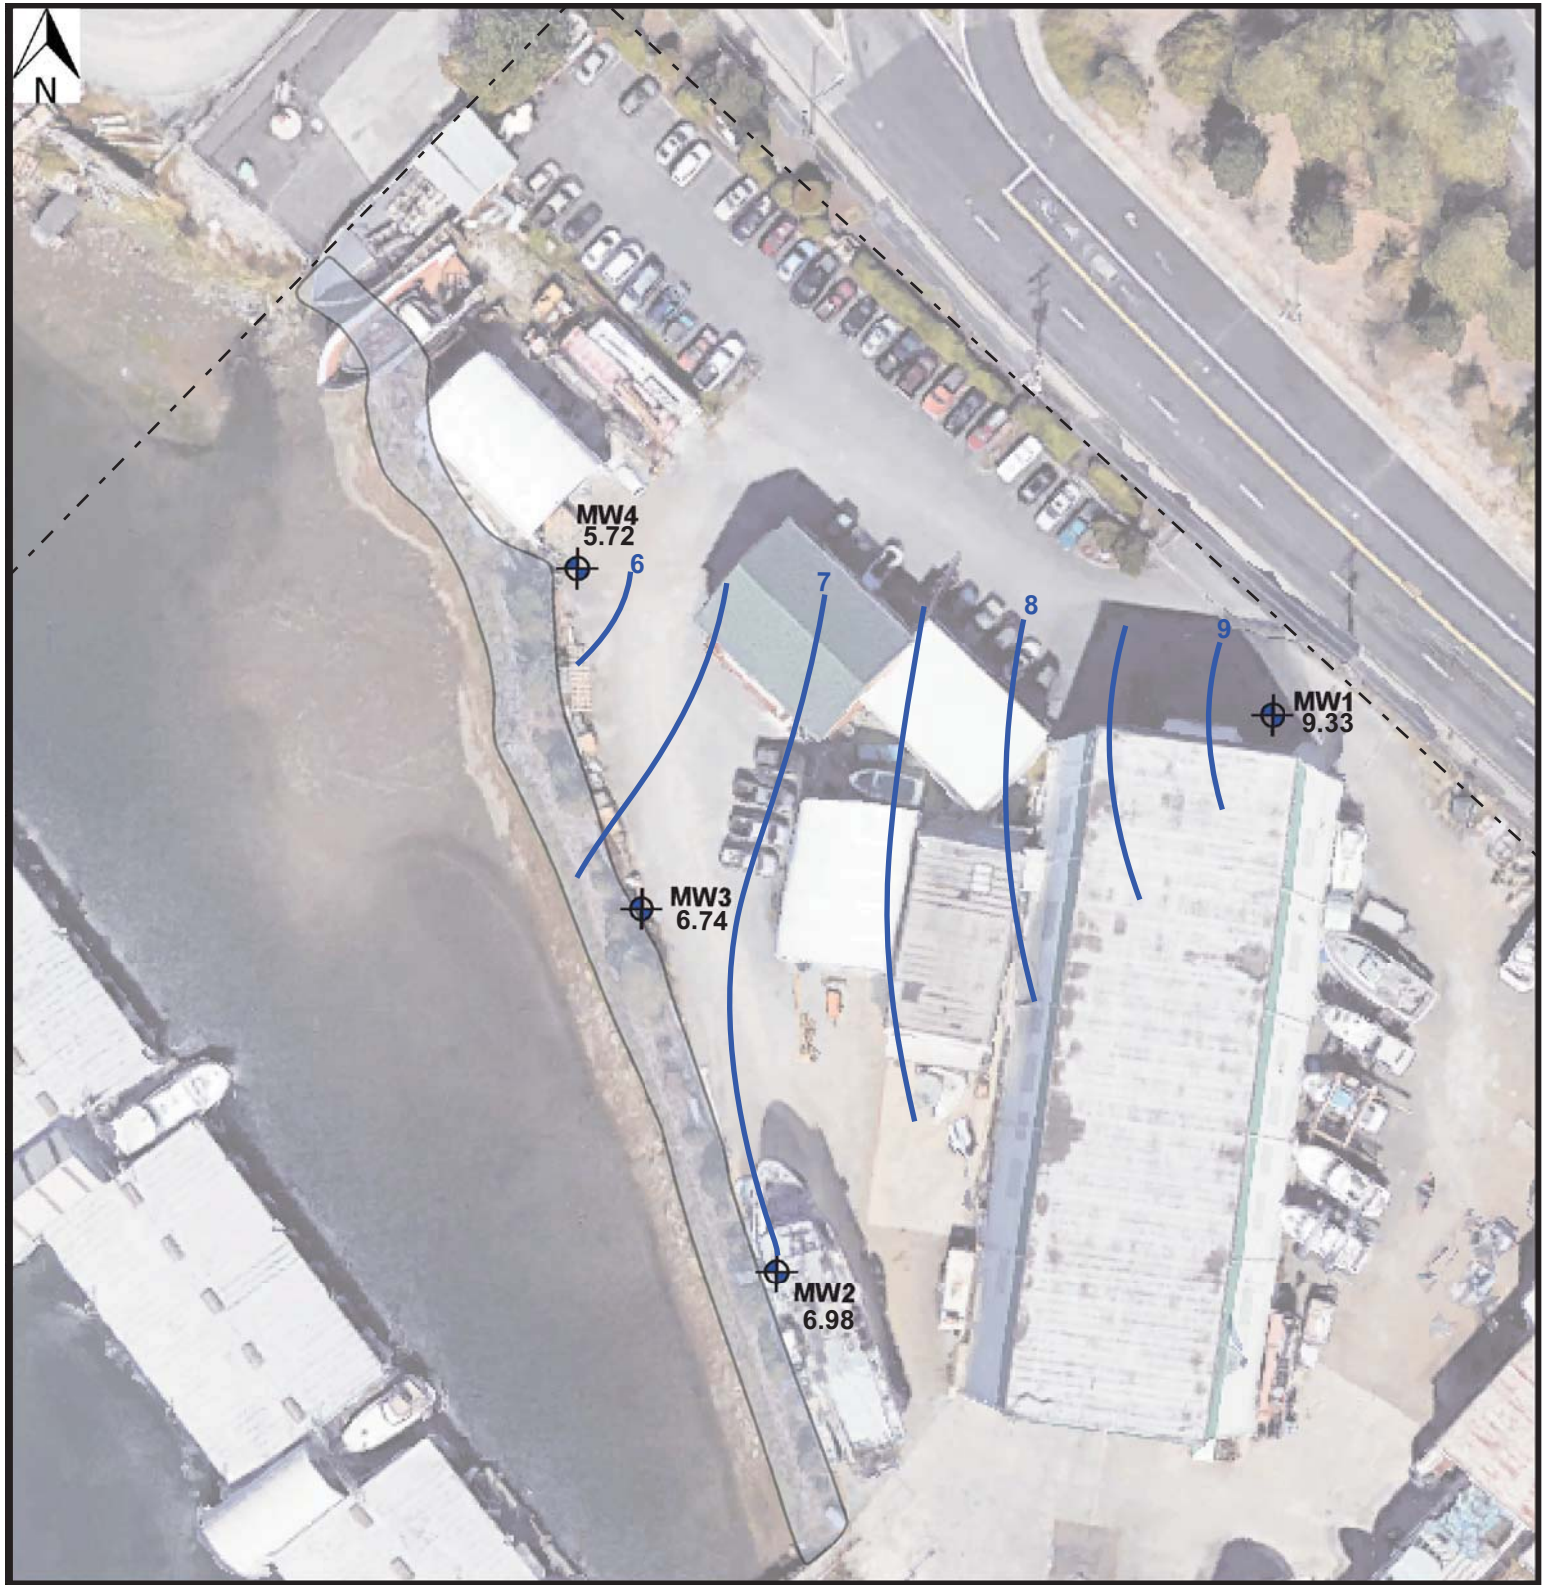
5

Calculated Groundwater Flow Direction and Gradient:

**POTENTIOMETRIC  
SURFACE MAP  
01/10/19**

Hydraulic Gradient is  
expressed in ft/ft
