**Port of Longview
TPH Site**

Interim Action Completion Report

September 2019

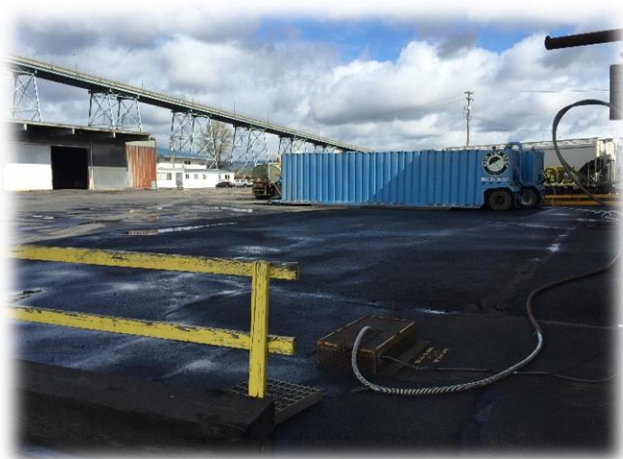
STORMWATER COLLECTION SYSTEM (W. OF TS2)

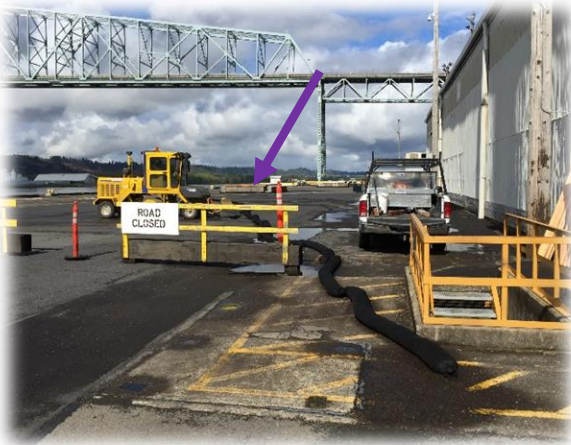
EAST (UPSTREAM) END OF PROJECT, AT STAIRWELL, SE CORNER OF TS2, LOOKING WEST. NOTE COMPOST WATTLE (TO DIVERT ANY EXCESS RUNOFF), SWEEPER, AND MAIN (CENTER) ACCESS HOLE IN BACKGROUND.

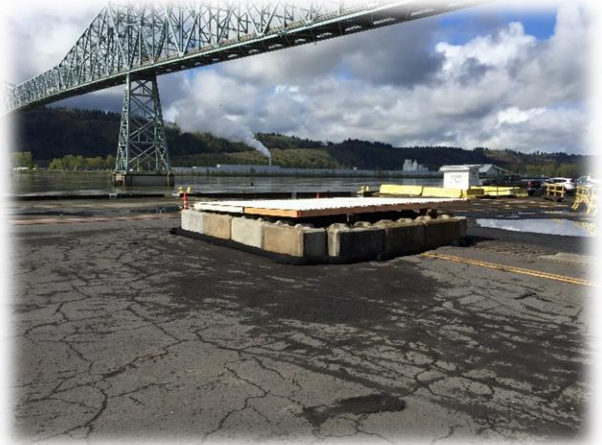
WEST ACCESS HOLE LOOKING S/SE. NOTE COMPOST WATTLE AND COVER. NOT SHOWN IS CLOSED-CELL BACKER-ROD UNDER BLOCKS.

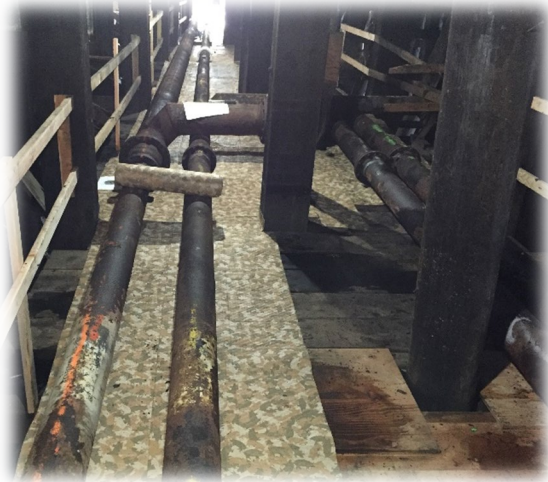
INSTALLATION OF NEW PIG 'HAMO' OIL-ONLY ABSORBENT MAT SURFACING UNDER DOCK.

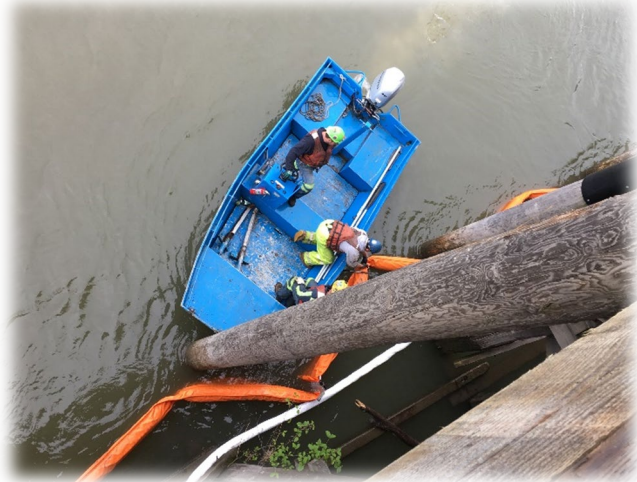
BOOM INSTALLATION

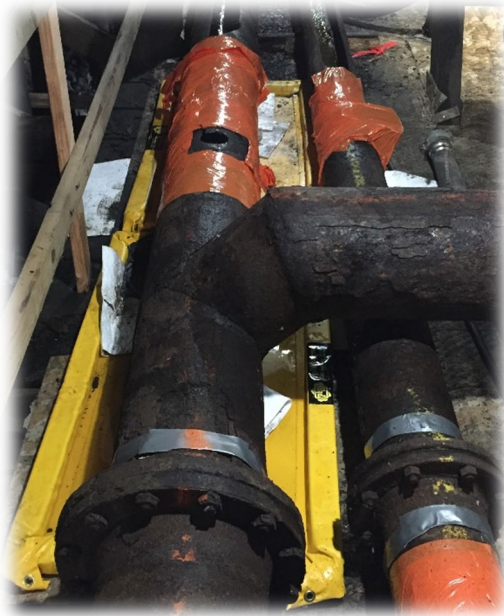
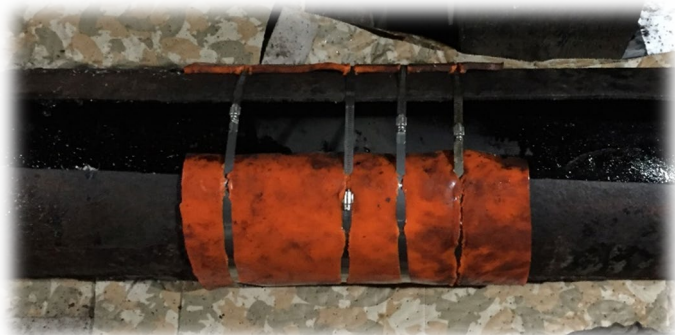
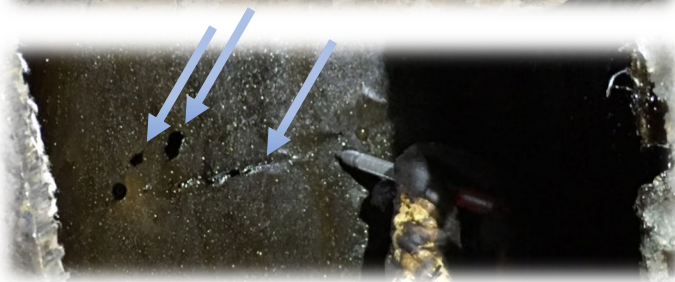
- Two leaks, no spills (Monday). Leaks promptly discovered on Line D (Orange, the 12” Line), approximately 70’ west of the main (center) access hole, as part of rover watchman BMP. It was contained by pre-deployed BMPs and addressed immediately.

FIRST LEAK. LINE D, 75' WEST OF CENTER. NO SPILLS	SECOND LEAK. LINE D, 60' WEST OF CENTER. NO SPILLS. NOTE PIPE PERFORATIONS AND CRACK.
---------------------------------------------------	---------------------------------------------------------------------------------------

The end result of the application of these BMPs was that no spillage of oil to the Columbia River occurred during execution of the project. Two minor leaks occurred due to the severely deteriorated condition of the pipes in places. The leaks were fully contained within the adsorbent mat placed under the pipes. However, as a precautionary measure, an absorbent boom was deployed under this section of pipe.

- Based on the Day 1 leaks and learning just how deteriorated some pipe sections have become, we decided to keep NRC on-site and evacuate the pipes more aggressively (i.e. nearly-continuously, beginning just as soon as pipe contents become accessible).

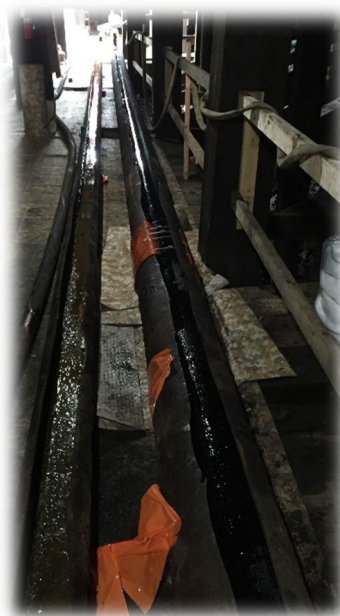
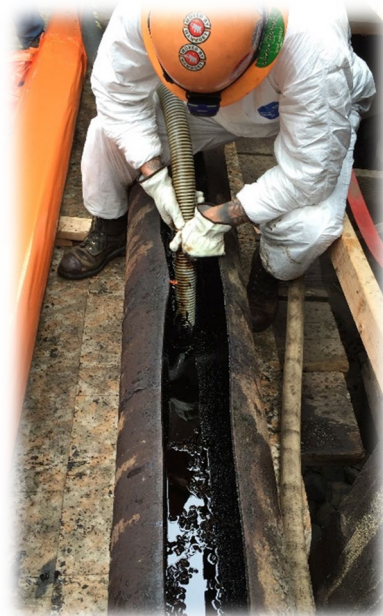
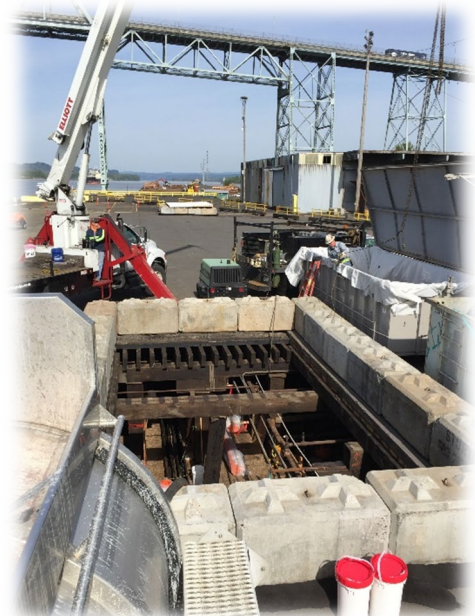
TROUGHED PIPE, W/ OIL.	VACUUMING PIPE.	SURFACE OPERATIONS.
------------------------	-----------------	---------------------

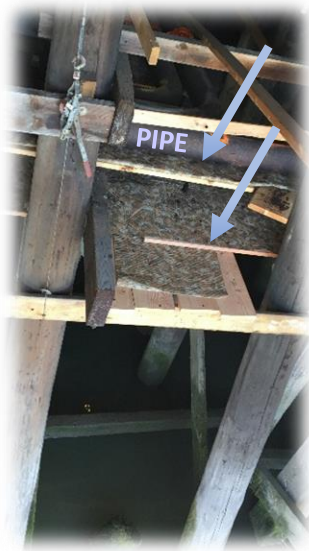
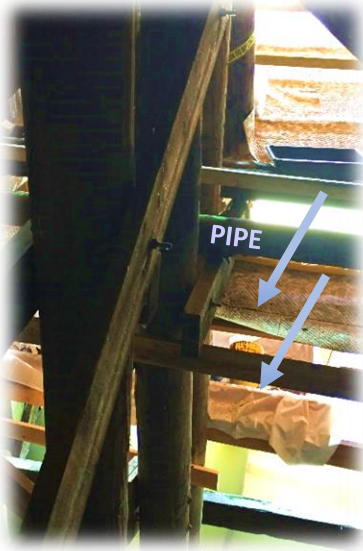
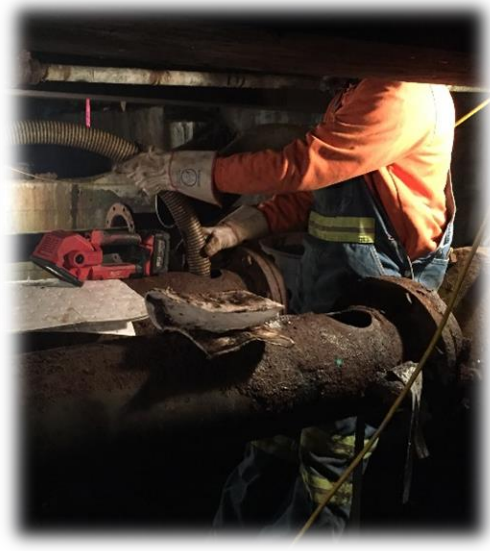
DOUBLE SCAFFOLDING IN KEY AREAS

PRE-VACUUMING NEAR BULKHEAD

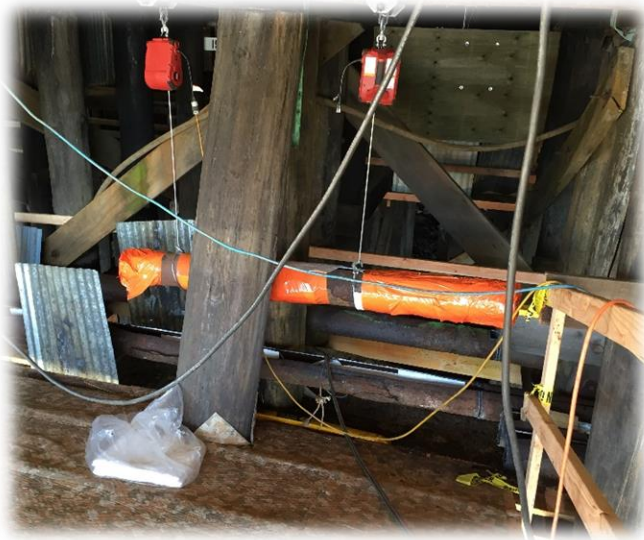
LIFTING PIPE NEAR BULLRAIL

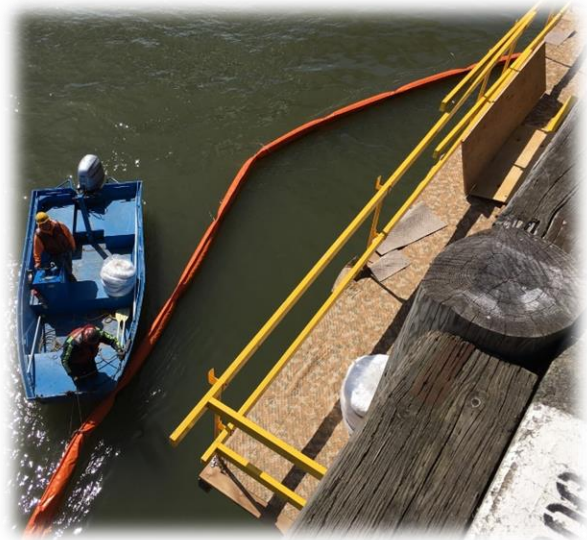
BOOMING "BALCONY" UNDER BULLRAIL

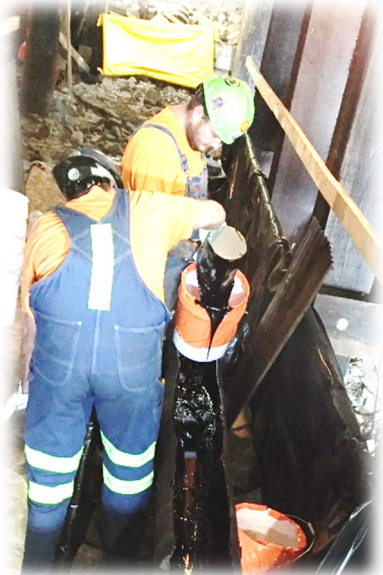
HAND-SCOOPING LINE 'E'

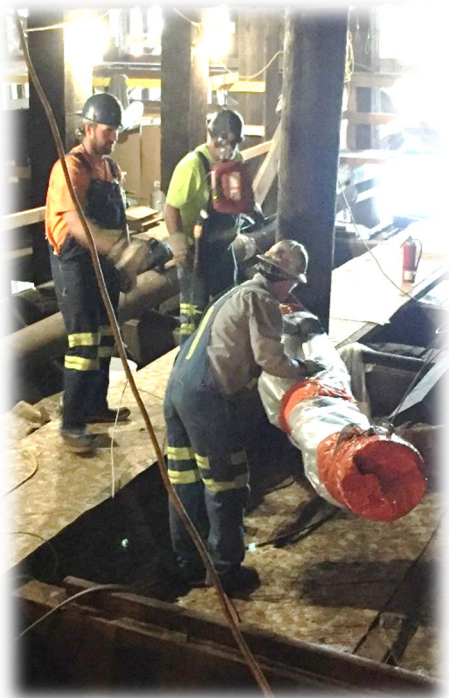
REMOVAL OF LINE 'E' END-SECTION

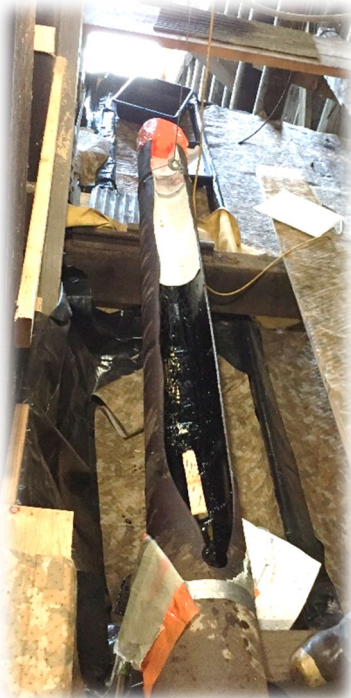
LINE 'E' TROUGHED

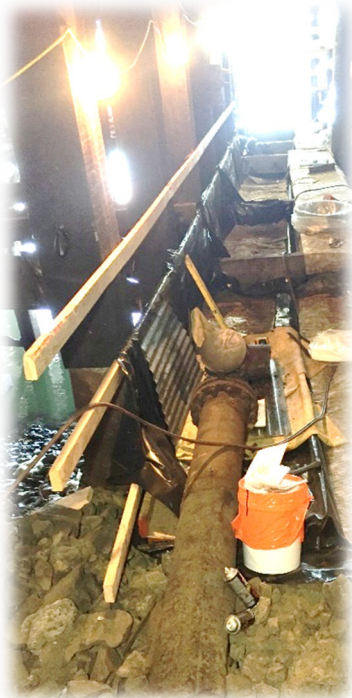
LINE 'E' REMOVED

- Friday: Line ‘E’ removed by noon. By day’s end, all metal recycled, and 24-buckets of product disposed of in NRC’s drop box. Line ‘E’s flange found to be in pristine shape, with no trace of oil seeping by.
