SUBJECT: BAKKER'S FINE DRY CLEANING SITE
11855 Northeast 8th Street
Bellevue, Washington
Facility/Site ID: 92645942
Cleanup Site ID: 11074
Project Number: 1021-001

FIGURE 1
EXPLORATION LOCATION PLAN

T E C H N I C A L M E M O R A N D U M

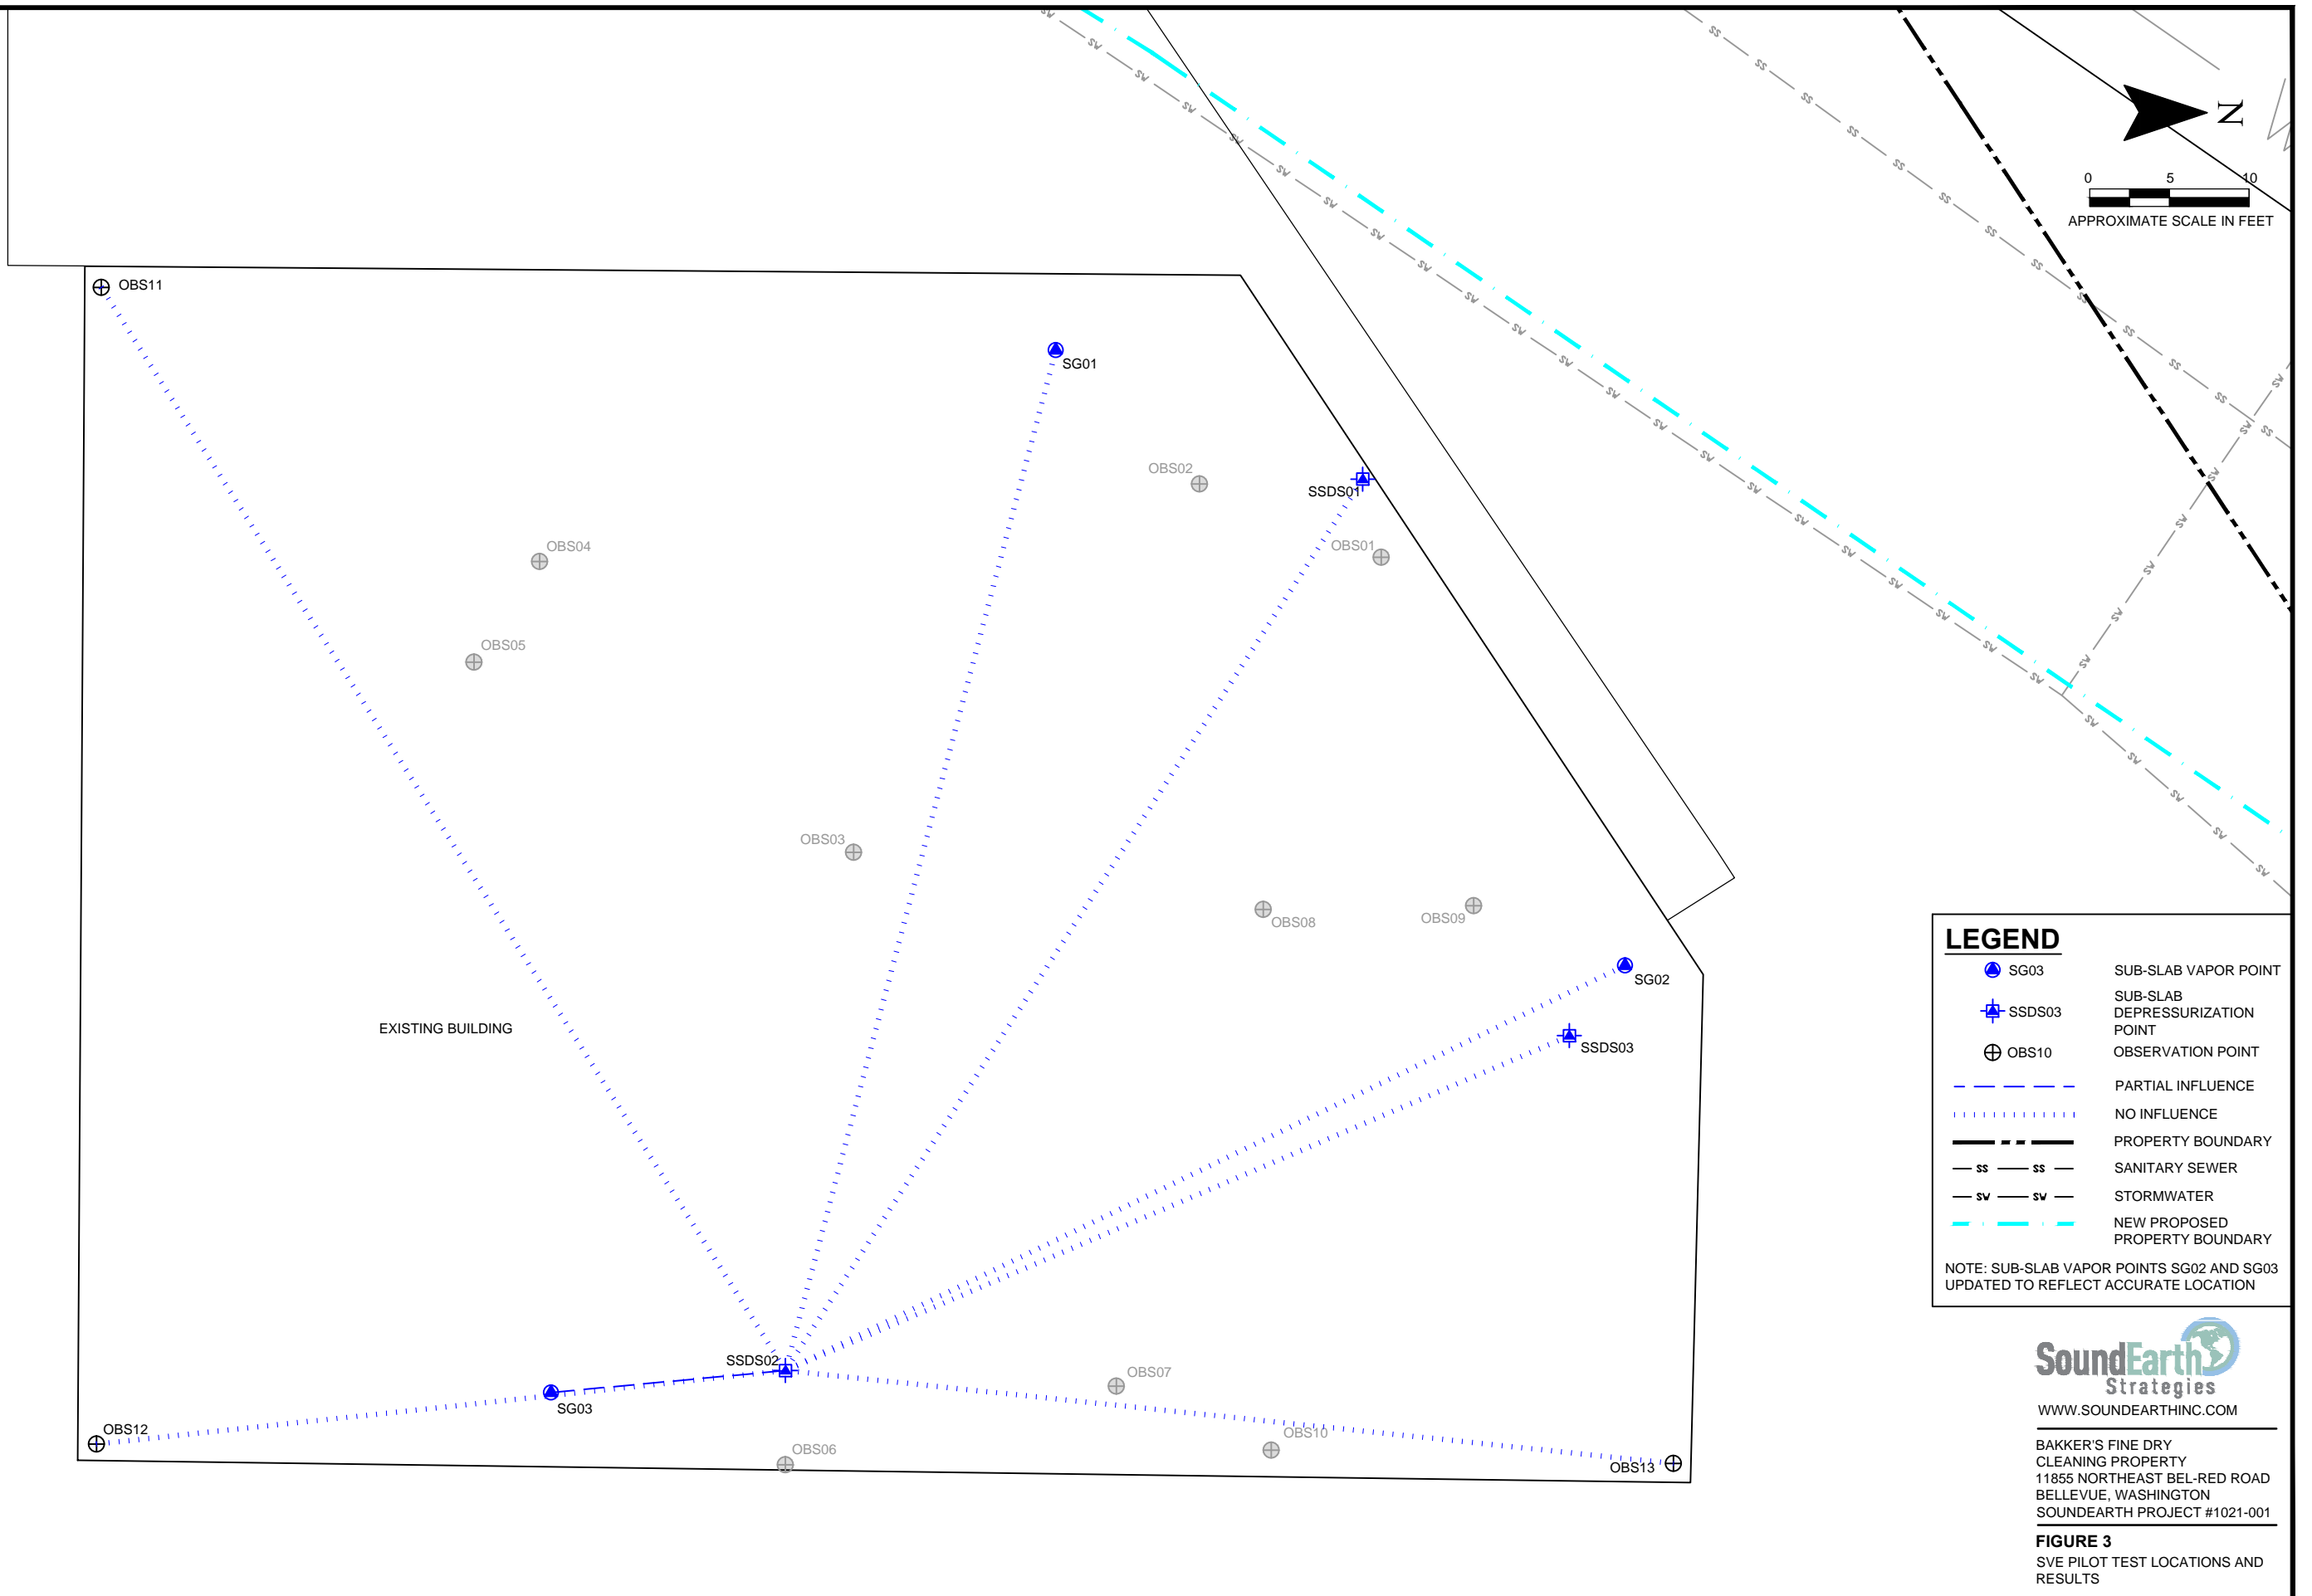
FIGURE 3
 SVE PILOT TEST LOCATIONS AND RESULTS

In the SVE system pilot test, air flow rates between 22 and 254 scfm were observed at SSDS02 at vacuums between 7 and 17 iow. A summary of the SVE system pilot test results for SSDS02 are presented in Table 5. The pilot test consisted of three main steps with 10, 15, and 20 iow applied at test sump SSDS02. The following observation points were used to evaluate the range of influence of the vacuum applied at test sump SSDS02: SSDS01, SG01, SG02, SG03, OBS11, OBS12, and OBS13. Observation points OBS11 through OBS13 (all placed along the perimeter of the Building) were selected to determine whether the pressure field from a stronger vacuum would extend out to the perimeter of the Building and allow for a reduction in the number of sub-slab penetrations and collection sumps. The higher vacuum yielded higher air flow rates beneath the slab, but did not extend the negative pressure field beneath the slab out to the perimeter of the Building. These results are presented in Table 6 and shown on Figure 3.

Based on the results of the SVE pilot test, a high air flow rate of 250 scfm was observed when a relatively moderate vacuum (16.5–17 iow) was applied beneath the Building slab, but a significant vacuum influence was not observed along the perimeter of the Building or in the test sump locations. Based on

the radius of influence observed during the SVE pilot test, an SVE system for the Building would include four 20-foot horizontal extraction lines installed beneath the slab.
