Response to Comments

Draft Cleanup Action Plan, Legal Documents, and State Environmental Policy Act Documents for the Pasco Landfill

Summary of a public comment period and responses to comments

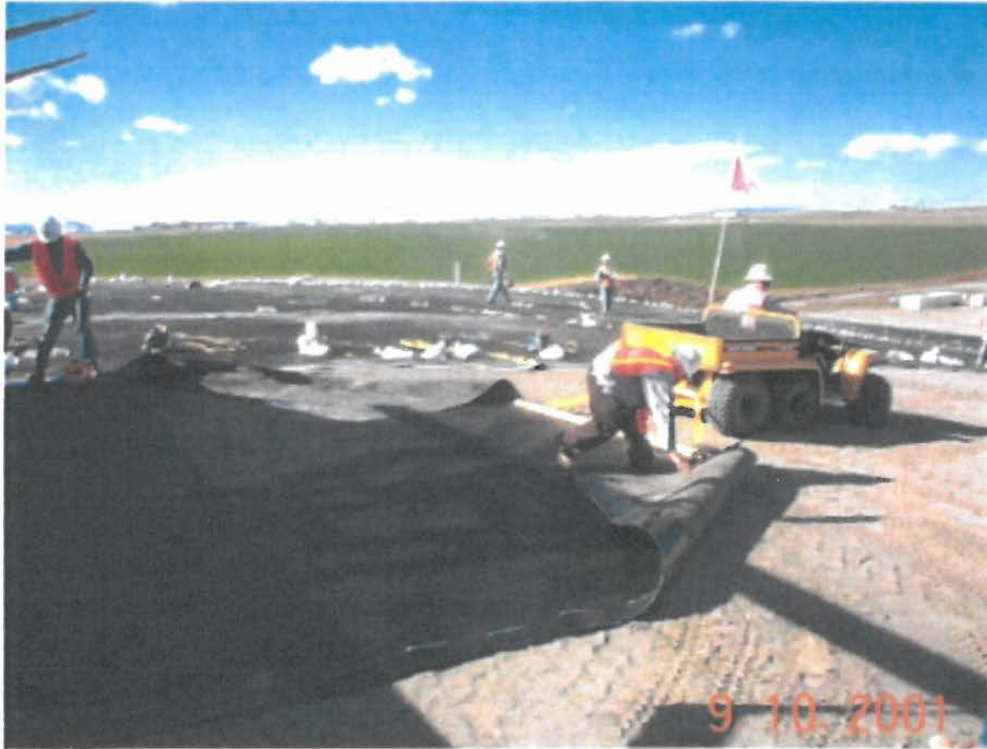
Deployment of 40 mil textured LLDPE geomembrane north slope MSW area.

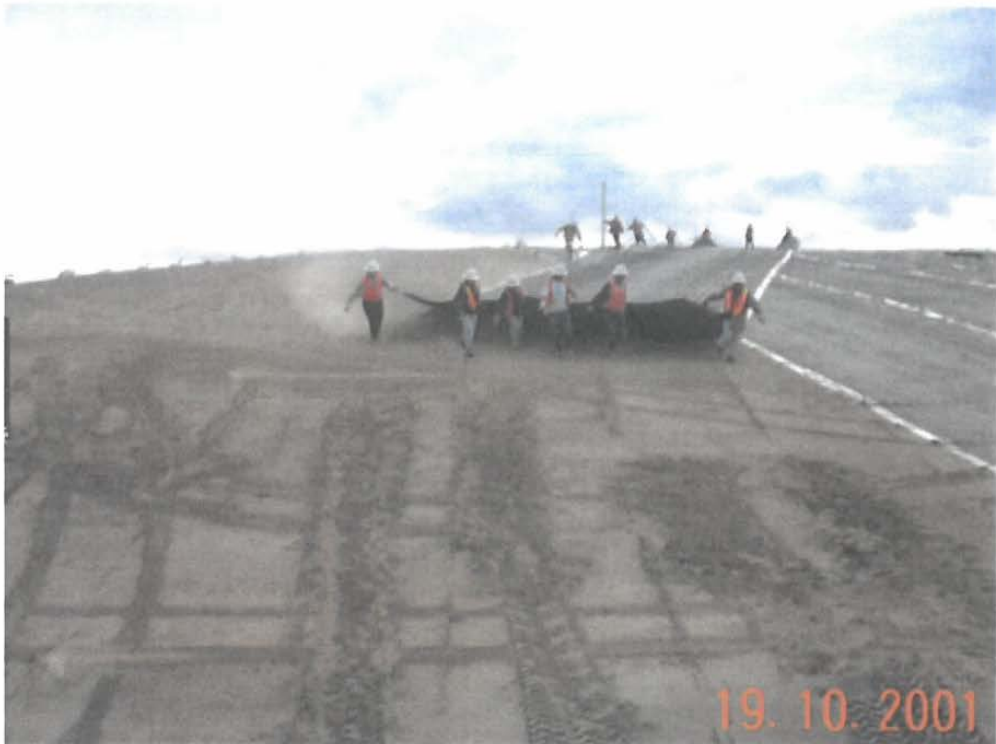
Deployment of 40 mil textured LLDPE geomembrane on west slope MSW area.

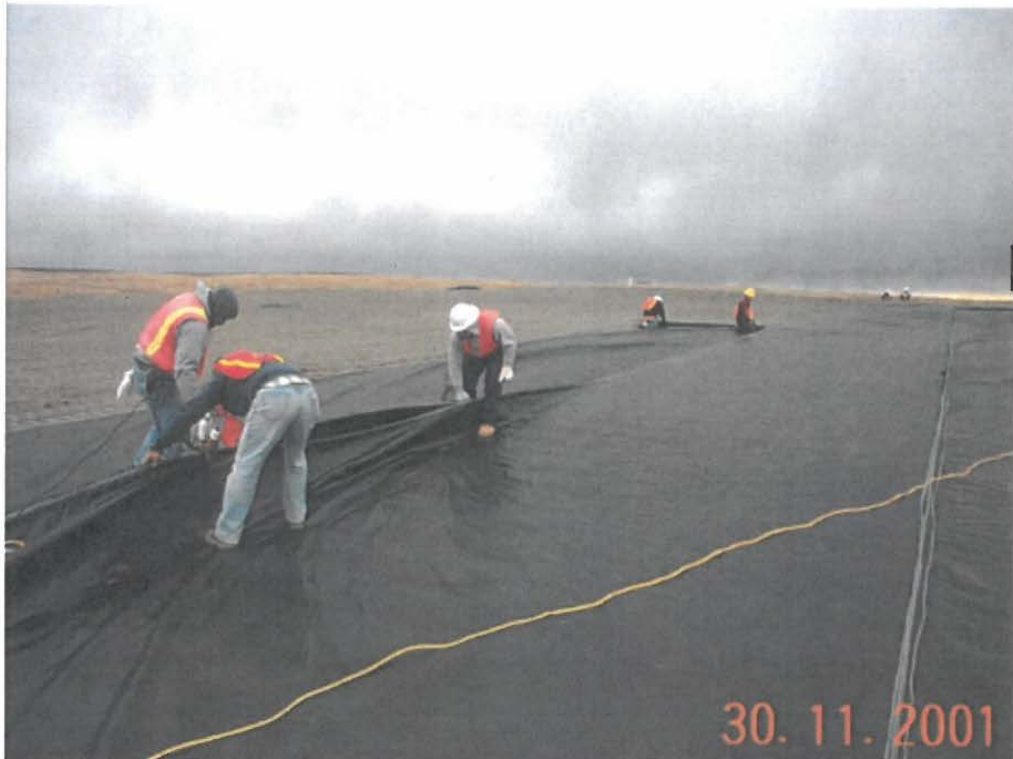
Field Lining Systems sewing geotextile.

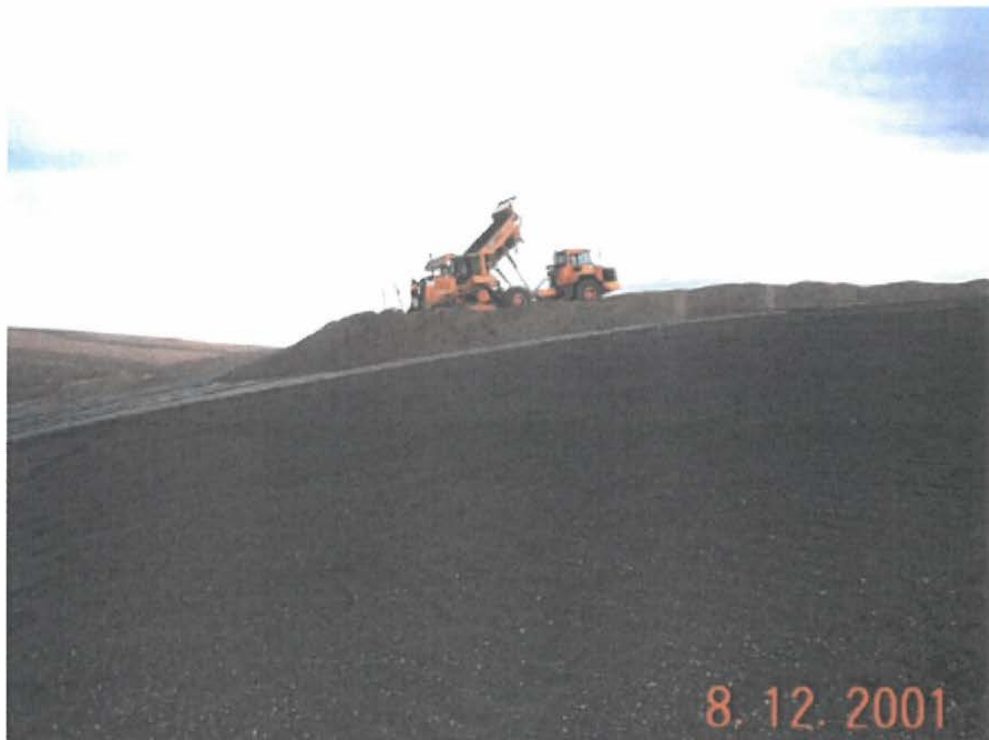
Vegetative soil layer placement on north slope of MSW area.

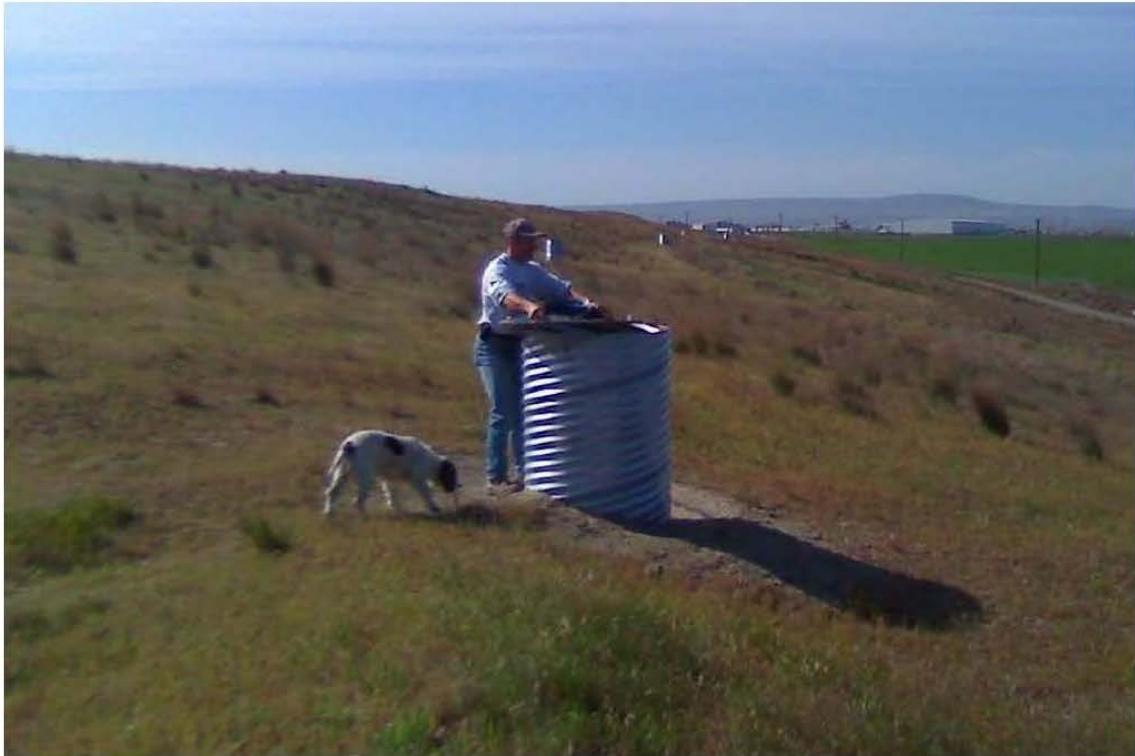
No differential settlement has occurred at the MSW Landfill since the cover was installed in 2002. The topography at the MSW landfill has remained the same, and no indentations or collapses in the landfill cover have ever been observed.

Photo of portion of MSW Landfill cover in 2010

The topography of the land above the MSW remains virtually identical to its topography when the cover was installed. As the photos from 2010, and 2019 (attached in Exhibit 8) show, there are no areas of differential settlement in the MSW. Given that differential settlement can, when extreme, damage or compromise the cover, its absence supports the opposite inference: the cover is experiencing no strain since there is no observable differential settlement after 17 years of cap service.

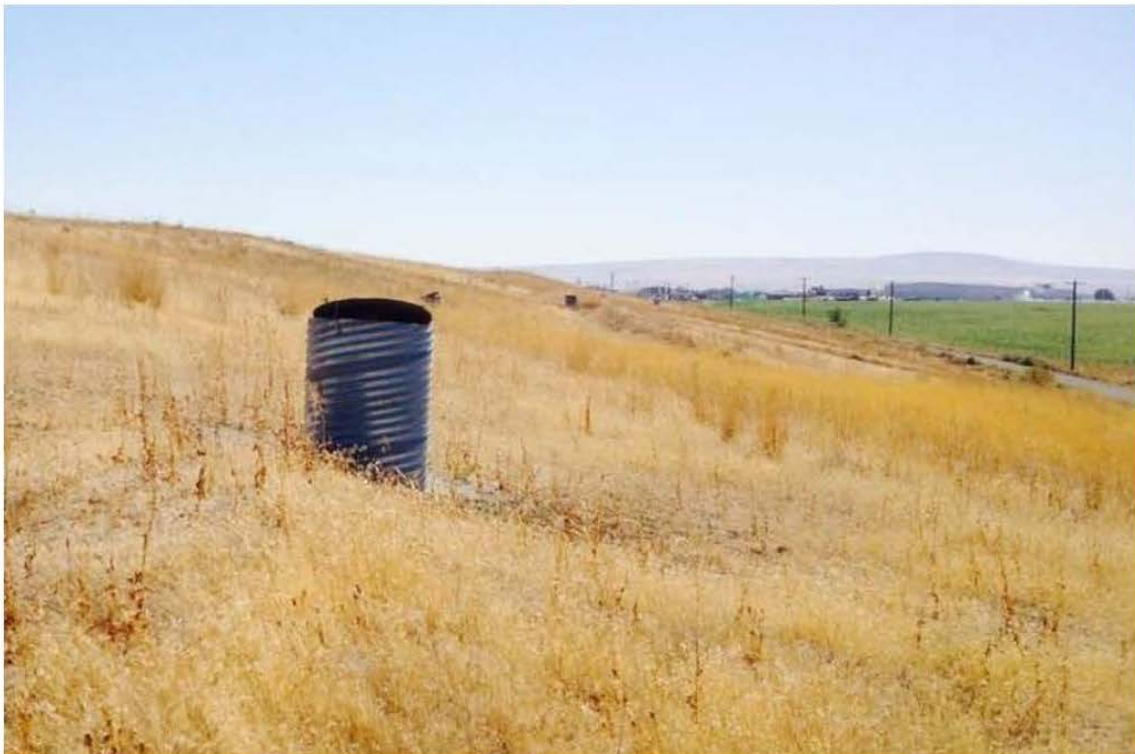
Photo of same portion of MSW Landfill cover in 2019
