## **Periodic Review**

Big Wallys  
9976 North Highway 2  
Coulee City, Washington 99115

Facility Site ID No. 14558  
Cleanup Site ID No. 12069

October 2019

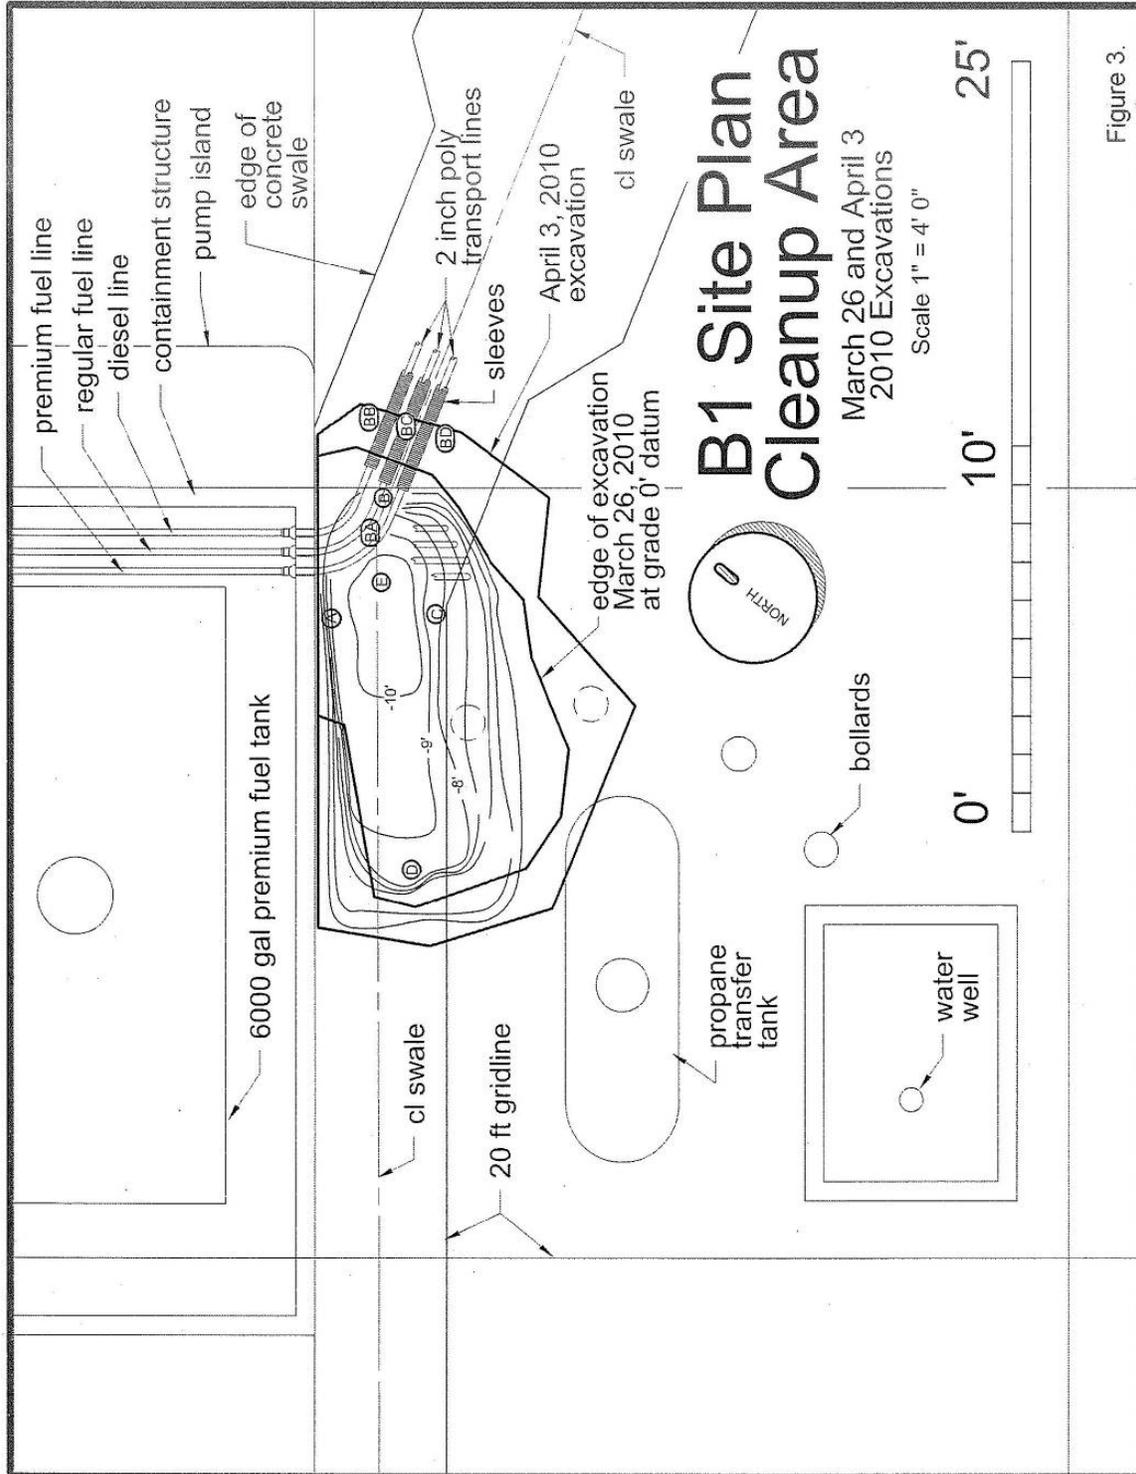
## 6.2 Sample Location Map

On March 26, 2010, soil was excavated to 10 feet below ground surface (bgs) at the point of release. Five soil samples were collected from the base of the excavation. Sample results indicated concentrations of gasoline; benzene, toluene, ethylbenzene, and xylene (BTEX) exceeded cleanup levels. Further excavation in the direction of the AST system was not attempted due to the risk of jeopardizing the structural integrity of the containment structure. A map with sample locations and a table with sample results are available as Appendices 6.2 and 6.3, respectively.

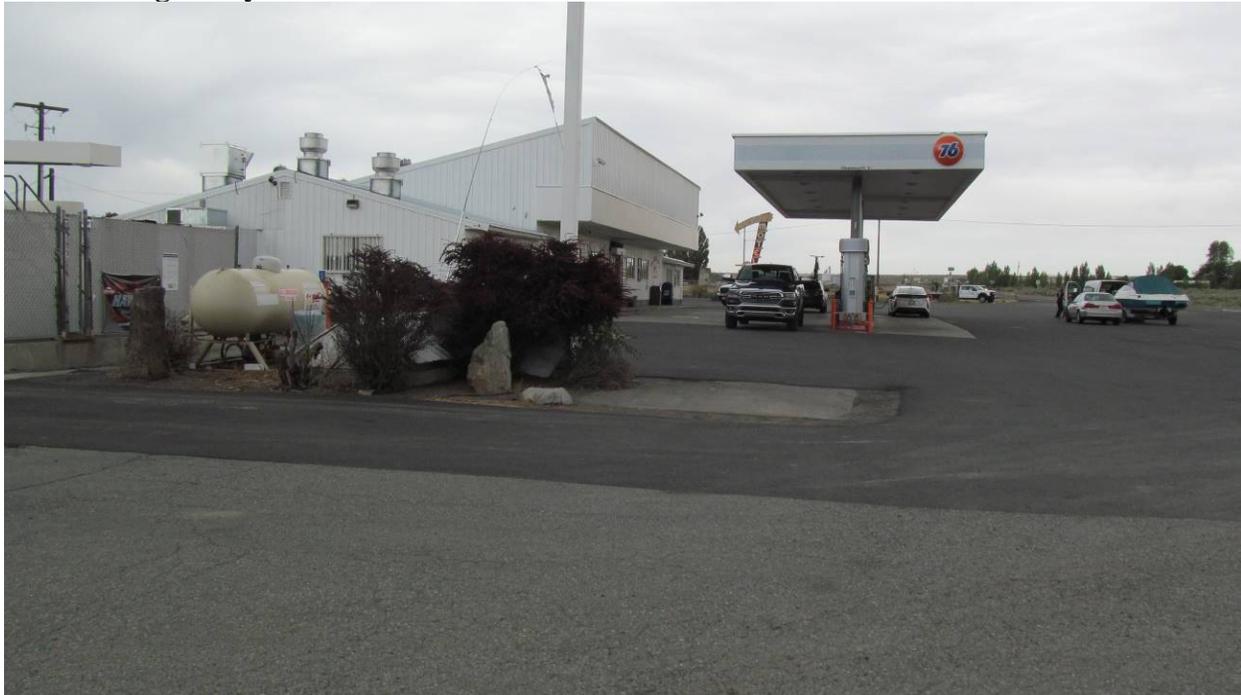
**Photo 1: Big Wallys - from the southeast**

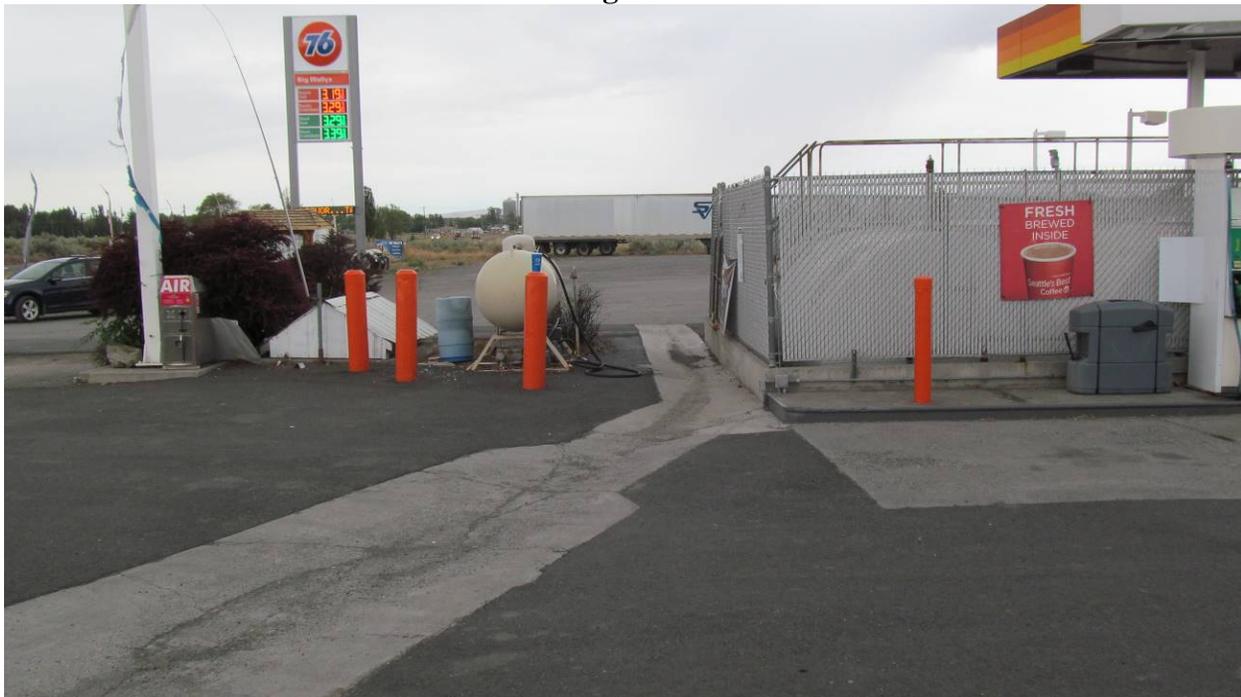
The residual contamination is located beneath a concrete containment area and is surrounded by paved surfaces. The permanent, impermeable surface combined with the property use limitations in the restrictive covenant effectively eliminate the direct contact exposure pathway.

**Photo 2: AST Containment Area and Fueling Island - from the west**

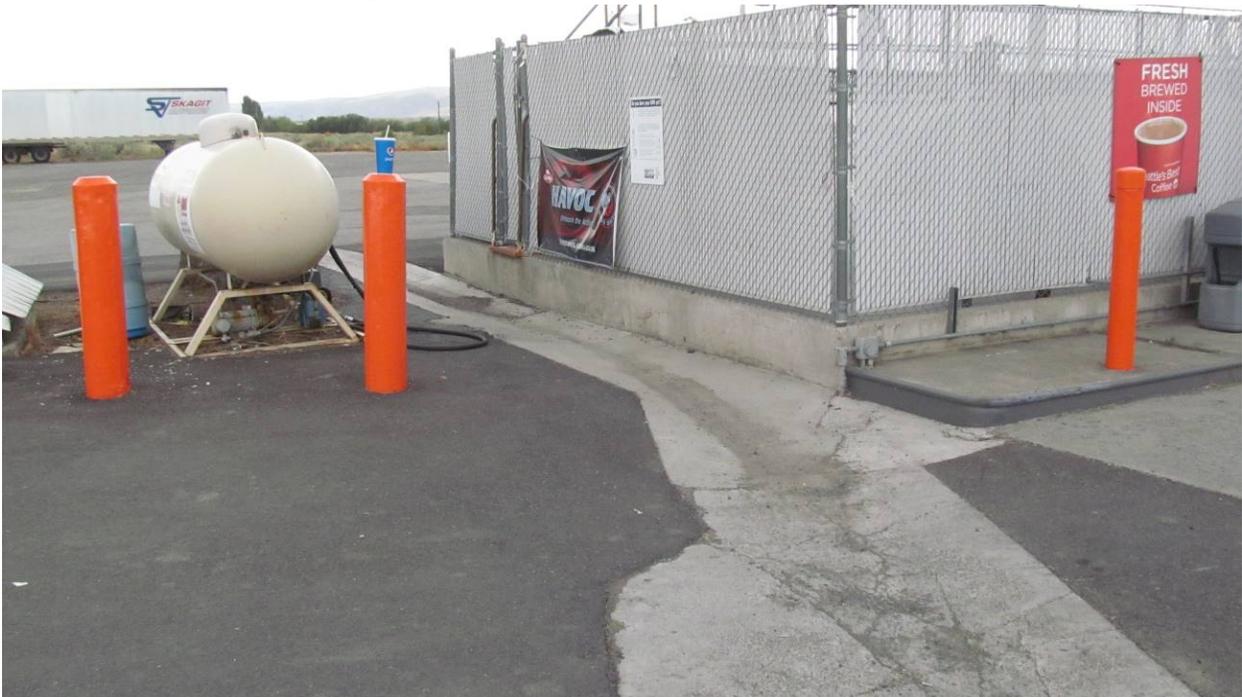
Based upon the Site visit conducted on August 21, 2019, the building and asphalt cover at the Site continue to eliminate direct exposure pathways (ingestion, contact) to contaminated soils. The asphalt appears in satisfactory condition and no repair, maintenance, or contingency actions have been required. The Site continues to operate as a retail fueling facility. A photo log is available as Appendix 6.5.

**Photo 4: Area of Residual Contamination – from the south**

Based on this periodic review, Ecology has determined the restrictions in the covenant are being followed. No additional remedial actions are required by the property owner. It is the property owner's responsibility to continue to inspect the Site to assure that the integrity of the cap is maintained.
