# REMEDIAL INVESTIGATION AND FEASIBILITY STUDY

Mount Baker Properties Site

S. McClellan Street and Martin Luther King Jr. Way S.  
Seattle, Washington

Project No. 160324 • December 31, 2019 • Final

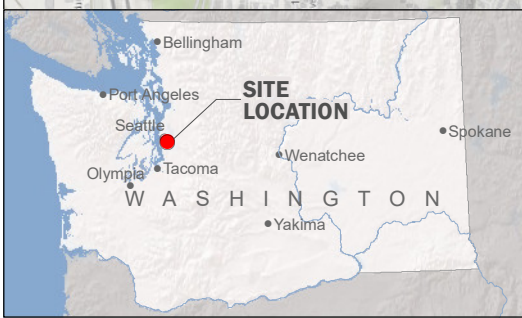
<b>JUN-2019</b>		BY: JAS / EAC	FIGURE NO. <b>1</b>
		PROJECT NO. 160324

**Site Location**

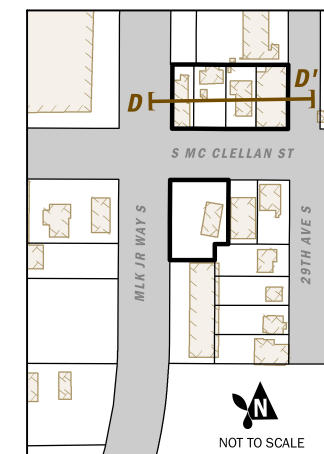
Note: Petroleum compounds include diesel and gasoline range petroleum hydrocarbons, benzene and total xylenes.

Horizontal Scale: 1" = 25'  
Vertical Scale: 1" = 10'  
Vertical Exaggeration 2.5x

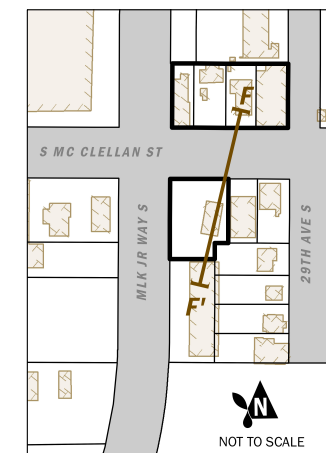
Note: Petroleum compounds include diesel and gasoline range petroleum hydrocarbons, benzene and total xylenes.

Horizontal Scale: 1" = 25'  
 Vertical Scale: 1" = 10'  
 Vertical Exaggeration 2.5x

**Cross Section F-F'**  
 Remedial Investigation and Feasibility Study  
 Mount Baker Properties Site  
 Seattle, Washington
