RE: Contract No. EP-S7-06-02; Technical Direction Document No. 10-06-0003  
Final Focused Sampling Assessment and Removal Action Report  
RAMCO Aluminum Waste Disposal Site, Dallesport, Washington

**Focused Sampling Assessment and Removal Action Report**  
**RAMCO Aluminum Waste Disposal Site**  
**Dallesport, Washington**  
**TDD: 10-06-0003**

**ATTACHMENT A**  
**Photographic Documentation**

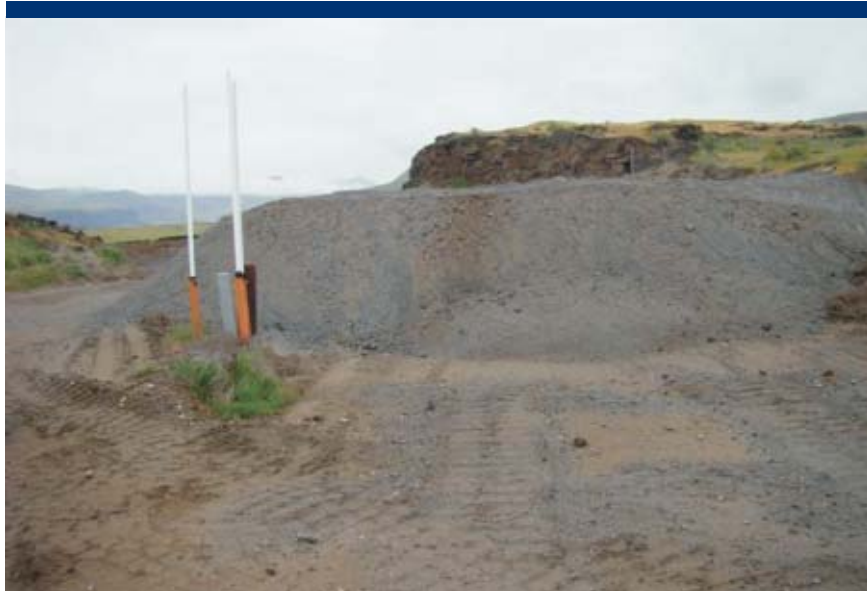
Photo 1 Monitoring well MW-1 (abandoned) at the west end of landfill. Stockpile of crushed dross behind well.

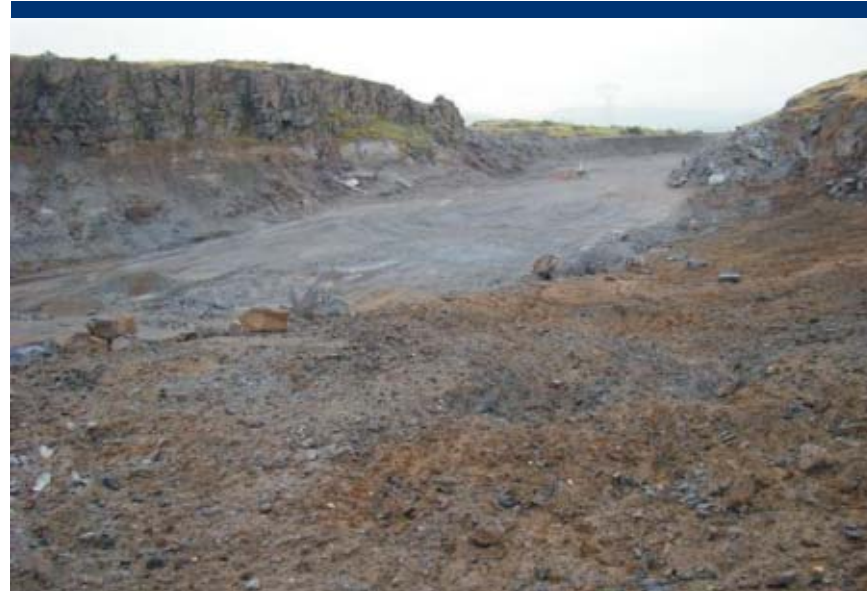
Photo 2 Basalt wall on southern side of landfill. Note Monitoring well MW-5 at west end and on far right of picture.

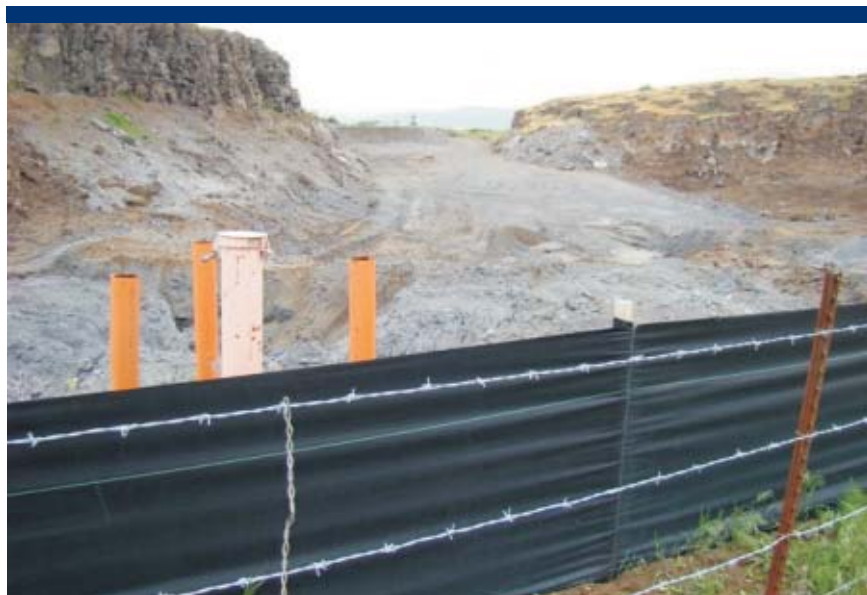
Photo 3 Basalt wall to south, entrance to landfill on opposite side, monitoring well MW-3 close up.

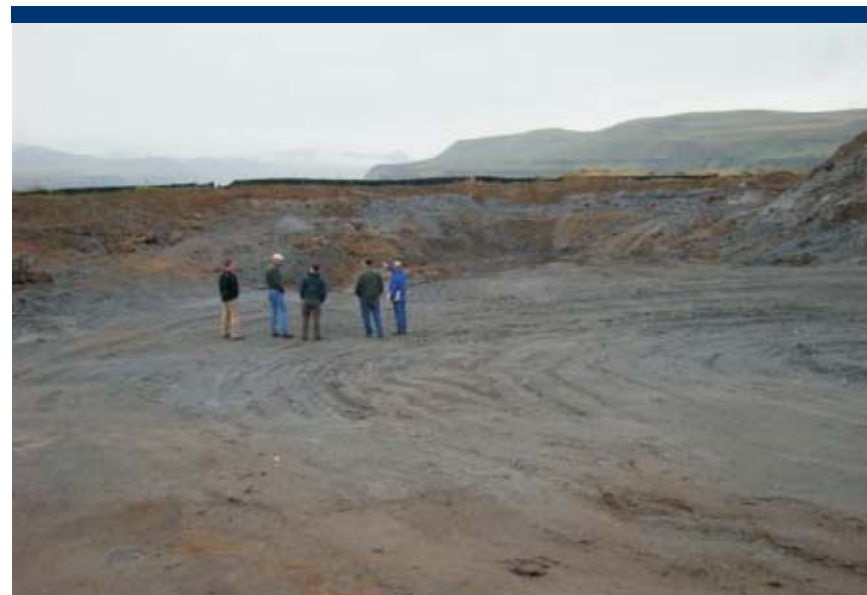
Photo 4 Site walk looking at silt fence border of US Army Corp property and extents of landfill.

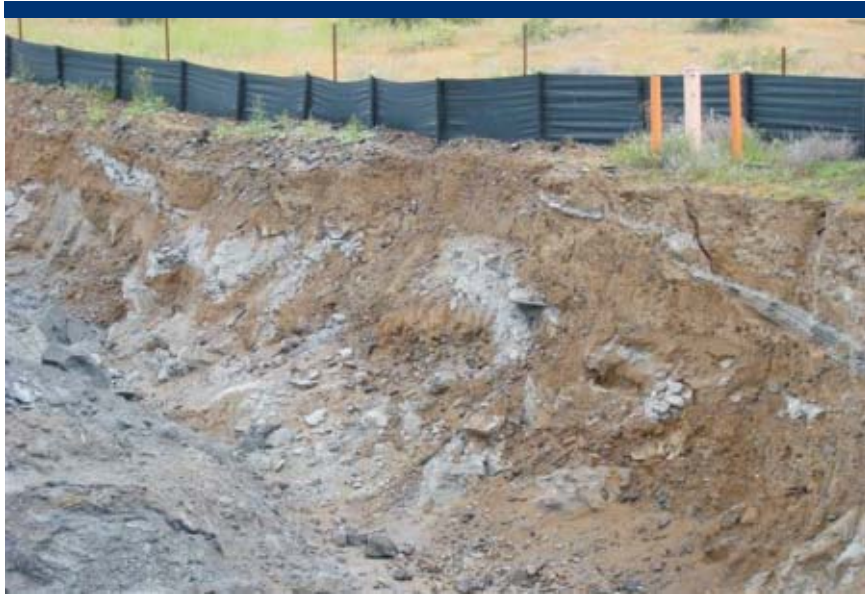
Photo 5 Sidewall and dross embedded in matrix. Monitoring well MW-3.  
Silt fence is Army Corps property line.  
*Direction: Northeast* *Date: 5/6/09*

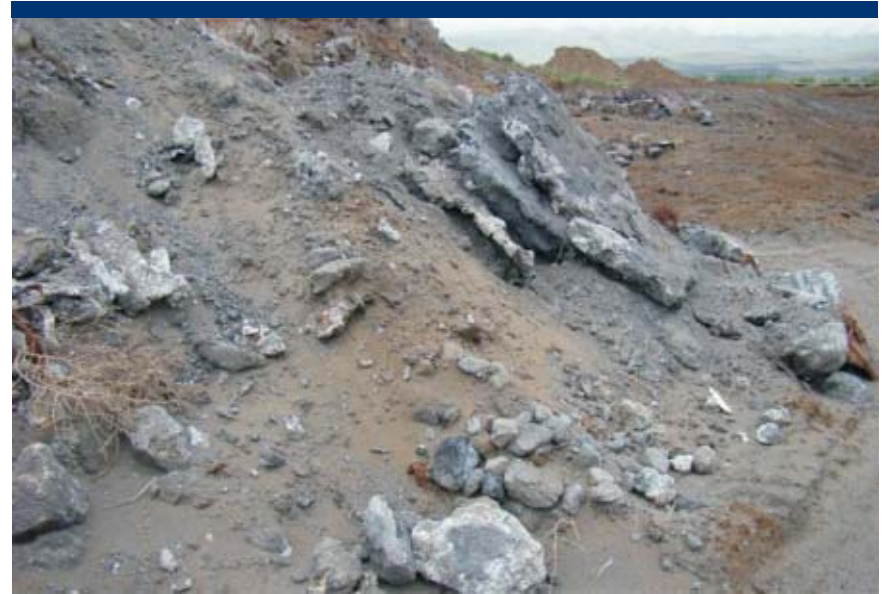
Photo 6 Aluminum waste inclusions, clast sizes several feet across.  
*Direction: Northeast* *Date: 5/6/09*

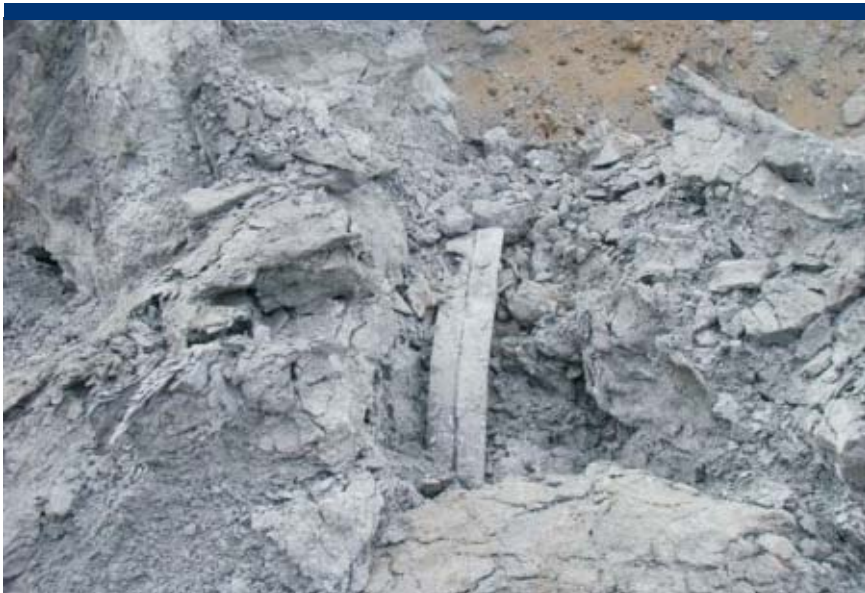
Photo 7 Dross material left exposed to dessicate for easier crushing.  
*Direction: Down* *Date: 5/6/09*

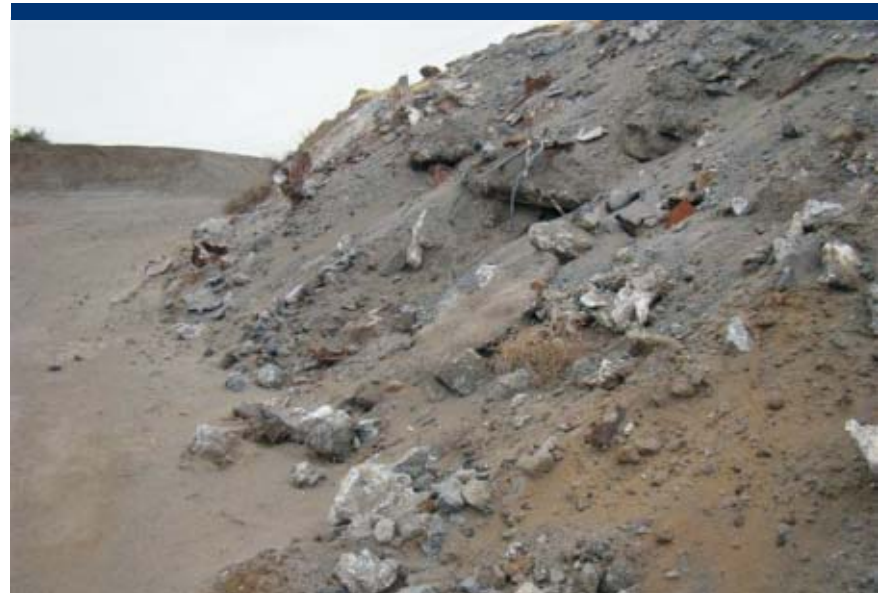
Photo 8 Aluminum inclusion stockpile estimated to be 25 tons.  
*Direction: West* *Date: 5/6/09*

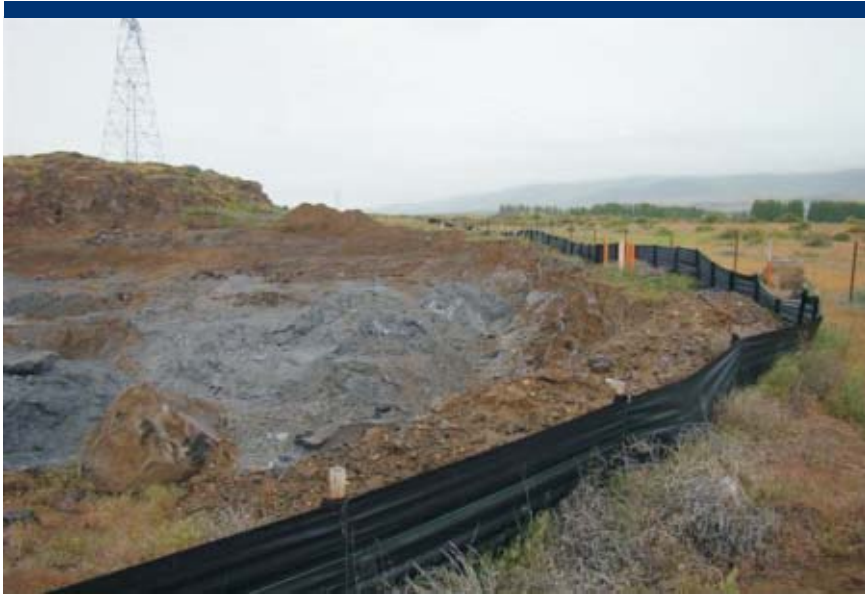
Photo 9 Landfill north boundary and silt fence along Army Corps property. Monitoring well MW-3 in right center of picture.

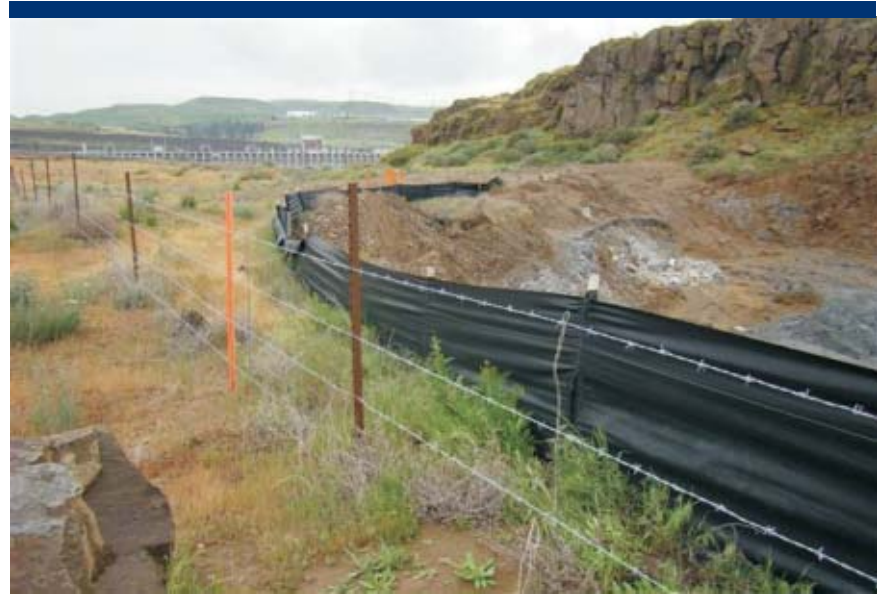
Photo 10 Landfill southern extent and US Army Corps border. Monitoring well MW-2 in top center of picture.

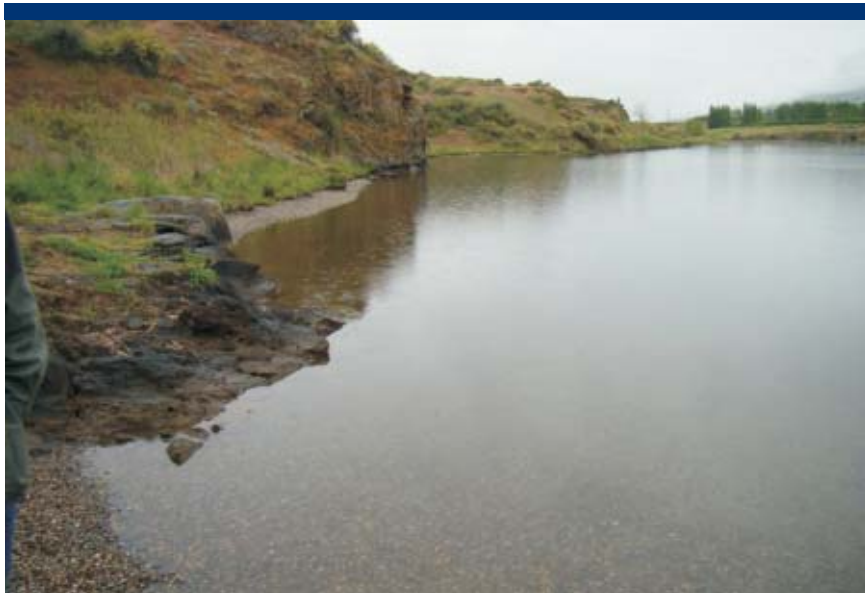
Photo 11 Spearfish lake western edge along basalt outcrop. Landfill is west of lake about 150 yards.

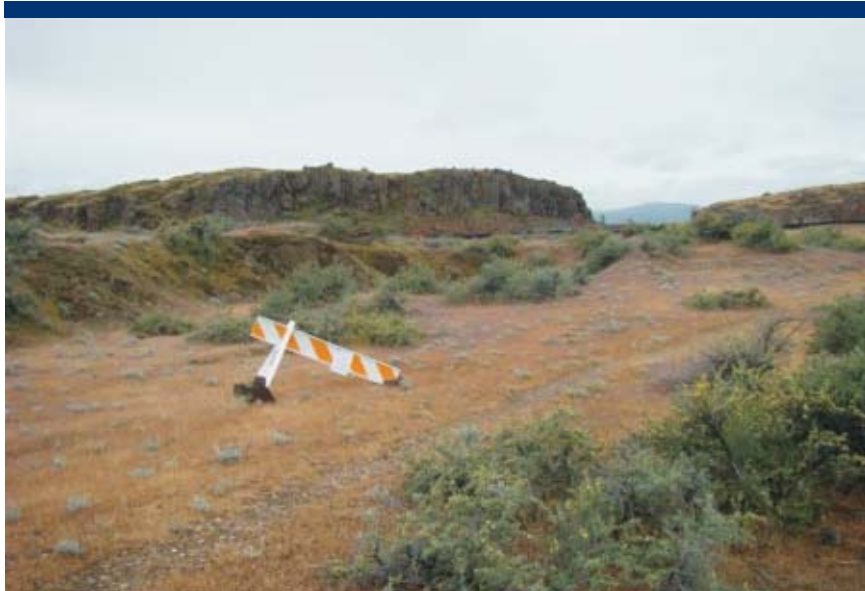
Photo 13 Shot of basalt outcrop on south side of landfill taken from saddle point between Spearfish lake and Ramco landfill.

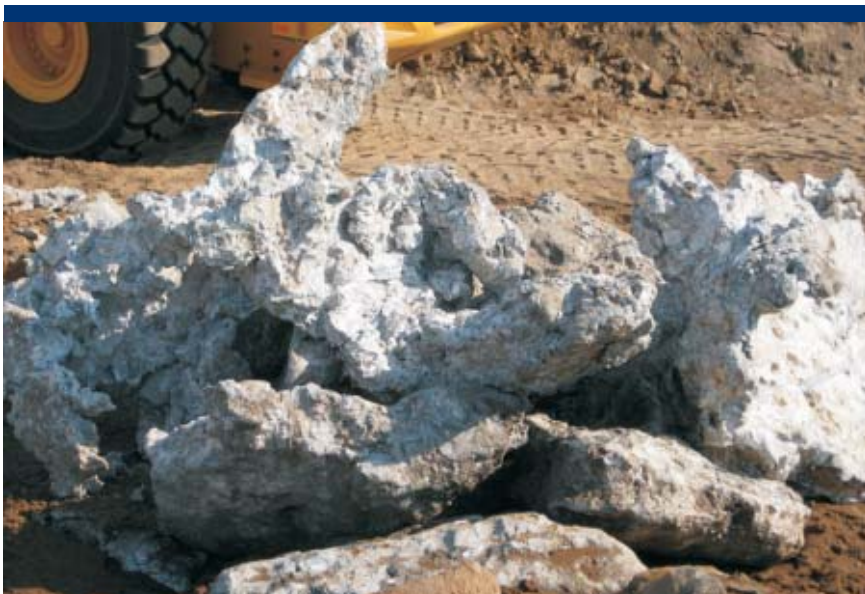
Photo 15 Aluminum dross (white dross, metallic form), a by-product of primary aluminum smelting. Chunks of aluminum/metal, silver/gray, dense, high metal content.

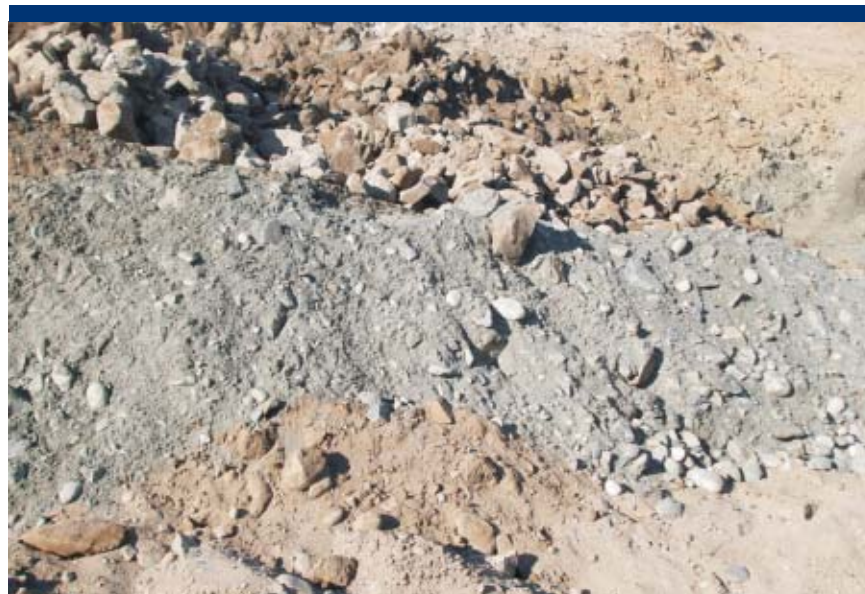
Photo 16 Aluminum dross (white dross, powder form) Silver/gray, powdery. Non-hazardous waste stream.

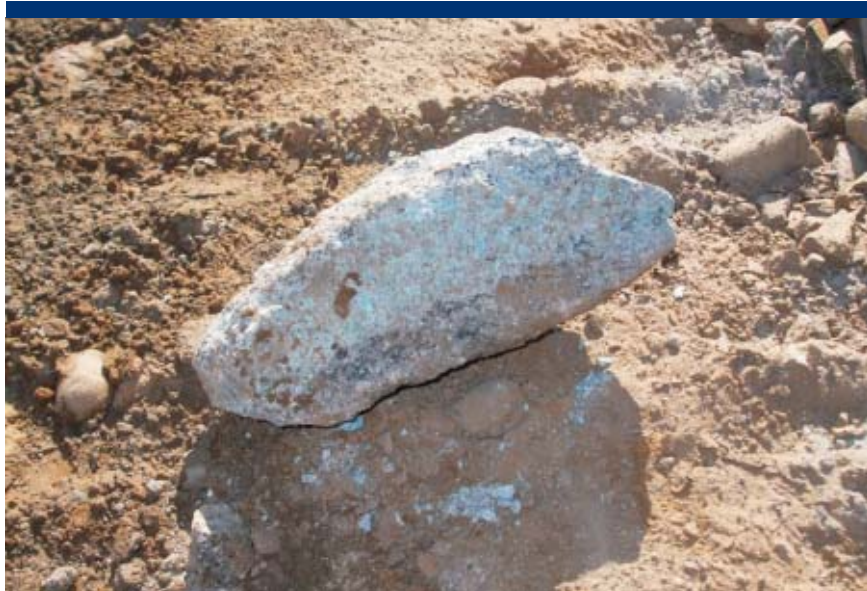
Photo 17 Salt cake, a by-product of secondary aluminum production Rock-like, black to silver/grey with blue. Non-hazardous waste stream.

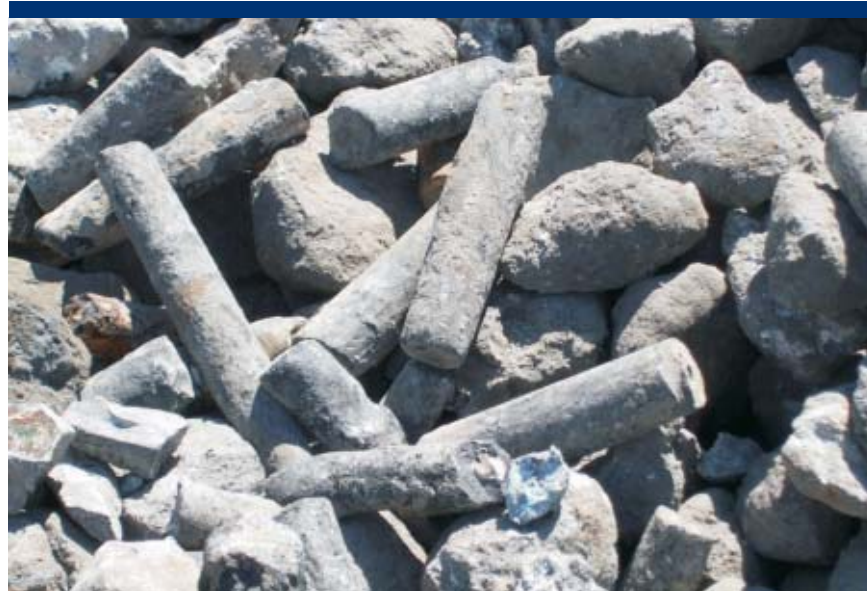
Photo 18 Anodes (cylinders/rods) and spent potliner. Black, carbon, relatively light. K088 waste stream.

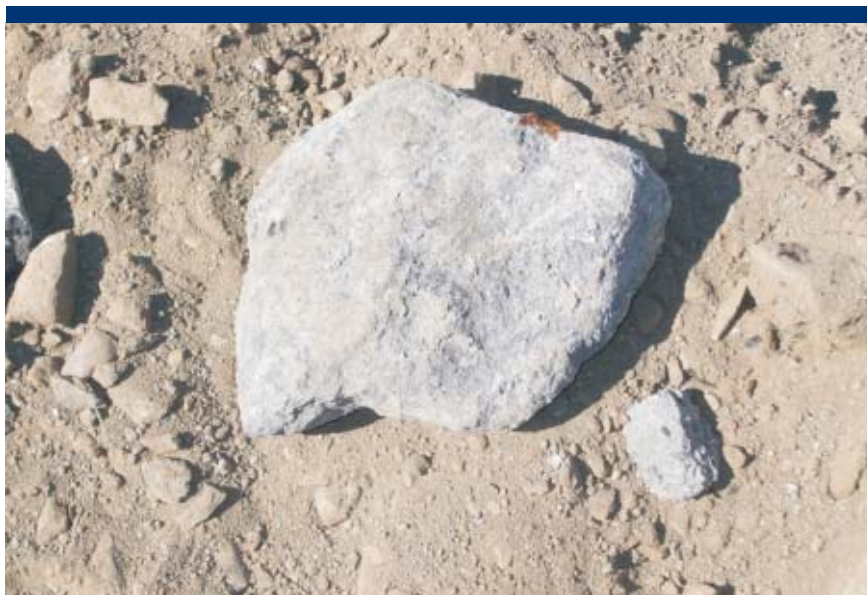
Photo 19 Spent potliner black, carbon, relatively light. K088 waste stream. Typical example, covered with gray dust.

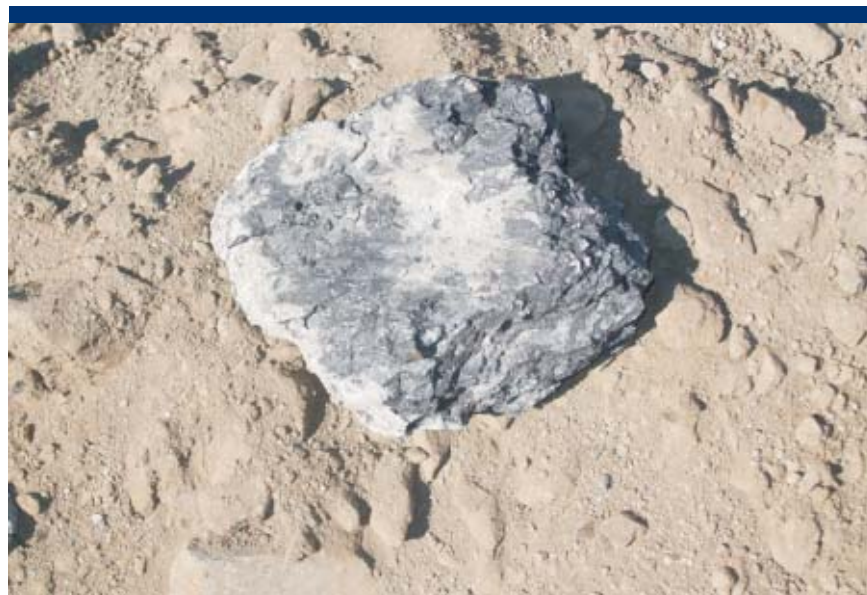
Photo 20 Spent potliner black, carbon, relatively light. K088 waste stream. Example with visible black carbon.

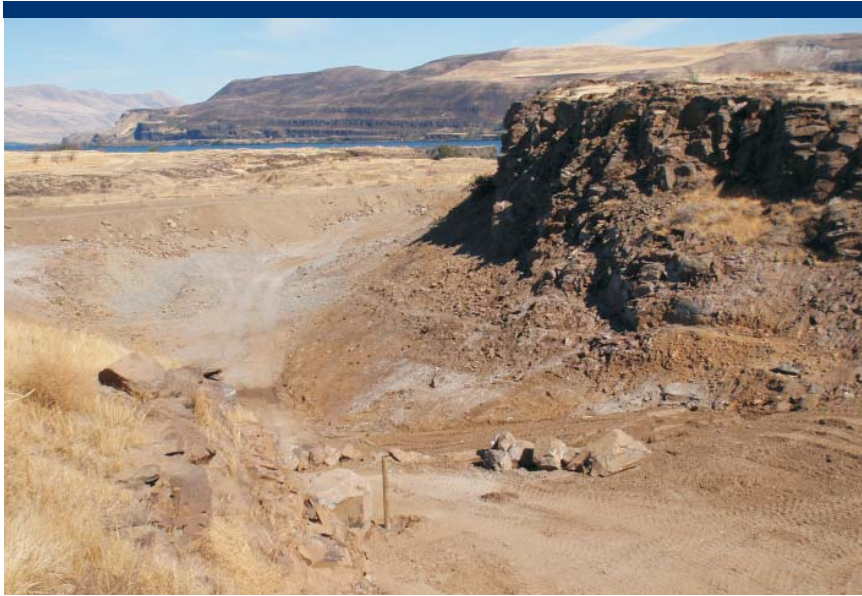
Photo 21 West entrance to the landfill post removal view. Note the fence post and large rocks to be used to gate the west entrance.

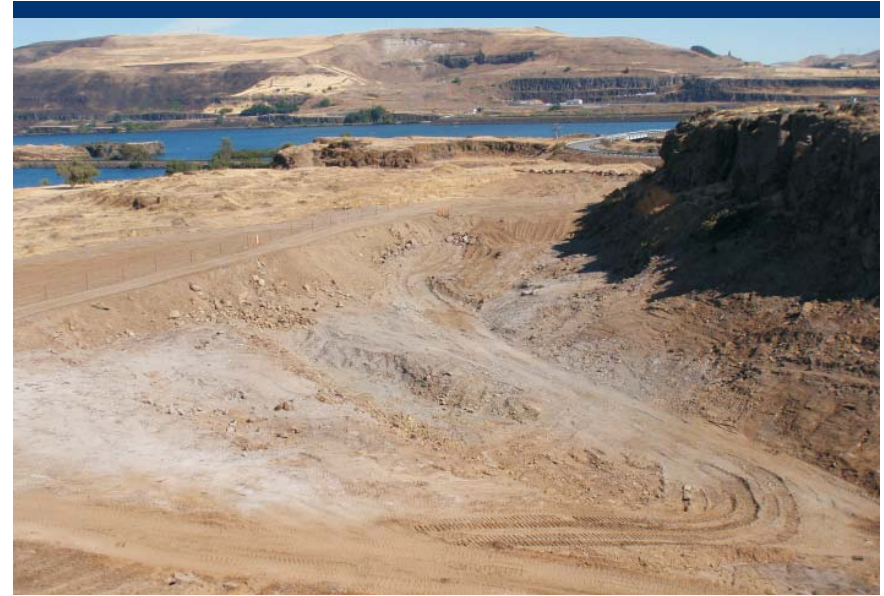
Photo 22 Landfill and aluminum waste material post removal view. In the background are Little Spearfish Lake and the Columbia River.

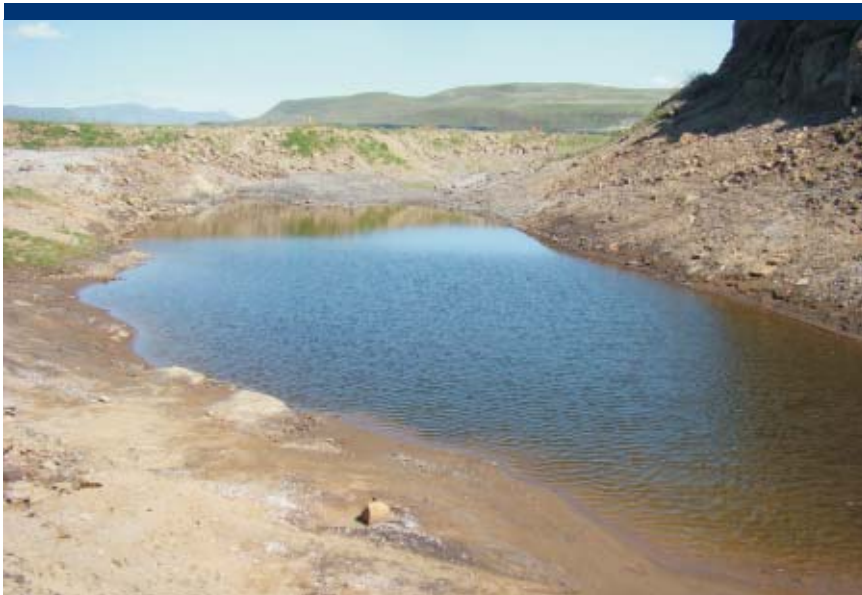
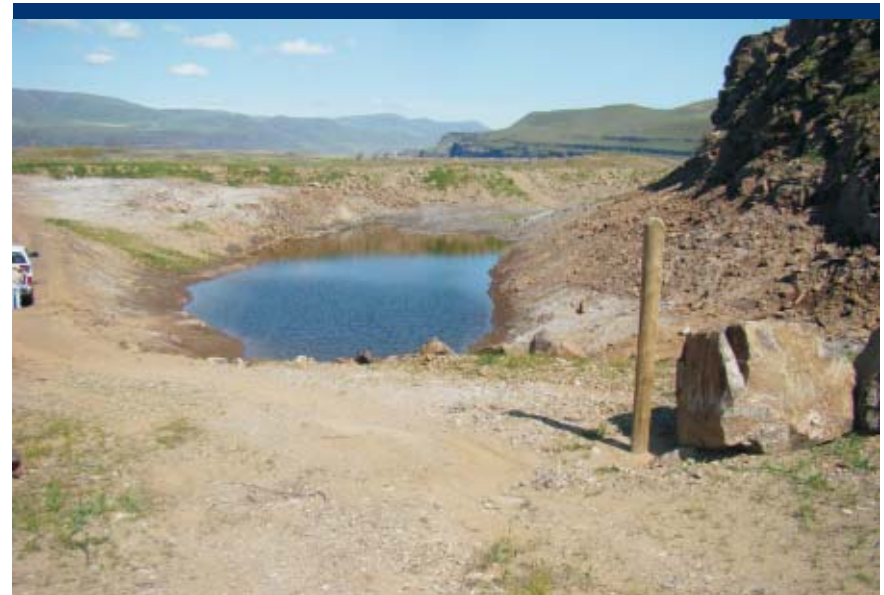
Photo 23 Temporary water body formed over the post removal site due to precipitation the winter of 2010/2011.

Photo 24 Temporary water body formed over the post removal site due to precipitation the winter of 2010/2011.
