INITIAL INVESTIGATION FIELD REPORT

<u>Site Name (Name over door):</u> WA DOT Deception Pass Bridge South	<u>Site Address (including City, State and Zip):</u> Hwy 20 MP 42 Oak Harbor, WA 98277	<u>Phone</u> <u>Email</u>
<u>Site Contact, Title, Business:</u> Ron Burke WSDOT	<u>Site Contact Address (including City, State and Zip):</u>	<u>Phone</u> (360) 848-7102 <u>Email</u> BurkeRO@wsdot.wa.gov
<u>Site Owner, Title, Business:</u> State of Washington	<u>Site Owner Address (including City, State and Zip):</u>	<u>Phone</u> <u>Email</u>
<u>Site Owner Contact, Title, Business:</u> Ben Wilkinson WSDOT	<u>Site Owner Contact Address (including City, State and Zip):</u>	<u>Phone</u> <u>Email</u>
<u>Previous Site Owner(s):</u>	<u>Additional Info (for any Site Information Item):</u> Contamination has been confirmed beneath Deception Pass Bridge which extends from the southern, Island County side to Pass Island. No parcel numbers are identified for this Site because it is within the State's right-of-way.

On July 30, 2019, Ecology received a report of soil exceeding lead cleanup levels beneath Deception Pass bridge.

Soil is impacted with lead at levels above MTCA cleanup standards. Recommendati

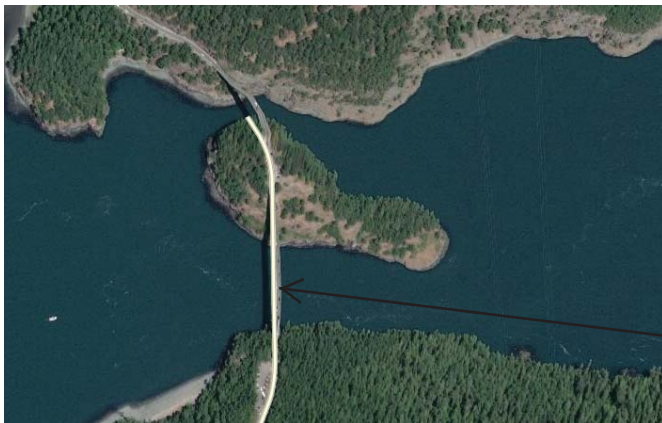
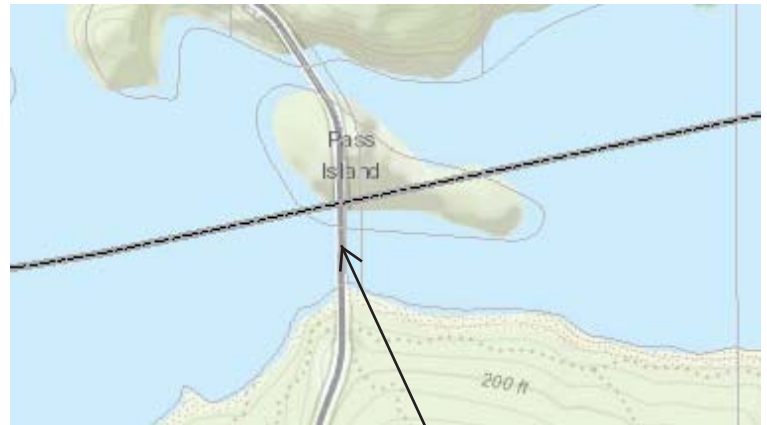
Deception Pass
Bridge

During a preliminary field investigation conducted prior to a bridge repainting project, WSDOT's Hazardous Materials Program Staff discovered paint chips in the soils beneath the north and south ends of the Deception Pass Bridge. Soil samples were collected from both ends of the bridge and analyzed for RCRA 8 metals. Lab results confirm the presence of lead at 320 mg/kg and 570 mg/kg in samples DP-N-1 and DP-S-1, respectively, which exceeds MTCA cleanup standards (Figures 1 and 2).

In a notification letter to Ecology, WSDOT described that soil remediation will take place after the repainting project is completed in July 2020.
