INITIAL INVESTIGATION FIELD REPORT

ERTS # 623271
 County Kitsap
 Parcel # 3778-005-001-0002
 FS ID # 14170 CSID # 11943

Site Name (e.g., Co. name over door): L & E Auto Sales	Site Address (including City and Zip+4): 2101 Burwell Place Bremerton, WA 98312	Site Phone: () - () -
Site Contact and Title (if any):	Site Contact Address (including City and Zip+4) if any:	Site Contact Phone: () - () -
Site Owner: Dorothy Romberg & Estate of Mevelyn Romberg	Site Owner Address (including City and Zip+4): 11538 17 th Avenue NE Seattle, WA 98125	Site Owner Phone: () - () -
Site Owner Contact (if any): Frick N Frack Holdings LLC (purchased 5/2/11)	Site Owner Contact Address (including City and Zip+4) if any: PO BOX 1010 Silverdale, WA 98383	Owner Contact Phone: () - () -
Previous/Additional Site Owner(s):	Previous/Additional Site Owner(s) Address (including City and Zip+4):	Phone: () - () -
Alternate Site Names: Romberg Property	Comments:	Is property > 10 acres? Yes <input type="checkbox"/> No <input checked="" type="checkbox"/>

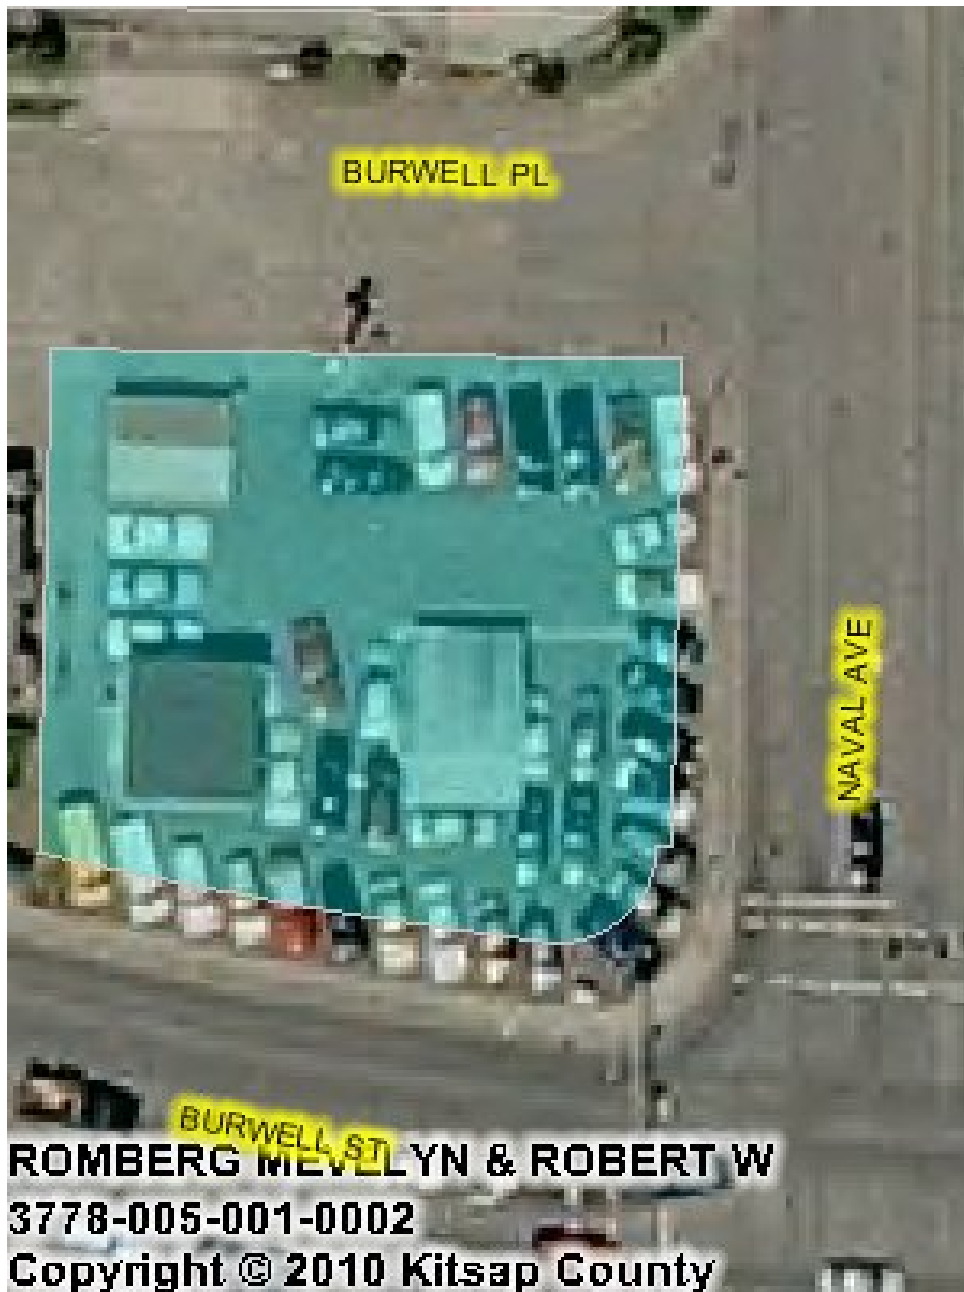
SITE MAP/DIAGRAM

Four underground storage tanks (3 gasoline and 1 waste oil) were removed from the site along with 75 tons of contaminated soils. Diesel, heavy oil, and BTEX contaminated soils remain in the subsurface soils at the site.

Description: The site is currently used as a used car lot, and is paved throughout the site. Evidence of recent (August 2010) excavation at the site. Contaminated soils are all subsurface.
