**Phase II Environmental Site Assessment  
Proposed Grays Harbor Potash Export Facility  
40600-HS-RPT-55046 | Revision 0**

### **Phase II Environmental Site Assessment Proposed Grays Harbor Potash Export Facility Hoquiam, Washington BHP Document No. 40600-HS-RPT-55046, Revision 0**

### **Phase I Environmental Site Assessment Proposed Grays Harbor Potash Export Facility Port of Grays Harbor, Hoquiam, Washington BHP Document No. 40600-HS-RPT-55034**

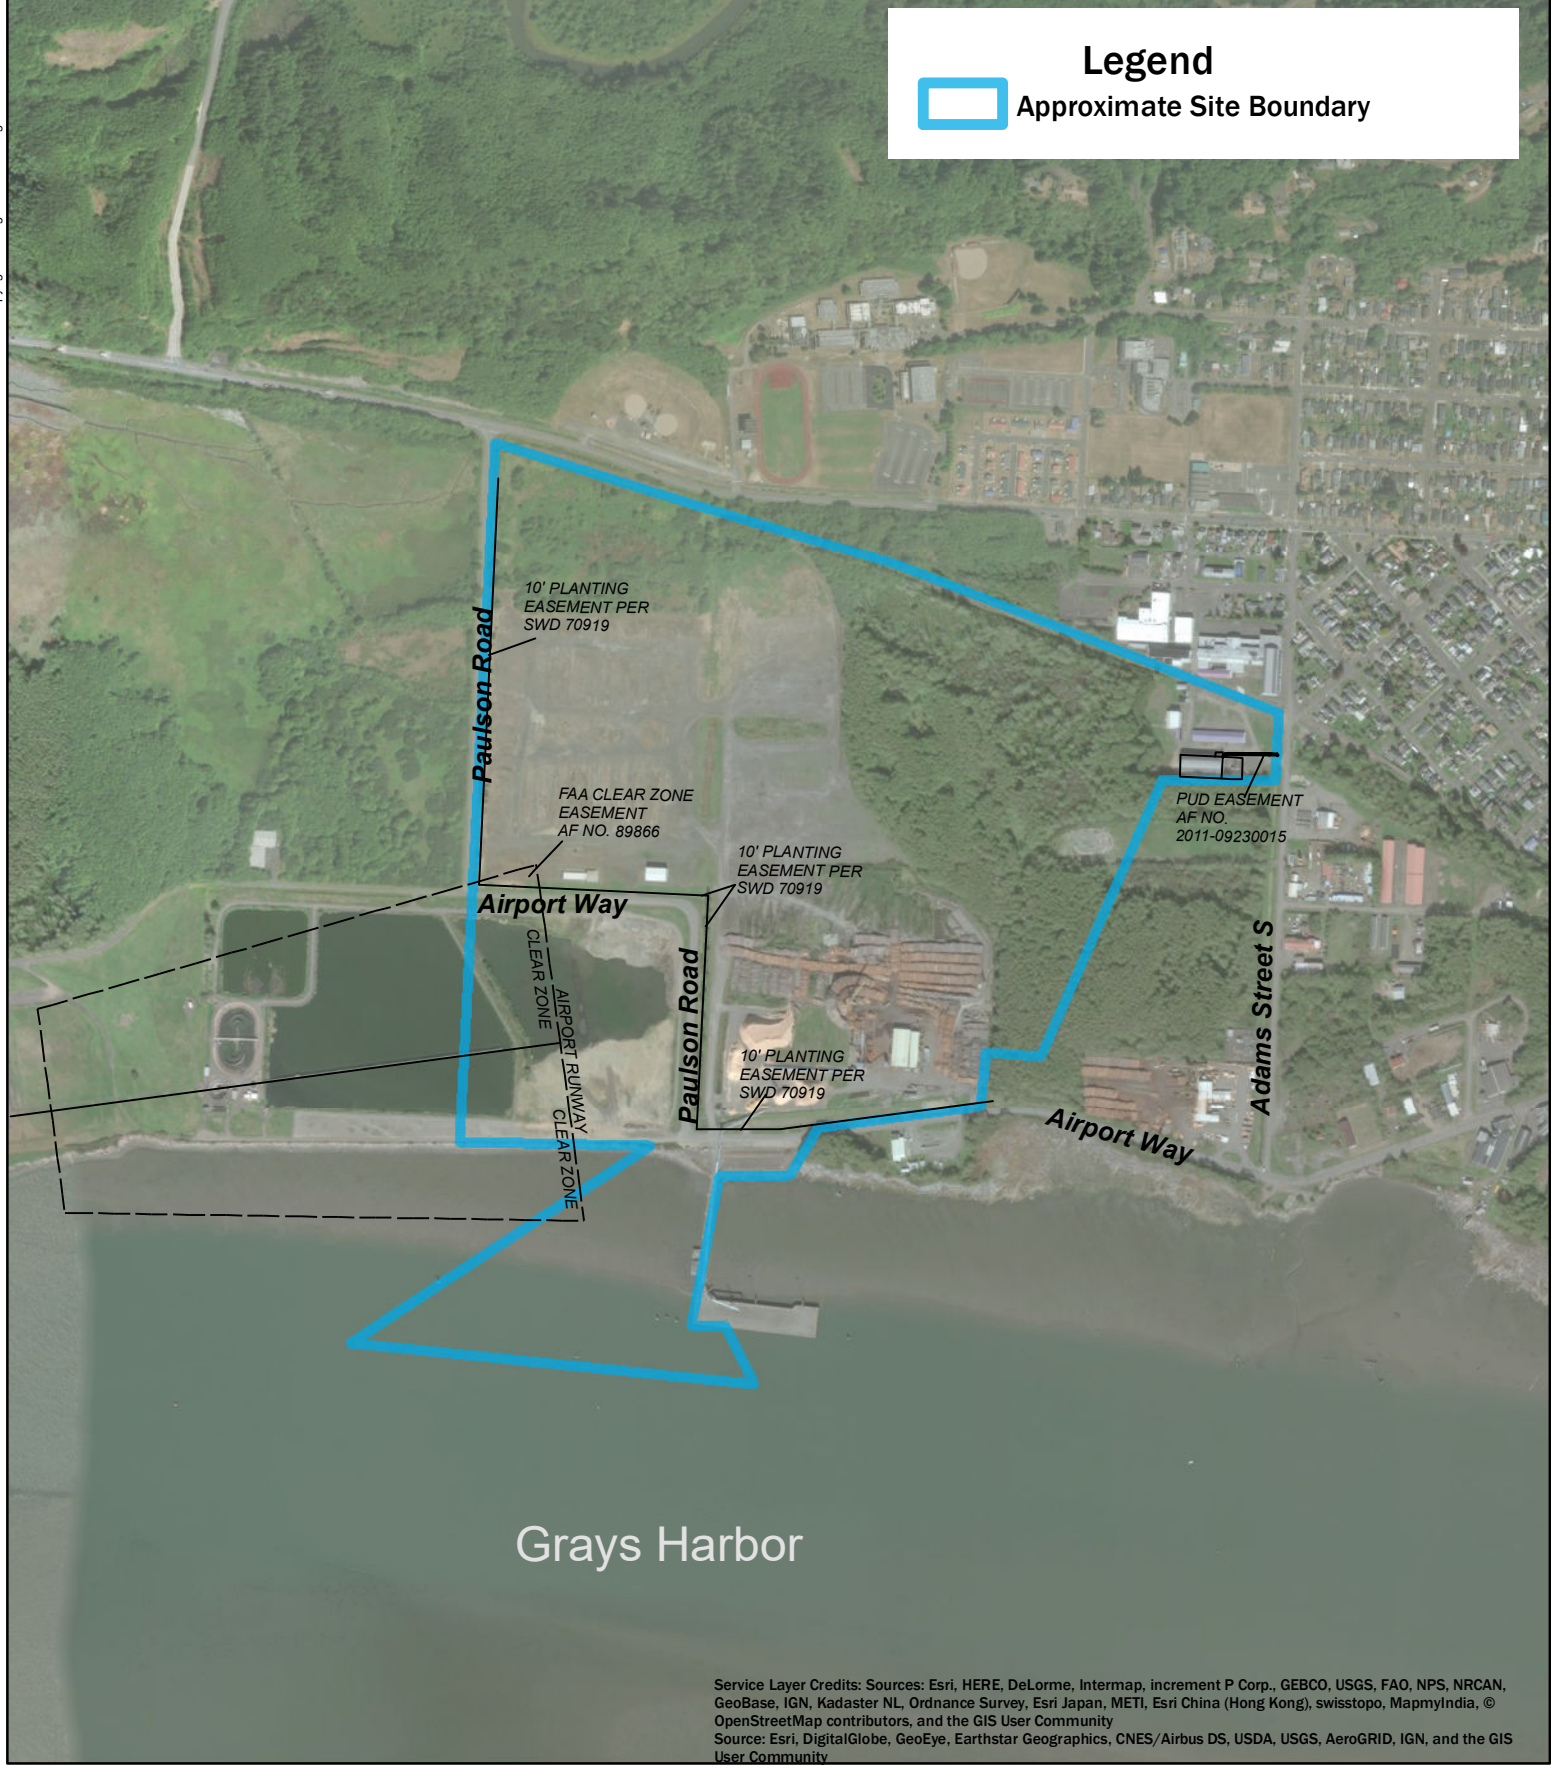
**Figure 5- Encumbrances Map**

This report summarizes the results of our Phase II Environmental Site Assessment (ESA) of the proposed Grays Harbor potash export site to be located at Port of Grays Harbor (Port) Terminal 3 and surrounding parcels in Hoquiam, Washington (herein referred to as “the site,” see Figure 1). The upland portion of the site is 212 acres and comprises tax parcels that are owned by the City of Hoquiam (City), Emerson Street Hoquiam LLC, Adams Street Hoquiam LLC, and the Port. The site tax parcels and existing conditions are shown on Figures 2 and 3. Encumbrances associated with the site parcels are shown on Figure 5.
