Revised Remedial Investigation / Feasibility Study Report

**View Ridge Plaza
220 Olympic Boulevard
Everett, Washington**

October 31, 2019
Terracon Project No. 81197152

Cleanup Site ID: 12644
Facility Site ID: 20079

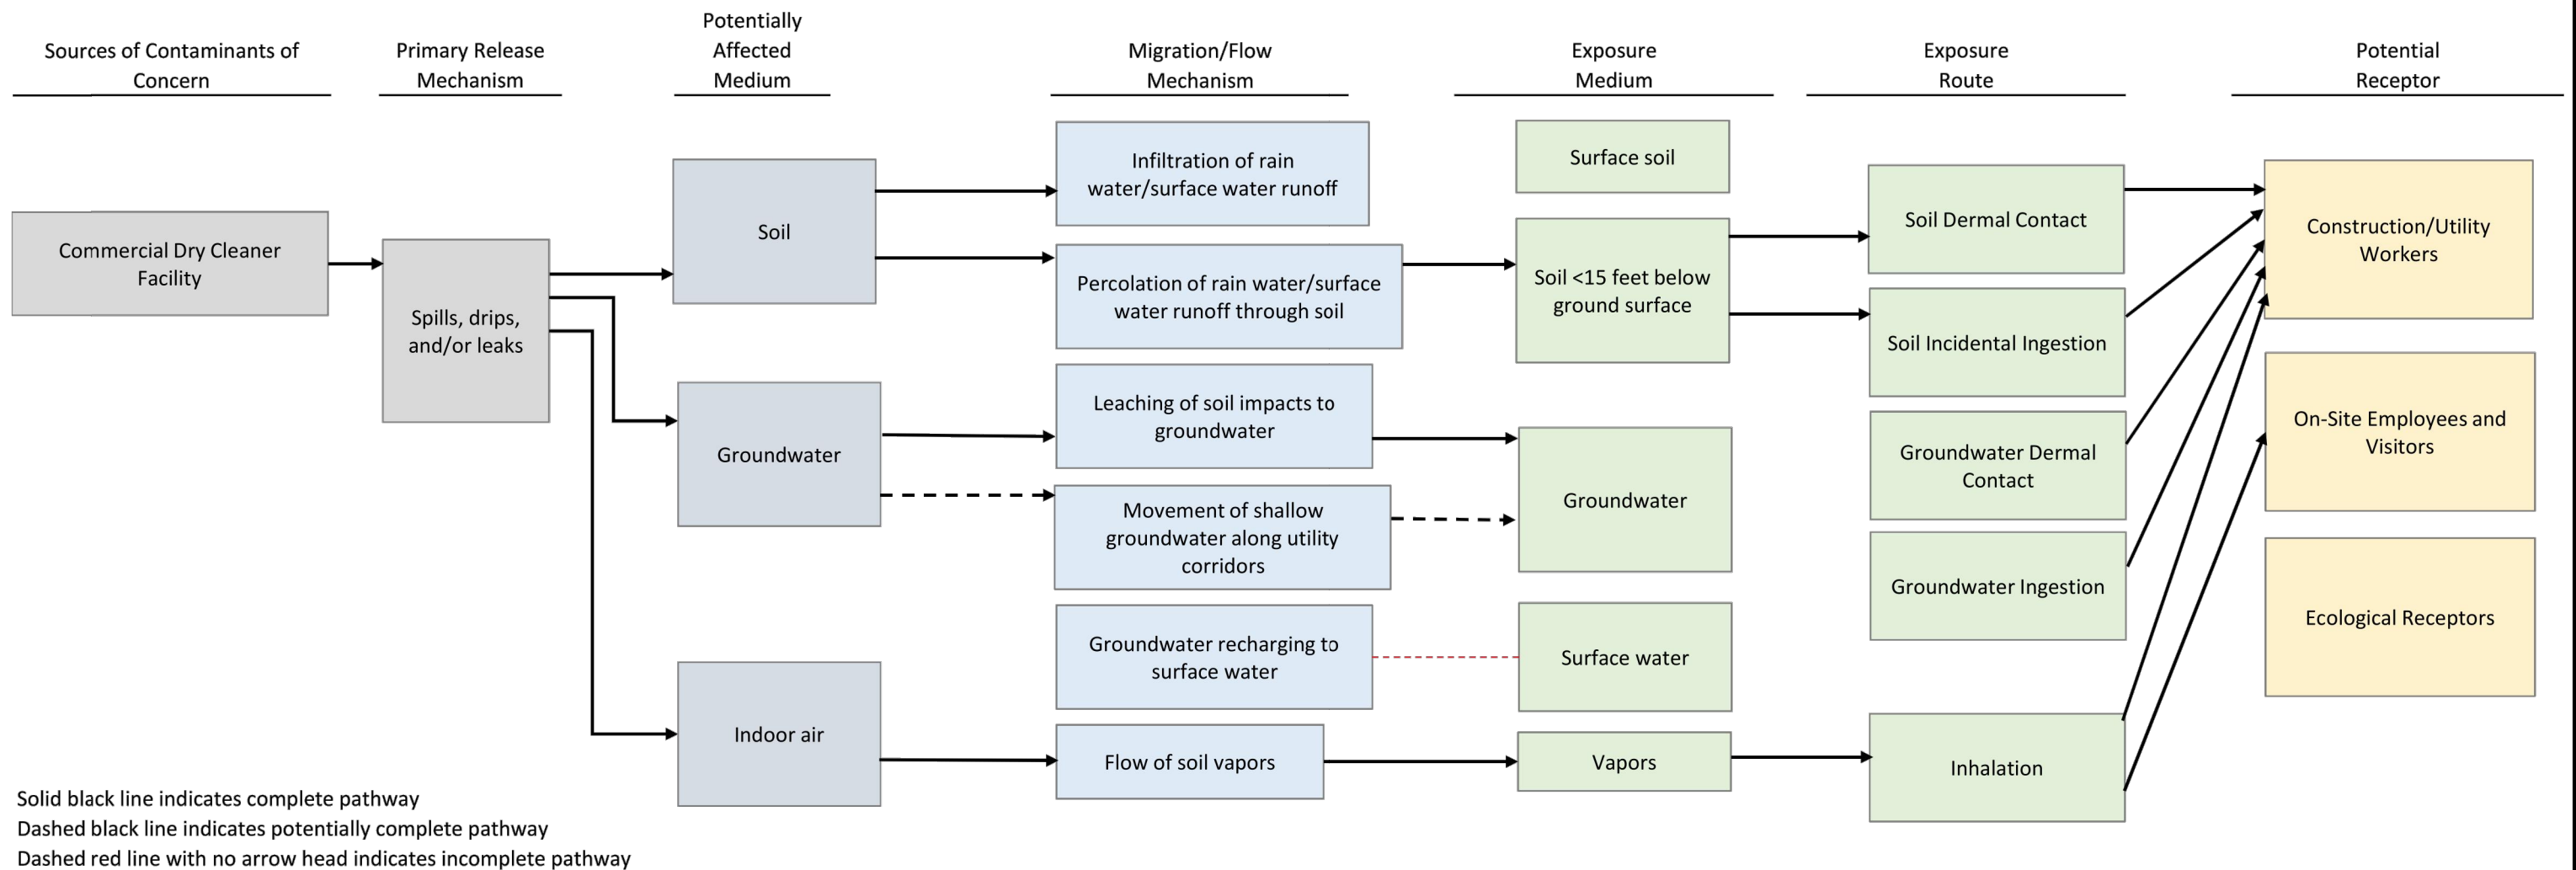
CONCEPTUAL SITE MODEL
 VIEW RIDGE PLAZA
 220 OLYMPIC BOULEVARD
 EVERETT, SNOHOMISH COUNTY, WASHINGTON

This section provides a conceptual understanding of the View Ridge Plaza Site derived primarily from the results of the historical research and the subsurface investigations performed at the Site by Terracon and others. Included is a discussion of the confirmed and suspected source areas, the chemicals and media of concern, the fate and transport characteristics of the release of hazardous substances, the potential exposure pathways, and the conceptual site model (CSM) summary.

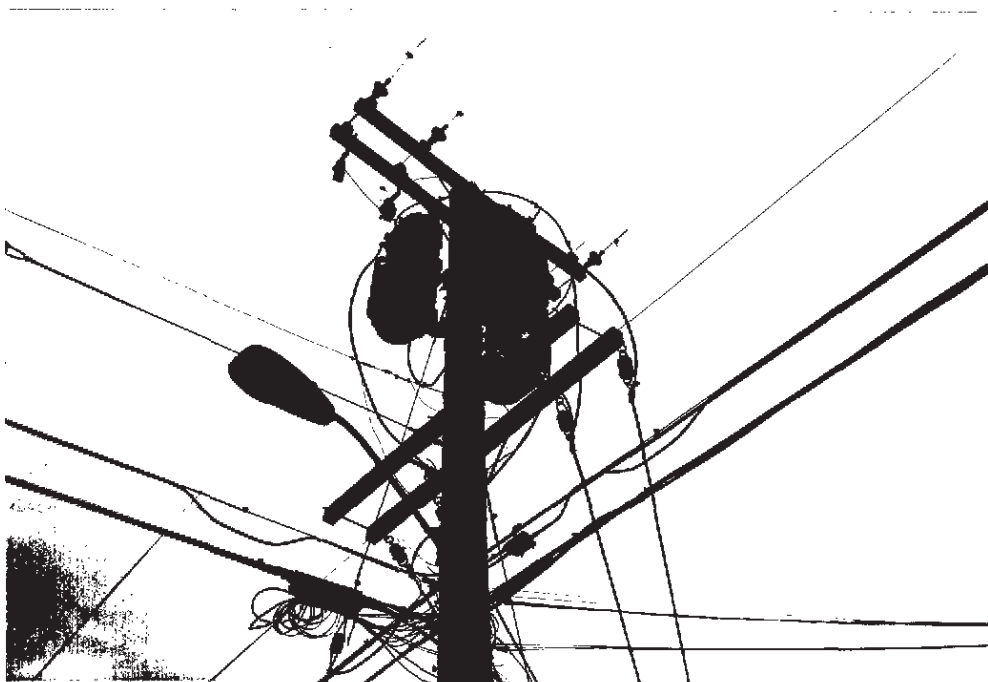
Photograph 4. A view of three pole-mounted transformers.

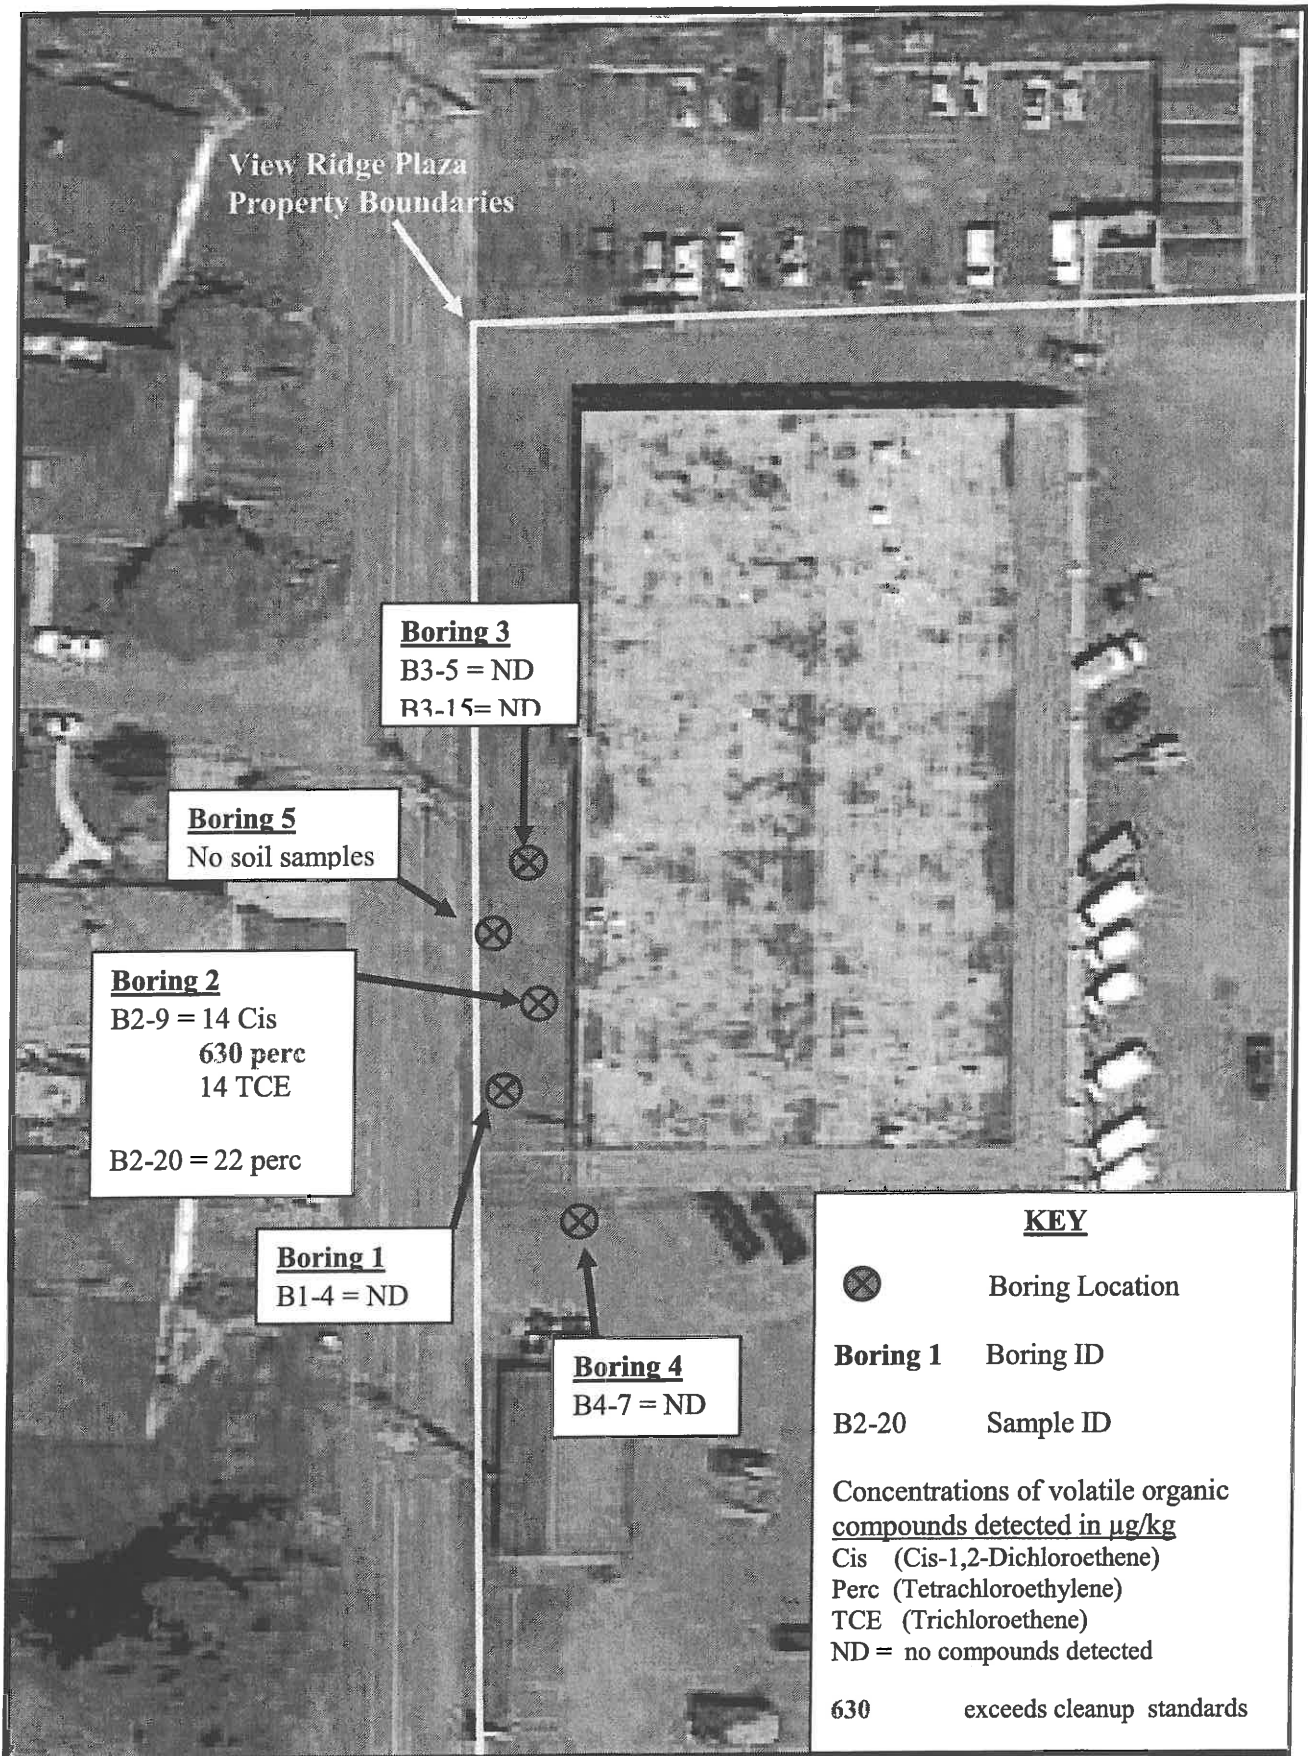
Figure 3. View Ridge Plaza boring locations and soil sample results.

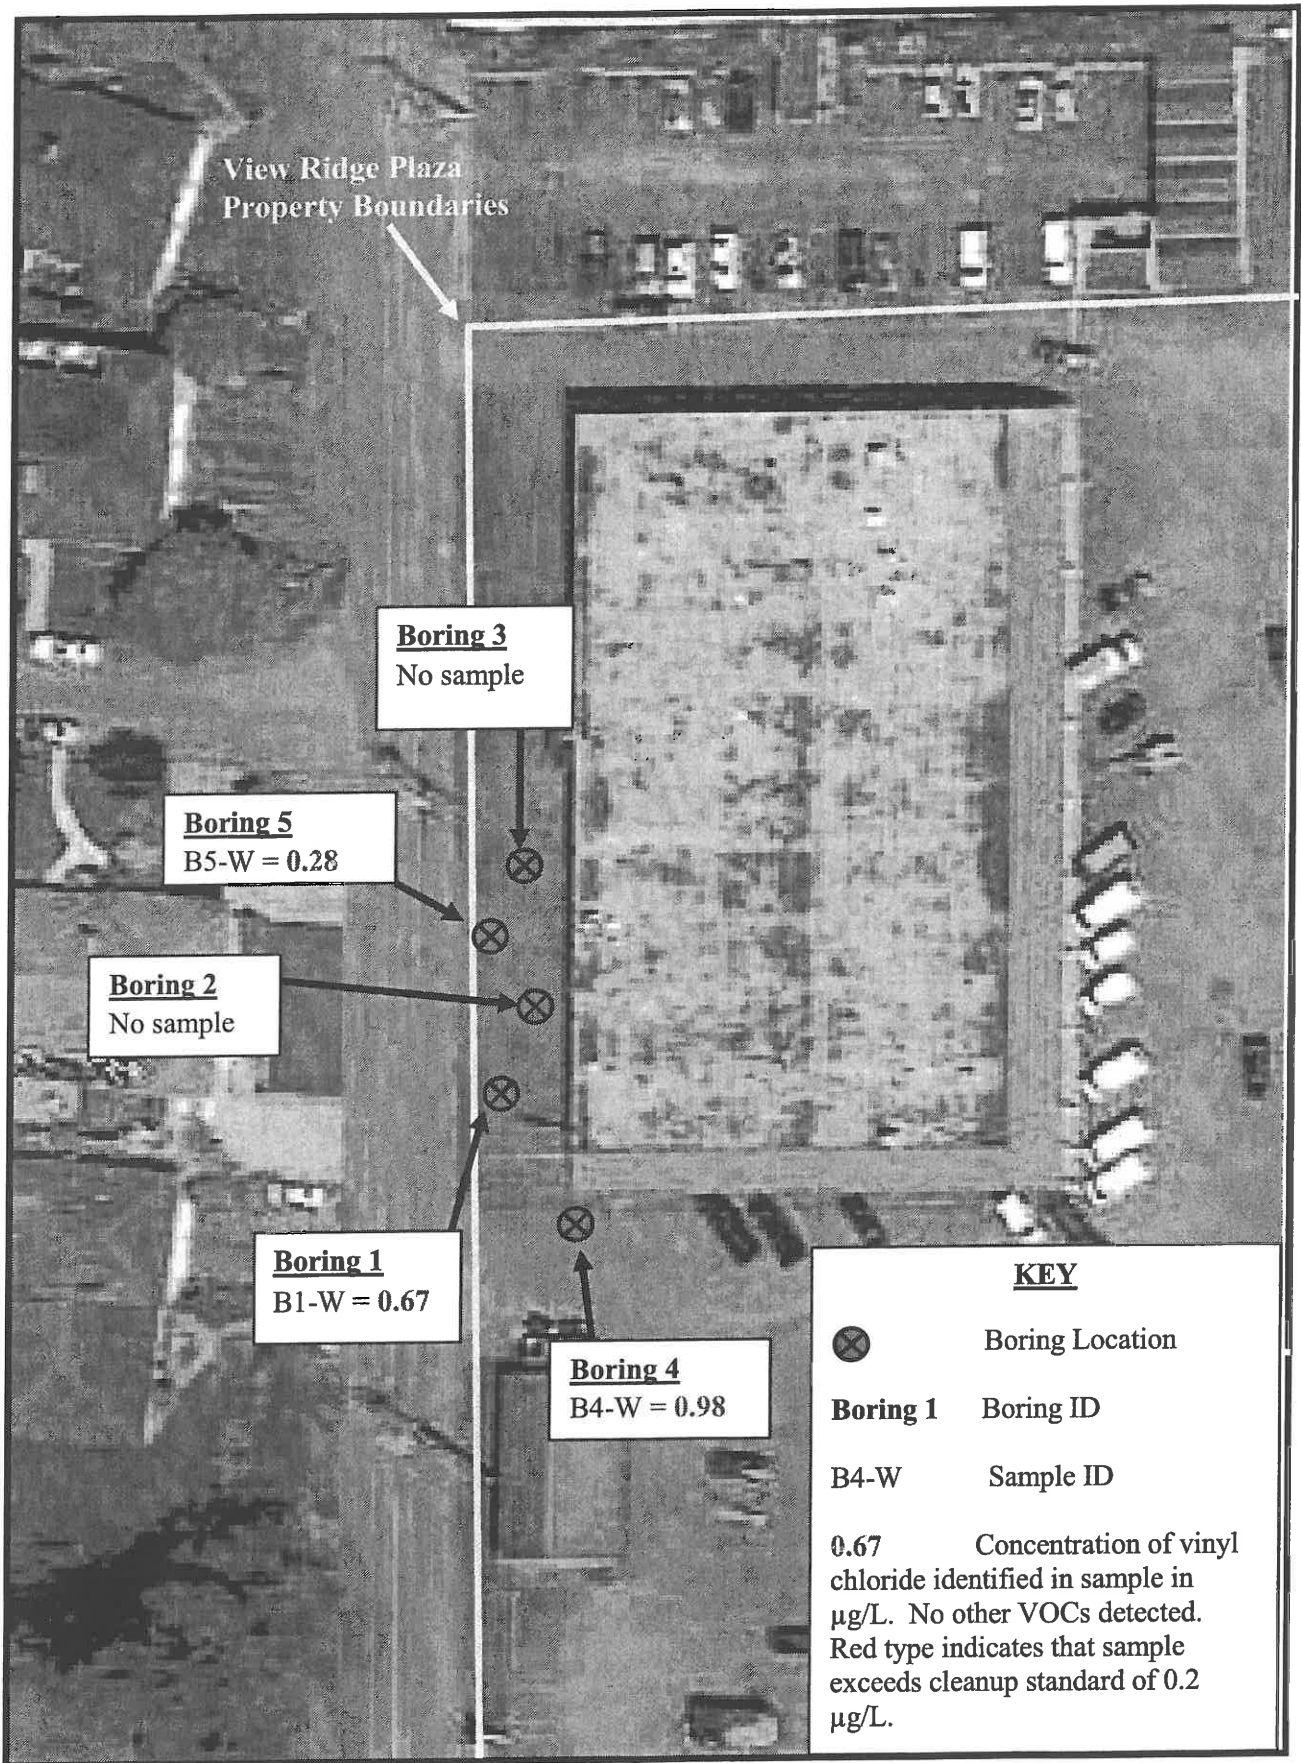
Figure 4. View Ridge Plaza boring locations with water sample results.

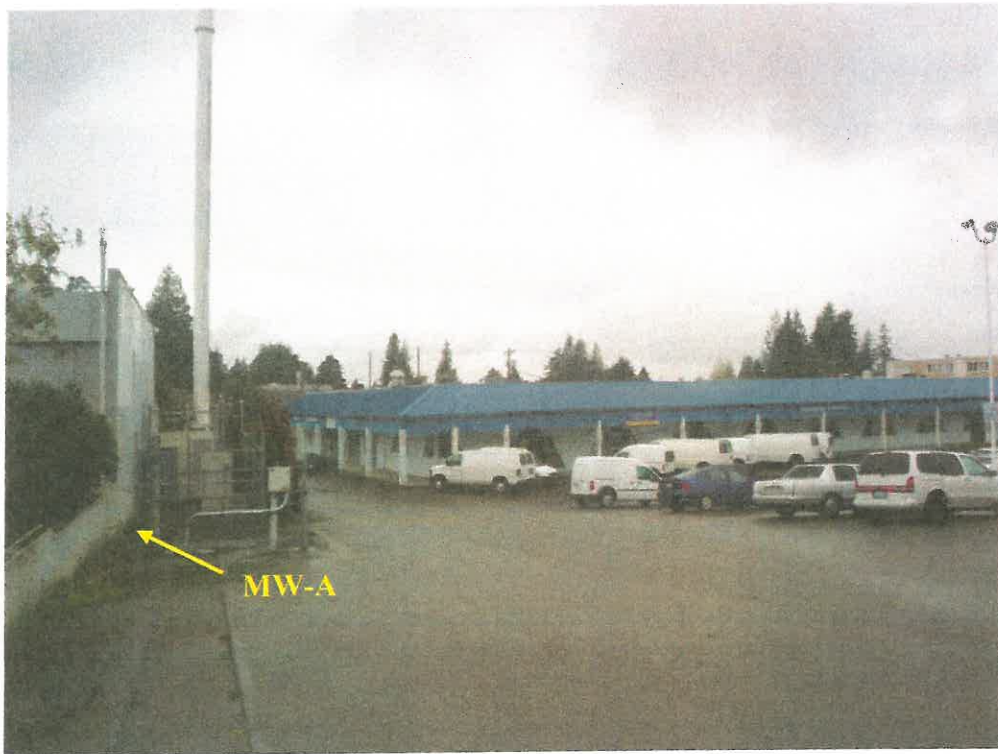
Figure 7. View of the View Ridge Plaza property looking west. Monitoring well MW-A is located in photo and 76 gasoline station is located along the left side of the photo.

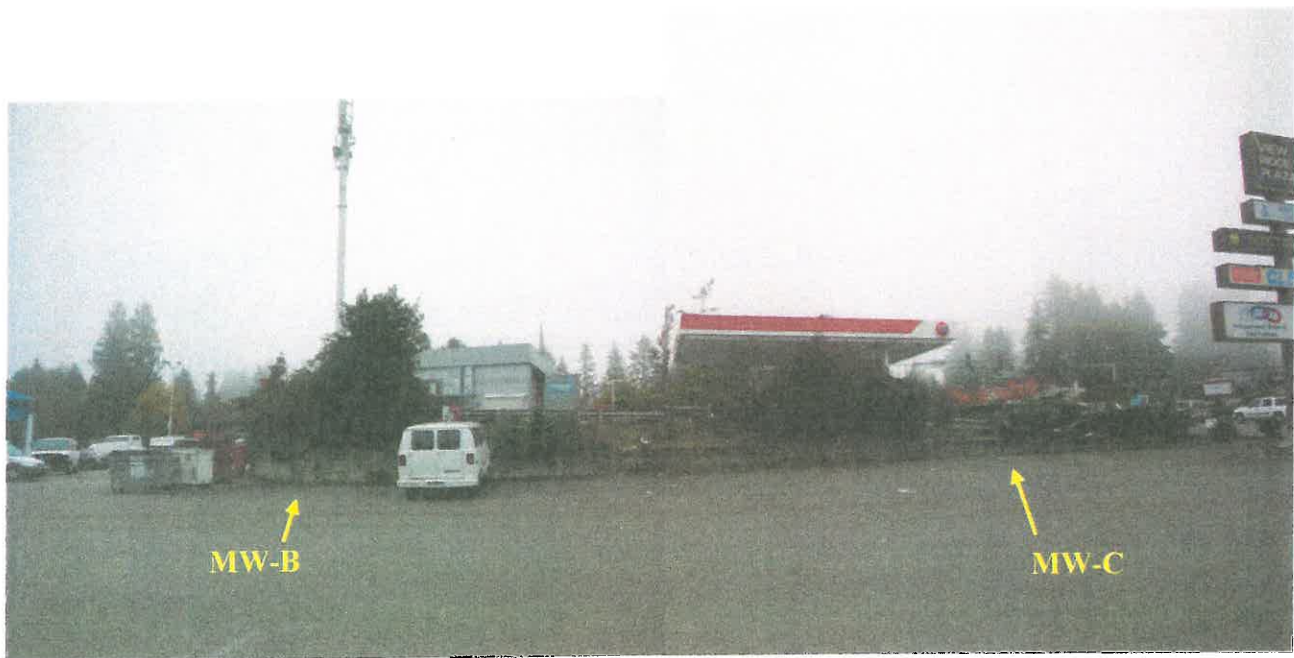
Figure 8. View of the southeastern portion of the site, looking west toward the 76 gasoline station. Monitoring wells MW-B and MW-C are identified in the photo.

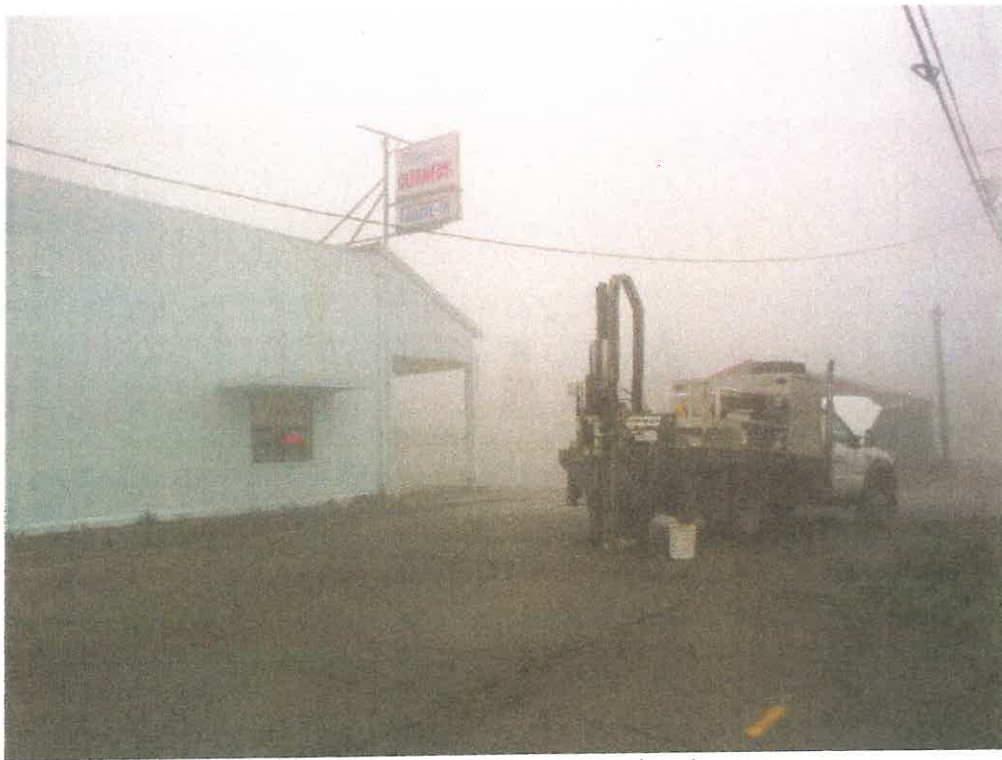
Figure 9. Location of Boring 1.

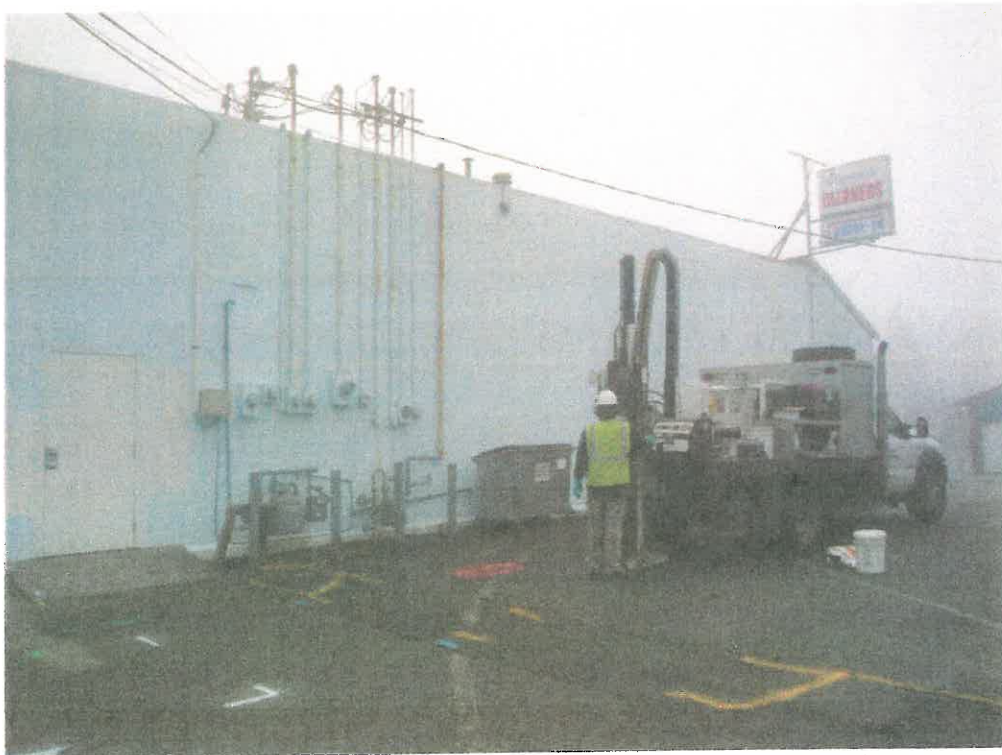
Figure 10. Location of Boring 2. Door in left side of photo is back door to the dry cleaner, currently utilized by Olympic Cleaners.

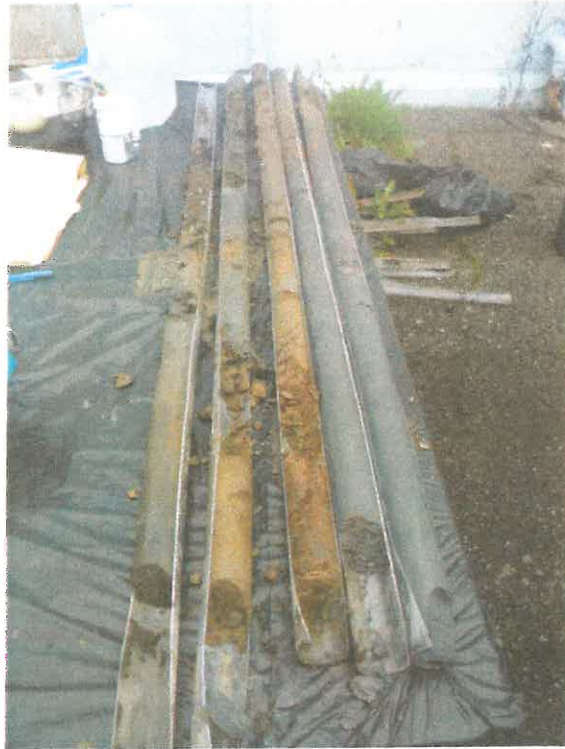
Figure 11. View of soil collected from Boring 2. Soil is dominantly tan or grey compact silt or clay to depths of 20'.

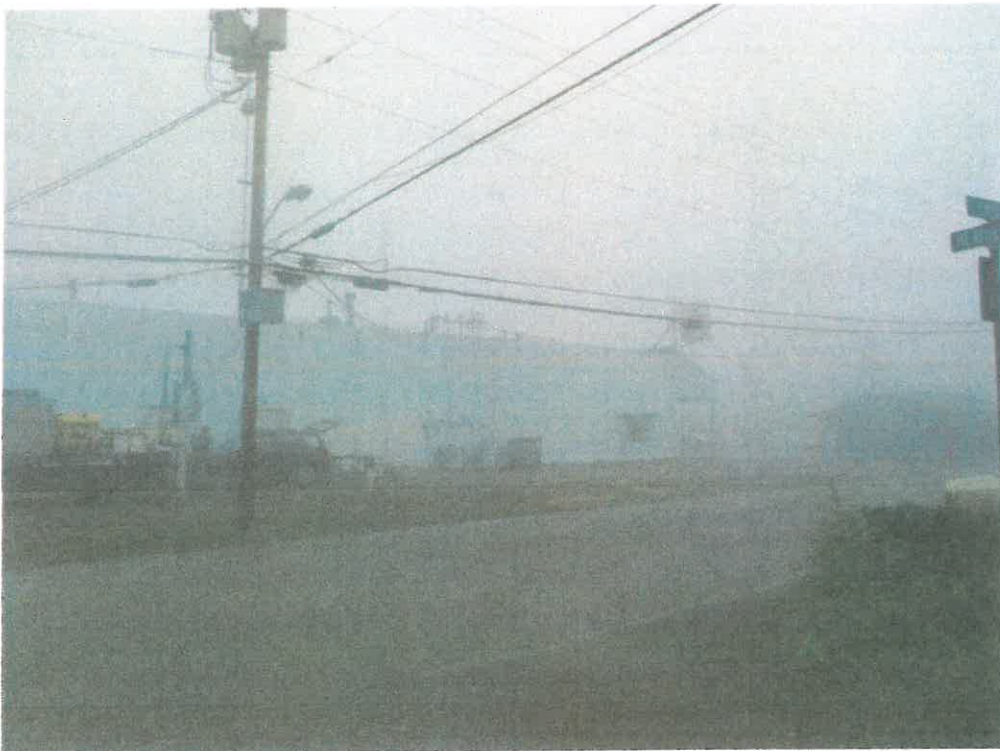
Figure 12. Location of Boring 3, looking eastward. Boring 3 is the northernmost boring location.

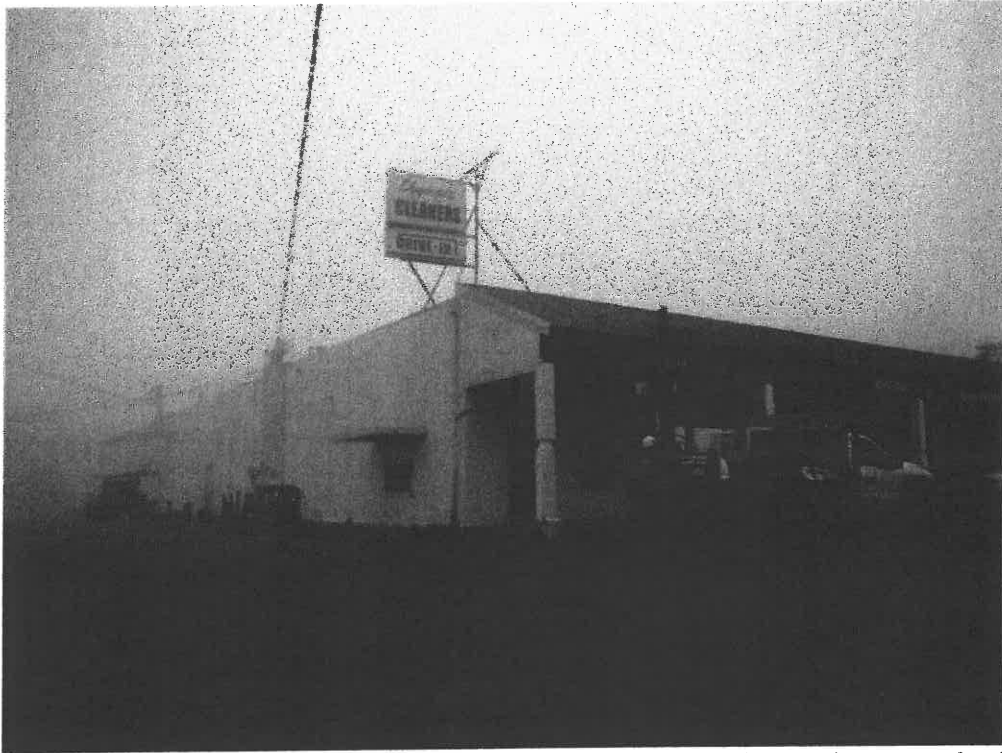
Figure 13. Location of Boring 4, looking northeastward. Boring 4 is the southernmost boring location.

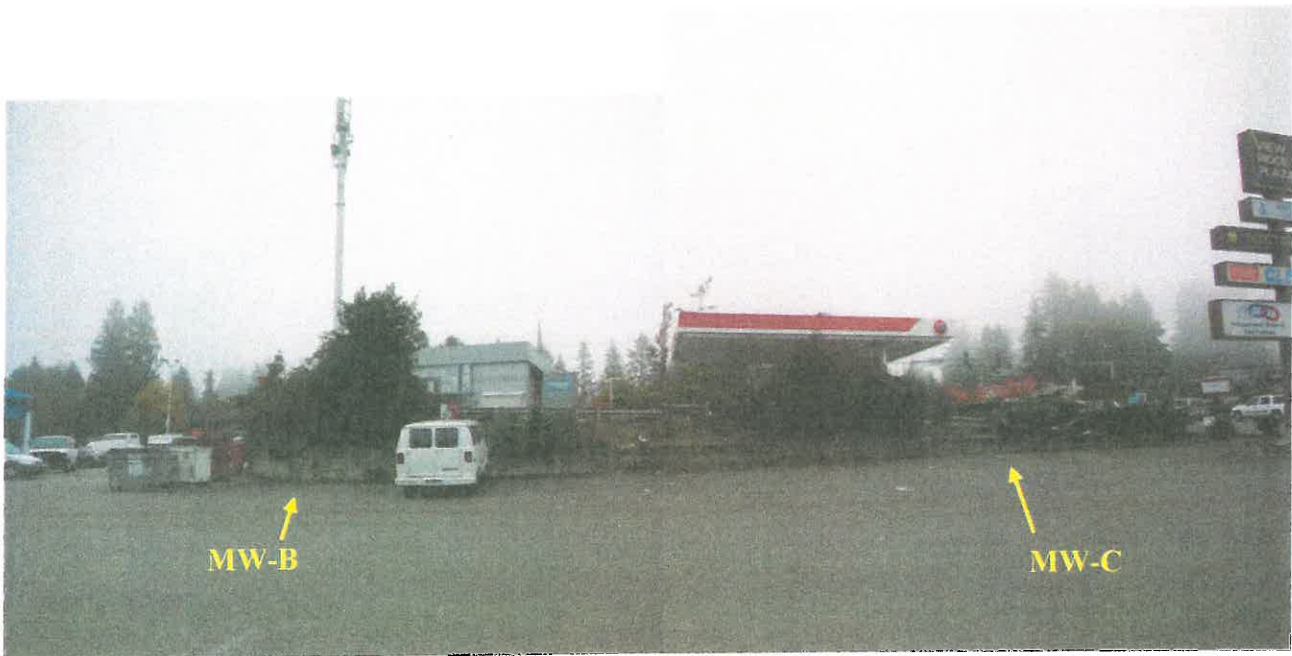
Figure 8. View of the southeastern portion of the site, looking west toward the 76 gasoline station. Monitoring wells MW-B and MW-C are identified in the photo.

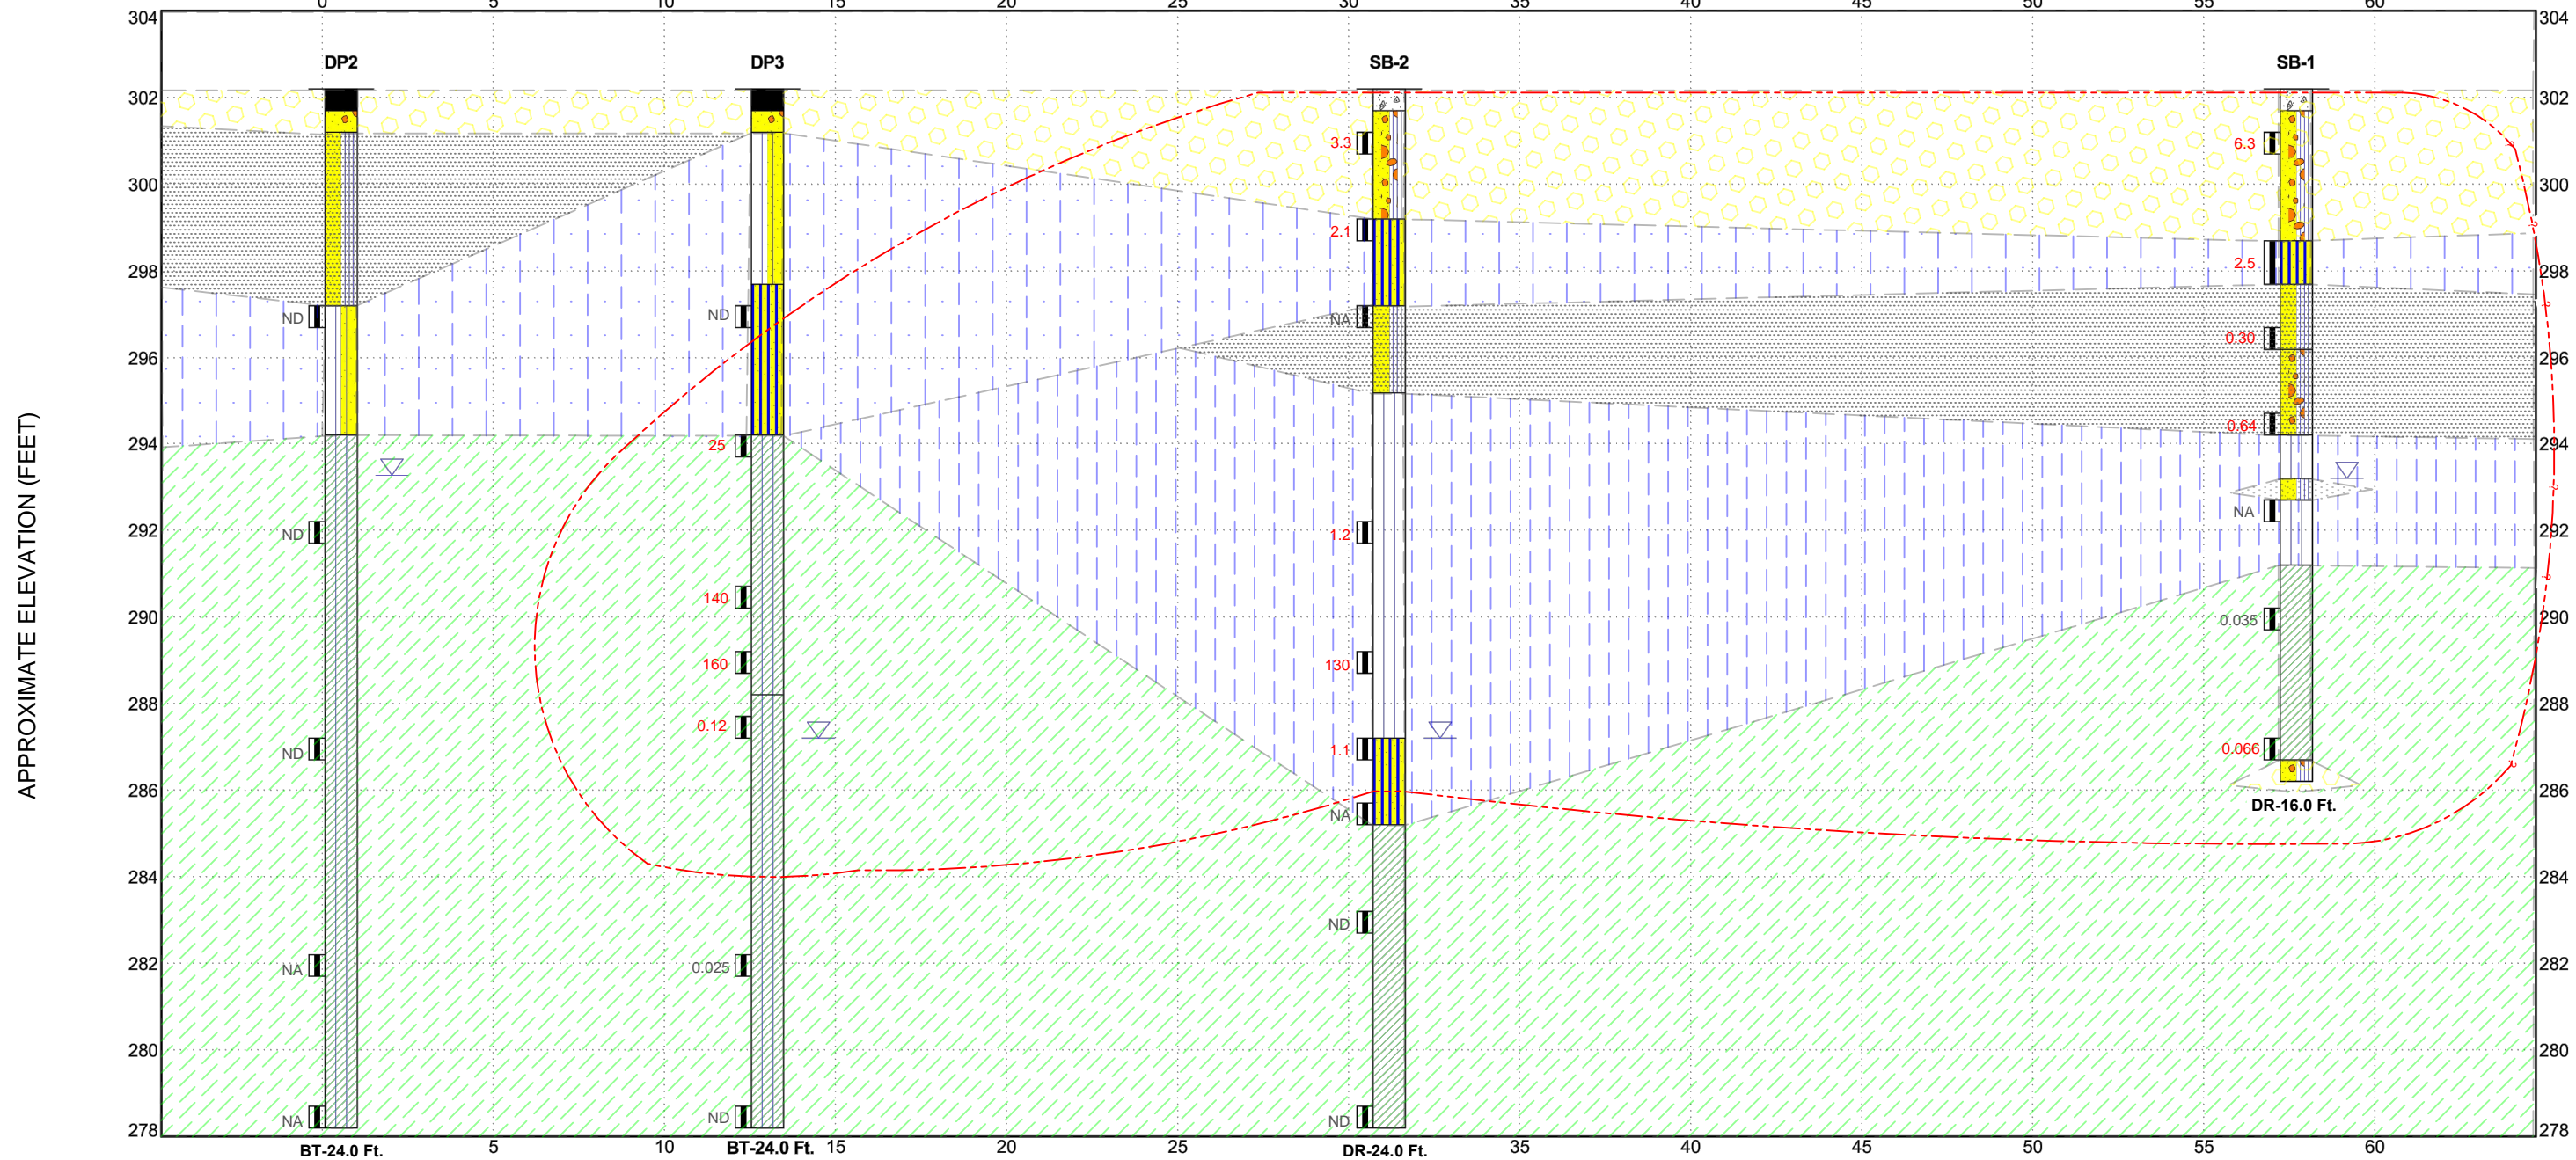
- Asphalt
 - Poorly-graded Sand with Gravel
 - Poorly-graded Sand with Silt
 - Silt with Sand
 - Silty Clay
 - Sandy Silt
 - Concrete
 - Poorly-graded Sand with Silt and Gravel
 - Silt
 - Lean Clay
- NOTES:**
 See Exhibit 4 for orientation of soil profile.
 See General Notes in Appendix C for symbols and soil classifications.
 Soils profile provided for illustration purposes only.
 Soils between borings may differ.
 DR- Direct Push Refusal
 BT- Boring Termination
