Environmental Site Assessment Report

Handy Mart – 1410 Ocean Beach Highway, Longview, Washington

HydroCon Project Number 2015-007.01

October 11, 2019

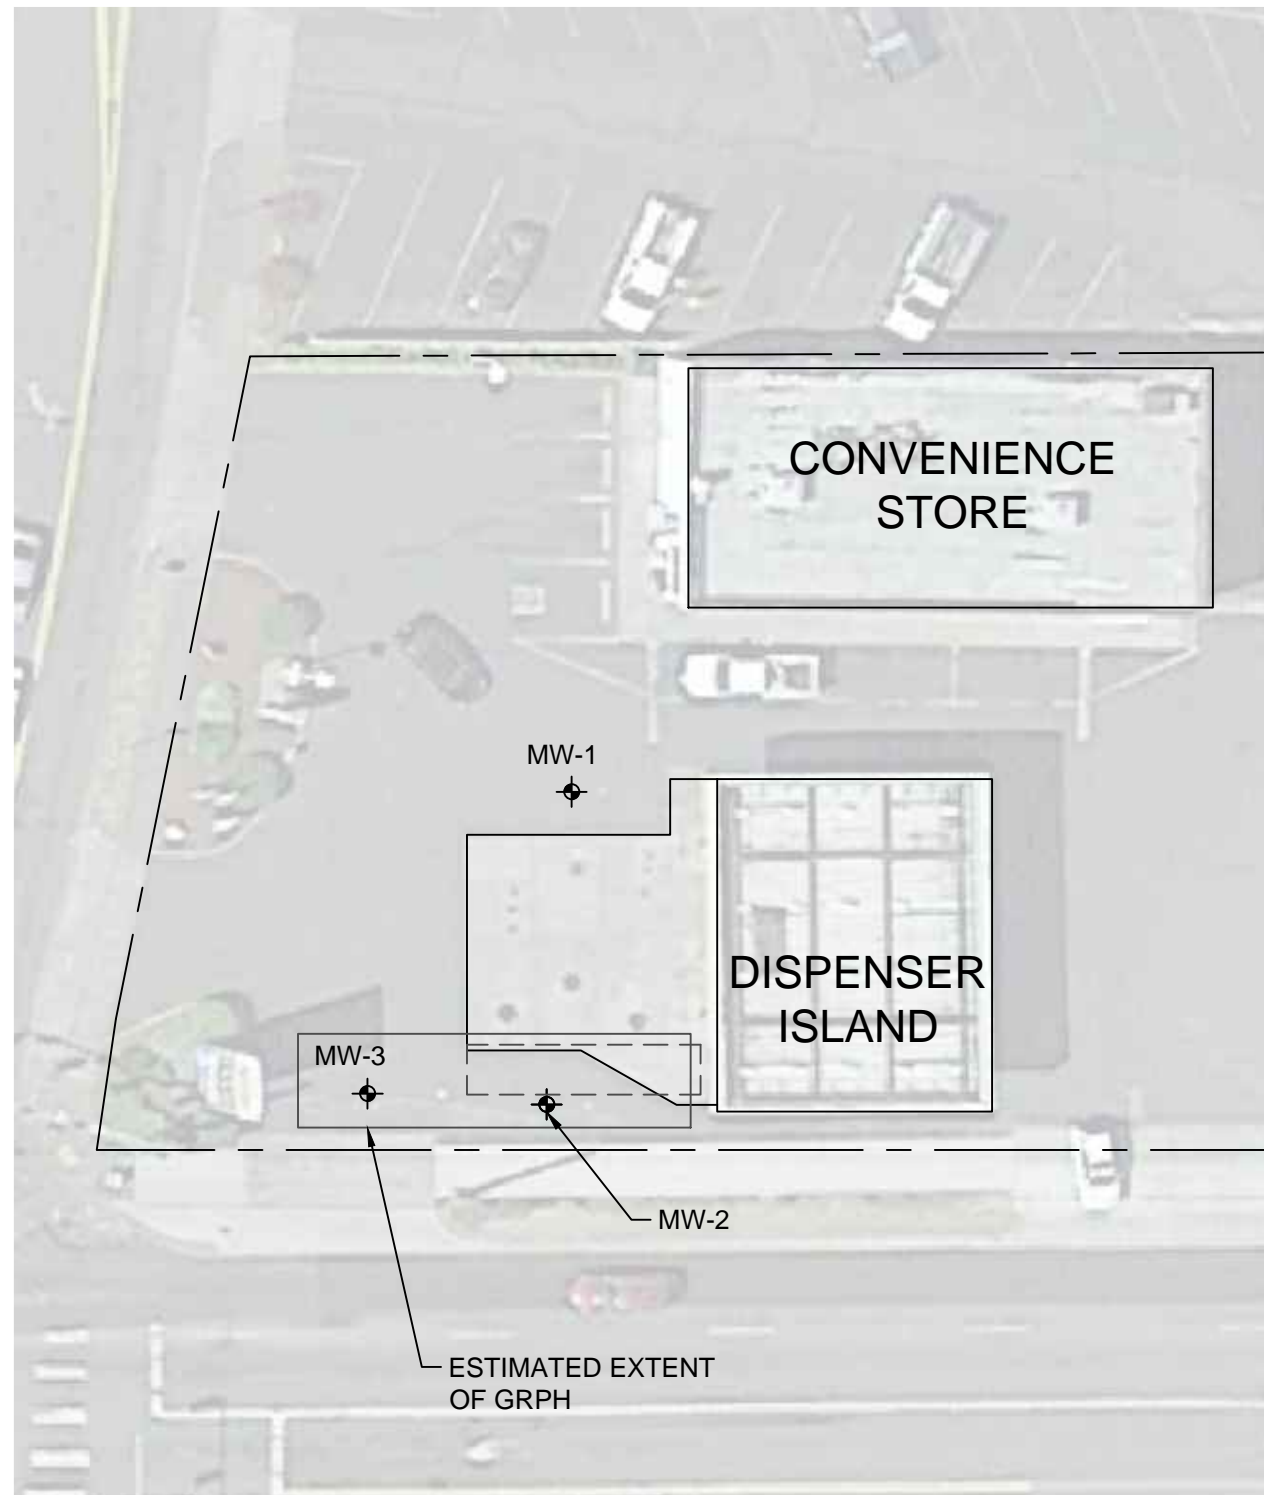
FIGURE 6
 SUMMARY OF GROUNDWATER ANALYTICAL RESULTS
 JUNE 2017
 WILCOX & FLEGEL - HANDY MART
 1410 OCEAN BEACH HWY
 LONGVIEW, WA

Parameter		GRPH [1]	Benzene [2]	Toluene [2]	Ethylbenzene [2]	Total Xylenes [2]
Cleanup Level*		800	5	1,000	700	1,000
Monitoring Well ID	Date Sampled					
MW-1	3/16/15	<100	15	1.3	<1	<3
	9/24/15	460	<1	4.4	<1	3.5
	2/2/16	<100	2.7	<1	<1	<3
	4/14/16	<100	1.41	<1	<0.5	<1.5
	8/10/16	<100	<0.2	<1	<0.5	<1.5
	11/17/16	<100	<0.2	<1	<0.5	<1.5
	3/15/17	<100	<0.2	<1	<0.5	<1.5
	6/30/17	<100	<0.2	<1	<0.5	<1.5
MW-2	3/16/15	310	7.0	3.5	3.3	25
	9/24/15	<100	<1	<1	<1	<3
	2/2/16	210	<1	3.7	<1	<3
	4/14/16	310	<0.2	<1	<0.5	<1.5
	8/10/16	326	<0.2	<1	<0.5	<1.5
	11/17/16	329	<0.2	<1	<0.5	<1.5
	3/15/17	<100	<0.2	<1	<0.5	<1.5
	6/30/17	<100	<0.2	<1	<0.5	<1.5
MW-3	3/16/15	<100	1.6	<1	<1	<3
	9/24/15	<100	6.1	<1	<1	<3
	2/2/16	<100	6.6	<1	<1	<3
	4/14/16	<100	3.7	<1	<0.5	<1.5
	8/10/16	<100	2.2	<1	<0.5	<1.5
	11/17/16	<100	0.314	<1	<0.5	<1.5
	3/15/17	<100	<0.2	<1	<0.5	<1.5
	6/30/17	<100	<0.2	<1	<0.5	<1.5

The groundwater analytical results are reported as parts per billion (µg/L) and are summarized on Table 4 and shown on Figure 6. The analytical results are summarized below.
