**SITE CHARACTERIZATION
GLENWOOD SHOPPING CENTER
418 SOUTH 48TH AVENUE
YAKIMA, WASHINGTON**

April 5, 2005

053-1378-100.000

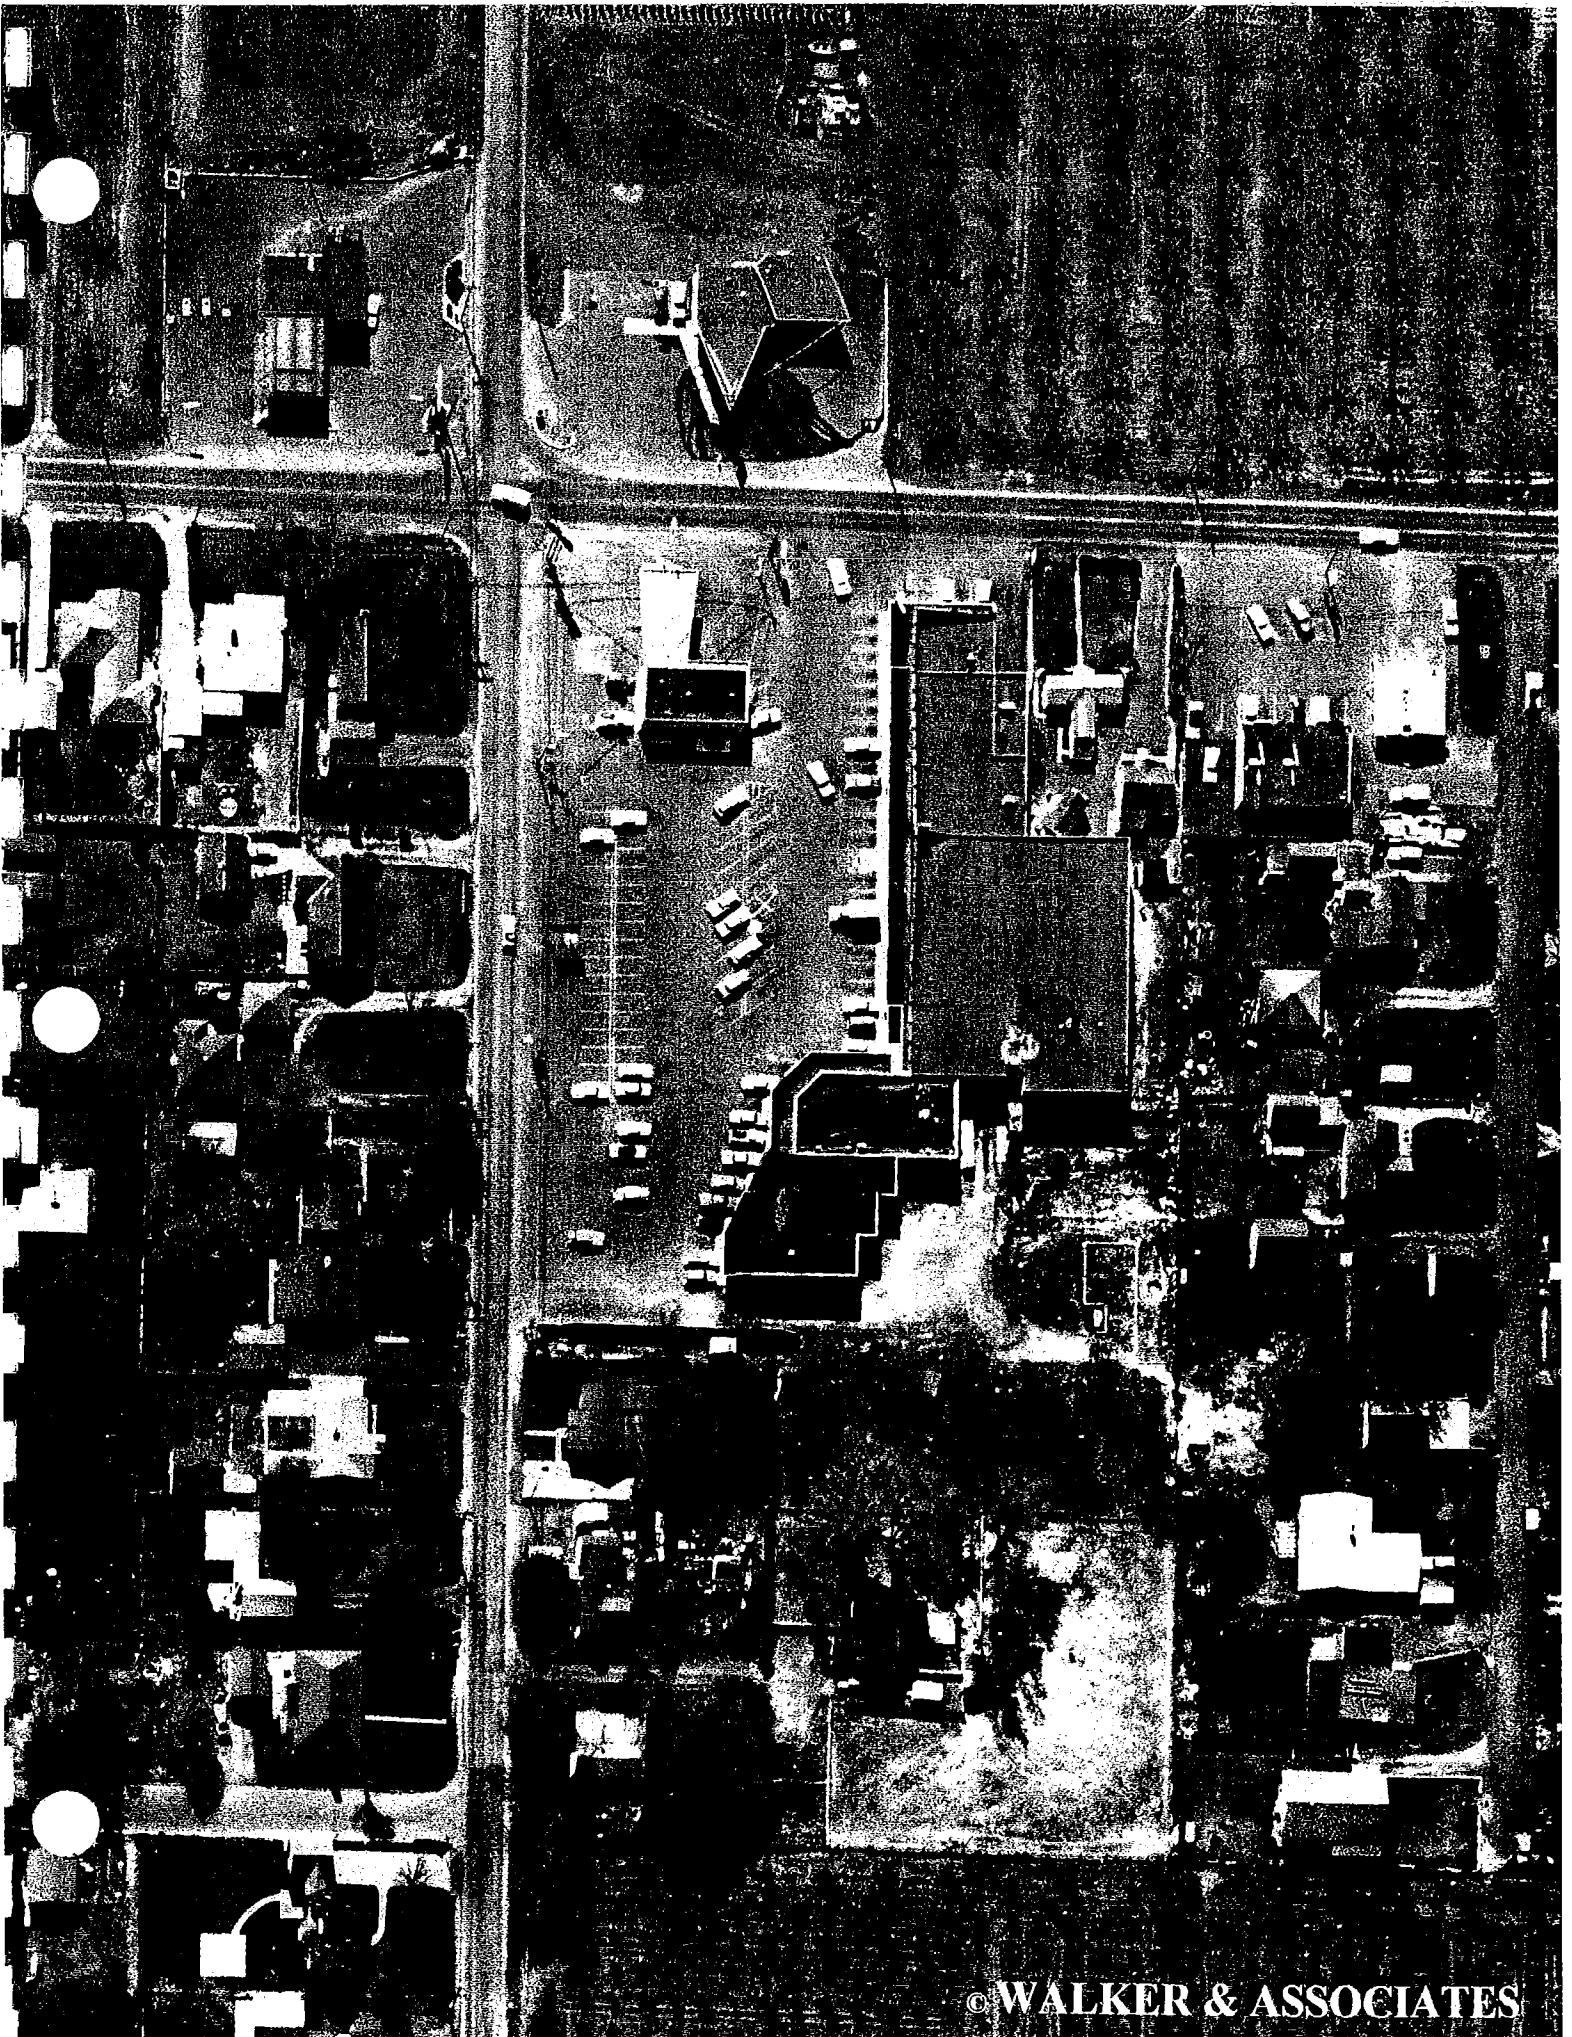
APPENDIX A
AERIAL PHOTOGRAPHS

The 1955 photograph shows the shopping center building and parking lot but the gas station area at that time was a vacant unpaved lot. The 1968 and 1978 photographs show the former gas station. The configuration of the gas station was the same in the 1968 and 1978 photographs.

The 1968 photograph shows a square area in the pavement immediately east of the gas station canopy. The 1978 photograph shows a square area in the pavement immediately southeast of the canopy. These two pavement "patches" may represent the location of former underground storage tanks.

The former subject property gas station was no longer present in the 1993 and 1998 photographs.
