MEMORANDUM

SUBJECT: Results of Additional Testing
Triumph Structures Aerostructures
1415 75th Street, Everett, Washington
VCP No. NW3183

SUBJECT: Ecology Opinion Letter Dated March 25, 2019
Triumph Structures Aerostructures
1415 75th Street SW, Everett, Washington
VCP No. NW3183

SUBJECT: Results of Additional Subsurface Drilling
Triumph Structures Aerostructures
1415 75th Street SW, Everett, Washington
VCP No. NW3183

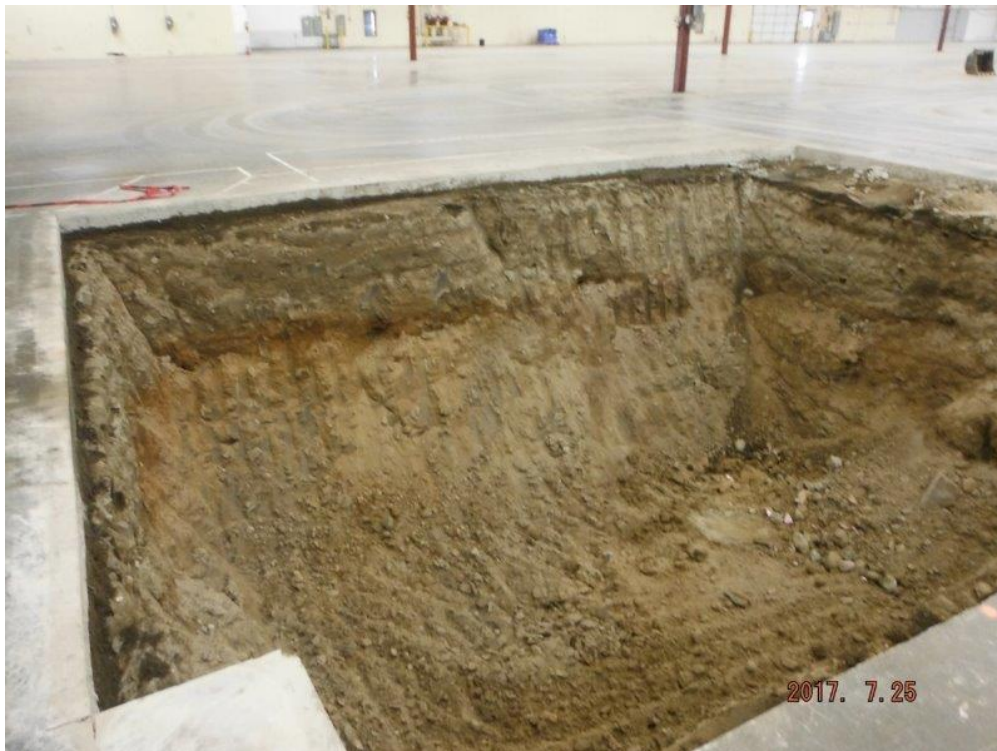
Fig. 2a - Remedial
Excavation Area 1
View to Northwest

SANDY SILT” was encountered. The boring/sampling depth was approximately 10.5 feet. SB-12 was located within Remedial Excavation area #1 which was excavated to a depth of 10 feet. DOF (Dave Cooper, Sr. Principal Geologist) observed no water flowing into the excavation during cleanup, so no shallow saturated ground water conditions existed at this location. The dry conditions are illustrated by the photographs shown on Figure 2.

Former
Everett, Washington
**Selected Views Remedial
Excavation Area 1
July 2017**
