INITIAL INVESTIGATION FIELD REPORT

<u>Site Name (Name over door):</u> Mustang Shop	<u>Site Address (including City, State and Zip):</u> 8504 S 228th St Kent, WA 98031	<u>Phone</u> <u>Email</u>
<u>Site Contact, Title, Business:</u> Nick Gerkin, Vice President Aerotech Environmental Consulting, Inc.	<u>Site Contact Address (including City, State and Zip):</u> 13925 Interurban Avenue South, Suite 210 Seattle, WA 98168	<u>Phone</u> (206) 482-2287 <u>Email</u> Nick@dirtydirt.us
<u>Site Owner, Title, Business:</u> Spring Faussett SeaO'Green LLC	<u>Site Owner Address (including City, State and Zip):</u> 14631 SE 263rd St. Kent, WA 98042	<u>Phone</u> <u>Email</u> spring@tigertailusa.com
<u>Site Owner Contact, Title, Business:</u>	<u>Site Owner Contact Address (including City, State and Zip):</u>	<u>Phone</u> <u>Email</u>
<u>Previous Site Owner(s):</u> Richard Herman	<u>Additional Info (for any Site Information Item):</u>	
<u>Alternate Site Name(s):</u>

Site Remediation Report, 228th Street Property, 8504 South 228th Street, Kent, WA 98031, Enviro Assessment, PC, September 10, 2018.

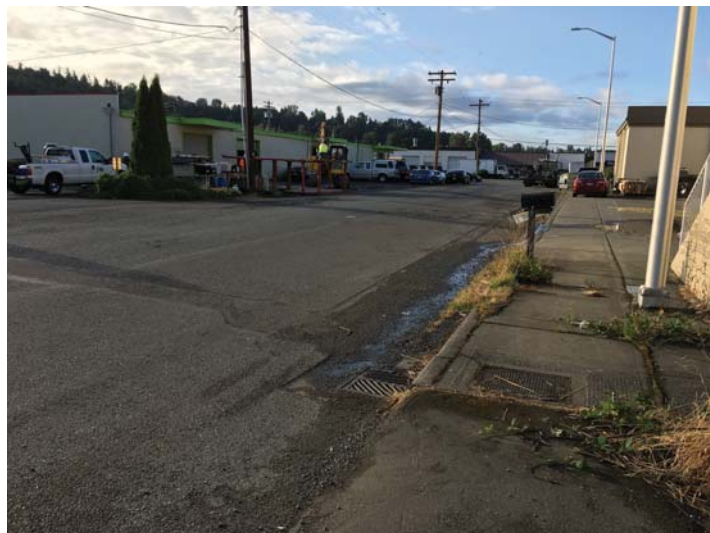
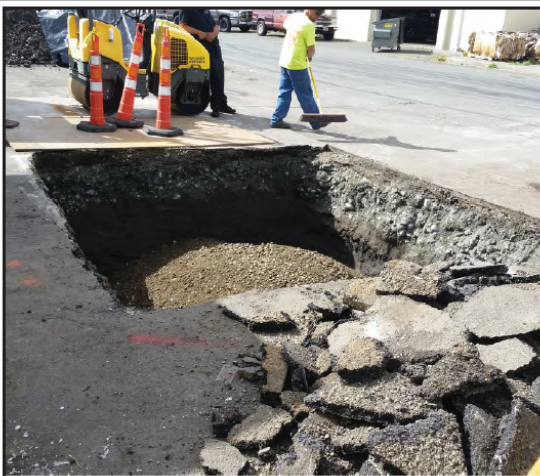
Area of Excavation during backfill process.

Approximately 52 tons of petroleum-contaminated soil was excavated from the paved area west of the building on the property and removed for off-site disposal in September 2018. Confirmation soil samples from the four excavation sidewalls were above the Method a cleanup level for benzene. In October 2019 the property was sold to the current owner, who plans to continue the cleanup and pursue an NFA through the VCP.
