**PHASE II PART 2 ENVIRONMENTAL SITE
ASSESSMENT**

**228TH STREET PROPERTY
8504 SOUTH 228TH STREET
KENT, WA 98031**

Project Number 2018-05-022

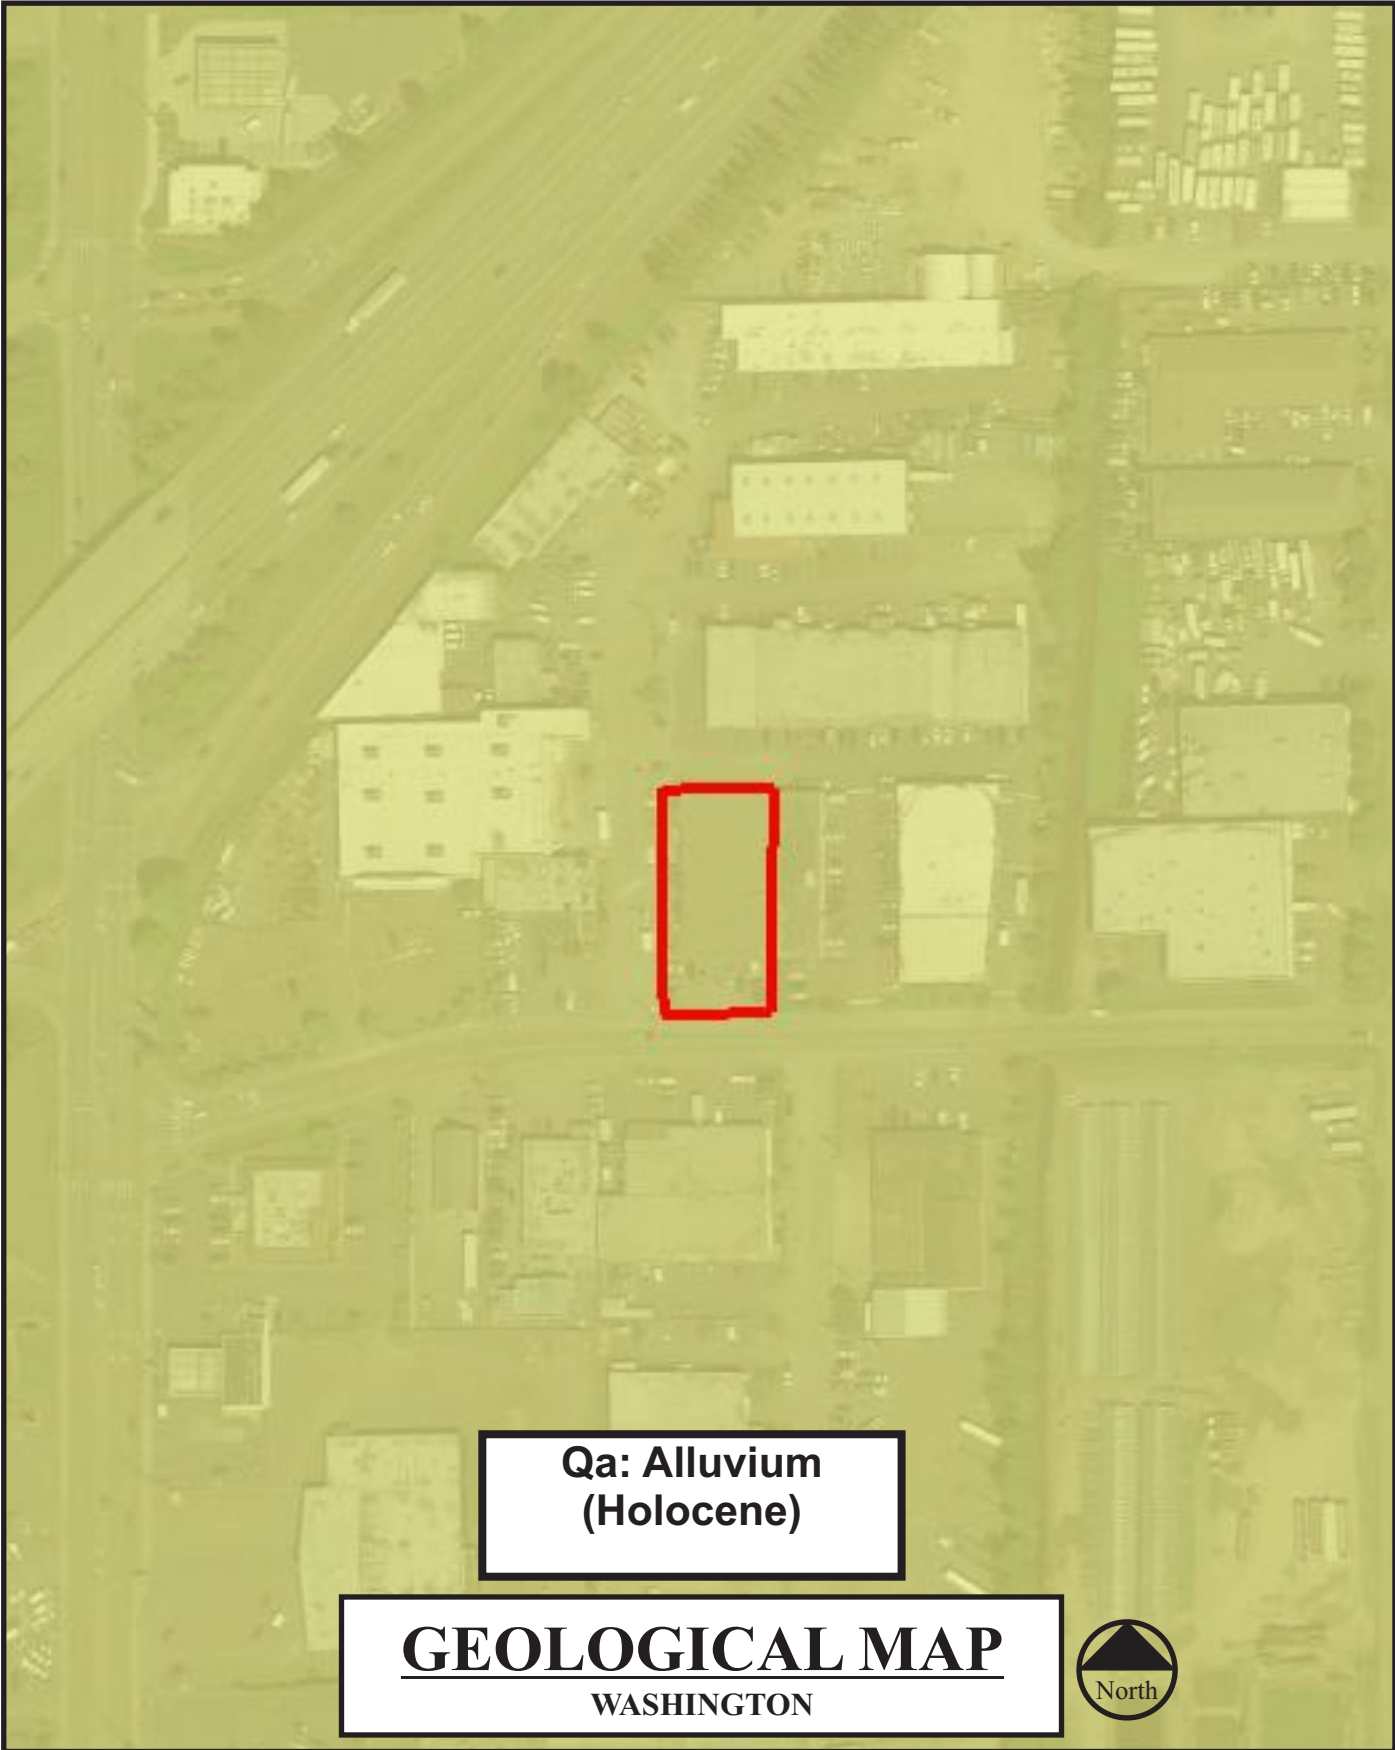
2018-05-022
MAY 31, 2018
PLATE: A3

**Qa: Alluvium
(Holocene)**

GEOLOGICAL MAP
WASHINGTON

According to the Geological Map of California, the Property is located within the Qa: Alluvium (Holocene) geological formation. A detailed description is as follows:

“Mostly unconsolidated silt, sand, and gravel valley fill with some clay; includes low-level terrace,

marsh, peat, artificial fill, and glacial deposits locally”³

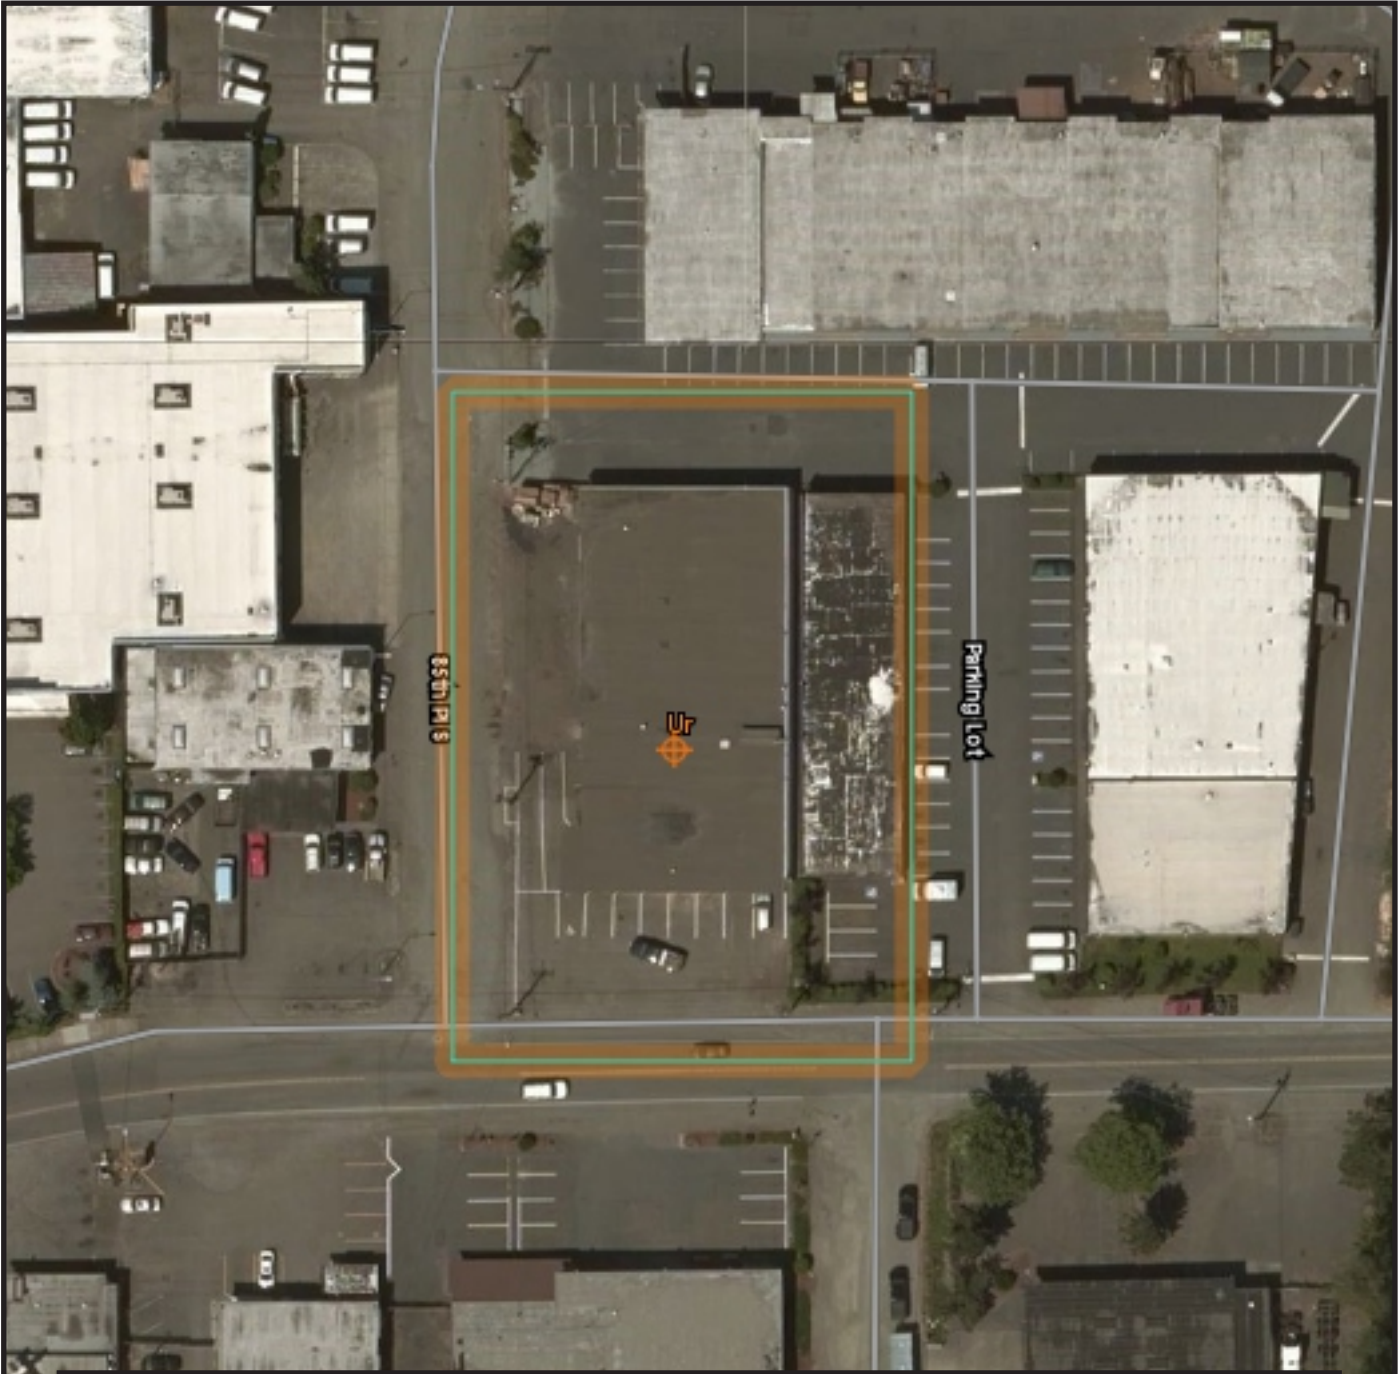
2018-05-022
MAY 31, 2018
PLATE: A4

King County Area, Washington (Wa633)			
Map Unit Symbol	Map Unit Name	Acres in AOI	Percent of AOI
Ur	Urban land	1.1	100.0%
Totals for Area of Interest		1.1	100.0%

SOIL MAP
NO SCALE

The soils of the Property are reported by the USDA as King County Area, Washington (WA633) as Urban Land represented with the map unit Ur². Soils encountered at the site are represented in the Plates located in the Appendix.

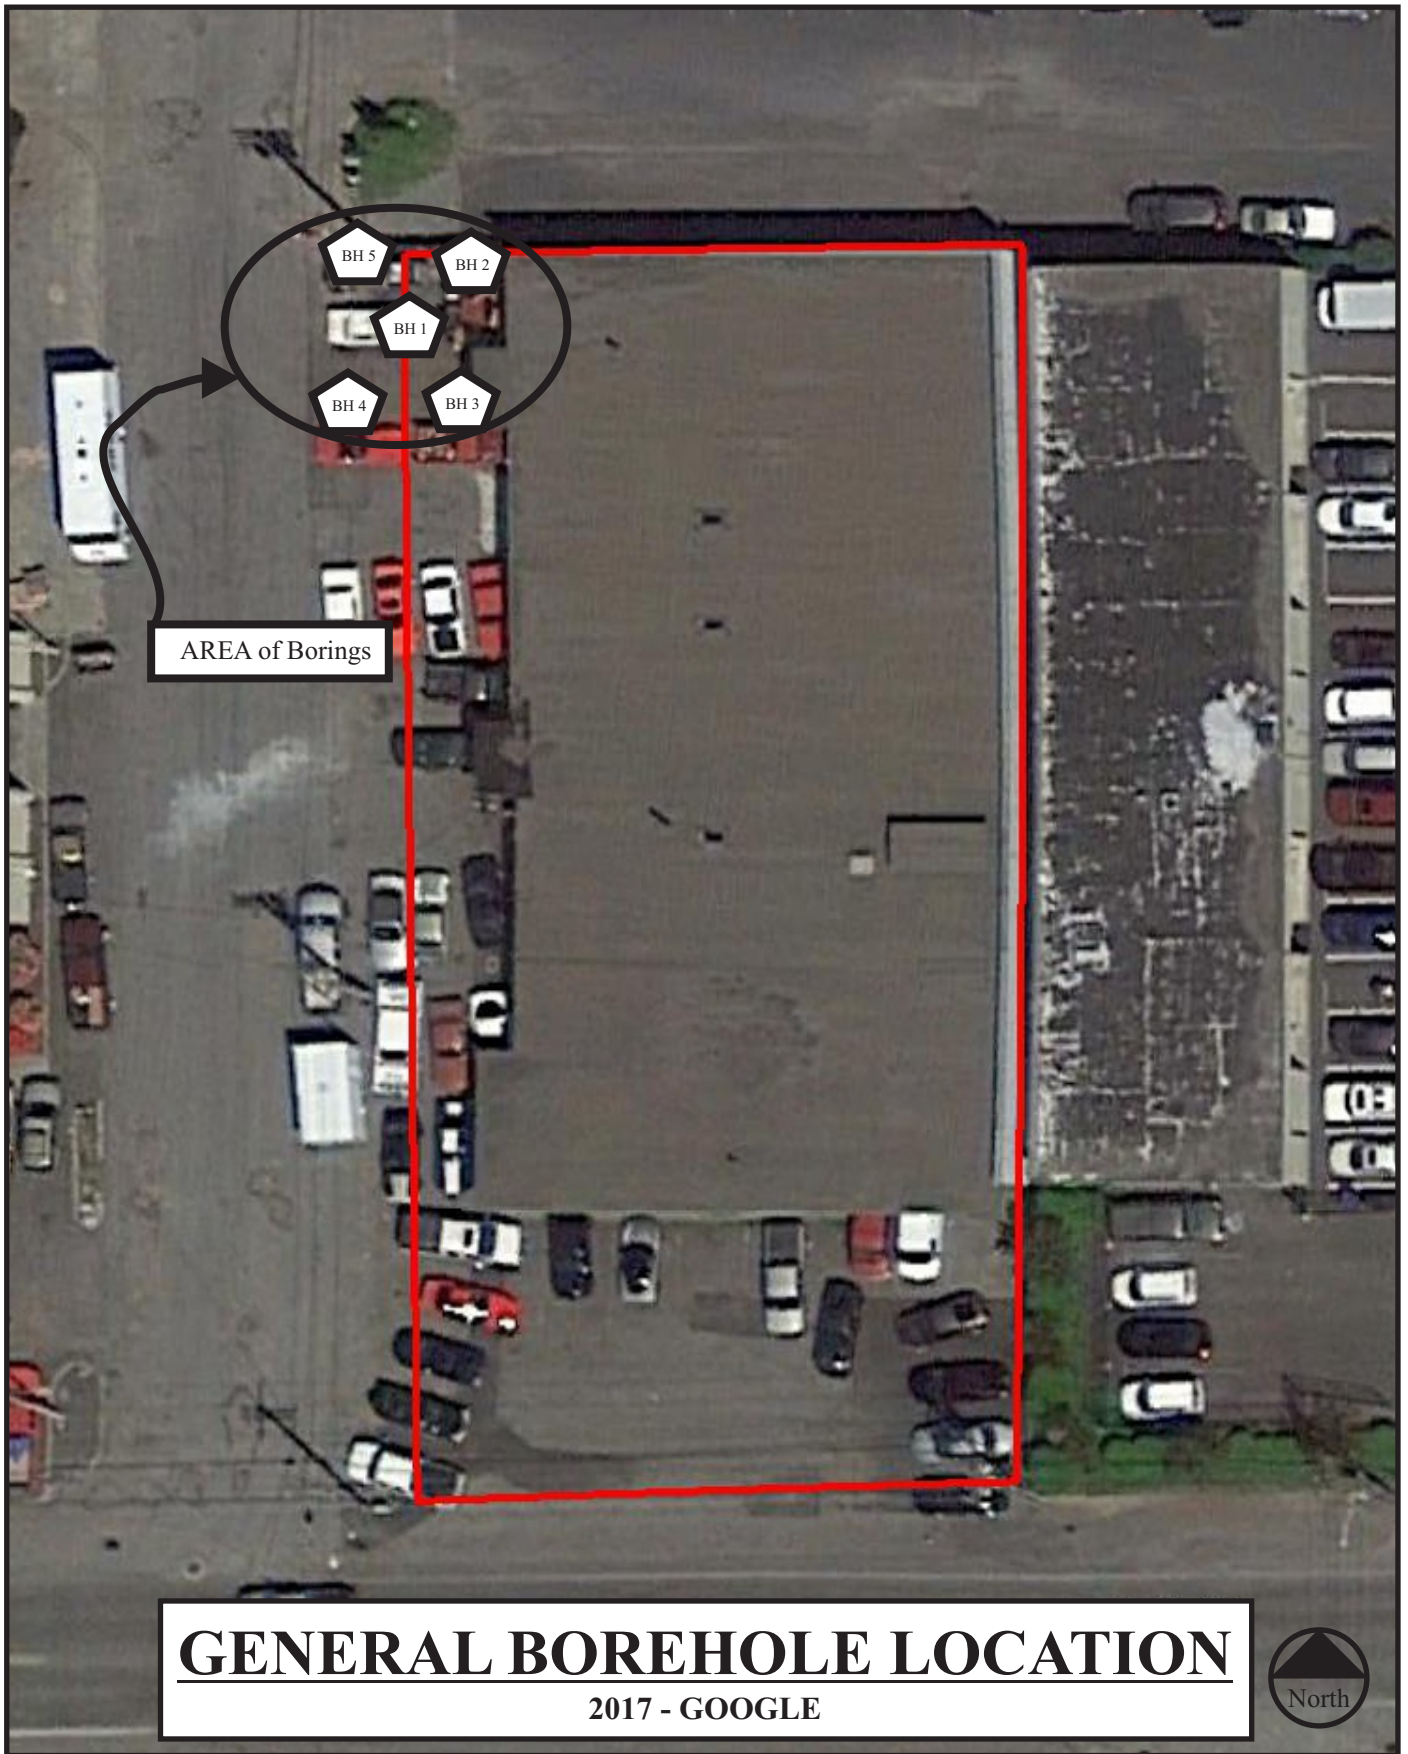
2018-05-022
MAY 31, 2018
PLATE: A5

GENERAL BOREHOLE LOCATION

- Borehole 1 was advanced in the center of the five boreholes in which the pattern resembles that of an X. BH1 was advanced to fifteen feet BGS to try and reach ground water. Ground water was encountered at 12.8'. Soil samples were collected above the water table at 5' and 10'. Soils collected were based on the clay layer, one taken from above the layer and one from within. Soil samples are aptly named by the borehole location and the depth of collection, BH1@5' and BH1@10'. Water sample is named BH1 H20.

- Boreholes 2, 3, 4 and 5 were advanced in the corners surrounding BH1. The two nearest the retaining wall and waste receptacles are BH2 on the east side and BH5 on the west closest to 228th Street. BH3 and BH4 were advanced on the southern corners of the X pattern, BH3 was located nearest the garage bay door and BH4 near 228th Street. Water was encountered at various depths in all boreholes. Soil samples were collected at various depths depending on the screening of the environmental professional. In BH2, BH3, and BH5 soils samples were collected from 5' and 10' BGS. In BH4 soil samples were collected from 4' and 10' BGS. Some vegetation debris was found in BH4 at 5' in depth and therefore soil samples were taken from above that.

Please refer to Plate A5 for the sample location map.

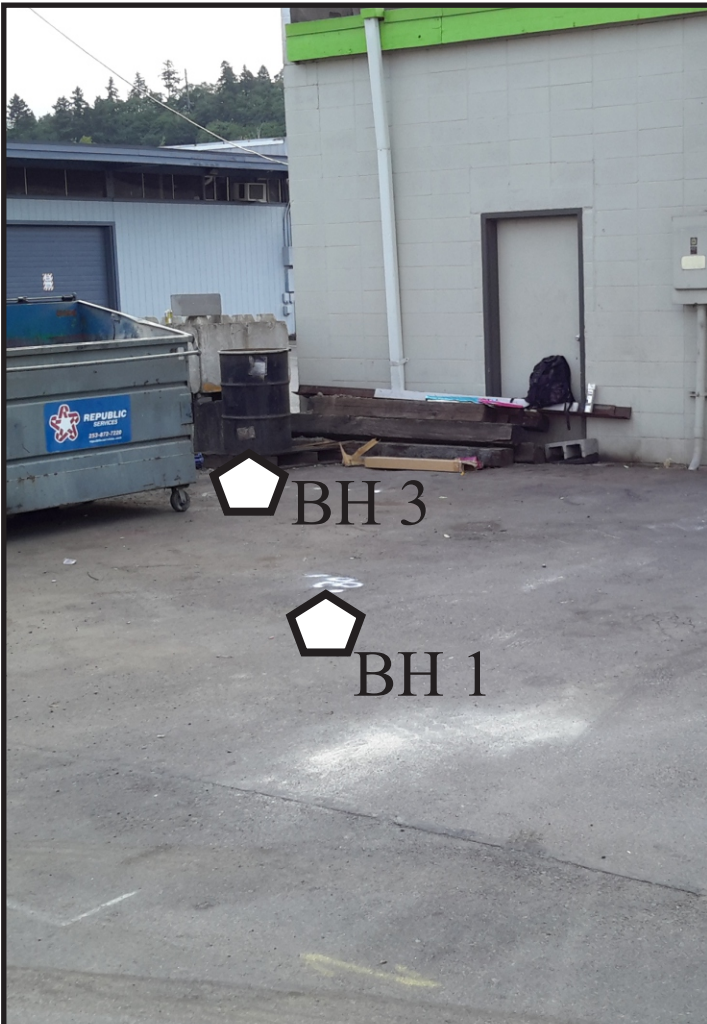
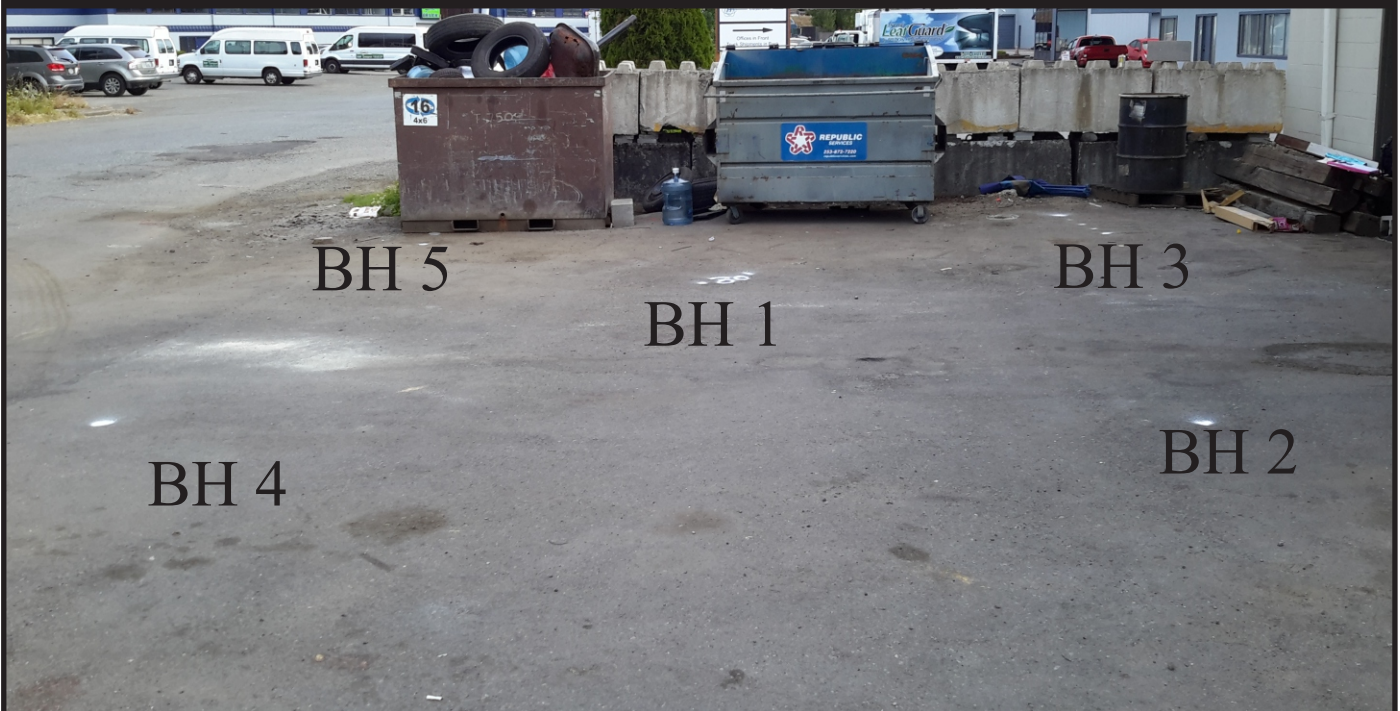
2018-05-022
MAY 31, 2018
PLATE: A6

DETAILED LOCATION

Borehole BH 1, BH 2, BH 3, BH 4, and BH 5 are all located on the northwest corner of the Property.

Upper photo shows three borehole locations indicated by

Lower photo shows area of all five borehole locations and their names, the locations are marked in white spray paint.
