2010 Remediation – As-Built Completion Report

BNSF Former Maintenance and Fueling Facility
Skykomish, Washington

**Construction Completion Report
2010 Remediation
BNSF Former Maintenance and Fueling Facility
Skykomish, Washington**

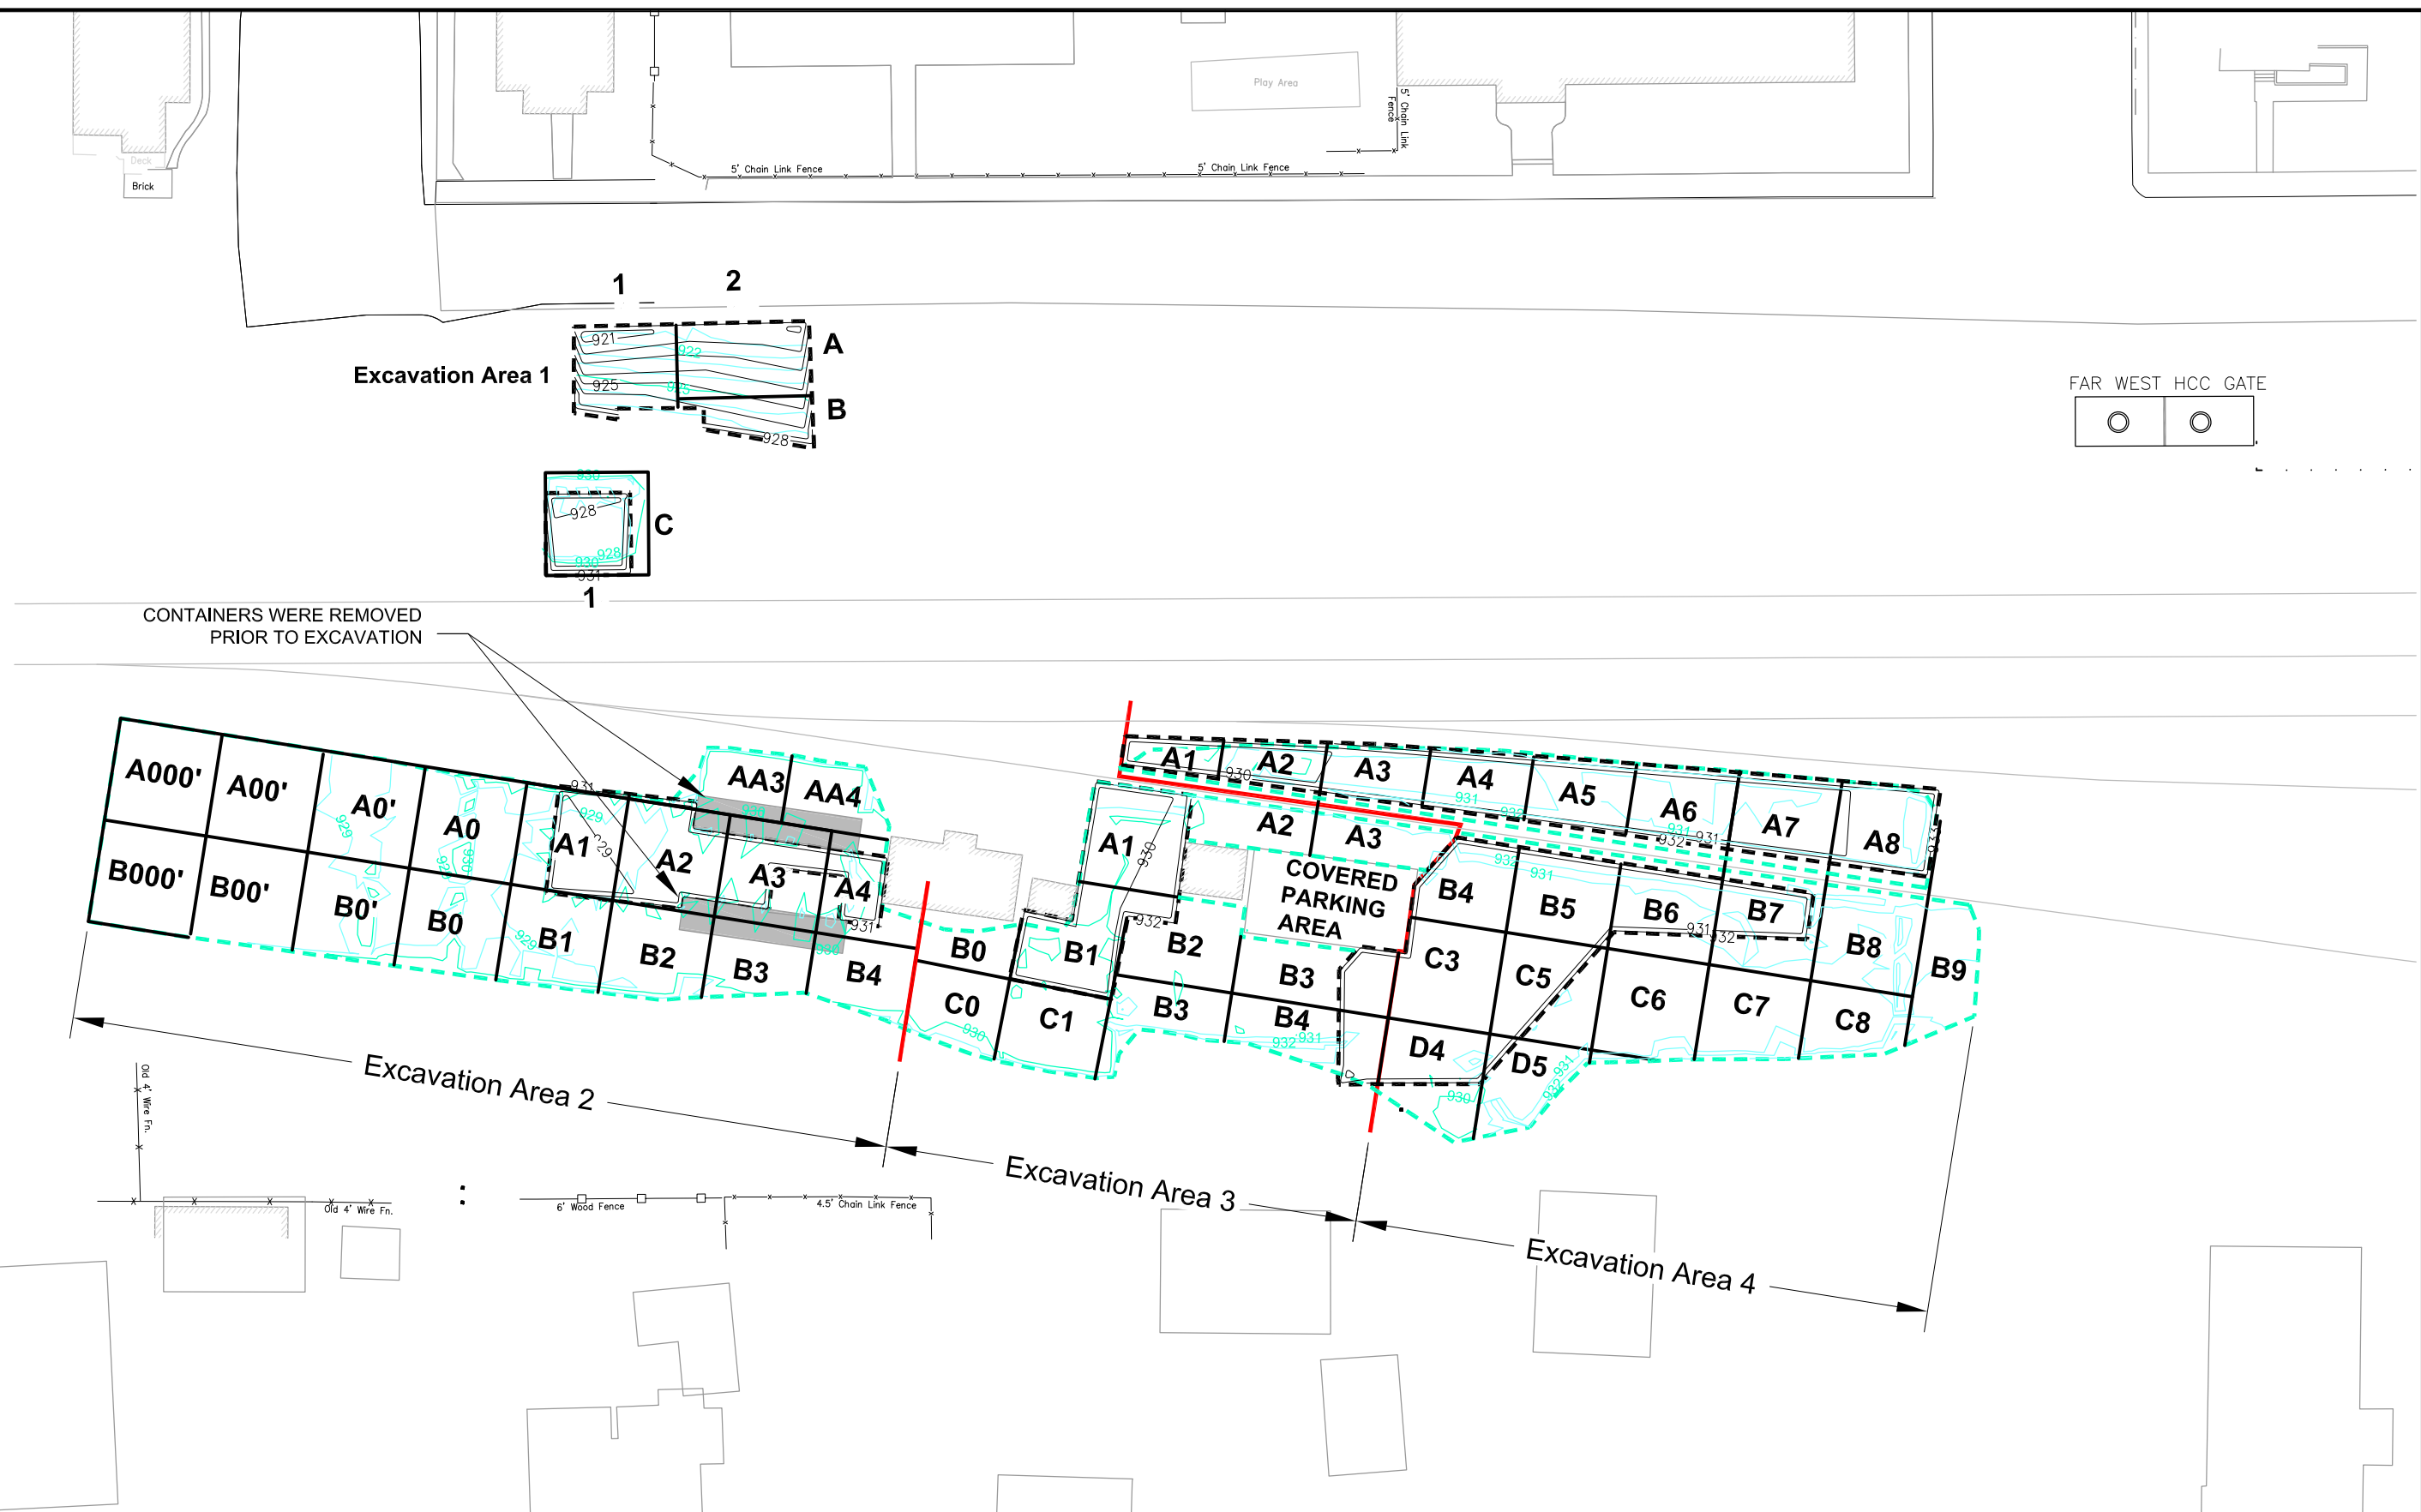
CONTAINERS WERE REMOVED PRIOR TO EXCAVATION
