**RE:                Technical Memorandum – Soil Vapor Extraction (SVE) System Installation**  
*4 Corners Cleaners*  
23886 SE Kent-Kangley Road  
Maple Valley, Washington 98038-6848  
AEG Project: 17-126

Associated Environmental Group, LLC (AEG) has prepared this Technical Memorandum to document the installation and monitoring of a soil vapor extraction (SVE) system to address environmental concerns for the *4 Corners Cleaners*, located at the above-referenced address in Maple Valley, Washington (Site). The scope of services for the installation and monitoring of the SVE system was presented in AEG's Cleanup Action Plan, dated May 29, 2019. The system was designed to extract and remove adsorbed vapor-phase tetrachloroethylene (PCE) and other volatile organic compounds (VOCs) from subsurface soil beneath the building, and treat the vapors using granular activated carbon (GAC). The system also mitigates the potential for vapor intrusion of VOCs detected beneath the dry cleaner space into the indoor air. This memorandum includes a summary of the installation activities, baseline startup sampling results, and recommendations for continued operations and monitoring for the Site. Figu

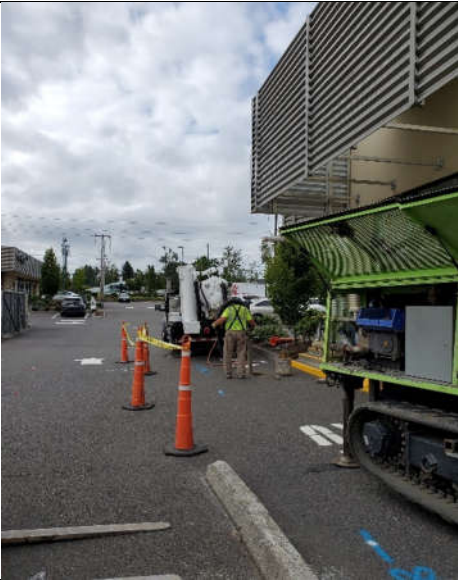
| Photo #1: | Installation of extraction well SVE-1 (facing south). | Photo #2: | Installation of extraction well SVE-2 (facing south). |

Five SVE wells were installed on August 9 and 10, 2019 by Cascade Drilling, LP (Cascade) using sonic drilling technologies. Four SVE wells (SVE-1 through SVE-4) are outside the tenant space and are 15 feet in depth with slotted screens from 2 to 15 feet bgs. SVE-5 was installed inside the tenant space using vacuum extraction to a depth of 3 feet bgs and completed with slotted screen from 6 inches to 3 feet bgs. All wells were sealed at the surface with bentonite and concrete grout.

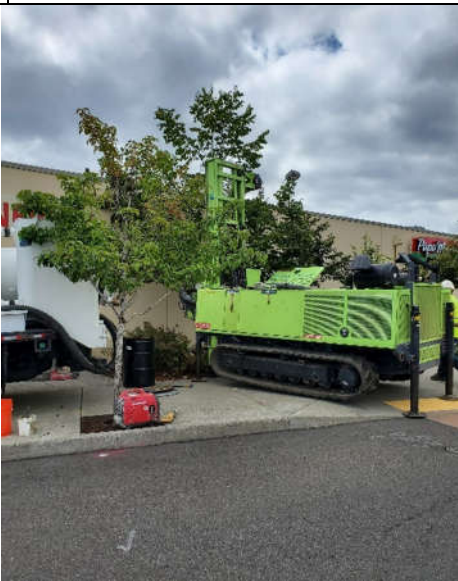
| Photo #2: | Installation of extraction well SVE-4 in the planter area (facing south east). | Photo #4: | Installation of extraction well SVE-5 inside the building. |

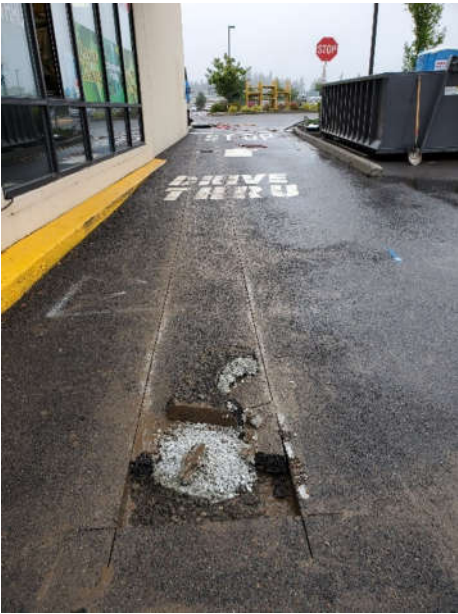
| <p>Photo #5:</p> | <p>Sawing cutting trenches and beginning the modification of SVE-1 (facing north).</p> |

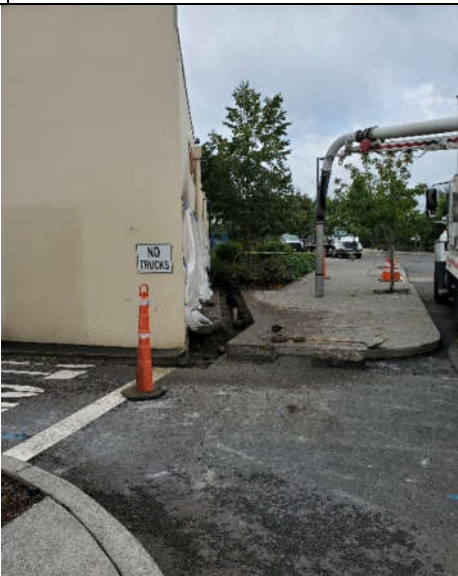
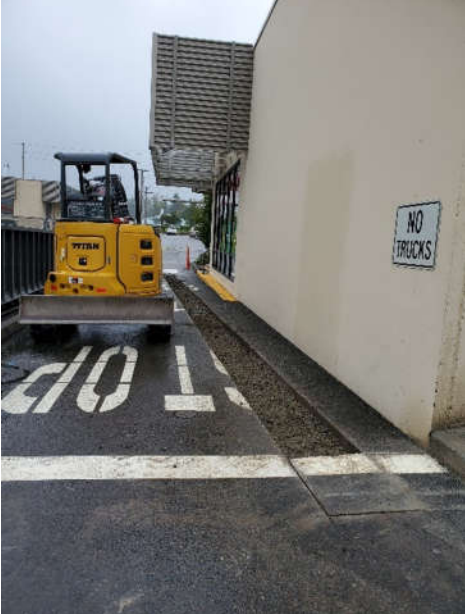
| <p>Photo #6:</p> | <p>Asphalt removal and beginning of trench excavation (facing south).</p> |

The conveyance piping was routed in 2-foot by 2-foot by 2-foot trenches layered with clean backfill and controlled density fill (CDF) to 4 inches bgs. The trench surfaces were restored with asphalt or concrete to the existing grade and conditions. Each SVE well has an independent 2-inch PVC piping for vacuum with a control valve, sample port, and vacuum gauge. These five underground pipes are terminated in the system compound and are connected to a common header connected to the SVE blower (see the attached Site Photographs in Appendix A).

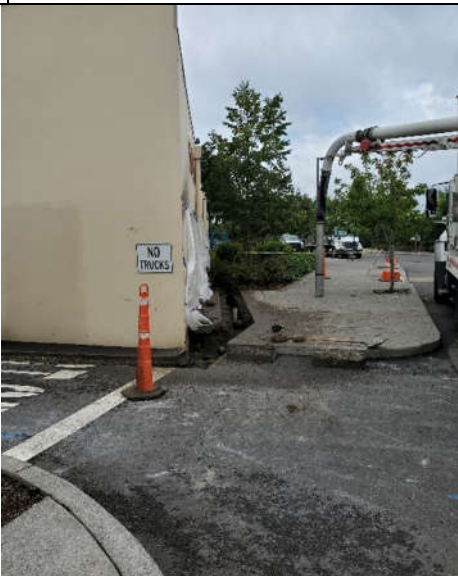
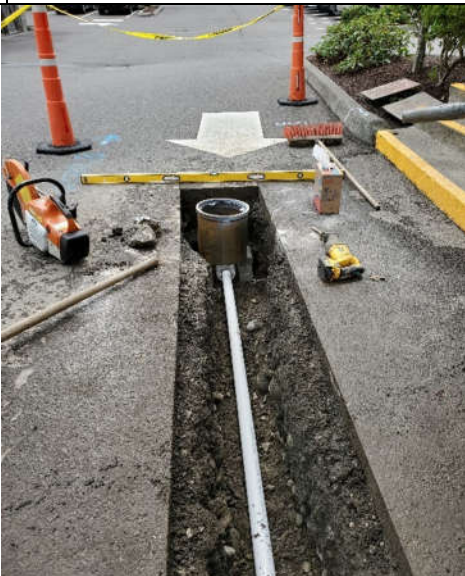
| <p>Photo #7:</p> | <p>Vacuum excavation used to complete trenches extraction well SVE-3 shown (facing west).</p> |

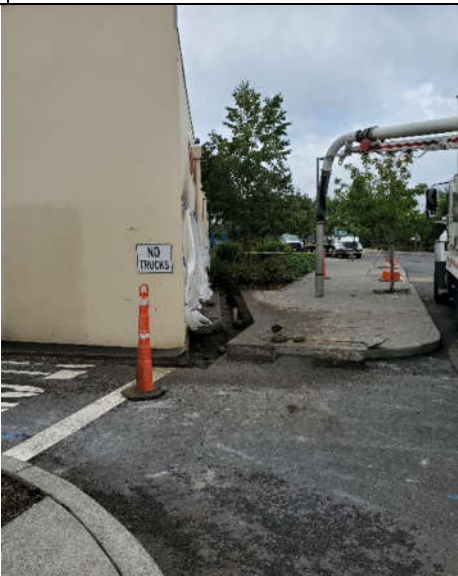
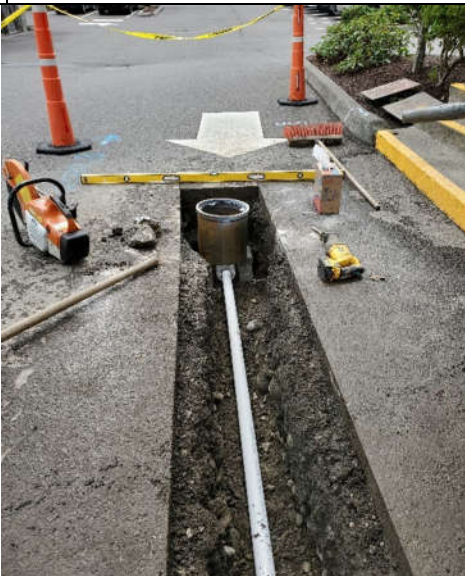
| <p>Photo #8:</p> | <p>Typical extraction well connection to PVC conveyance piping (SVE-1 facing south).</p> |

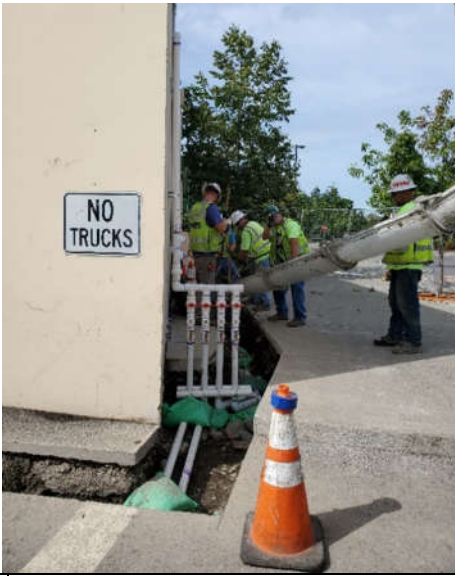
| Photo #9: | Installation of CDF in the trenches before final concrete or asphalt (well manifold facing west). | Photo #10: | Asphalt installation finished to existing grade (facing south). |

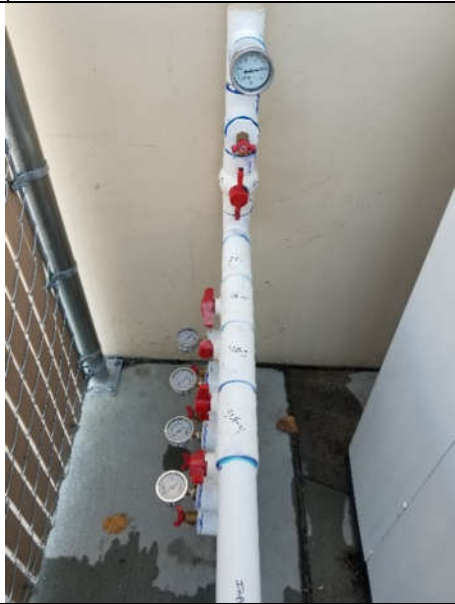
| Photo #11: | SVE well control valve manifold. | Photo #12: | Vacuum applied to extraction well SVE-5 (~19 to 20 inches water column vacuum). |

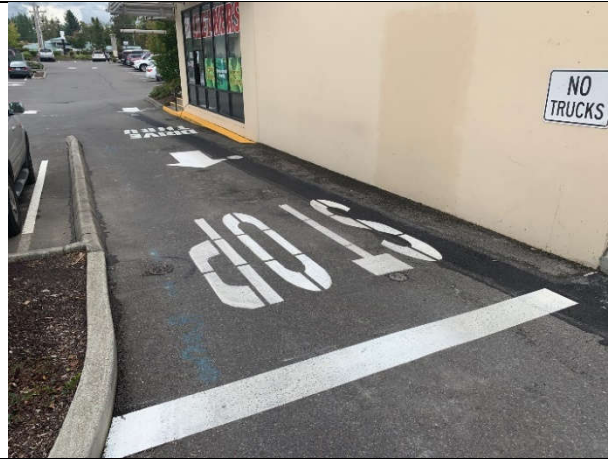
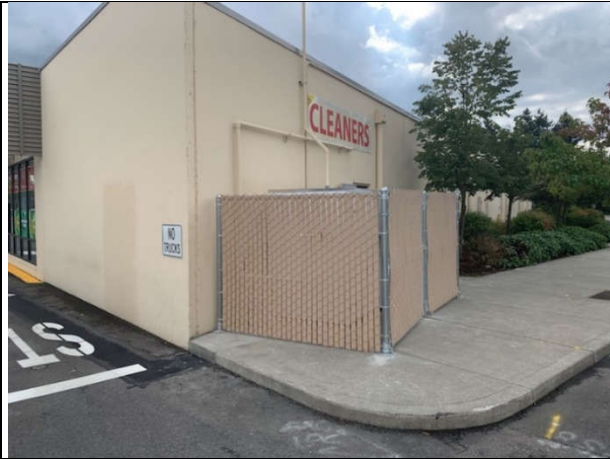
| <p>Photo #13:</p> | <p>Site drive thru restored to existing condition.</p> |

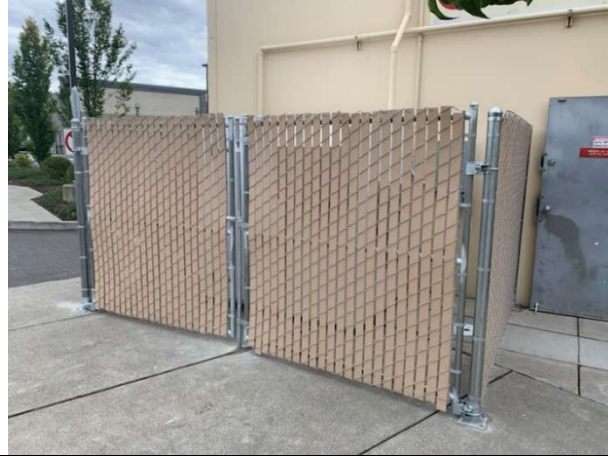
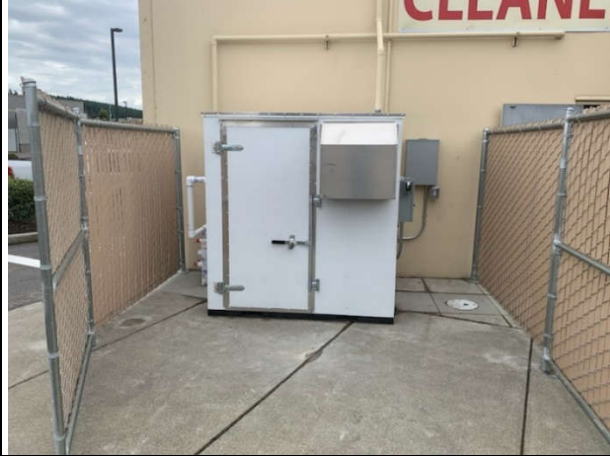
| <p>Photo #15:</p> | <p>Final gates installed (facing south east)</p> |
