Site Investigation Summary Report

Mercer Megablock Project

Seattle, Washington

October 15, 2019
19409-04

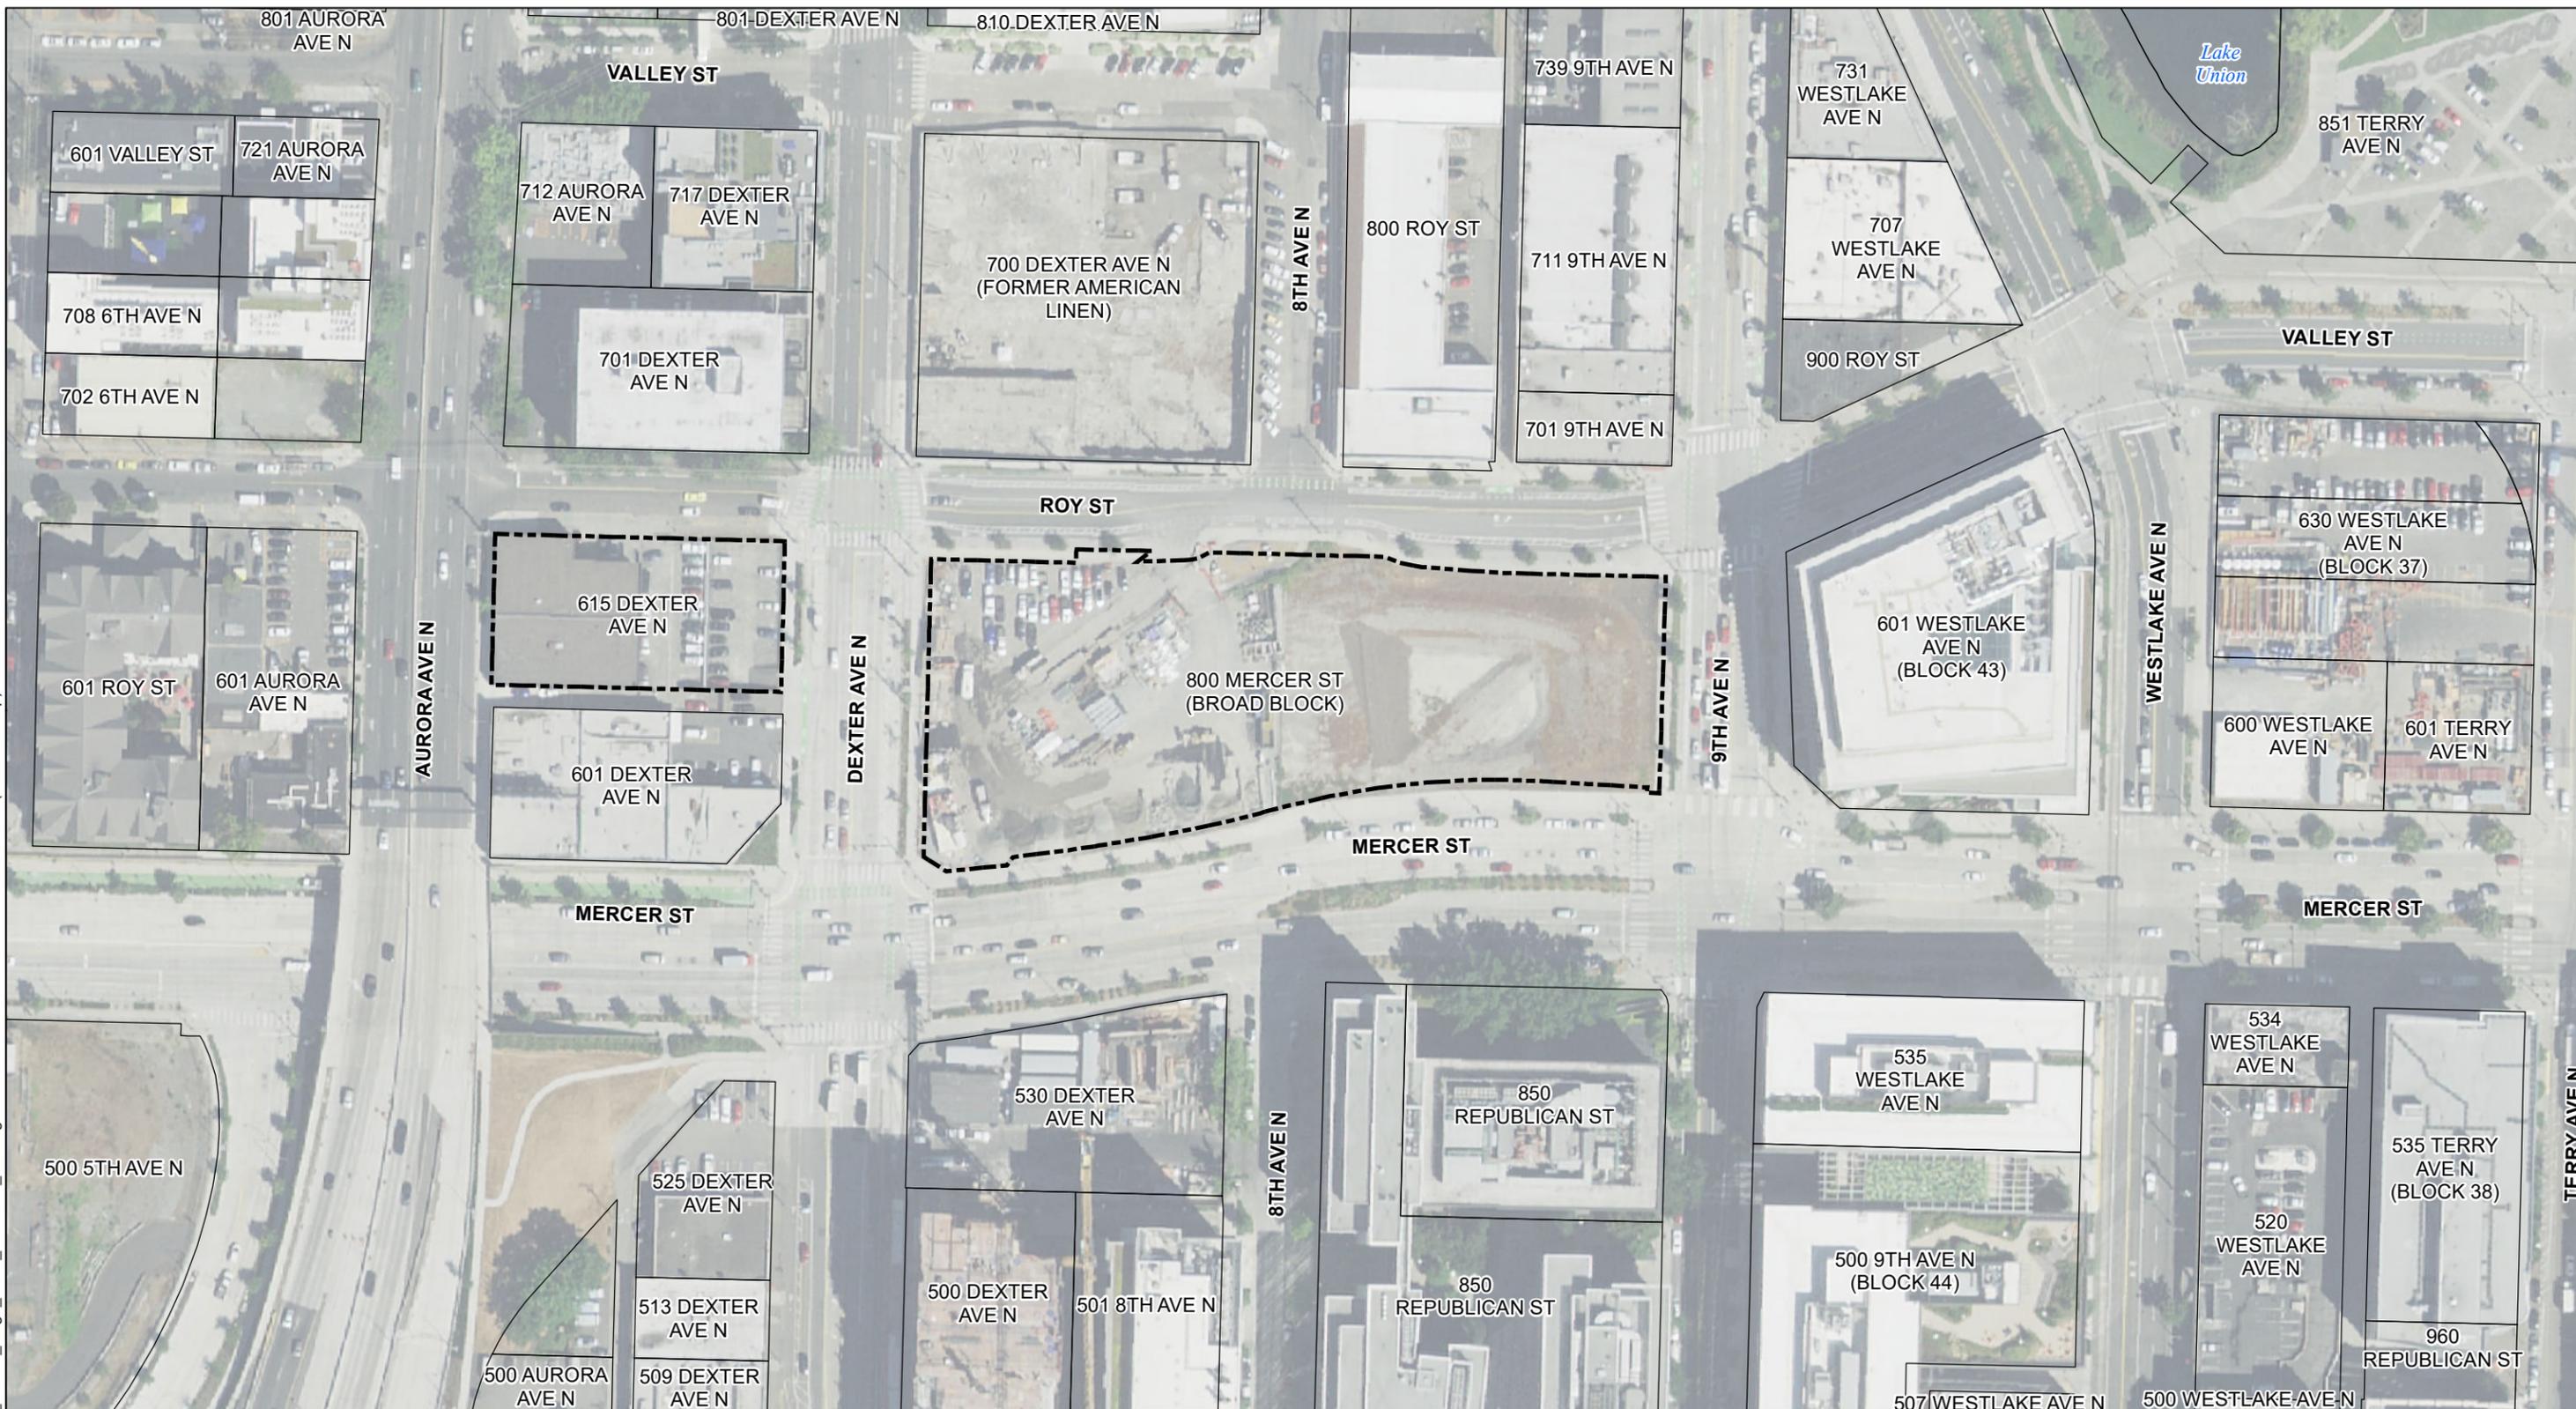
1

The MMB consists of two separate properties—615 Dexter Avenue North (615 Dexter) and 800 Mercer Street (Broad Block). A map of the MMB and surrounding properties is presented in Figure 2. The areas of concern (AOCs) and current site conditions for both 615 Dexter and Broad Block are provided in Figures 3 and 4, respectively.

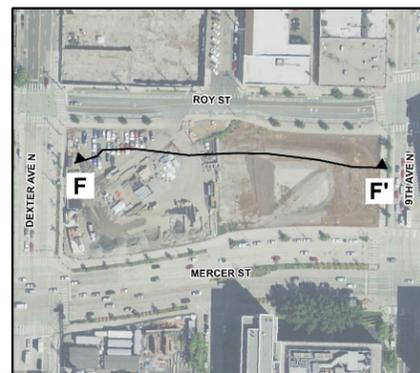
Mercer Megablock Seattle, Washington	
Generalized Subsurface Cross Section F-F'	
19409-04	10/19
	Figure 12

- Fill
- Sand
- Gravel
- Silty Sand
- Silt and/or Clay

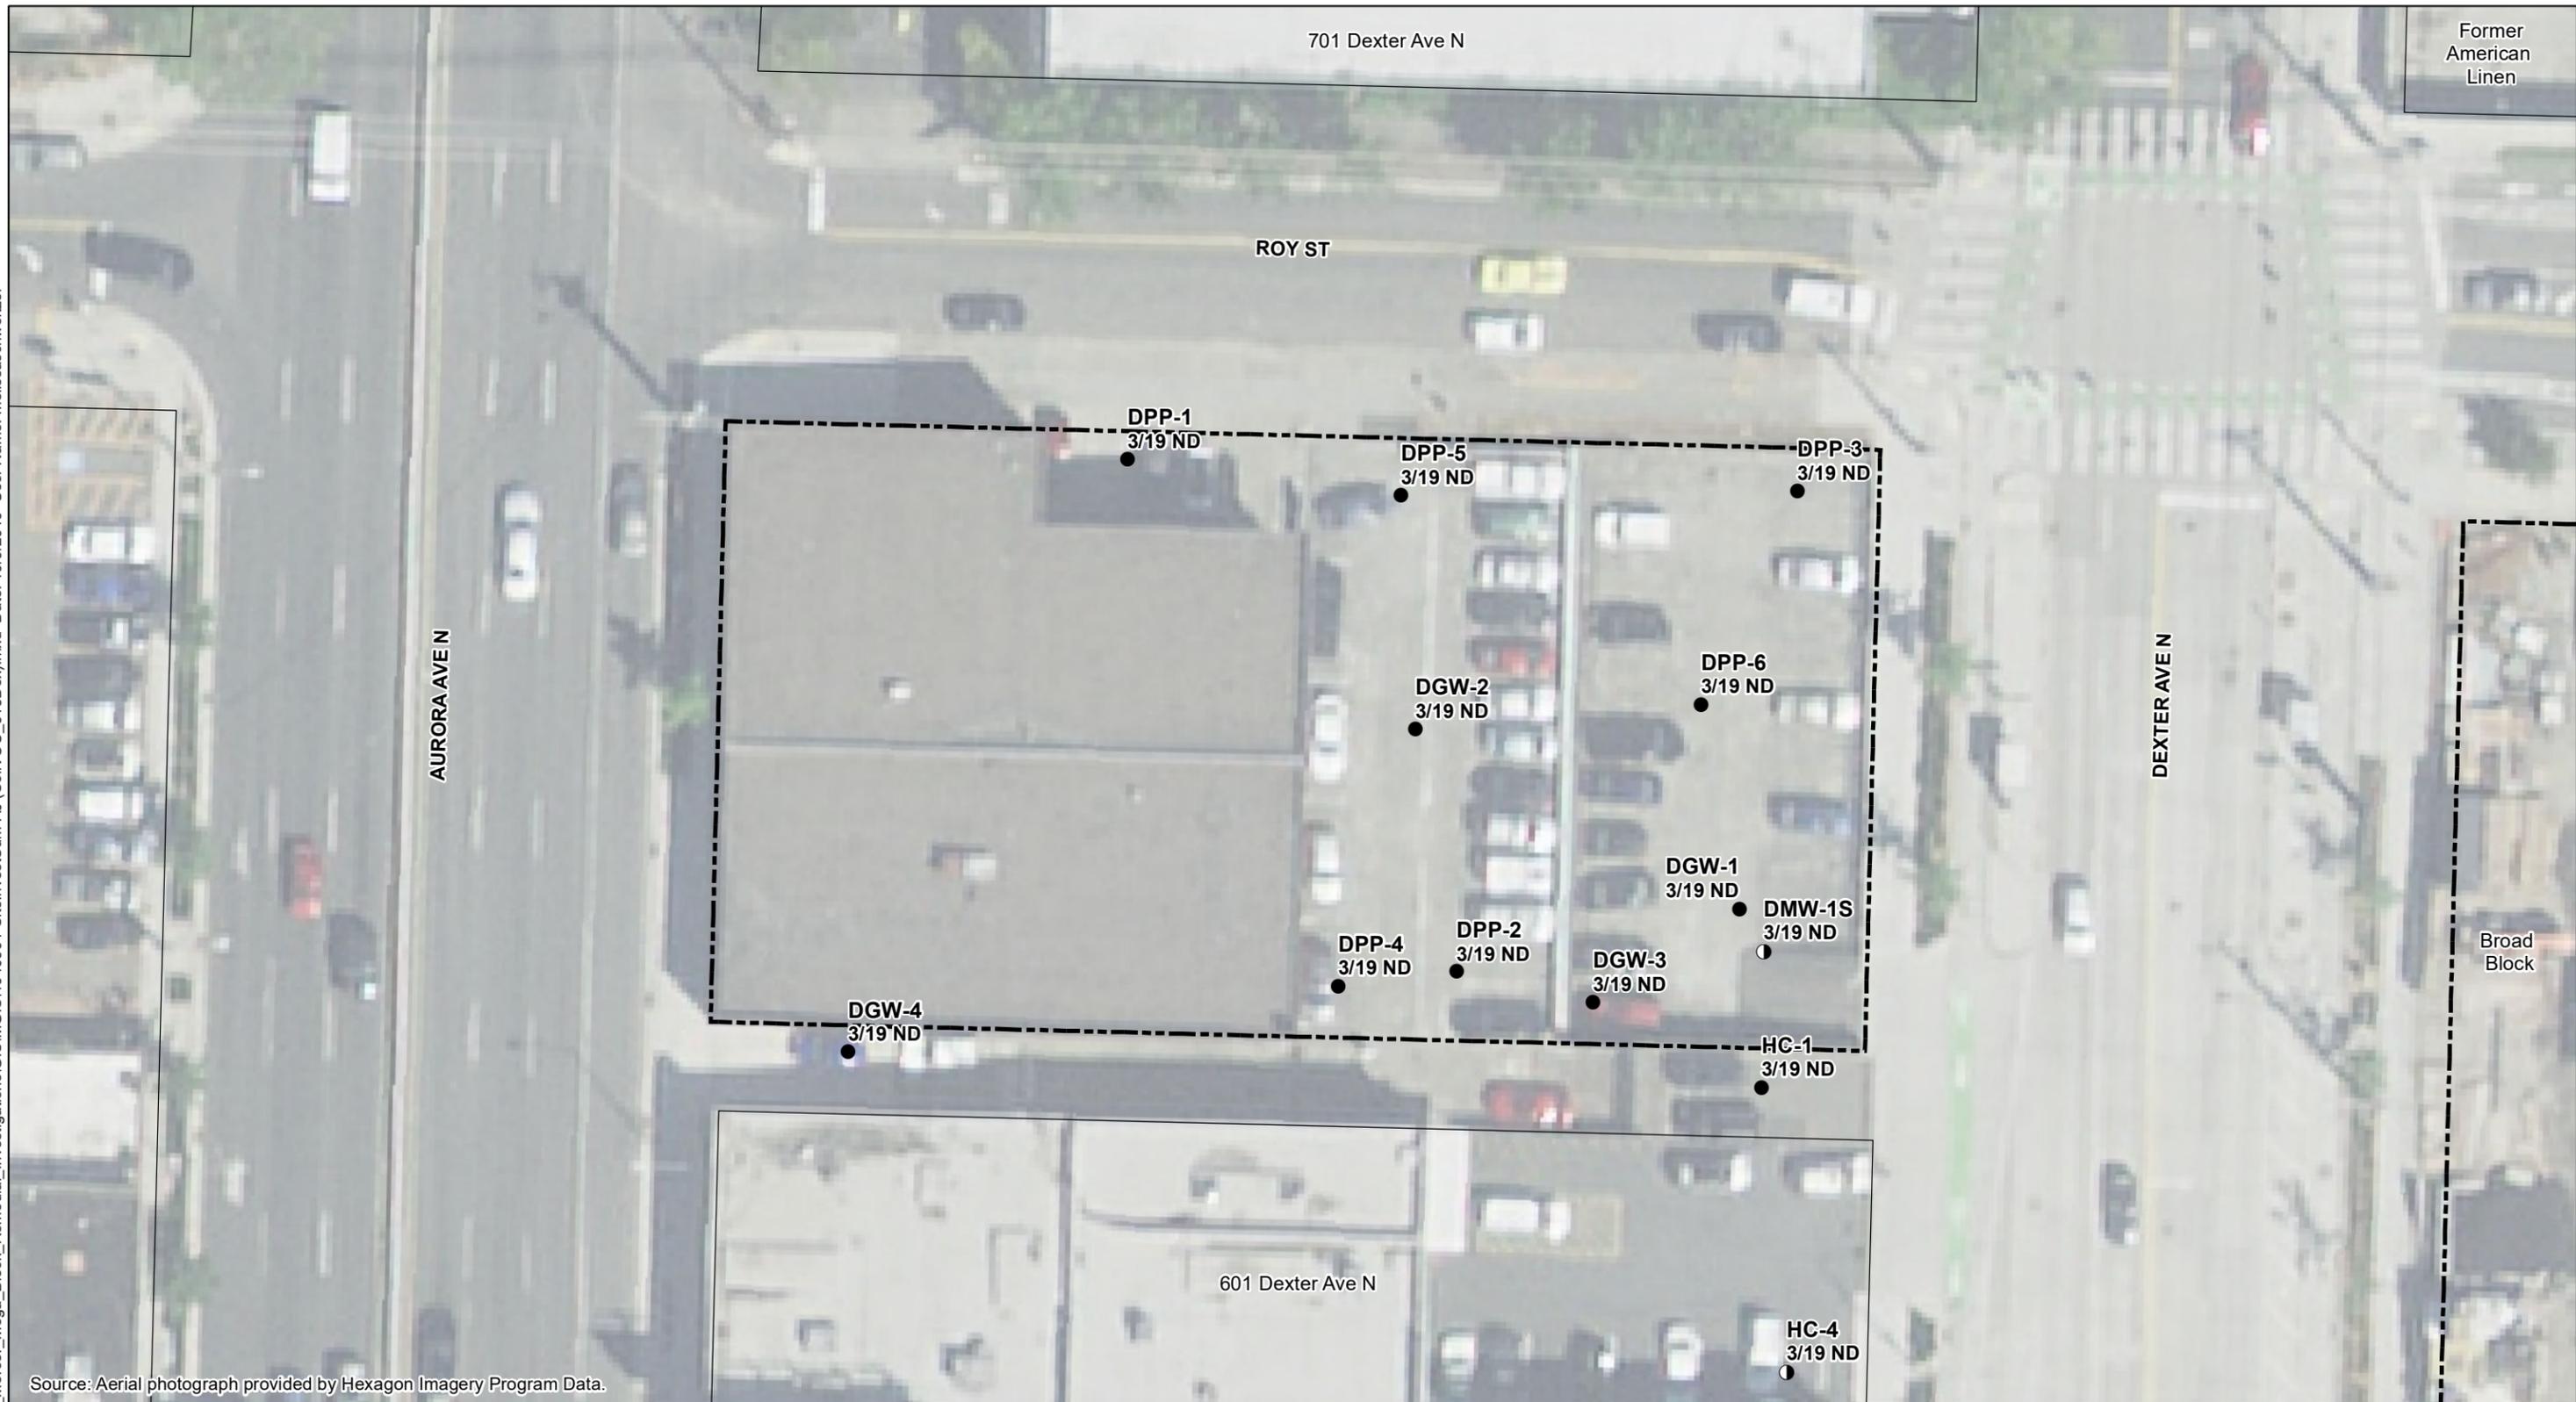
HARTCROWSER Figure
19

A total of 45 soil samples collected from 615 Dexter were submitted for chemical analysis. The distribution of chemical analysis of soil samples from 615 Dexter is summarized in Table 8. Detected concentrations of TPHs, cVOCs, and metals in soil from 615 Dexter are presented in Figures 19, 20, and 21, respectively. The concentrations of TPH and cVOCs from 615 Dexter are also illustrated on subsurface cross sections (Figures 24 through 27).
