CONCEPTUAL SITE MODEL AND DATA GAPS REPORT
Former Jensen Shipyard
FRIDAY HARBOR, WASHINGTON

Subject: CONCEPTUAL SITE MODEL AND DATA GAPS REPORT, FORMER JENSEN SHIPYARD, FRIDAY HARBOR, WASHINGTON

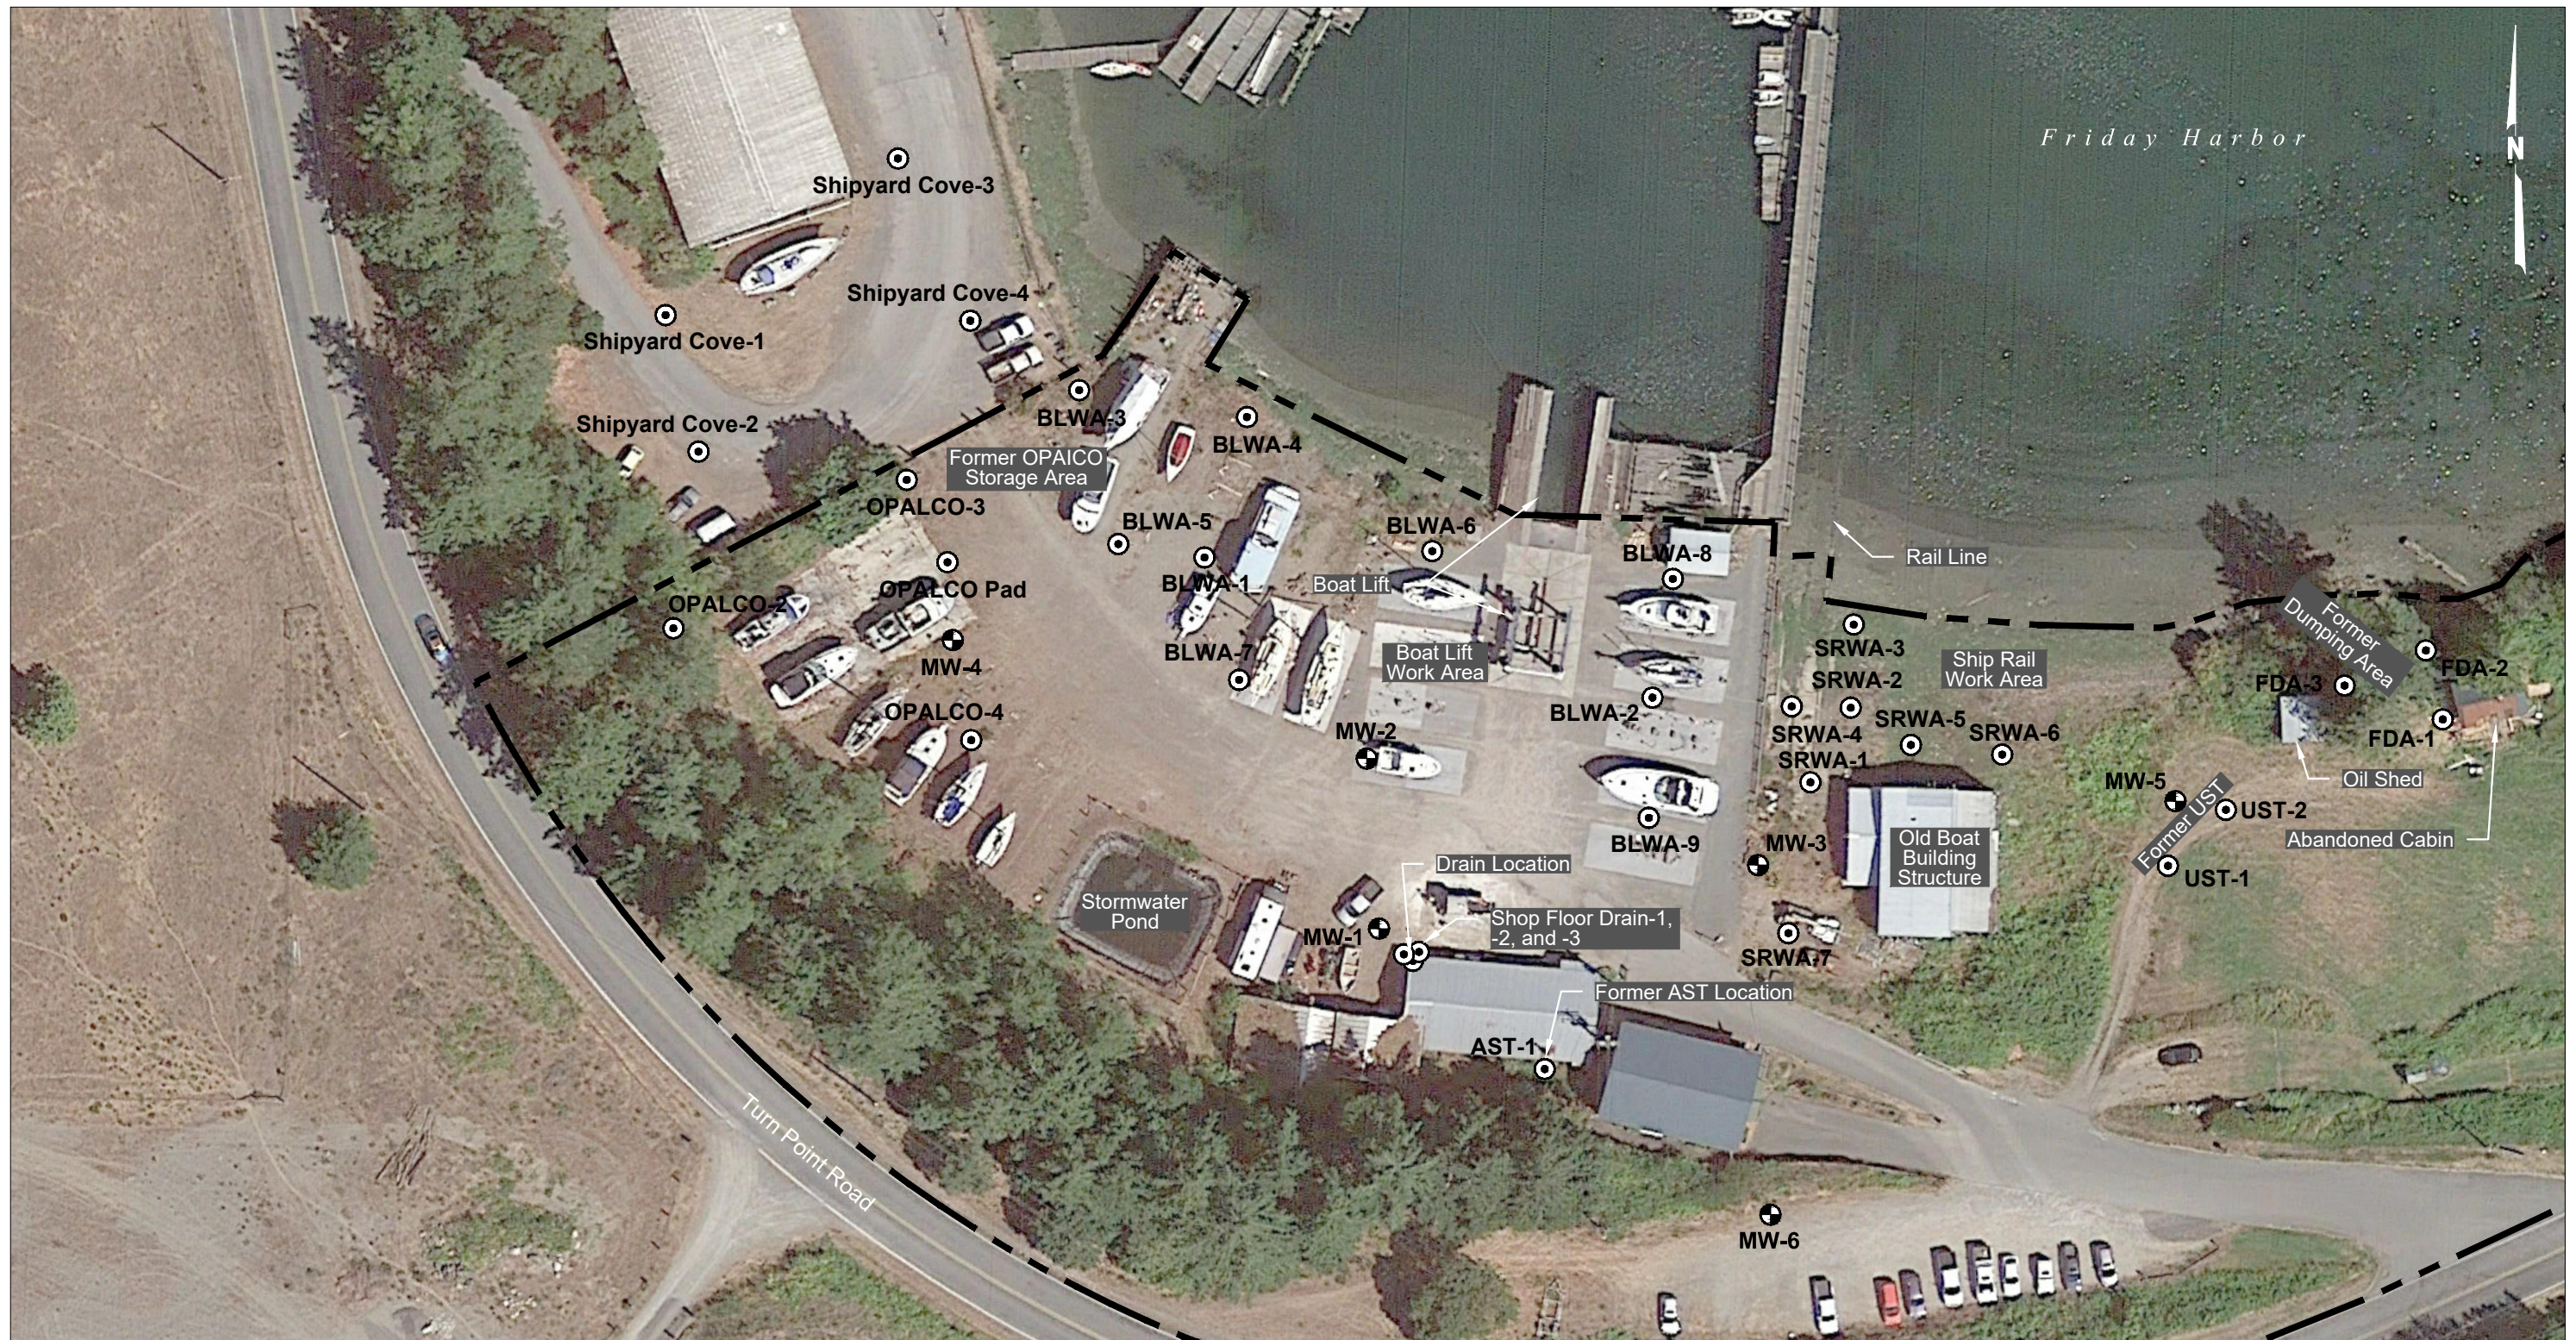
Jensen Shipyard 1293 Turn Point Road Friday Harbor, Washington	
UPLANDS PRIMARY SOURCE AREAS	
September 2019	101579-001
SHANNON & WILSON, INC. GEOTECHNICAL AND ENVIRONMENTAL CONSULTANTS	
FIG. 3

- 1. General boat maintenance is site wide primary source.

The former OPALCO storage area is in the western portion of the site and extends north to the shoreline. Contamination in this area includes surface contamination of cPAHs, cadmium, copper, lead, and zinc. The contamination is likely due to shipyard operations in the area, including stripping paint. Additionally, OPALCO may have stored creosote-treated wood. The OPALCO building burned down and only the building foundation remains, contributing to the cPAH contamination in the area.

The BLWA is near the shoreline. cPAHs and zinc contamination exists in the surface soil. Copper, lead, and TPH-D are present a few feet deep, and are not vertically limited. Metals contamination is likely from stripping and applying paint in the work area. cPAH contamination is likely from the presence of treated wood in the area or draining bilges, which frequently contain engine oil or lubricants. TPH-D contamination may be from dumping of fuel, draining of bilges, or leaks while working on boats in the work area. Fill was likely brought in at some point to elevate this area, which may have been contaminated from its former area of use. The limits of contamination in the BLWA are not defined to the south.

The SRWA is to the west of the boat building, a structure where boats were historically built and repaired. A rail line exists to the east of the pier. Surface contamination includes copper and zinc, likely from the paint stripping operations, or loose paint flaking off boats during their transport. Deeper contamination includes cPAHs, arsenic, lead, mercury, and

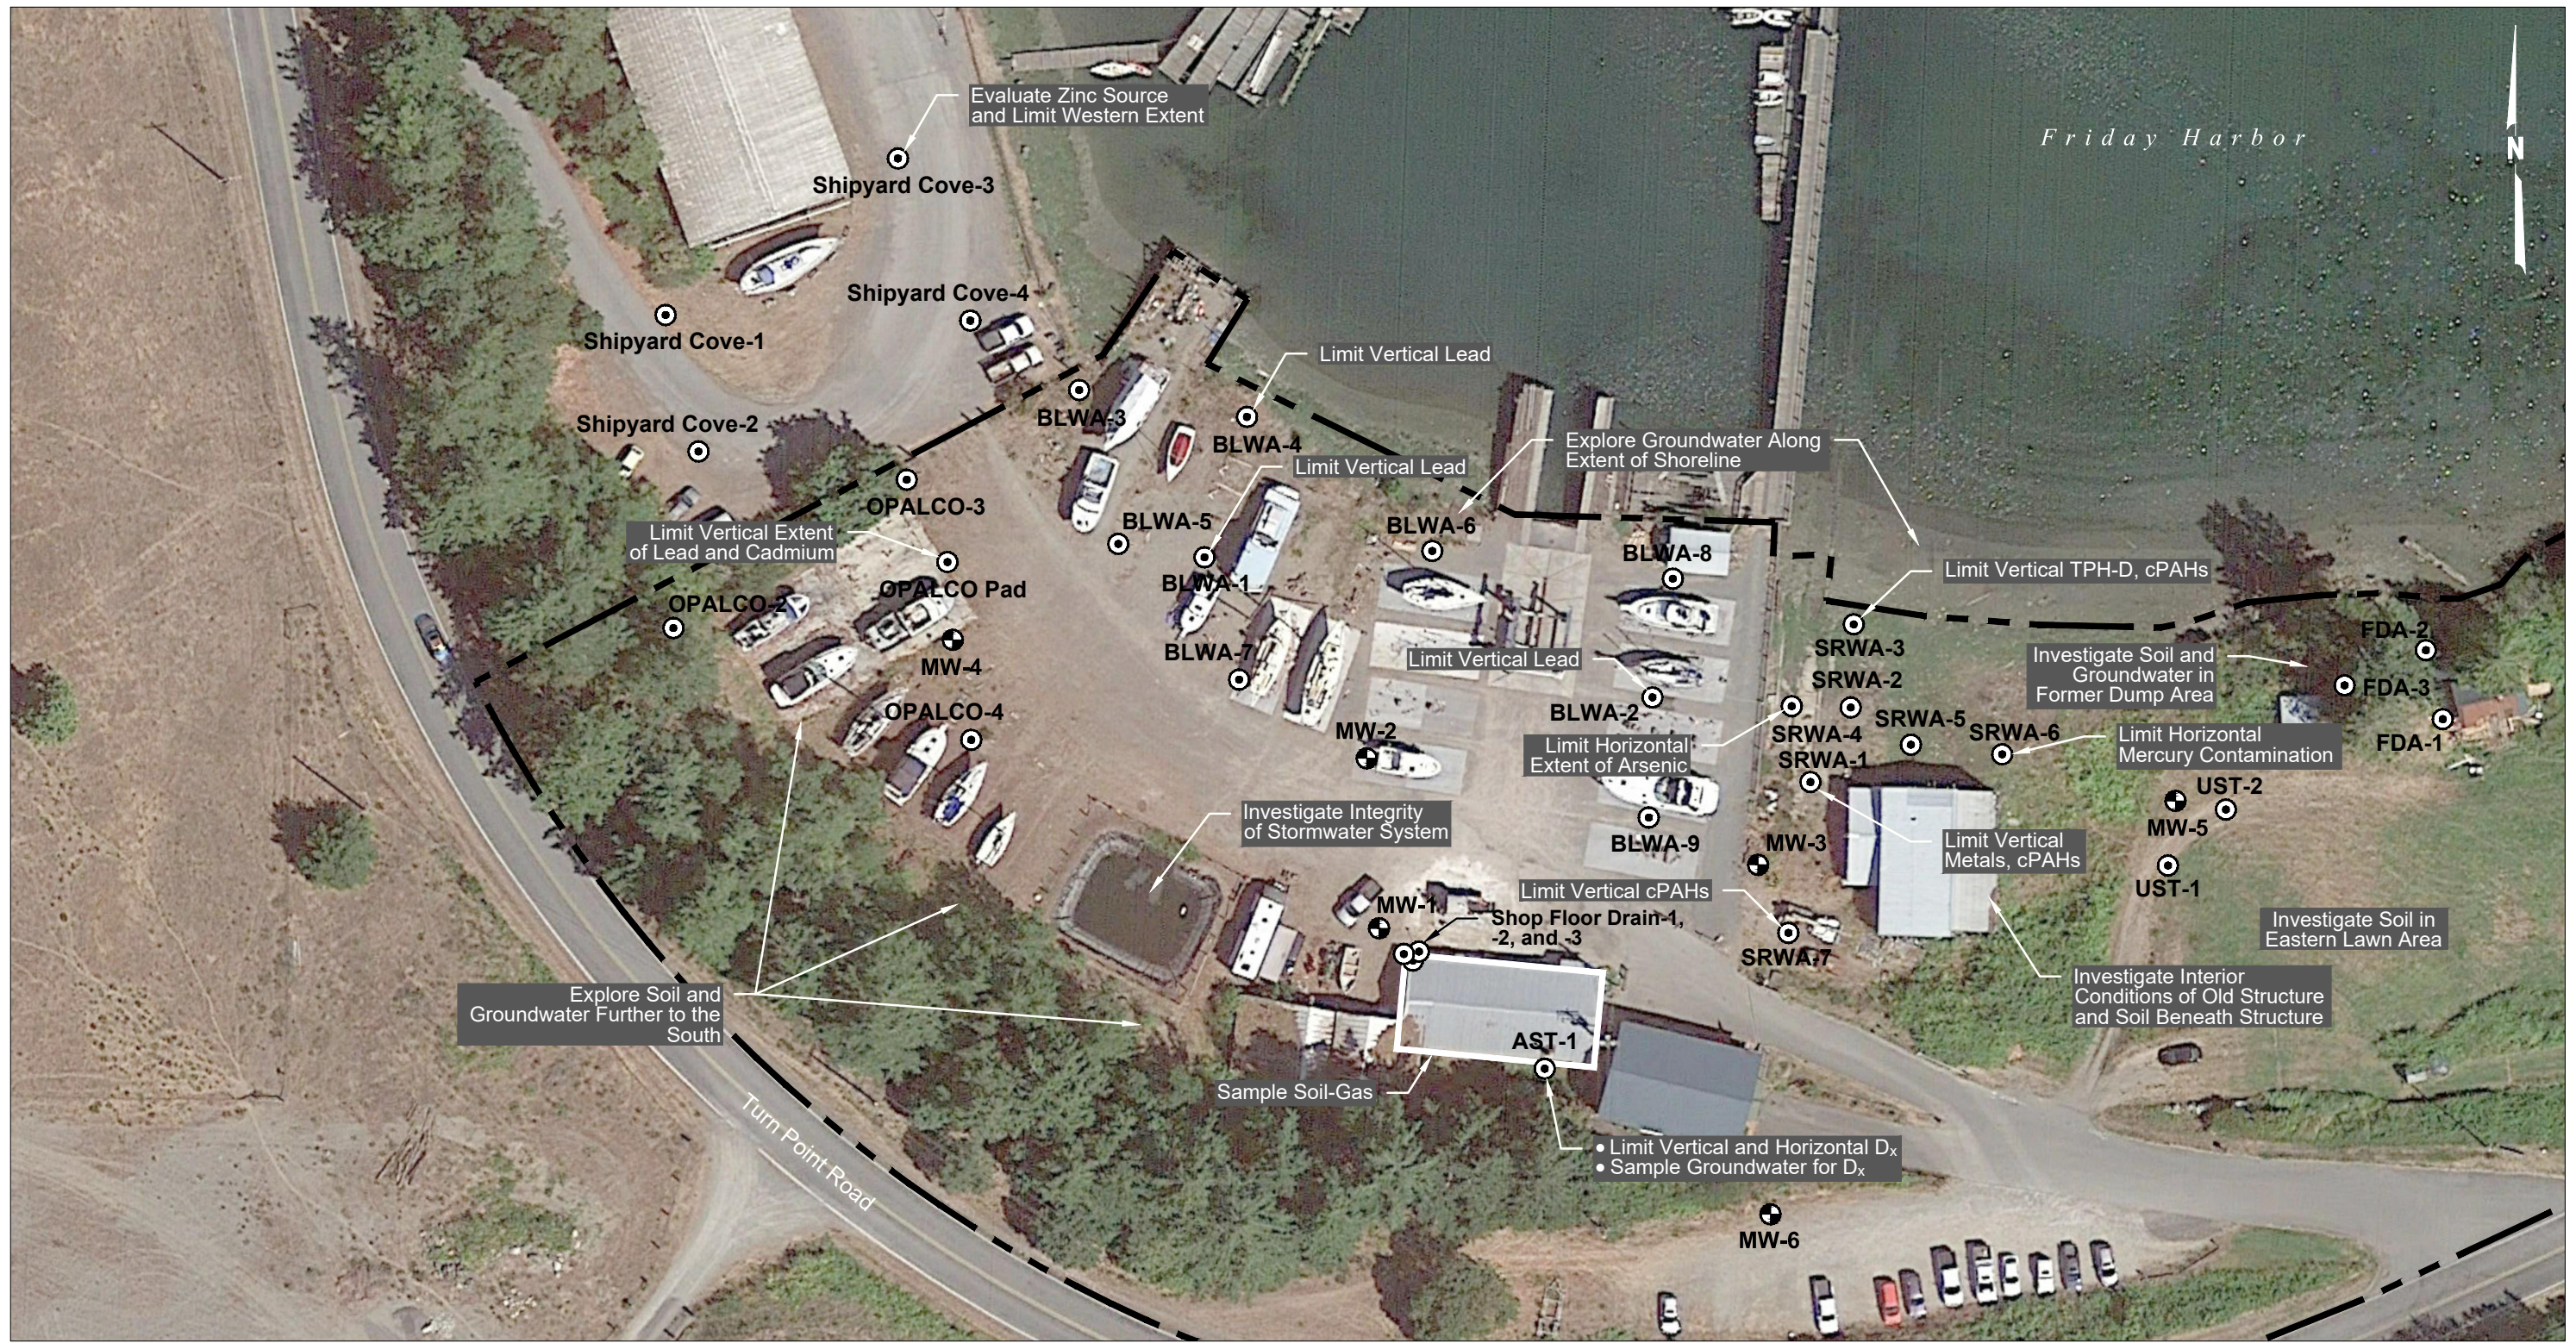
MW-1 Monitoring Well Designation and Approximate Location

To fill in the data gaps, additional exploration and delineation is recommended. Additional recommended explorations are shown in Figure 5.
