## SITE HAZARD ASSESSMENT

### Worksheet 1: Summary Score Sheet

**SITE NAME:** Mill Creek Crossing Prime Cleaners

18001 Bothell Everett Hwy, Suite 125

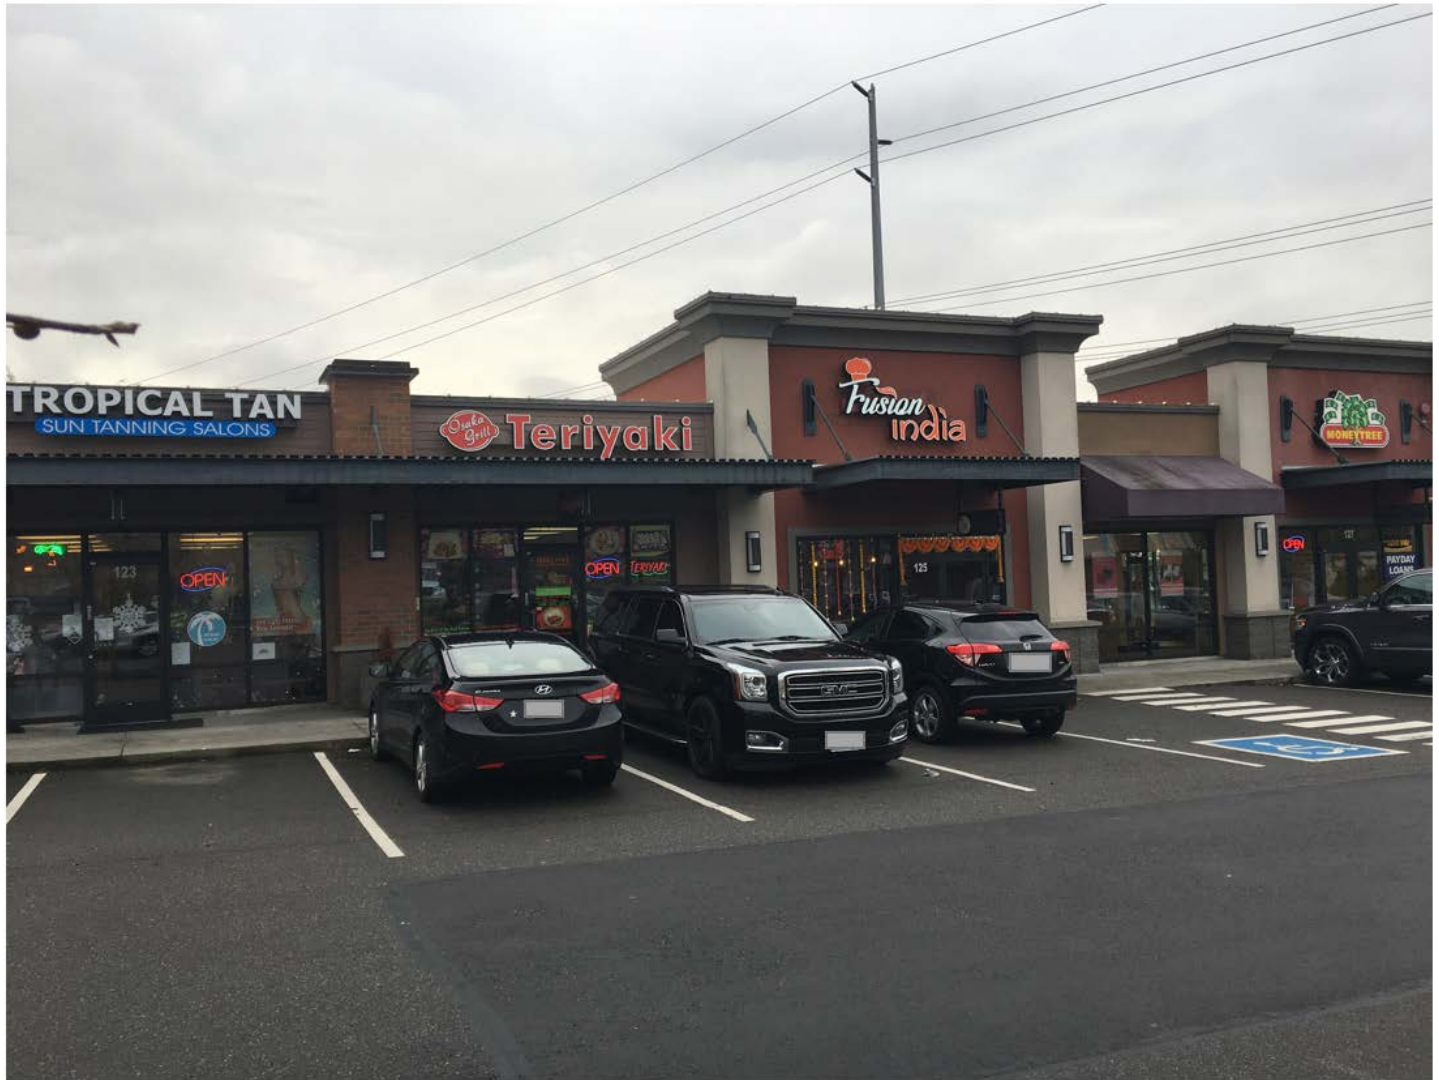
Occupants of the end of strip mall where the dry cleaners were historically located. Prime Cleaners was located in the Fusion India space, and another cleaner was located in the Money Tree space. Photo from December 5, 2019 site visit (boxes added later to cover license plates).

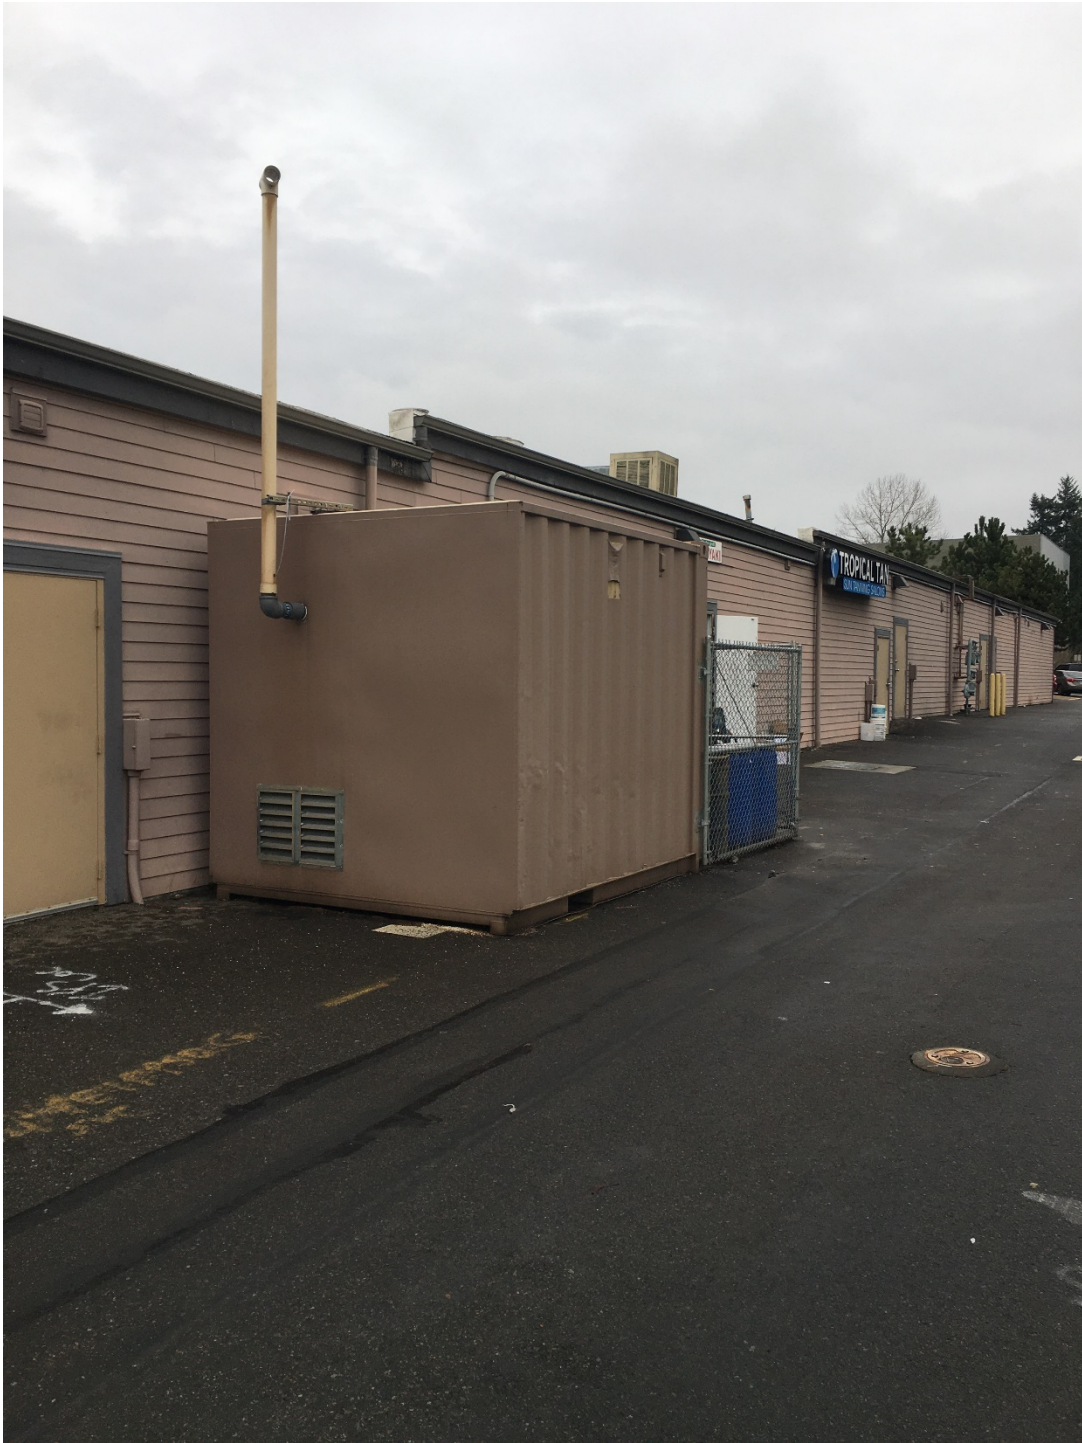
Conex box housing DPE system located on the south side of the retail building. MW-4 is visible in the bottom right portion of the photo. Photo from December 5, 2019 site visit.

DPE system startup was in February 2017; following a few months of troubleshooting and addressing mechanical issues, the system has been running continuously since June 2017 other than scheduled maintenance and groundwater sampling events. Groundwater monitoring since system startup has shown decreasing concentrations of PCE in the previously impacted wells. As of the January 2019 sampling, only MW-4 and -8 had PCE above cleanup levels, with a maximum concentration of 12.1 µg/L. (see Figure 4).

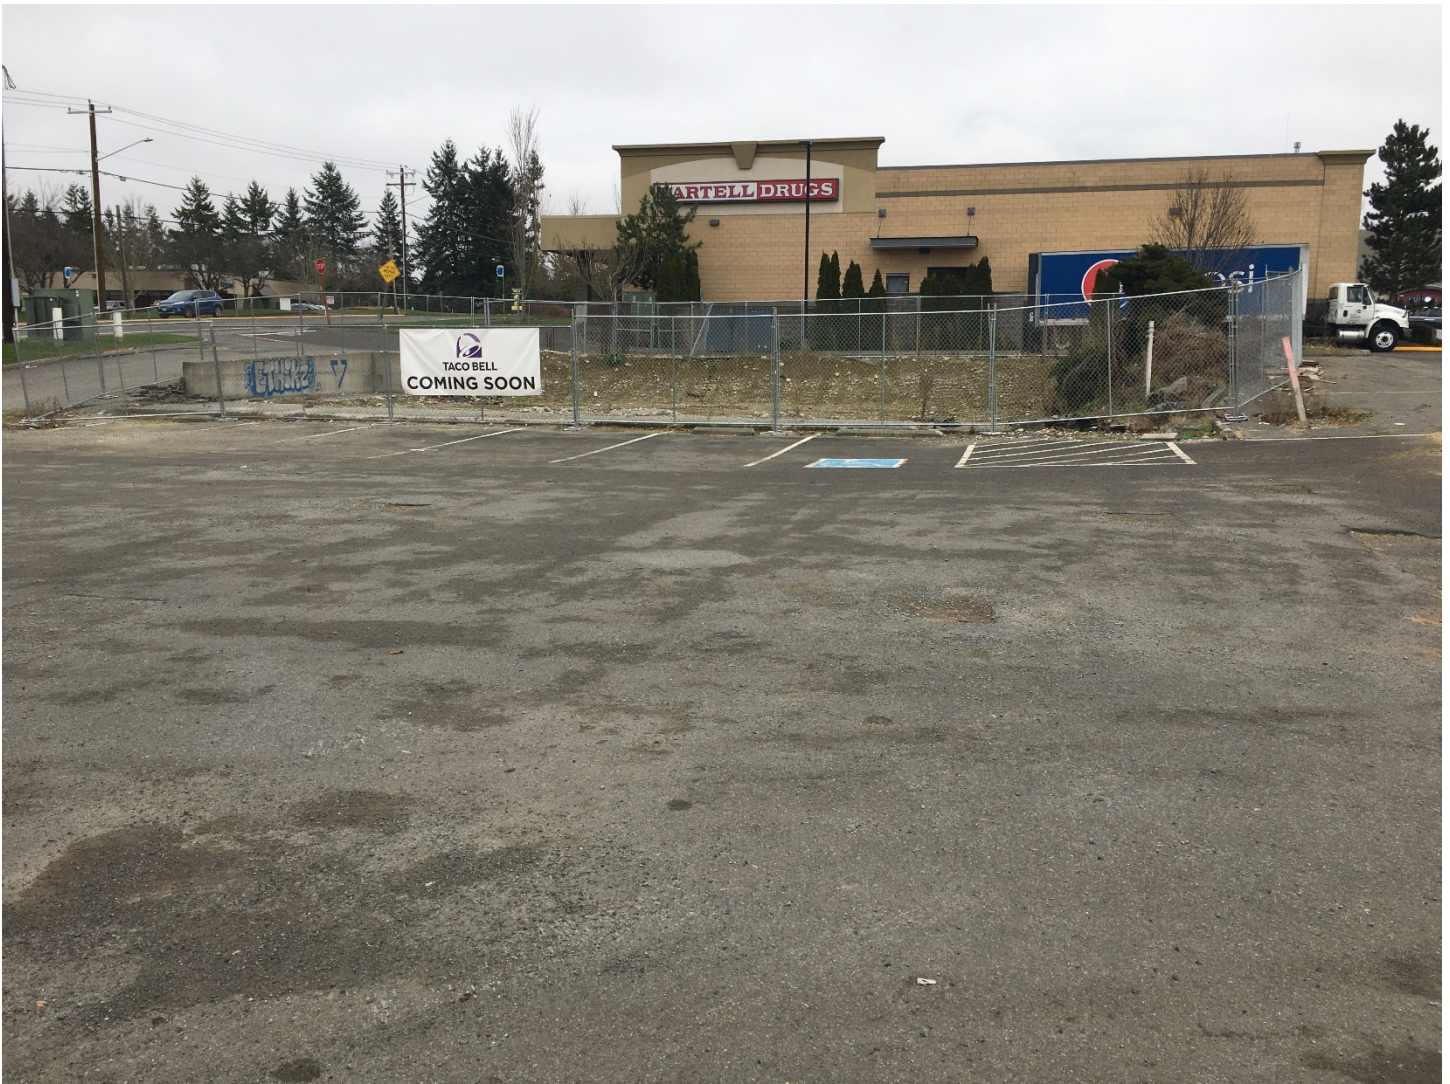
Former location of Plaid Pantry building in the northwest portion of Mill Creek Crossing plaza. Photo from December 5, 2019 site visit.

The Assessor visited the Site on December 5, 2019. Conditions generally reflected those described in Site reports. The Plaid Pantry building in the northeast corner of the plaza had been demolished by the time of the visit. Photos from the visit are included below.
