**PHASE I**  
**ENVIRONMENTAL SITE ASSESSMENT REPORT**

**King County Tax Parcel Nos. 3622069065, 0121069002, and 3522069018**  
**Ravensdale, Washington**

**Farallon PN: 1280-002**

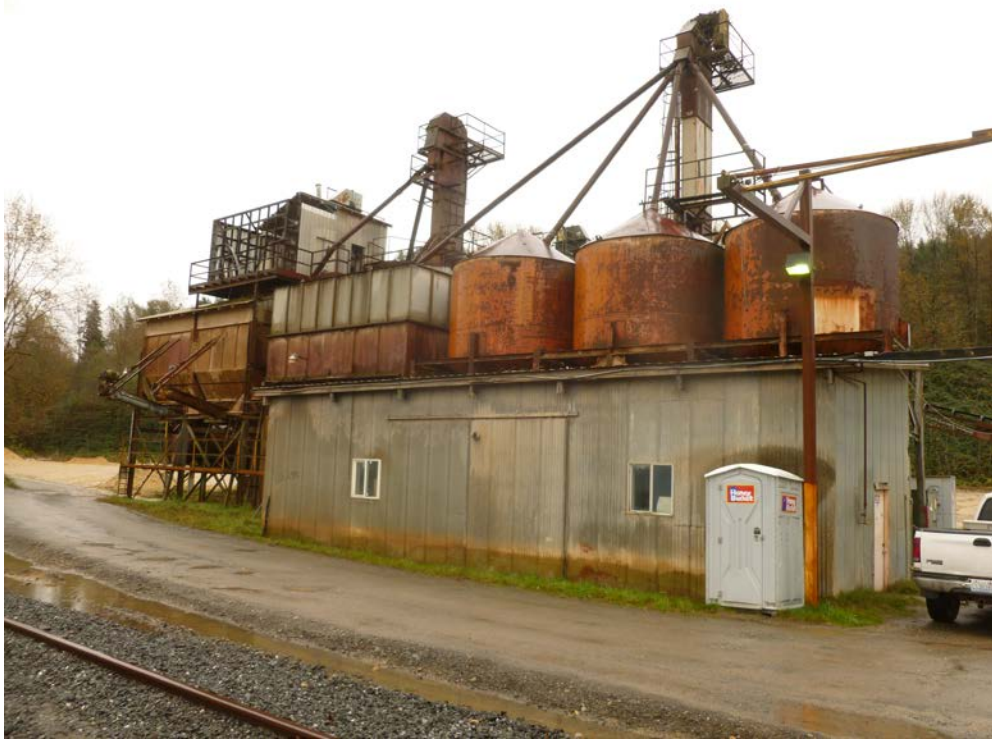
**Photograph 1:** Office building and former sand mining equipment, looking southeast.

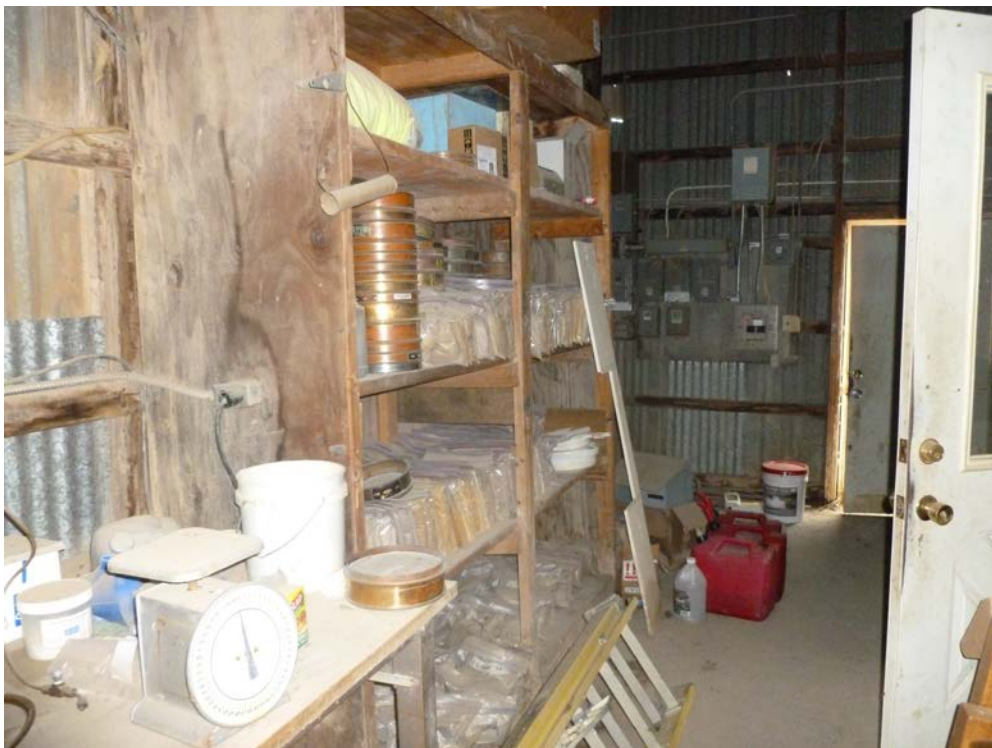
**Photograph 2:** Interior of former laboratory building.

Farallon observed three 3-gallon gasoline containers, one 5-gallon bucket of equipment cleaner, and 2 quarts of engine oil in the former laboratory building at the Site. The containers were not situated in secondary containment, and the three gasoline containers were not properly labeled. Farallon did not observe staining in the vicinity of the containers at the time of the reconnaissance.

Mine laboratories are known to use chlorinated solvents and other hazardous materials as part of operations. The potential release of hazardous substances in connection with mining operations, including the possible storage and handling of hazardous substances at and near the former laboratory building, represents a recognized environmental condition for the Site.

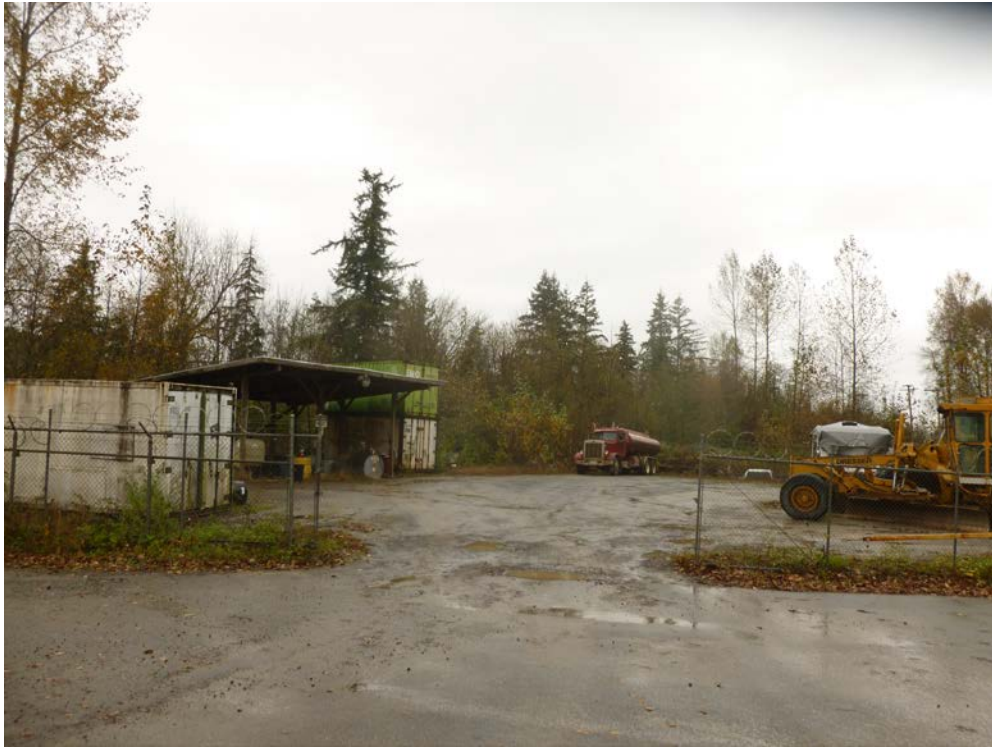
**Photograph 3:** Equipment storage area, aboveground storage tank (AST) and drums, looking east.

One 500-gallon diesel fuel AST, one empty 150-gallon gasoline AST, and one 150-gallon waste-oil AST were observed in the equipment storage area on the northeast portion of the Site. All three ASTs were situated in secondary containment, sealed or covered, and properly labeled. Significant staining was observed in the vicinity of the ASTs. The potential release of hazardous substances in connection with the current storage and handling of hazardous substances represents a recognized environmental condition for the Site.

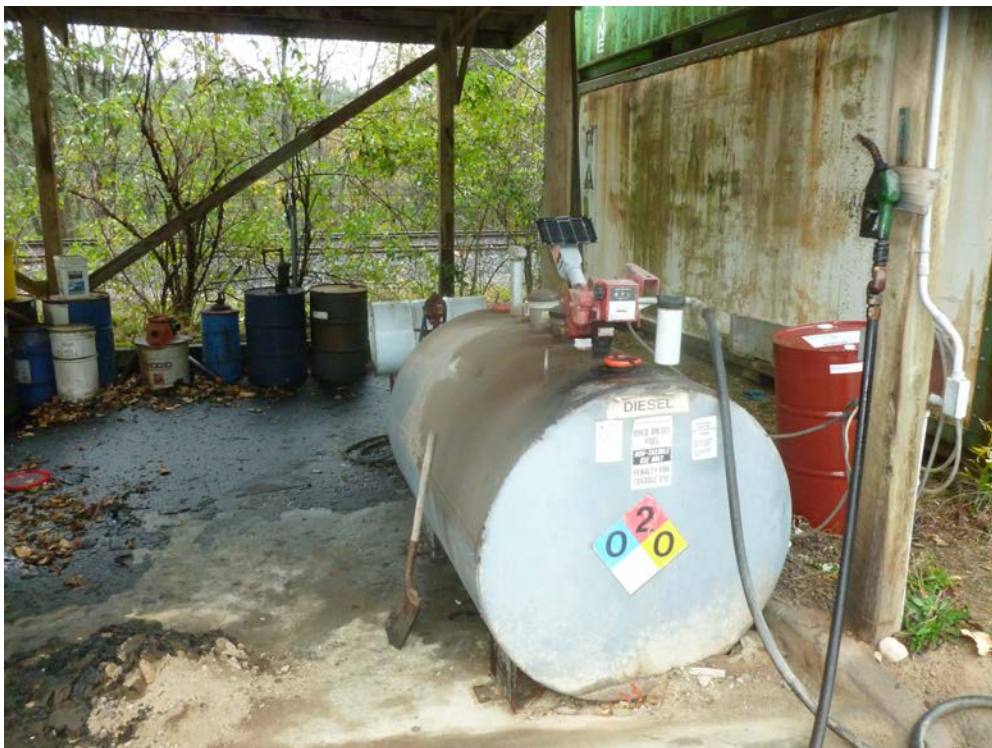
**Photograph 4:** Diesel AST and hazardous materials storage in equipment storage area.

Farallon observed various containers of hazardous materials, petroleum products, antifreeze, new motor oil, lube oils, and grease ranging in size from 1 quart to 55-gallon drums in a large metal container and in the covered equipment storage area. The materials are used as part of Site operations.

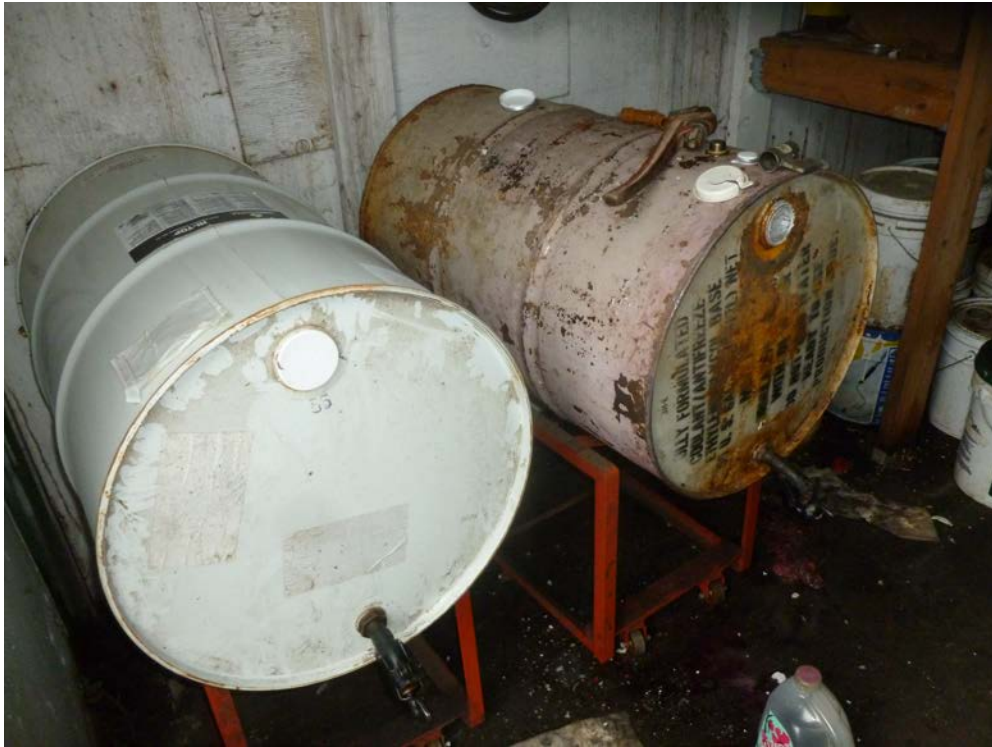
**Photograph 5:** Hydraulic oil drum and antifreeze in hazardous materials storage in equipment storage area.

Although some of the containers were stored in designated storage rooms, situated in secondary containment, sealed or covered, and properly labeled, some of the containers in the large metal container were not in secondary containment at the time of the site reconnaissance. Farallon observed substantial staining in the equipment storage area at the time of the reconnaissance.

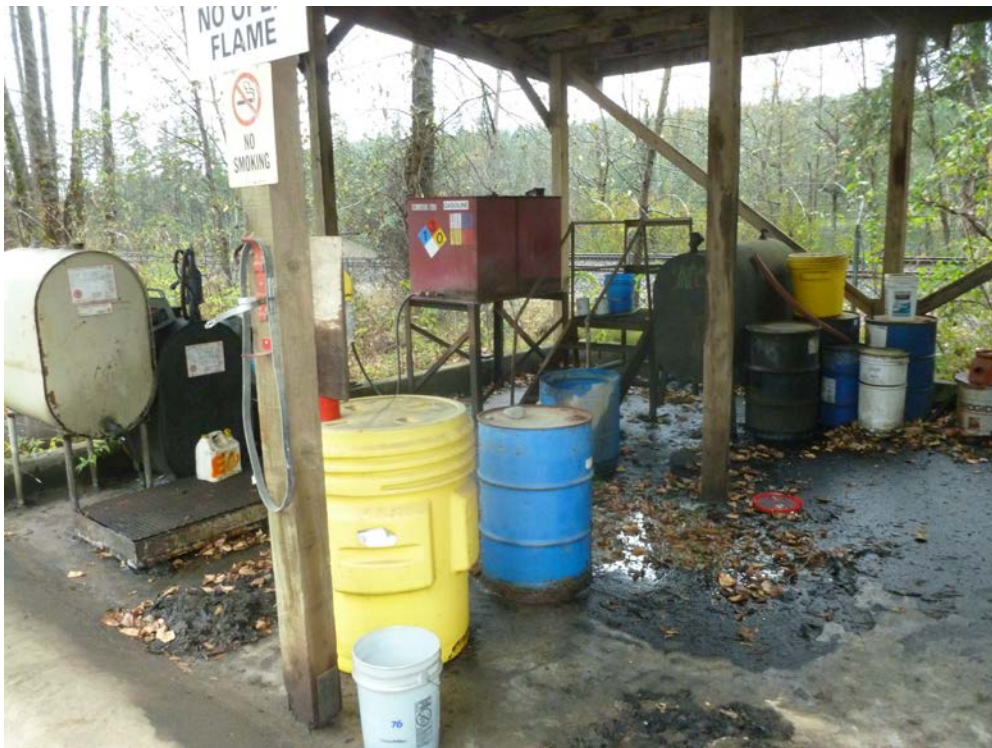
**Photograph 6:** Empty gasoline AST and other hazardous material containers under canopy in equipment storage area.

One waste-oil AST was situated in secondary containment under a canopy in the equipment storage area. Evidence of a waste-oil spill was observed under the canopy during the site reconnaissance. The spill appeared to be contained by the secondary containment concrete pad and berm surrounding the hazardous materials storage area. According to the Site representative, mobile equipment is the only source of waste oil at the Site; Modern Machinery disposes of the waste oil after servicing the equipment (Farallon 2014c).

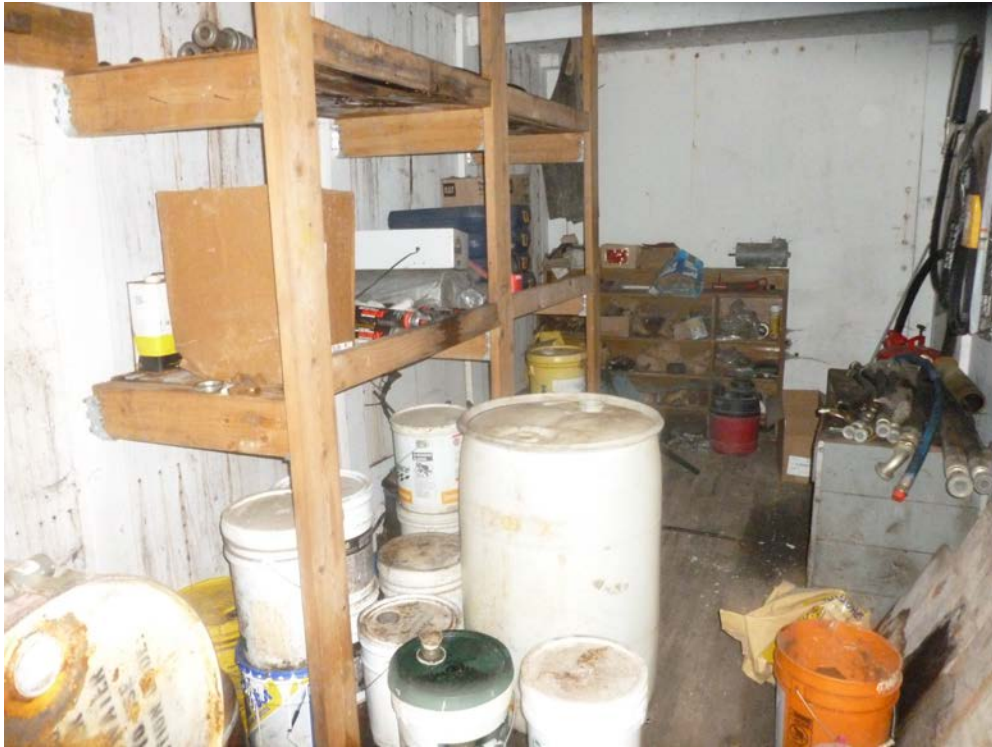
**Photograph 7:** Hazardous materials storage container in equipment storage area.

The potential release of hazardous substances in connection with the current storage and handling of hazardous substances represents a recognized environmental condition for the Site.

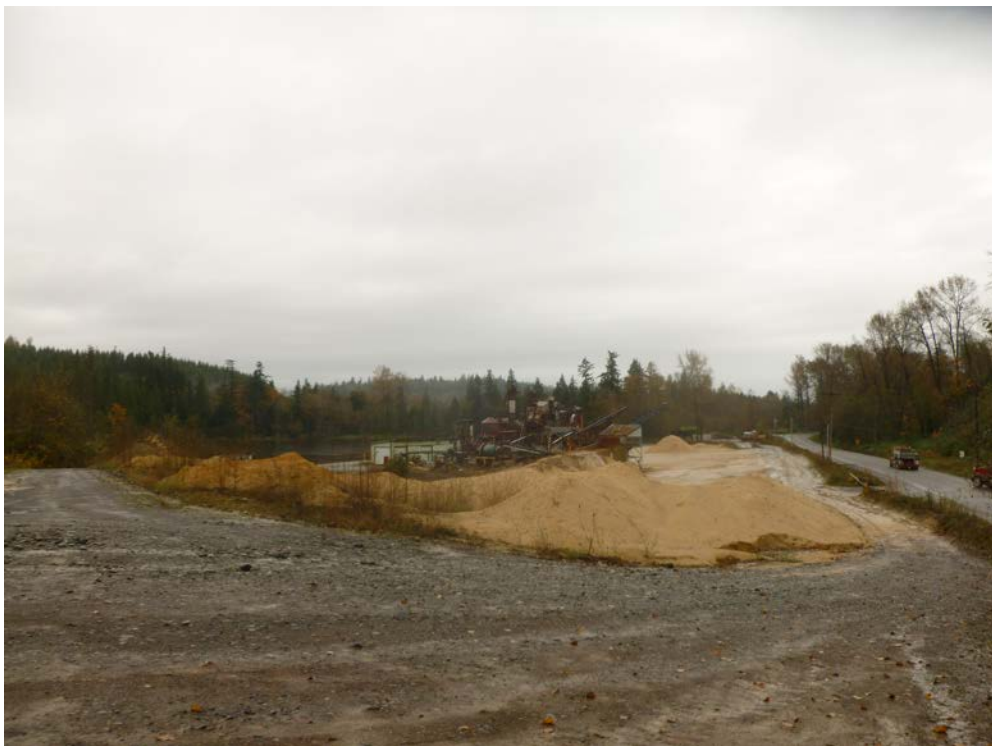
**Photograph 8:** Sand piles, former sand mining equipment, and office on northeast portion of Site, looking east.

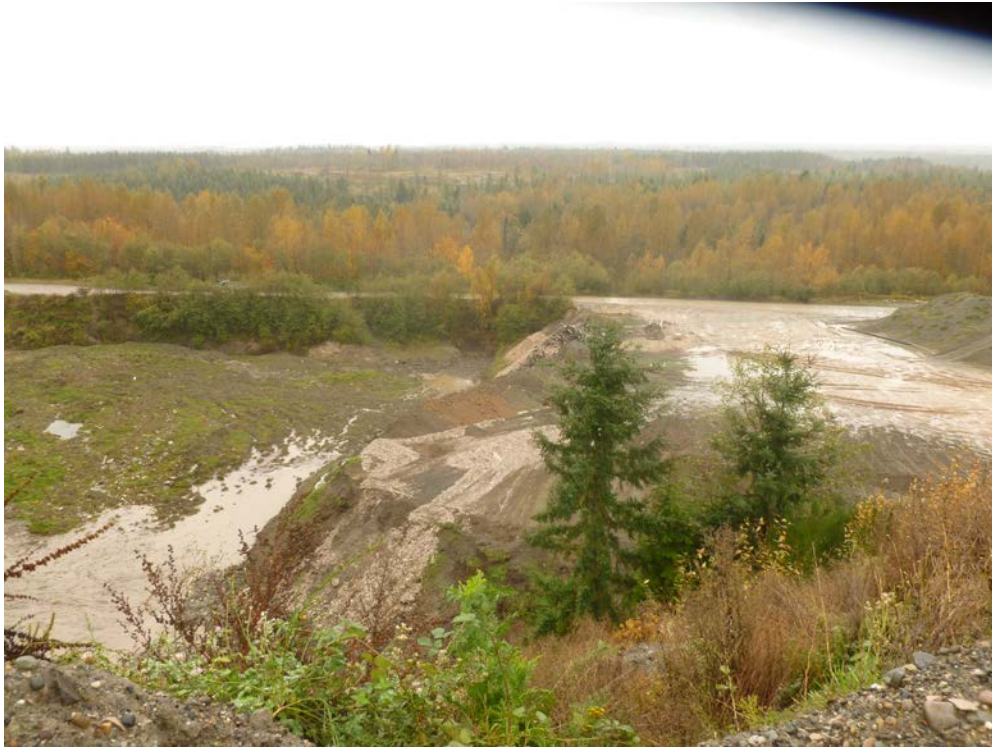
**Photograph 9:** Sand mine filling area, looking west.

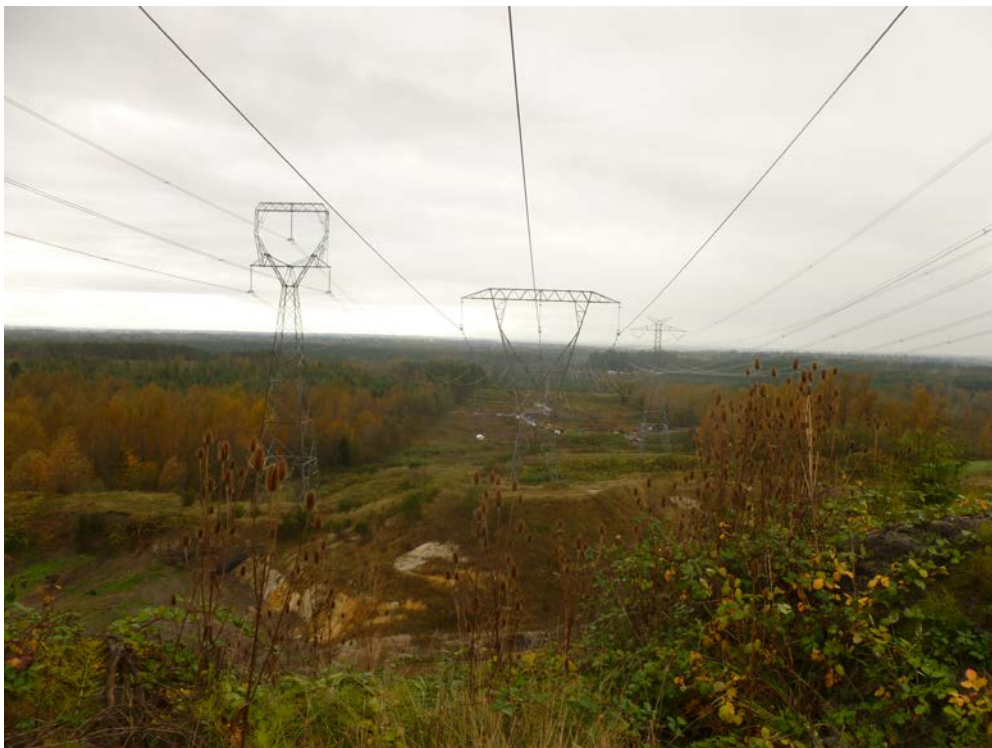
**Photograph 10:** Sand mine filling operations, Bonneville power lines, and west-adjacent properties, looking west.

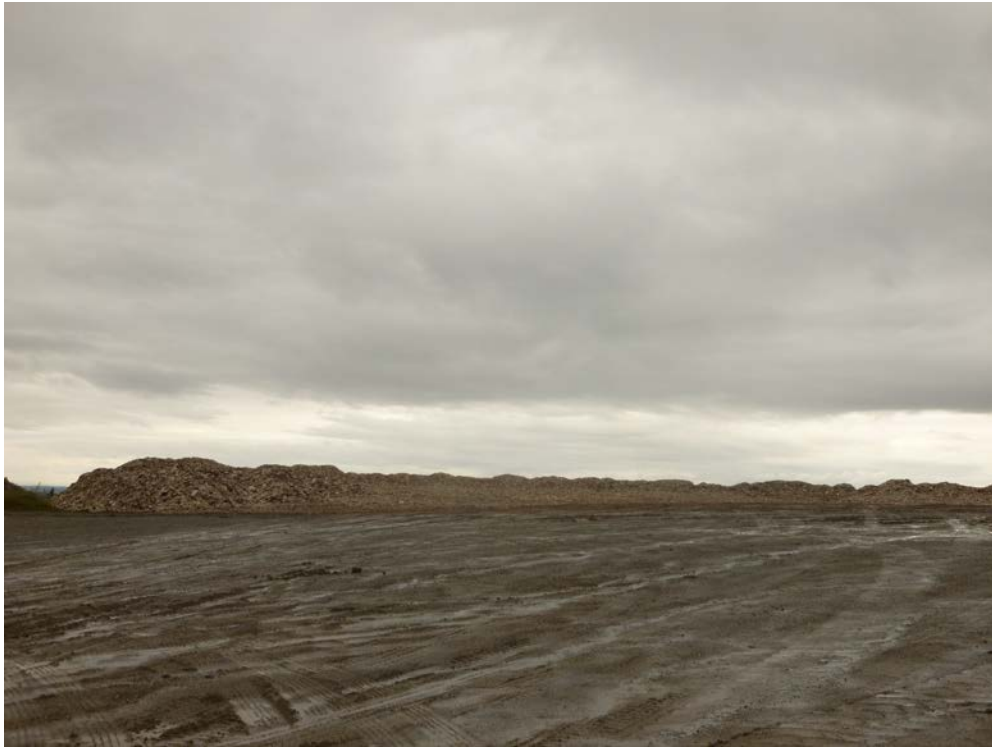
**Photograph 11:** Sand mine filling operations, looking northwest.

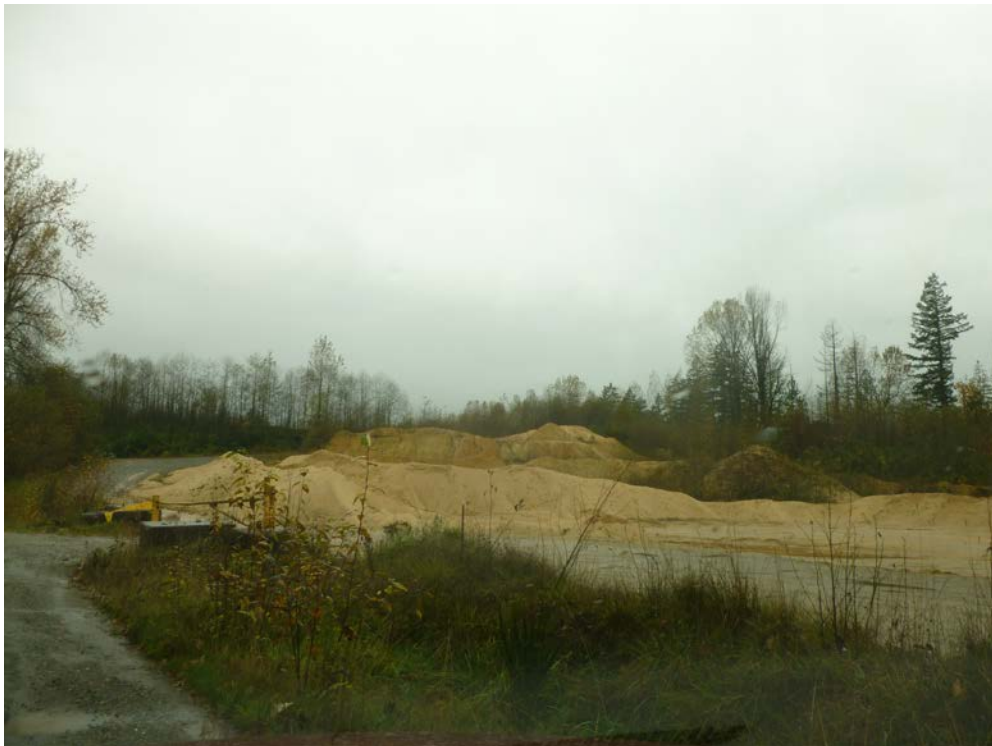
**Photograph 12:** Sand piles, looking northwest.

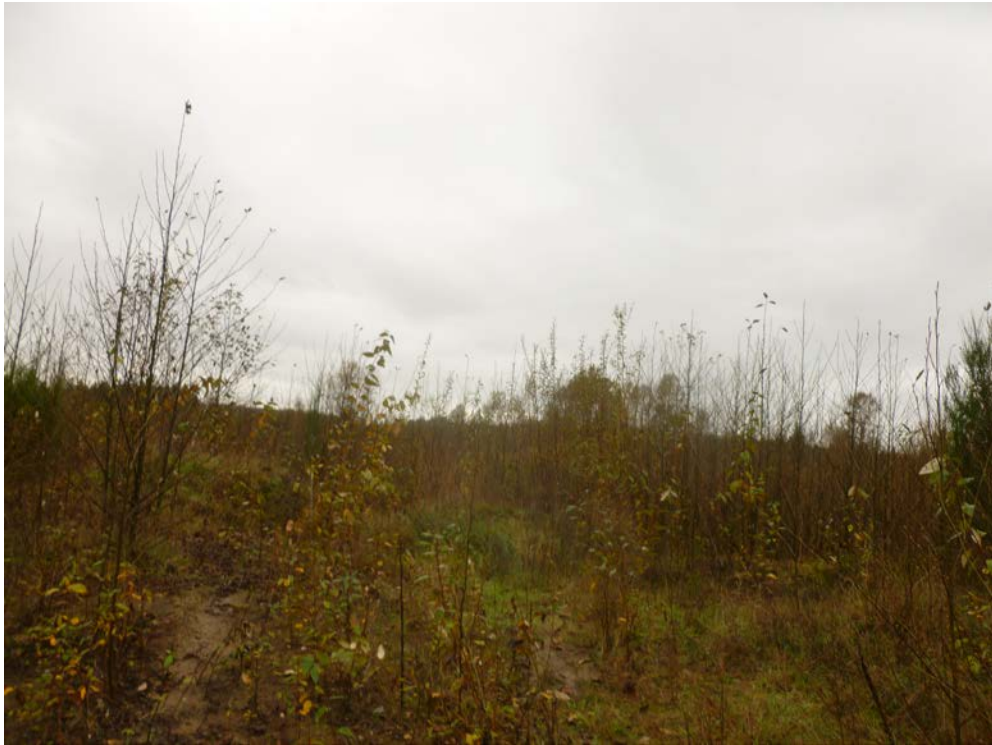
**Photograph 13:** Tailings pond area, looking west.

Four mine tailings ponds are present on the northwestern portion of the Site. The ponds were overgrown with vegetation, did not contain water, and were not being discharged to at the time of the site reconnaissance. The tailings ponds are associated with former mining operations on the Site. The potential release of hazardous substances in connection with mining operations on the Site represents a recognized environmental condition for the Site.

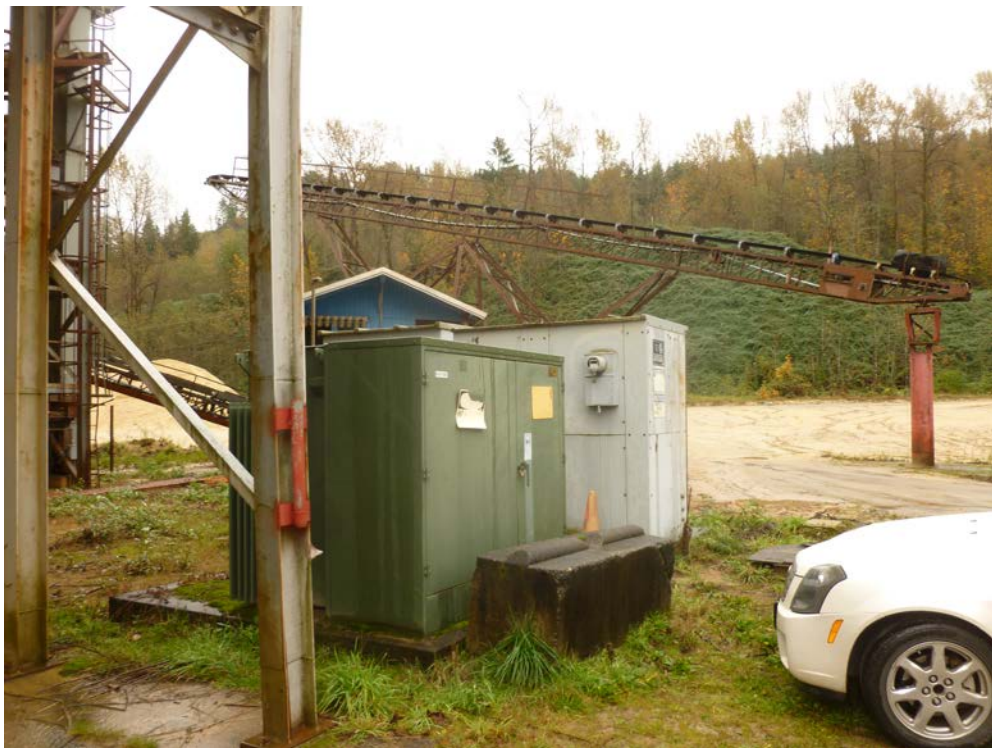
**Photograph 14:** Pad-mounted transformers on northeastern portion of Site, looking east.
