REMEDIAL INVESTIGATION REPORT
Reserve Silica Ravensdale Site
Prepared for: Reserve Silica Corporation

Project No. 160315-01 • November 2017

Aspect Consulting, LLC

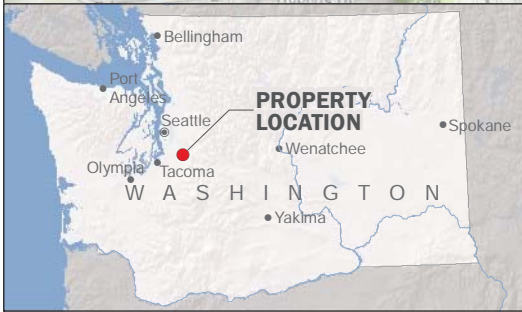
OCT-2017	BY: CEB / RAP	FIGURE NO. 1-1
	PROJECT NO. 160315	REVISED BY: ---

Property Location Map
 Remedial Investigation Report
 Reserve Silica
 Ravensdale, Washington

The Remedial Investigation (RI) Report has been prepared for the Reserve Silica Ravensdale Property, located in Ravensdale, Washington (the Property; Figure 1-1). The Property is comprised of seven tax parcels, totaling 377 acres, which were used, in part, first for coal and then for silica sand mining from the early 1900s through 2007. Coal mining, which occurred in the early to mid-1900s, consisted of a combination of surface open pit and underground mining. Silica sand surface mining activities occurred between the mid-1960s and 2007.
