**PRELIMINARY INVESTIGATION  
RESERVE SILICA PROPERTY  
RAVENSDALE, WASHINGTON**

**Prepared for:  
Preston Gates & Ellis, LLP  
Seattle, WA**

**Prepared By:  
Tacoma Environmental Sciences, Inc.  
Tacoma, WA**

## **PRELIMINARY SITE INVESTIGATION FINAL REPORT – EXECUTIVE SUMMARY**

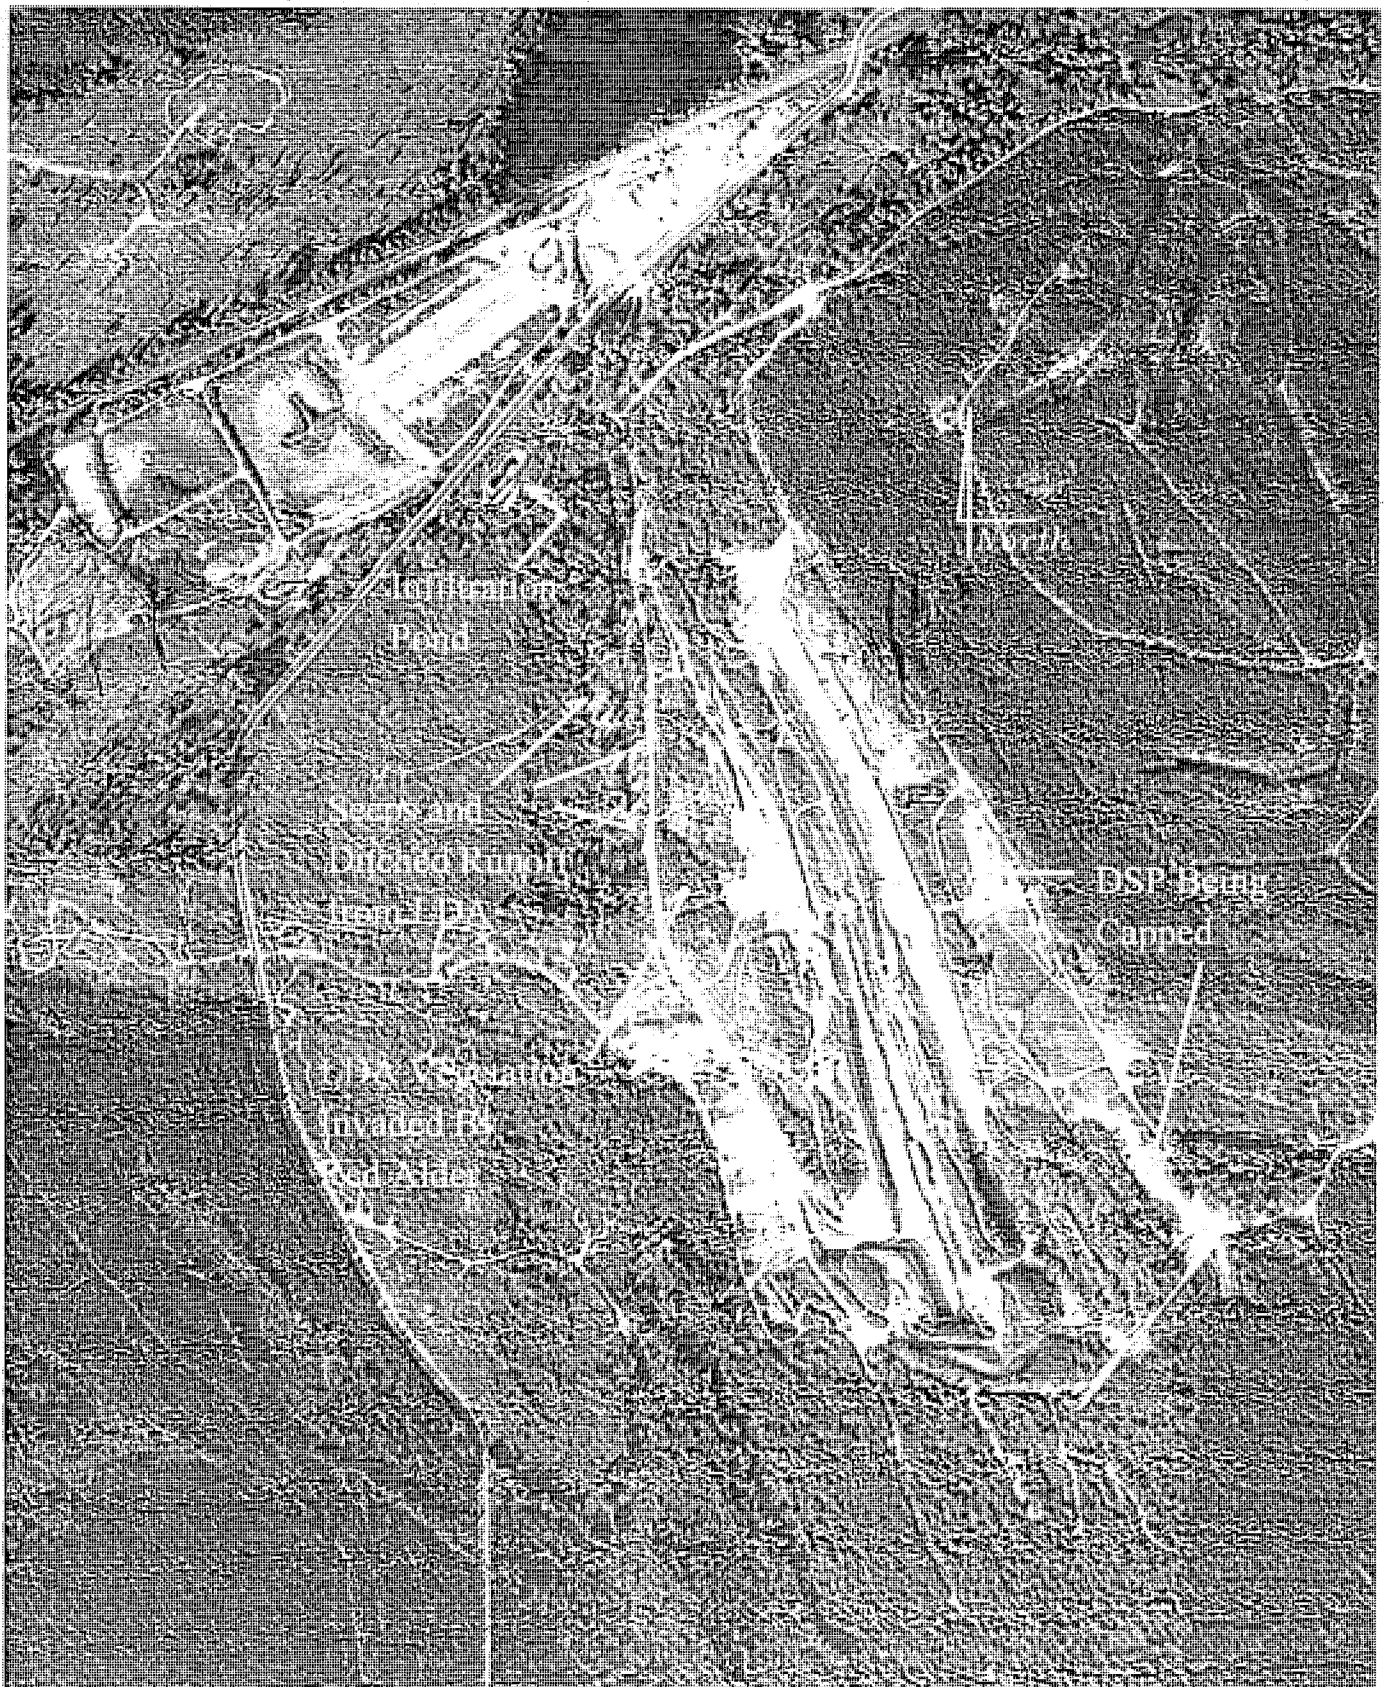
Photo 1-4. 1995 aerial photograph of Ravensdale site. Showing completed landfilling of Dale Strip Pit (DSP). Grading of DSP cap is in progress. Seeps and pooled leachate are present at Lower Disposal Area (LDA). Infiltration ponds can be seen northwest of LDA. Woody vegetation has invaded LDA cap.

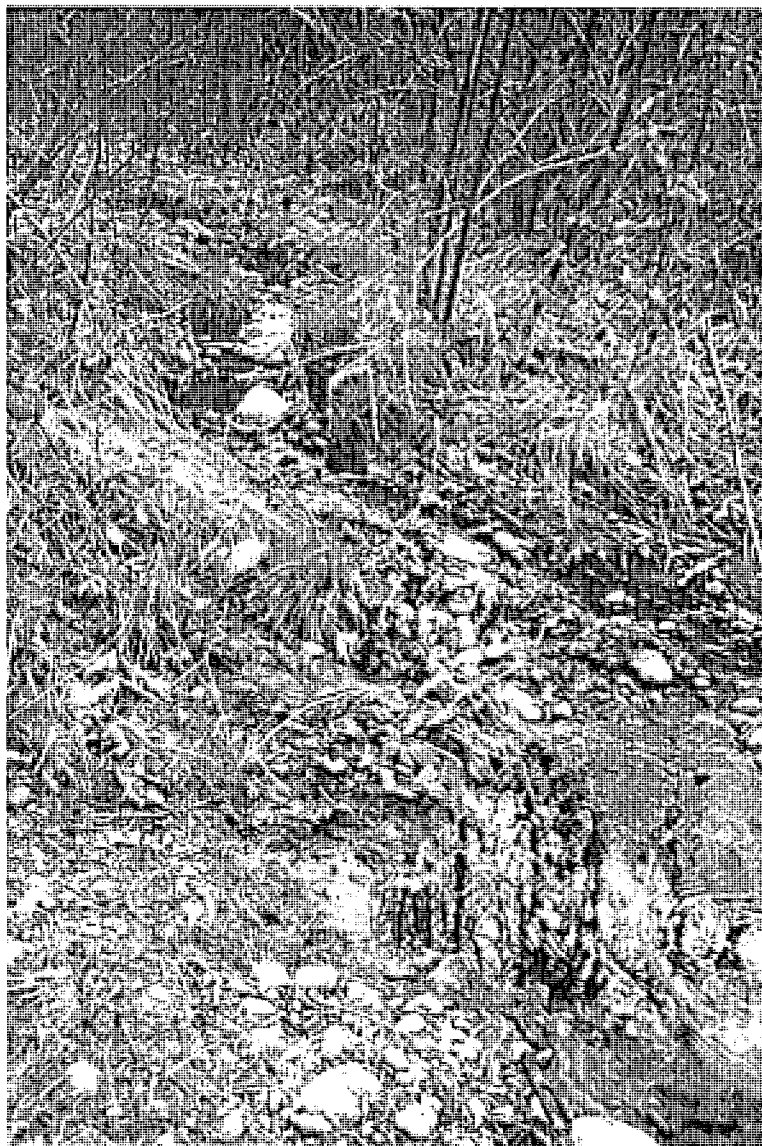
Photo 3-4 LDA. View to south at north end of seepage diversion channel at infiltration pond access road. Showing dark brown color of water. (pH measures ca. 10.5 during storm events.)

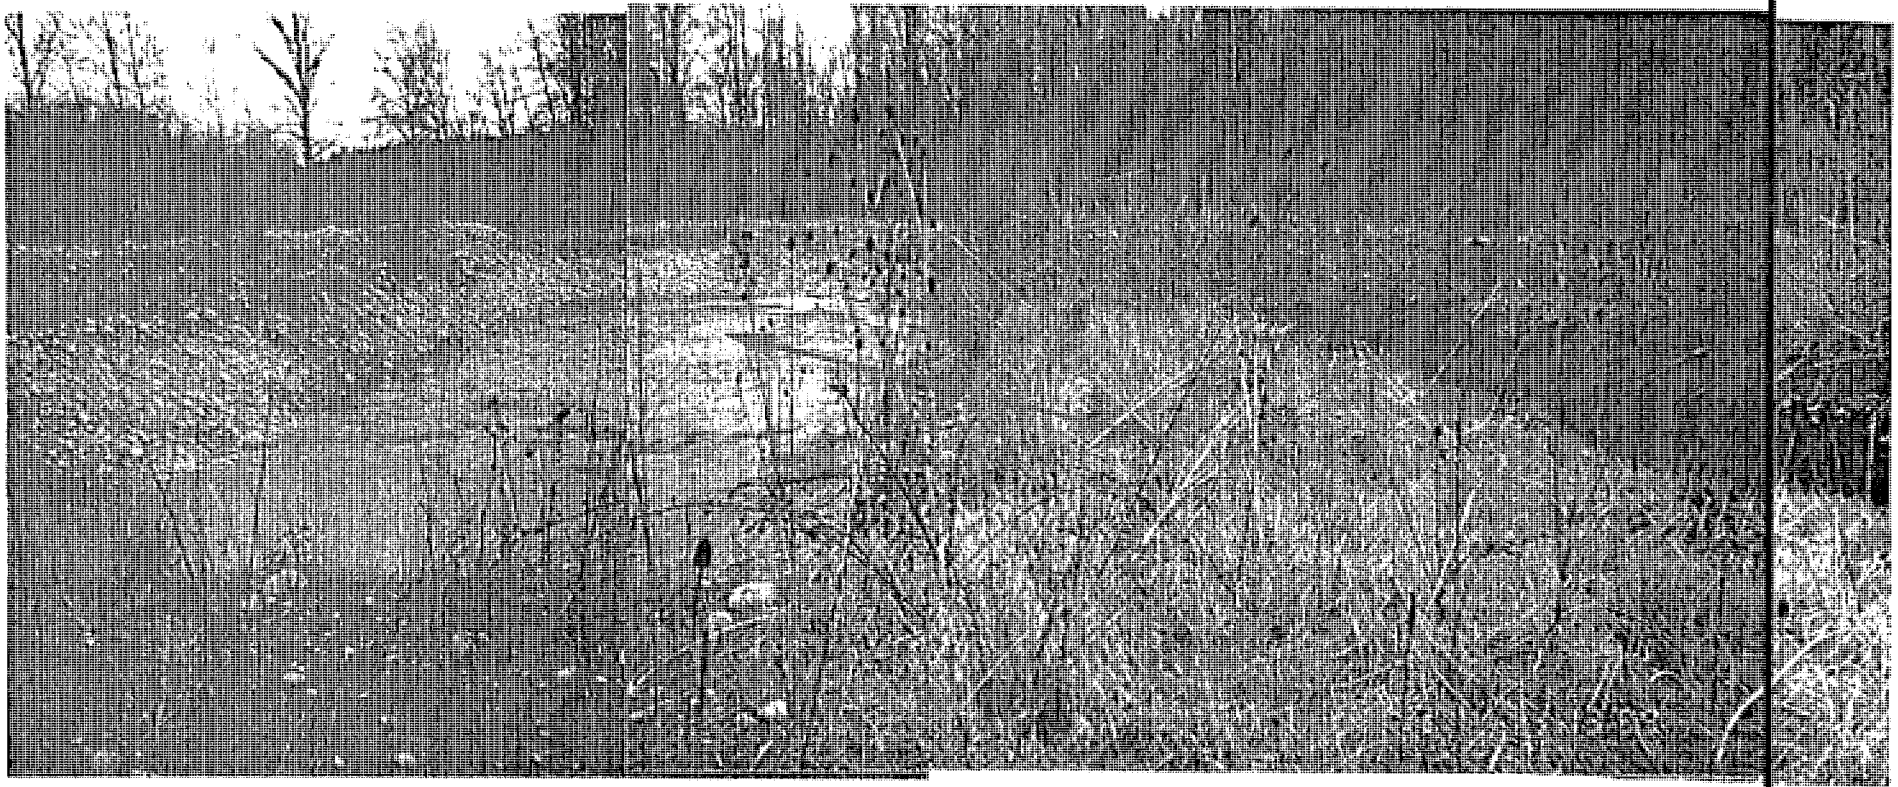
Photo 3-5 (a) LDA. Views north and northeast from infiltration pond access road. Showing west (photo this page, "A") and east infiltration ponds (photo next page "B"). Water first flows to east pond, overflow then occurs into west pond. East pond generally contains water and exhibits slower infiltration rates than the west pond, which only receives water during large storm events.

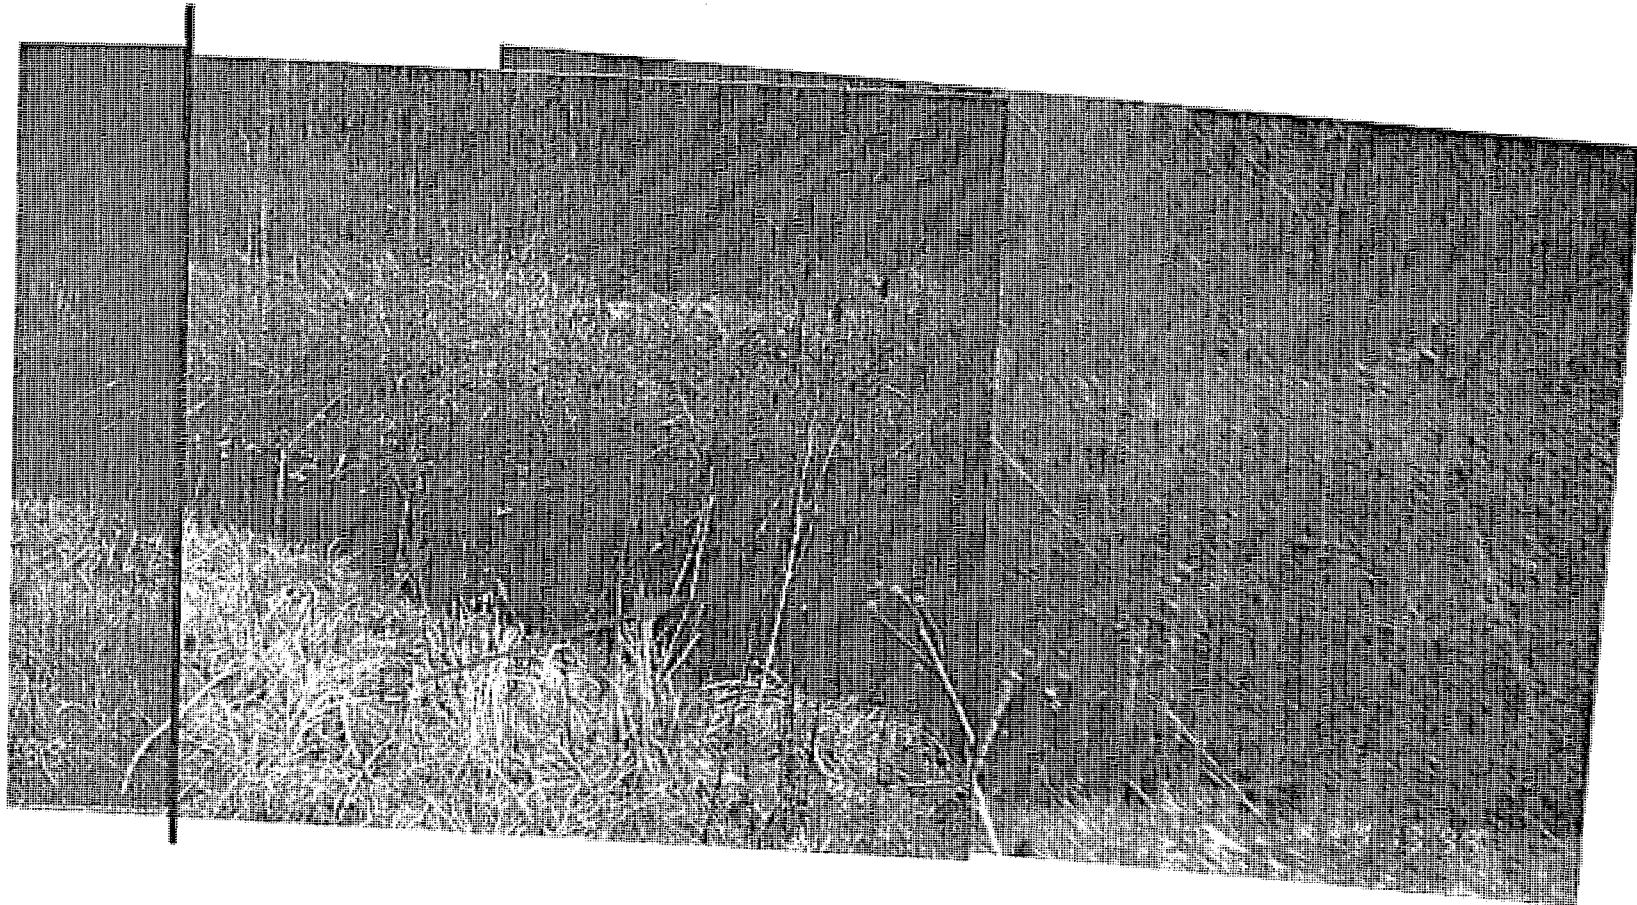
Photo 3-5 (b) LDA. Showing east infiltration pond ("B").

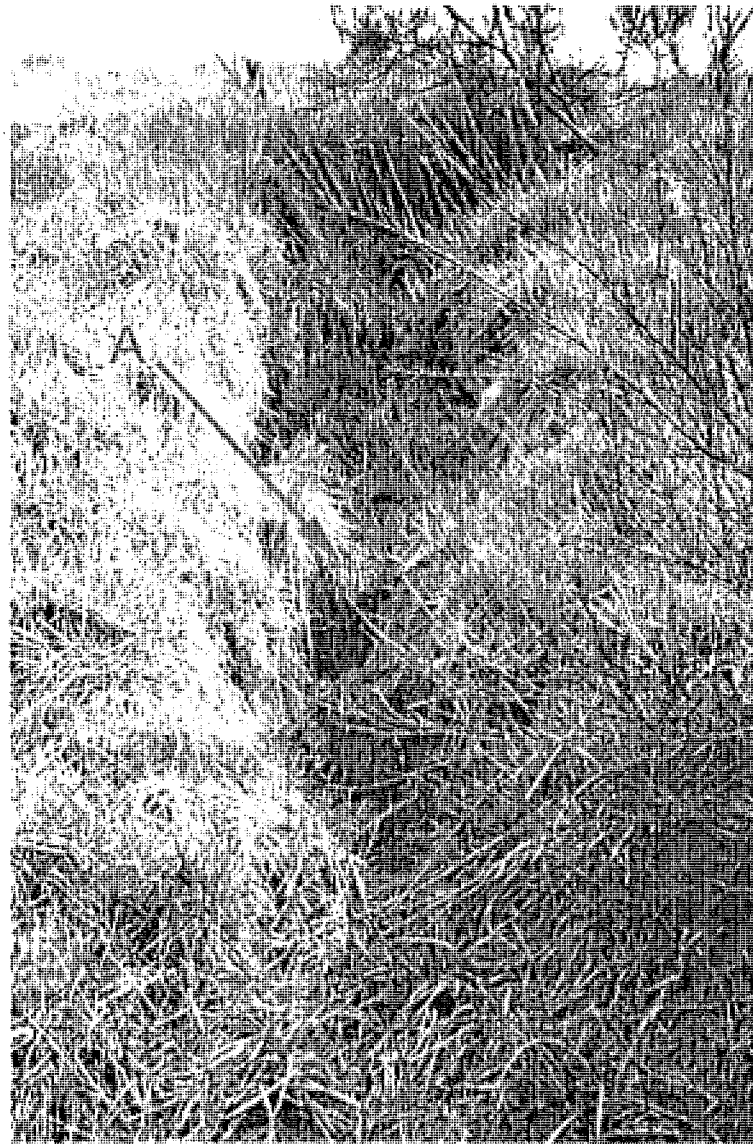
Photo 6-2 LDA. Surface erosion and cap failure ("A") on central part of the LDA.

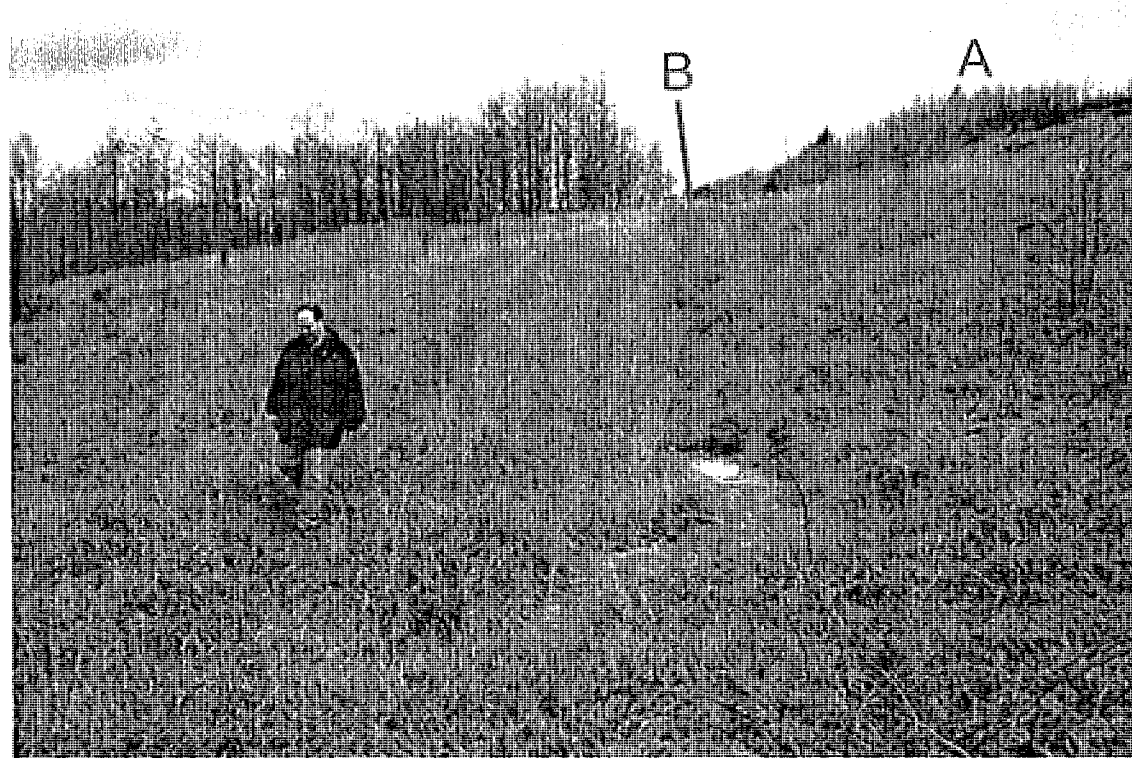
Photo 6-5 LDA. View to northeast from southwest part of LDA. Showing incised surface drainage patterns ("A-B") on LDA cap. Note exposed CKD in bottom of drainage at "A".

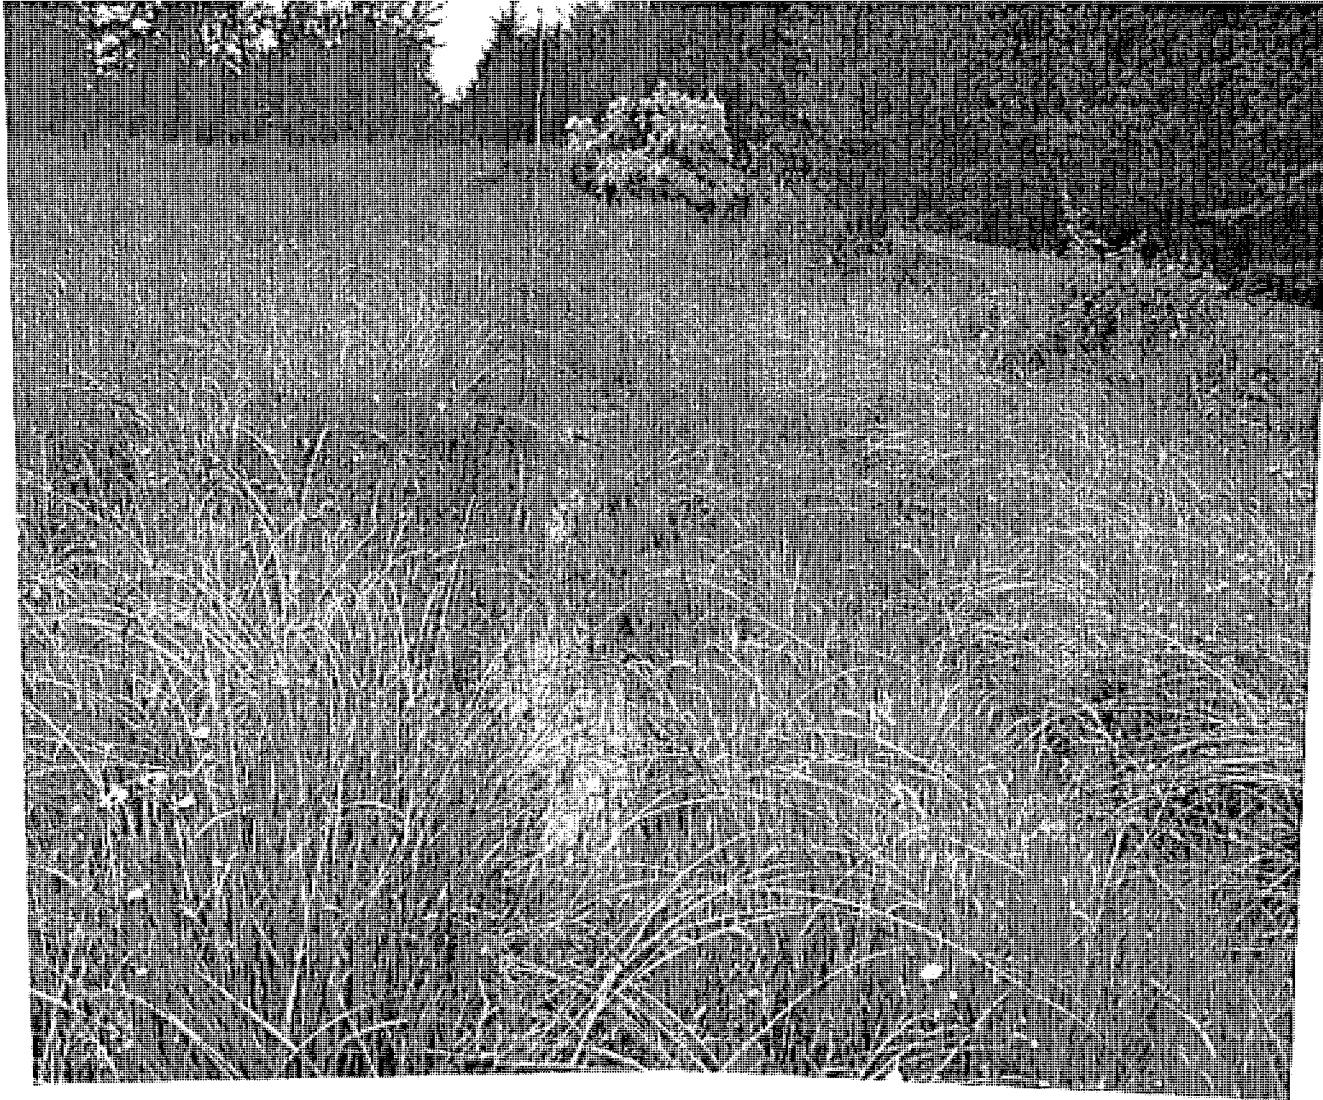
Photo 6-7 DSP. View from east-central part of DSP cap to the north. Showing ponded water in vehicle ruts on cap surface. Vehicle access is not restricted and the property receives heavy recreational vehicle use. UHR is visible at right of photo. June 1999.
