**Re: Summary of RI Data Gaps Investigation Results: Plant Site and Lower Haul Road
Reserve Silica, Ravensdale, Washington**
Project No. 160315-002-04

Property Location Map
 Plant Site Investigation
 Reserve Silica
 Ravensdale, Washington

Plant Site Investigation
Reserve Silica
Ravensdale, Washington

Lower Haul Road Investigation Locations

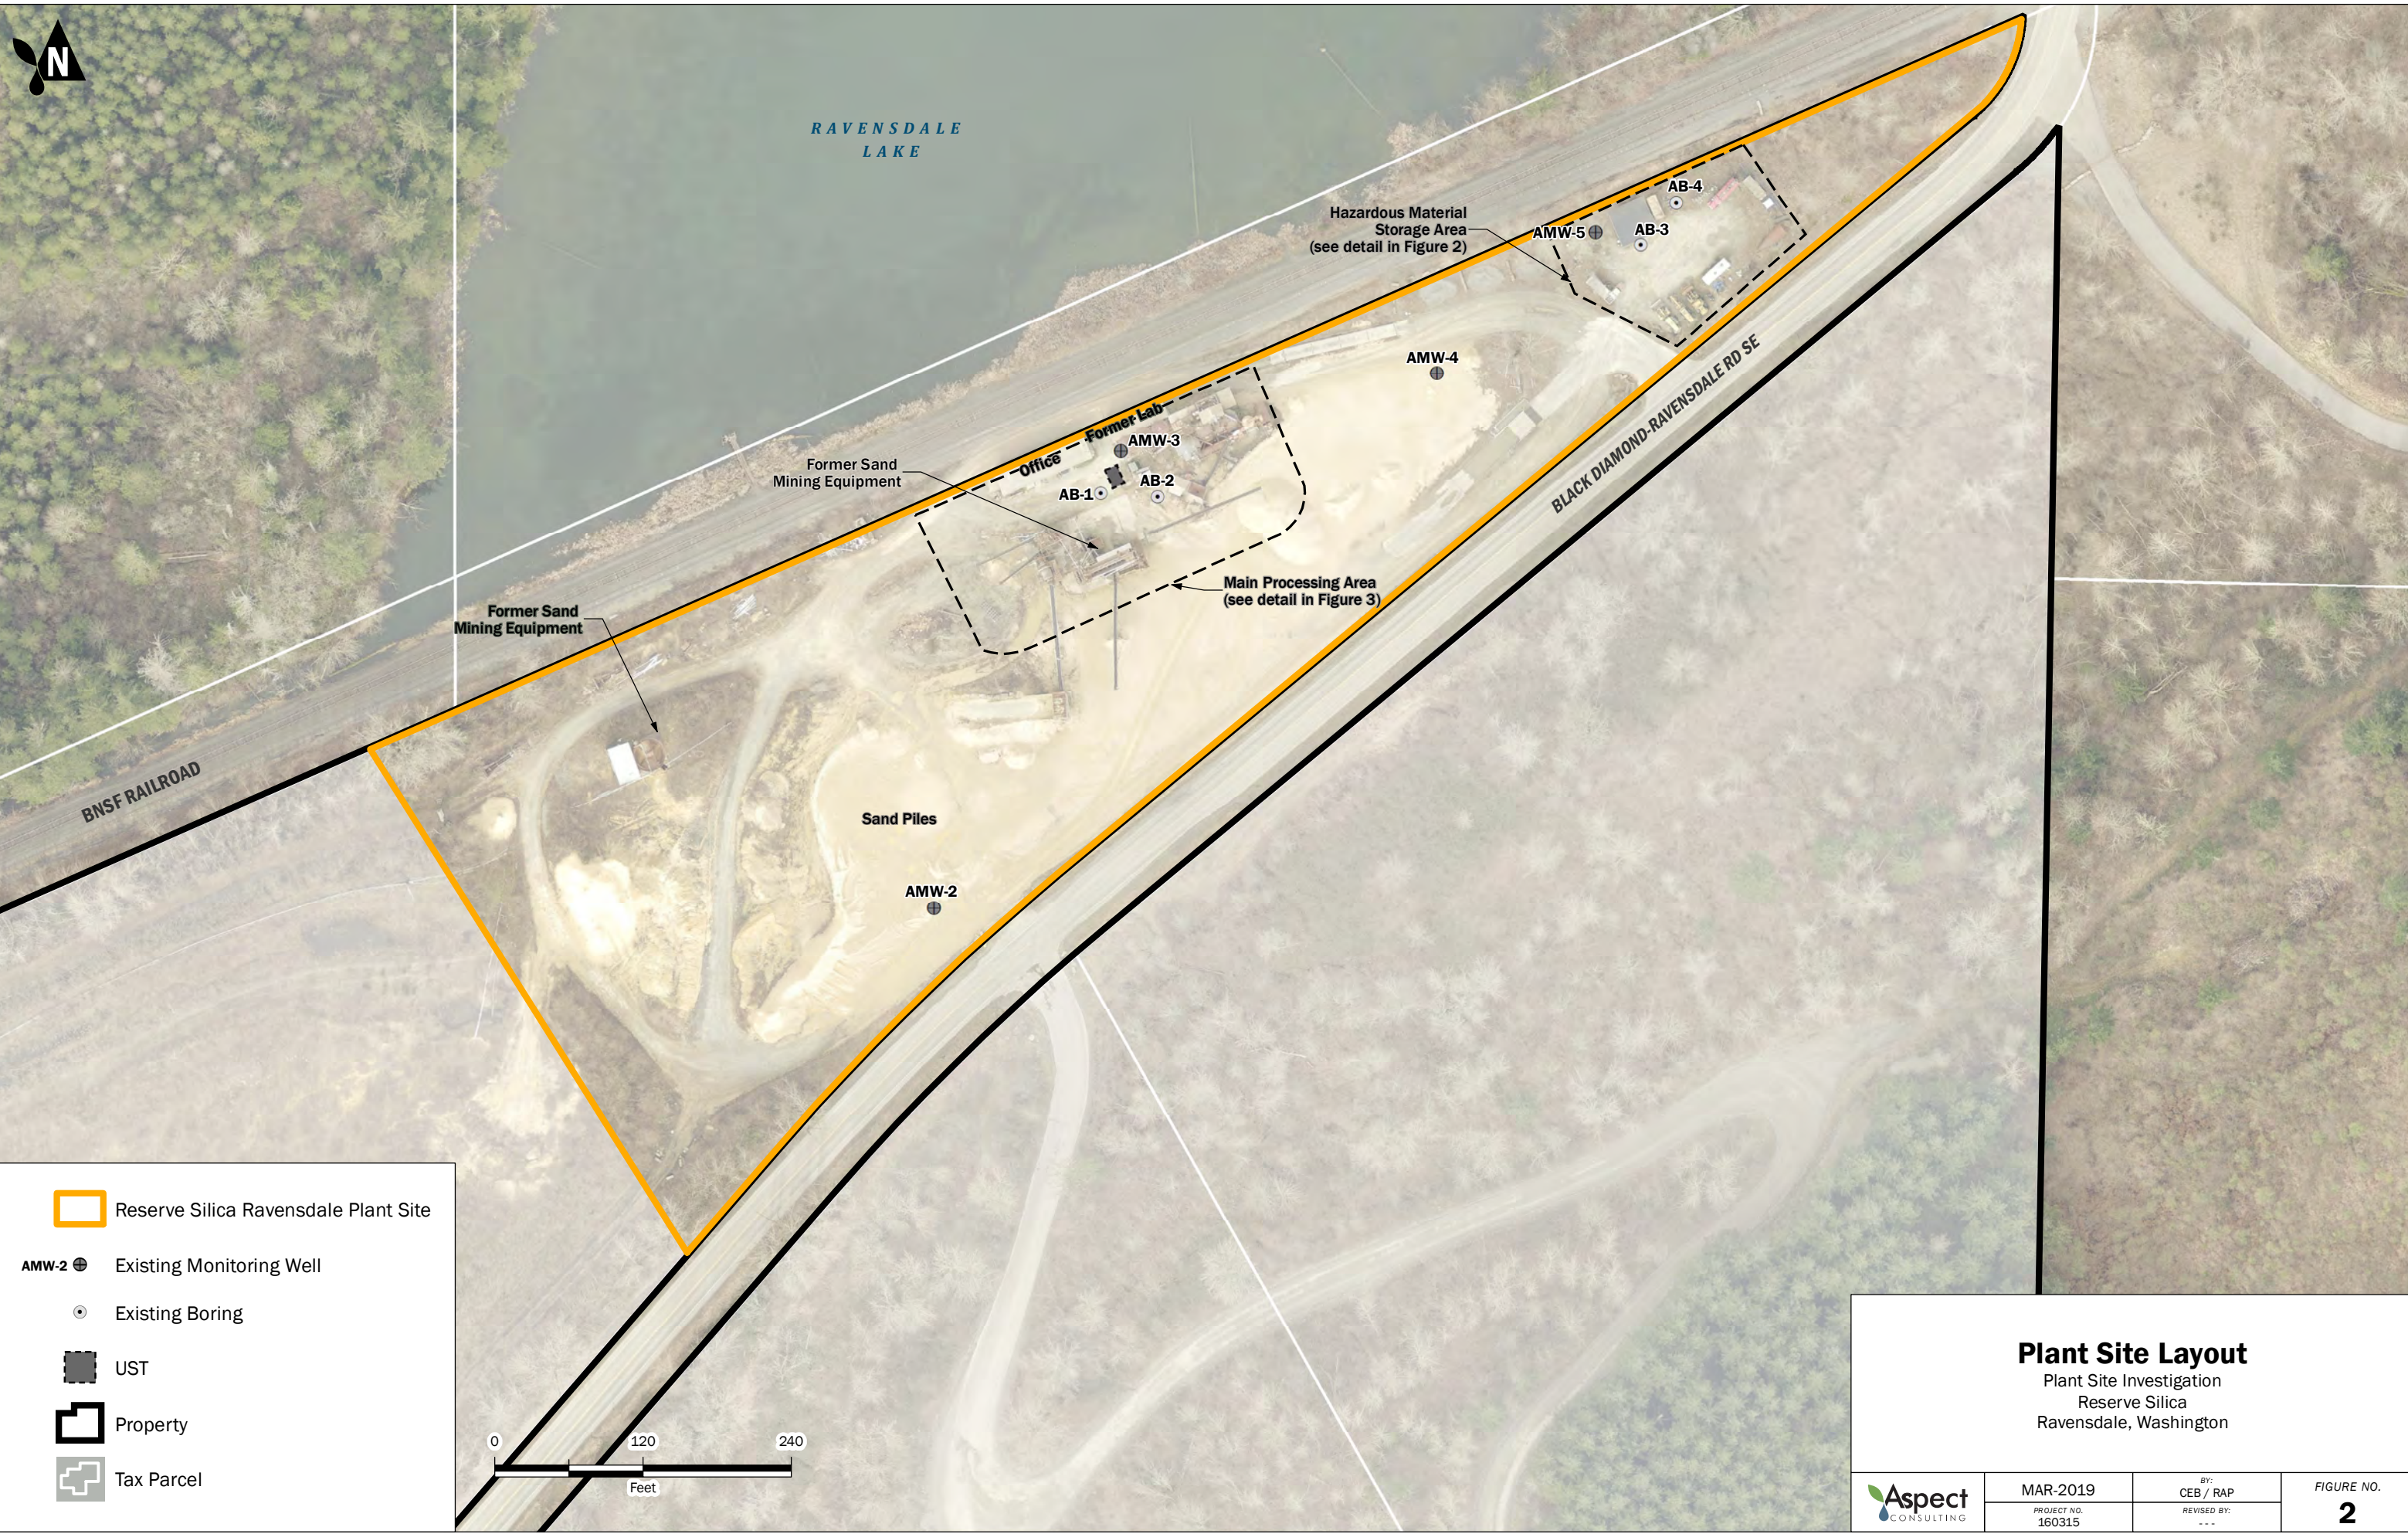
Hazardous Material
Storage Area
(see detail in Figure 2)

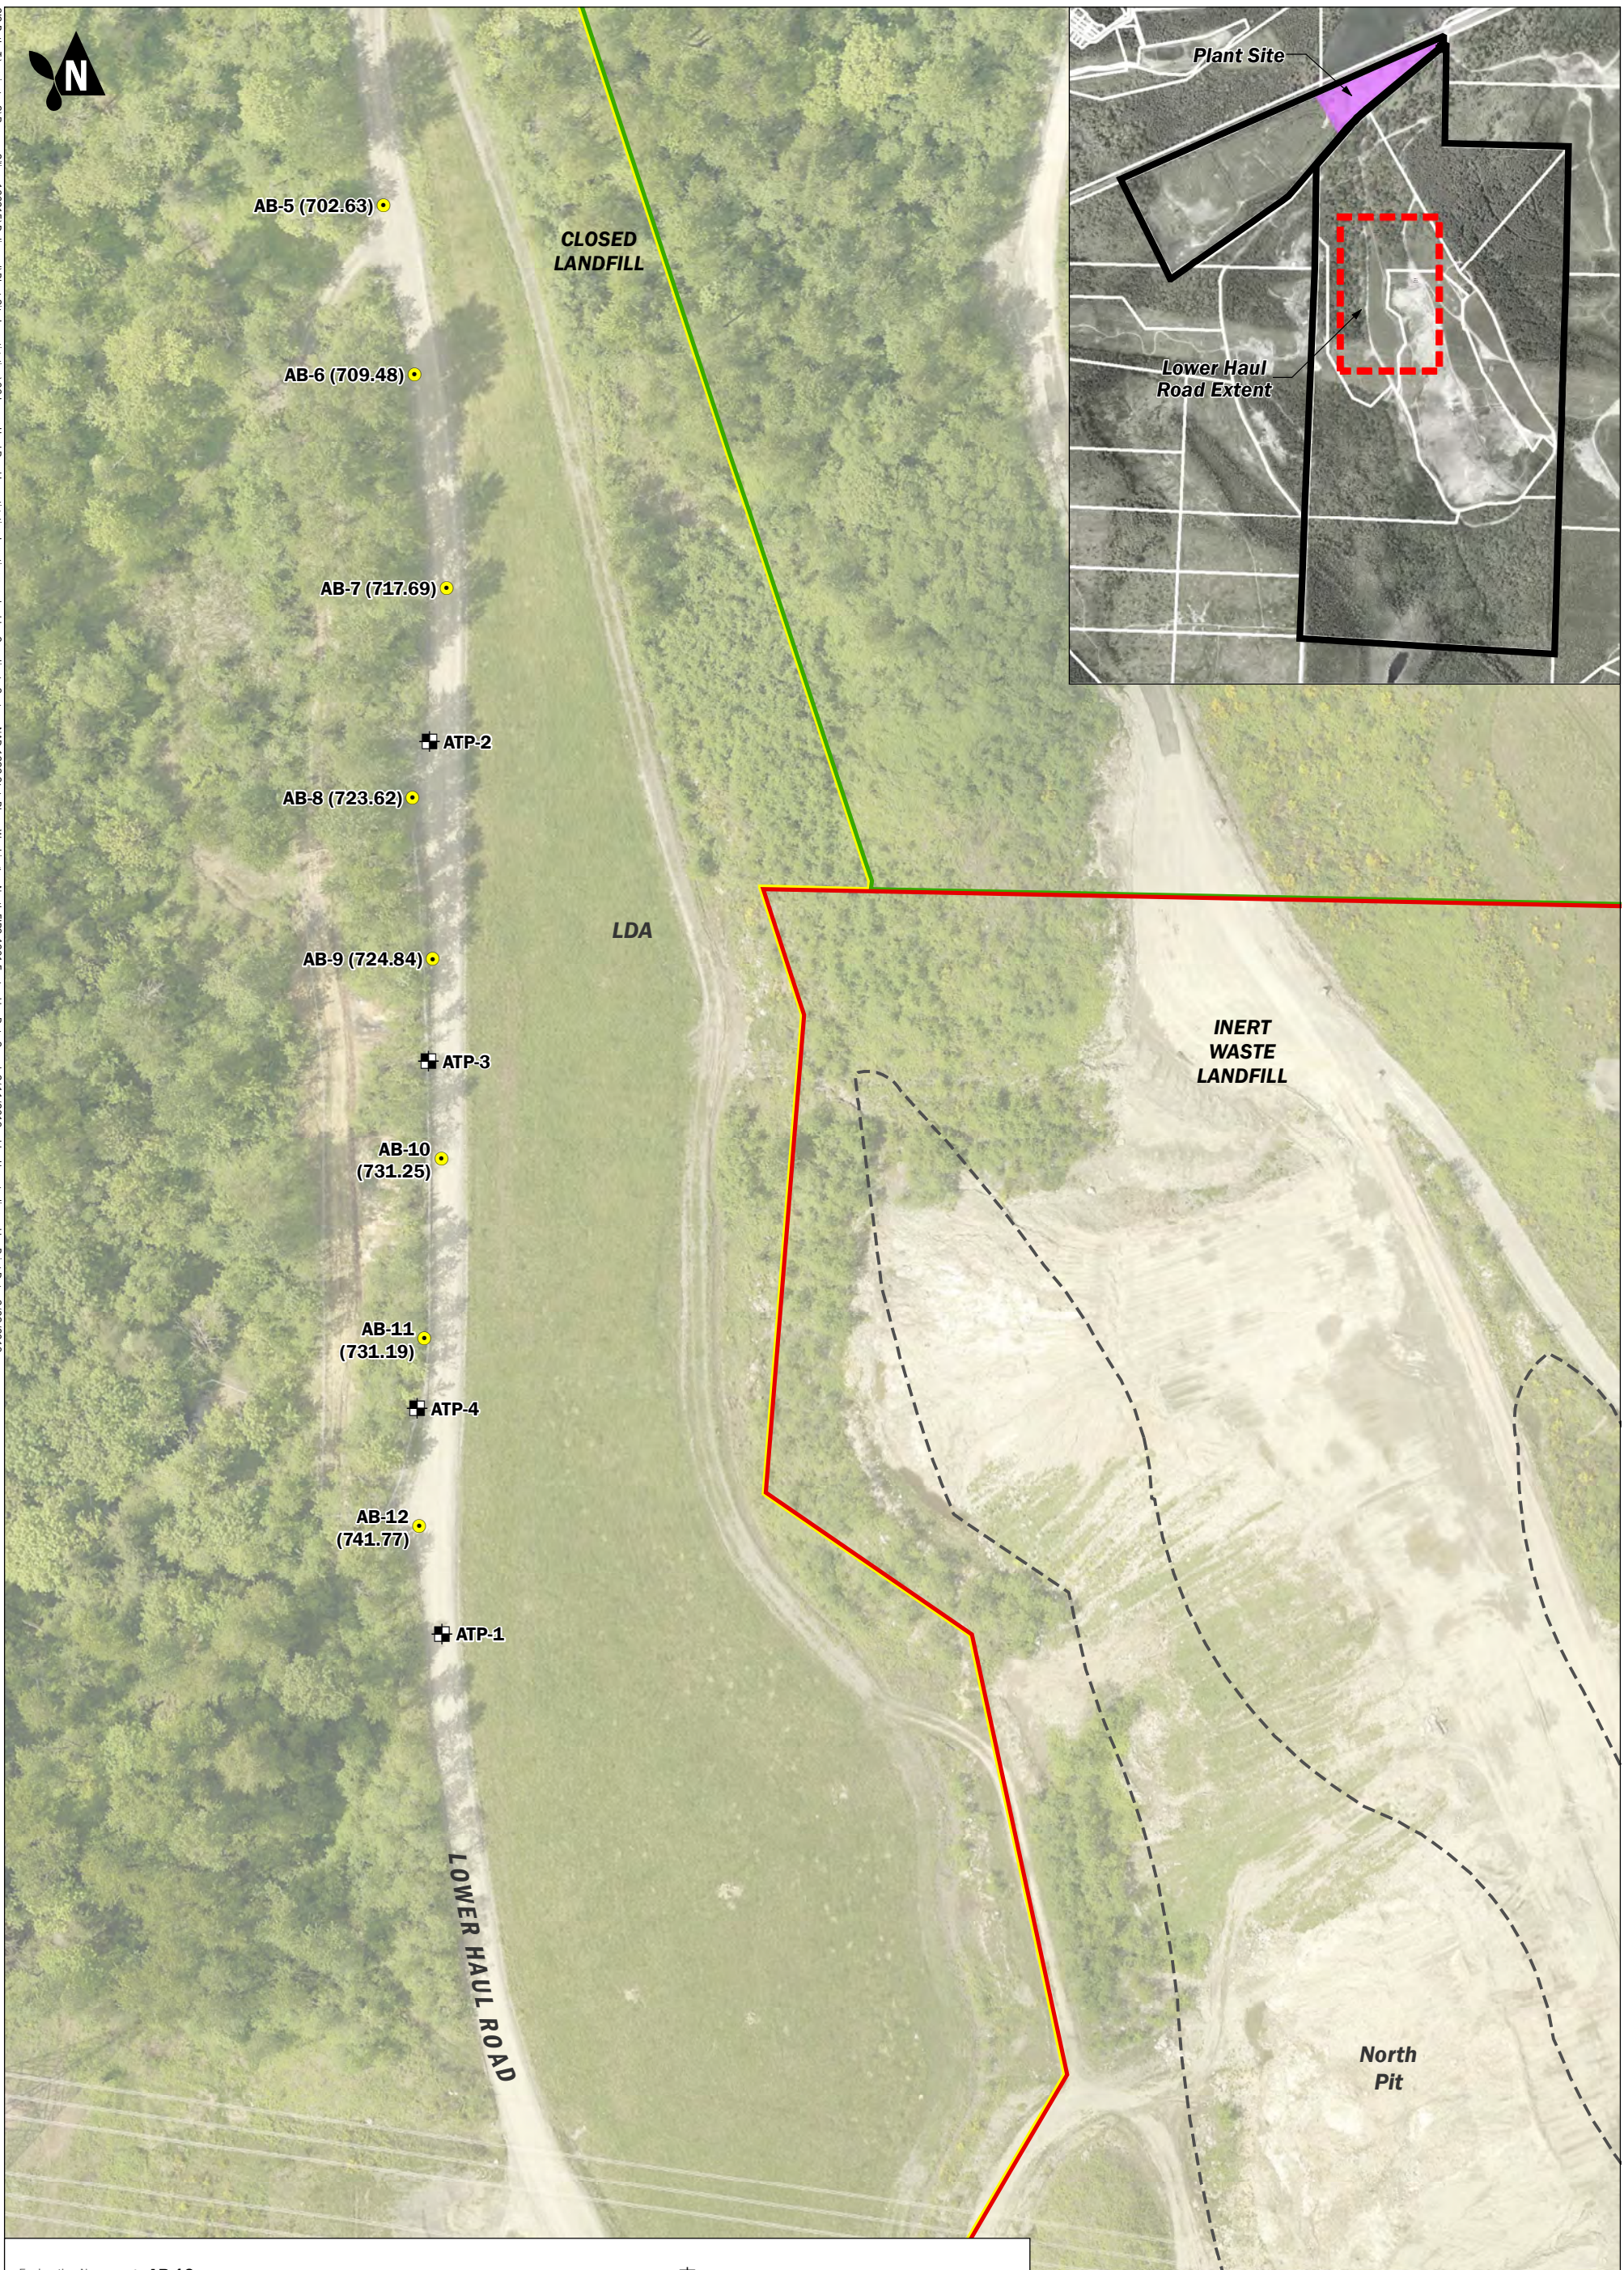
On April 5, 2018, Aspect observed four test-pit explorations (ATP-1 through ATP-4; Figure 6) excavated along the Lower Haul Road in the general area of the soil borings completed during previous RI field activities. Test pits were excavated to refusal, which occurred between approximately 3 feet and 5.5 feet bgs. Soils observed were classified in accordance with the ASTM Method D2488 *Standard Practice for Description and Identification of Soils*, and soil descriptions, field screening results, and other relevant details (staining, odors, etc.) were recorded on the test-pit logs provided in Appendix A. Photographs of the test pits are included in Appendix B.

Soils observed in the Lower Haul Road test pits primarily consisted of gravelly, silty sand with slag fragments and orange-yellow sand with coal and slag fragments to the maximum depths excavated (5.5 feet bgs in ATP-2). Anthropogenic debris (bricks and plastic fragments) were encountered in roadbed material in test pit ATP-2.

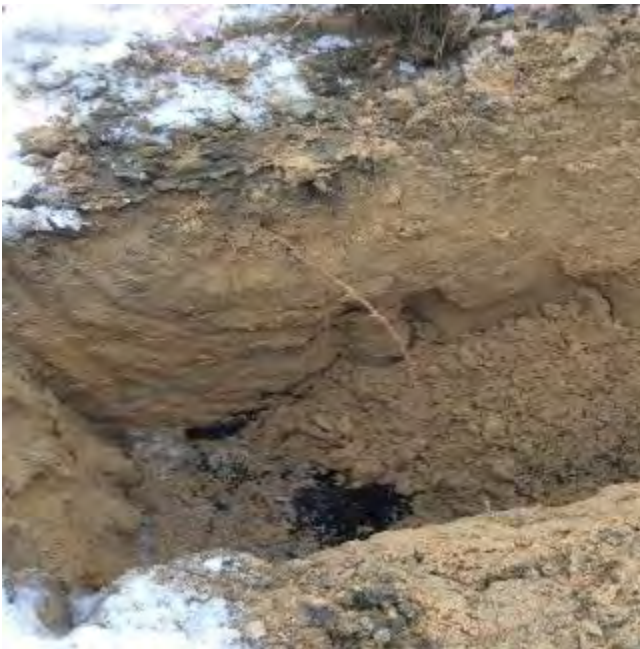
Photograph 71. TP-17

Depth (feet)	Elev. (feet)	Exploration Completion and Notes	Sample Type/ID	Analytical Sample Number & Lab Test(s)	Field Tests	Material Type	Description	Depth (ft)
1		Backfilled with cuttings		TP-17-1.0 BTEX, NWTPH-Dx, CPAHs, Naphth	PID= 0.0 Sheen= None		FILL Moist, orange-yellow SAND (SP); medium to coarse sand, trace root fragments, no odor.	1
2							COAL TAILINGS Moist, black coal	2
3							Bottom of exploration at 2.4 ft. bgs.	3
4								4

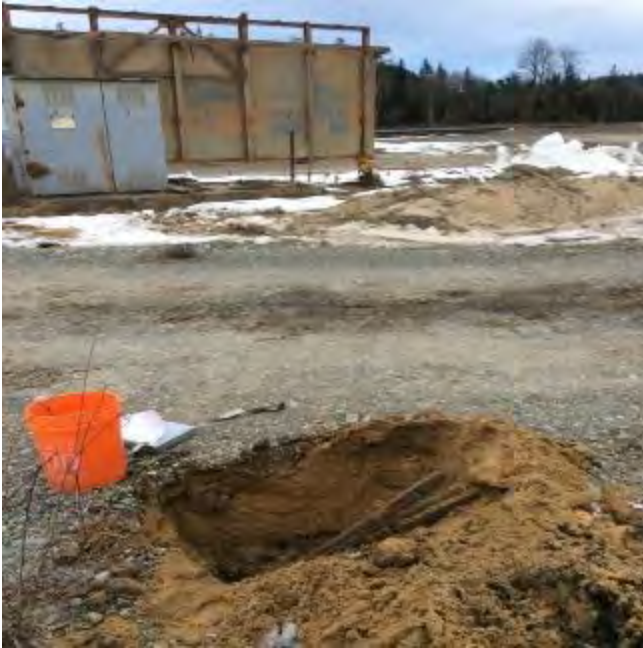
Photograph 74. TP-18

Depth (feet)	Elev. (feet)	Exploration Completion and Notes	Sample Type/ID	Analytical Sample Number & Lab Test(s)	Field Tests	Material Type	Description	Depth (ft)
1		Backfilled with cuttings		TP-18-0.8 BTEX, NWTPH-Dx, CPAHs, Naphth	PID= 0.0 Sheen= Slight		FILL Moist, yellow-orange SAND (SP); medium to coarse, no odor.	1
2							COAL TAILINGS Moist, black coal	2
3							Bottom of exploration at 1.8 ft. bgs.	3
4								4

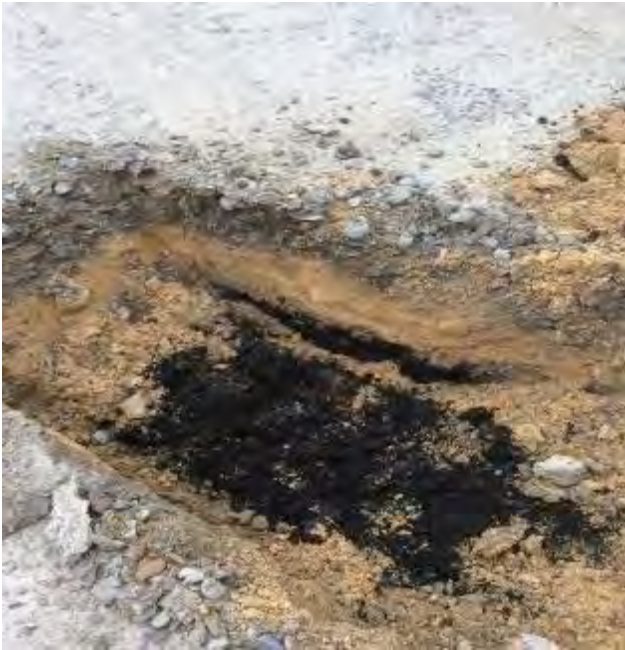
Photograph 76. TP-19

Depth (feet)	Elev. (feet)	Exploration Completion and Notes	Sample Type/ID	Analytical Sample Number & Lab Test(s)	Field Tests	Material Type	Description	Depth (ft)
1		Backfilled with cuttings		TP-19-0.5 BTEX, NWTPH-Dx, CPAHs, Naphth	PID= 0.0 Sheen= None		<p>FILL</p> <p>Moist, brown, sandy GRAVEL (GP); medium to coarse sand, fine to coarse gravel (base course).</p> <p>Moist, yellow-orange SAND (SP); trace fine gravel, medium to coarse sand, no odor.</p> <p>COAL TAILINGS</p> <p>Moist, black coal</p> <p>Bottom of exploration at 1.1 ft. bgs.</p>	1
2								2
3								3
4								4

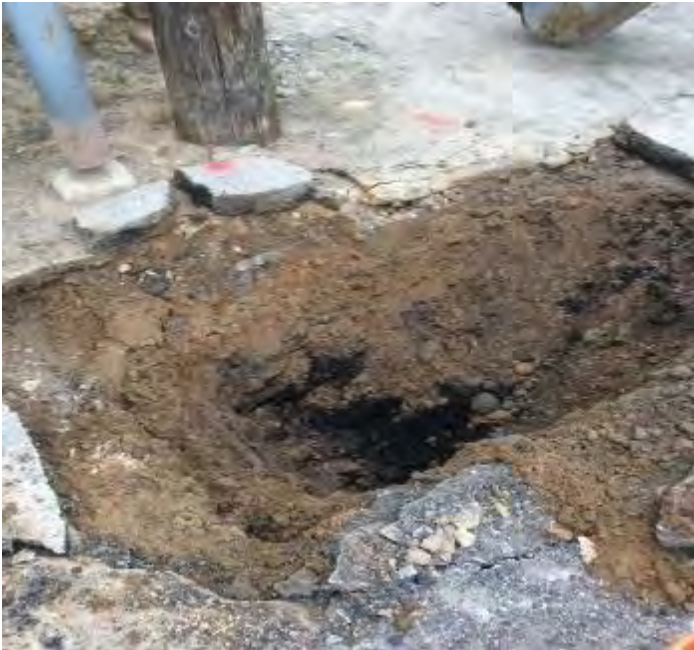
Photograph 78. TP-20

Depth (feet)	Elev. (feet)	Exploration Completion and Notes	Sample Type/ID	Analytical Sample Number & Lab Test(s)	Field Tests	Material Type	Description	Depth (ft)
1		Backfilled with cuttings		TP-20-0.6 BTEX, NWTPH-Dx, CPAHs, Naphth	PID= 0.0 Sheen= Slight		FILL Black, Asphalt; including underlying gravelly base course.	1
							Moist, yellow-orange, gravelly SAND (SP); fine gravel, medium to coarse sand, no odor.	
							COAL TAILINGS Moist, black coal	
							Bottom of exploration at 1.4 ft. bgs.	
2								2
3								3
4								4

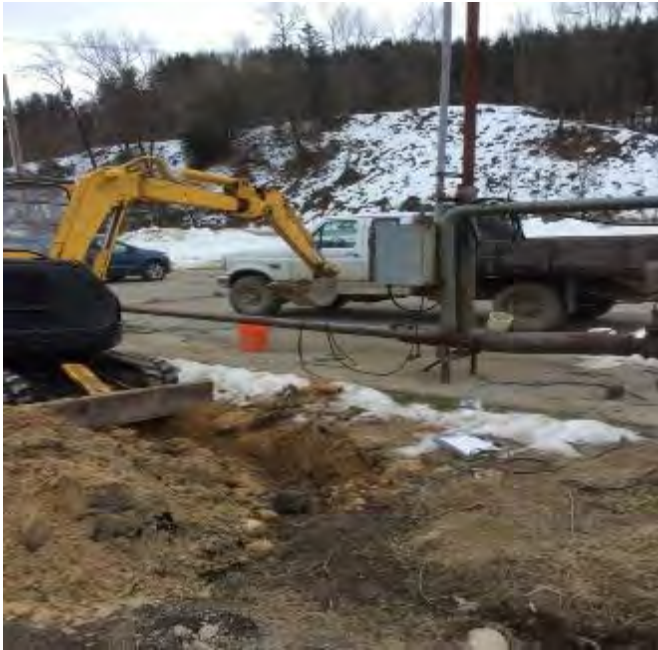
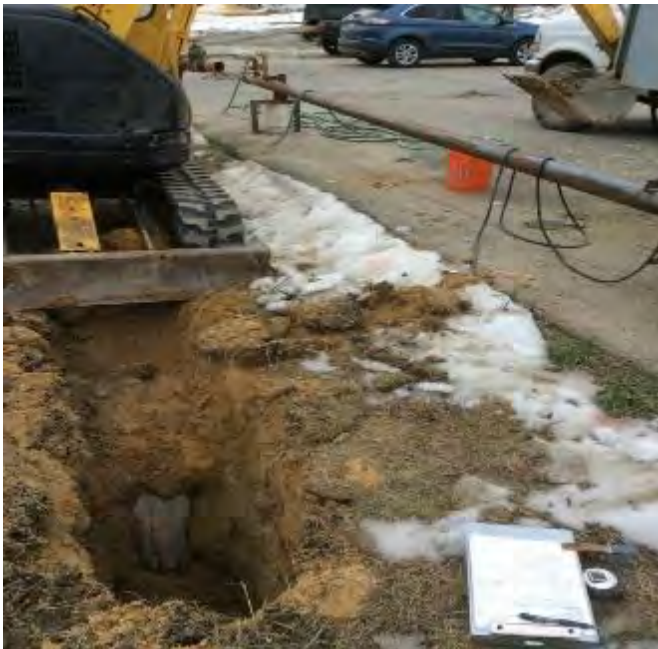
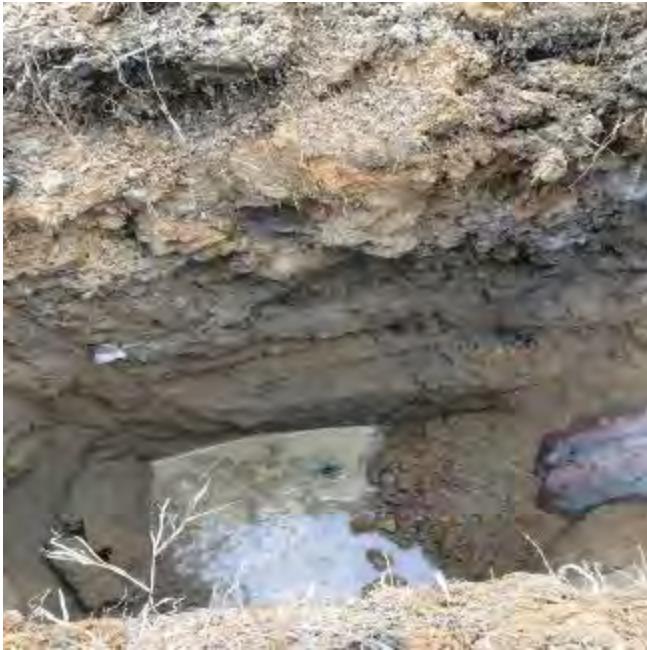
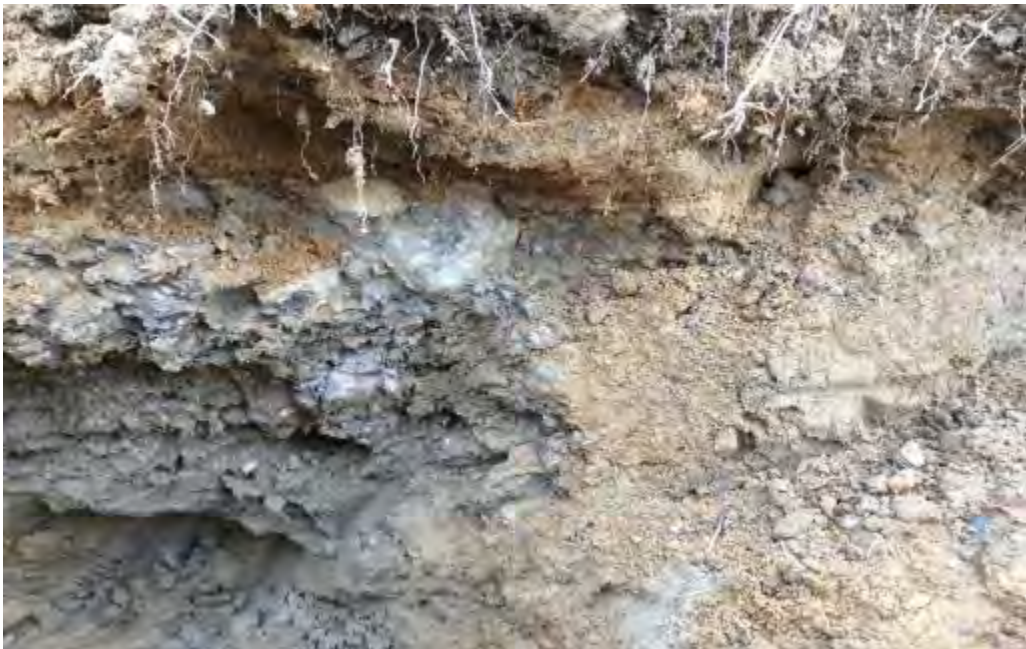
During excavation of TP-21, an abandoned sump vault was encountered at approximately 2 feet bgs (Figure 3). The sump vault appeared filled with concrete or similar material. The soil in TP-21 exhibited petroleum-like odors and gray staining between 2 and 4 feet bgs. Soil was collected from this depth interval for chemical analysis.
