**2019 ANNUAL REPORT**  
Remedy Implementation  
Crownhill Elementary School Site  
Prepared for: Bremerton School District

Project No. 100094-007-01 • January 14, 2020 • Final

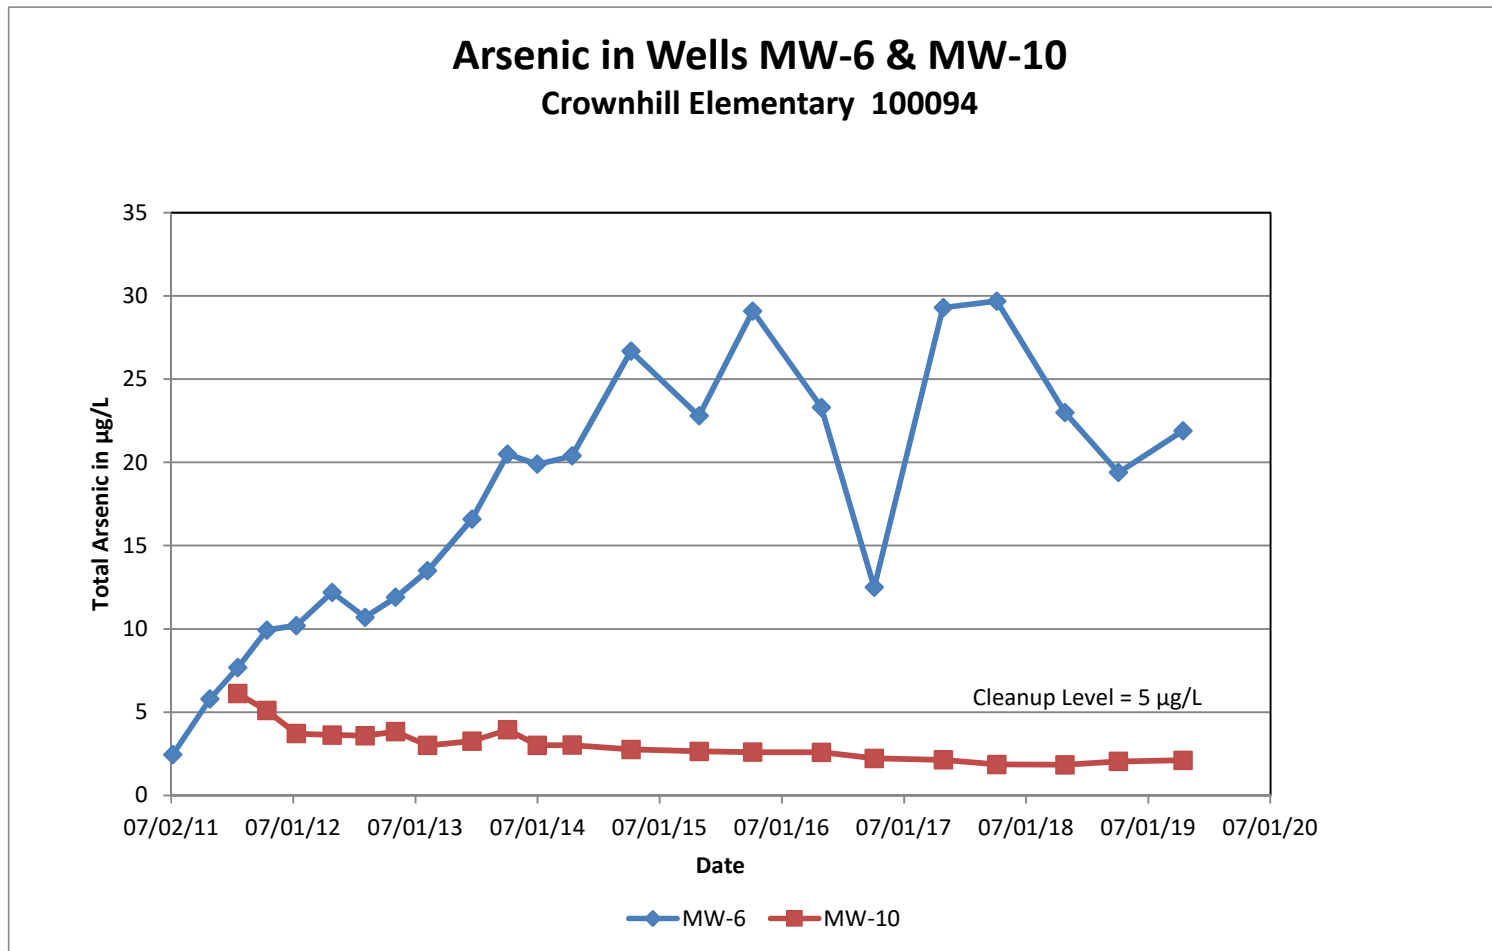
## Figure 2. Arsenic in Wells MW-6 and MW-10

Figure 2 shows arsenic concentrations measured at MW-6 and MW-10 since those wells were installed. Concentrations at MW-6 exhibited an increasing trend through the April 2016 monitoring round. More recent results have fluctuated widely. The April 2018 result (29.7 µg/L) was the highest concentration measured to date, and significantly lower concentrations were measured in the three rounds conducted since then. The cause(s) of arsenic concentration fluctuation at MW-6 is unknown.

- 1) Well MW-6, installed in March 2011, provides early warning of potential arsenic migration.
- 2) Well MW-10, installed in December 2011, is the conditional point of compliance for arsenic in groundwater.

The arsenic concentrations measured at MW-10 in 2019 are slightly higher than the 2018 measurements, but remain well below the contingency action trigger level of 4.5 µg/L.

<sup>4</sup> As shown on Figure 2, the arsenic cleanup level was also exceeded at MW-10 the first two times it was sampled following its installation in December 2011. Arsenic at MW-10 has been consistently below its cleanup level in the last 17 monitoring rounds.

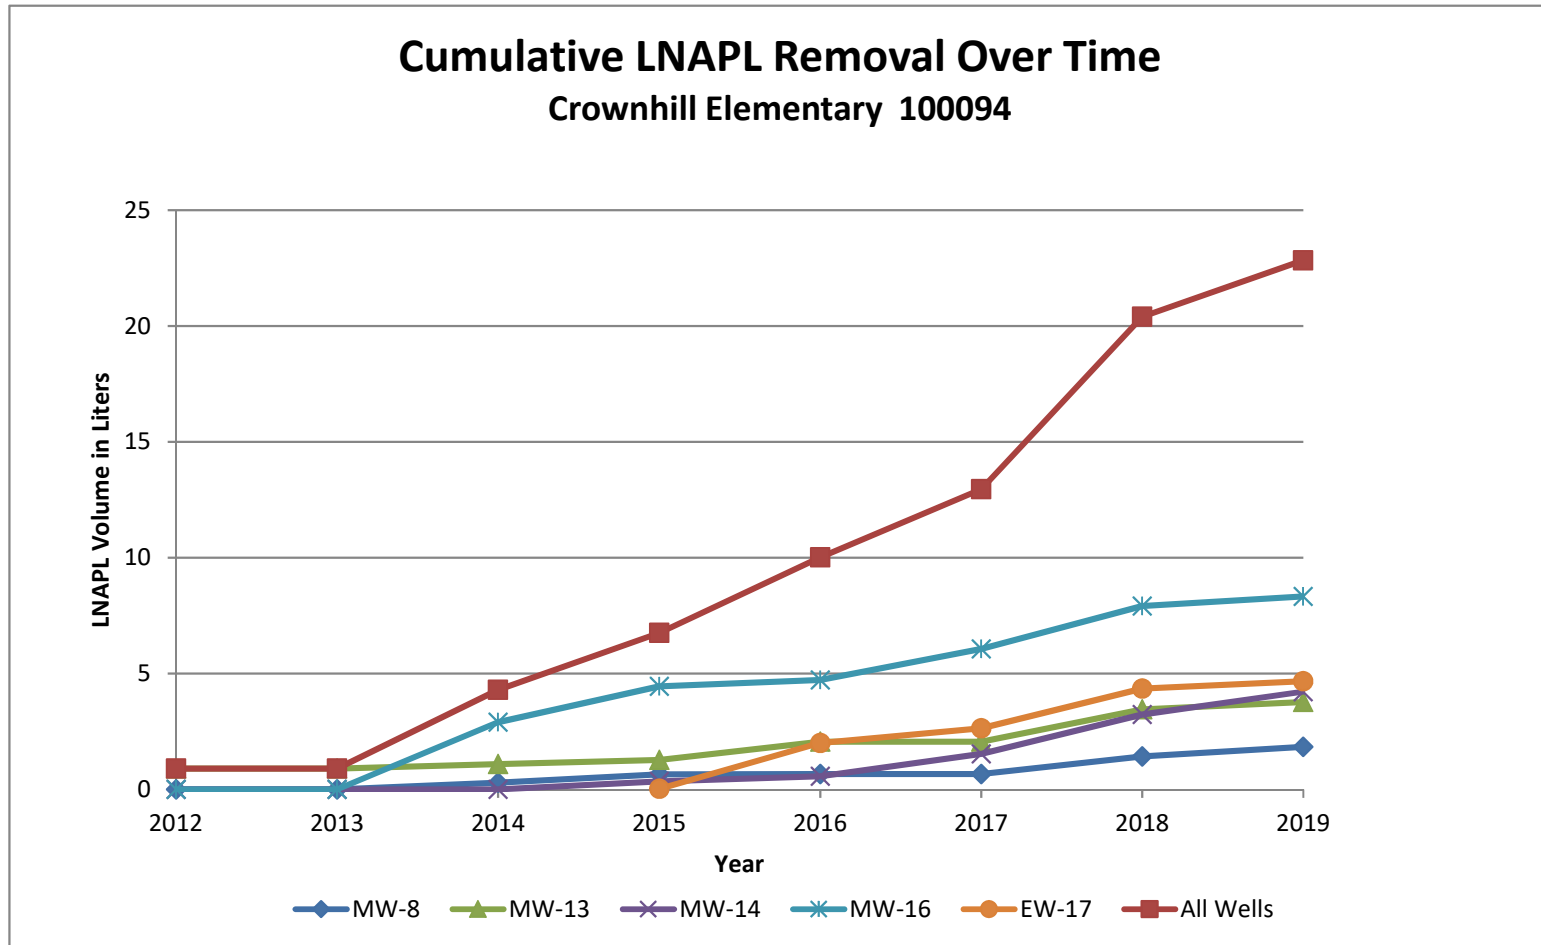
### Figure 3. Cumulative LNAPL Removal Over Time

Bottom-filling bailers are used to periodically remove LNAPL from Site wells. LNAPL removal is attempted whenever an LNAPL layer thickness of at least 0.3 foot is measured in a well (prior to bailing). In 2019, LNAPL removal was conducted concurrent with the two LNAPL thickness/groundwater monitoring rounds discussed above, in general accordance with the requirements of the *LNAPL Removal Work Plan* (Aspect, 2015b). Bailing was attempted from all five LNAPL-containing wells (MW-8, MW-13, MW-14, MW-16, and EW-17) in both the April and October rounds. Table 3 shows estimated LNAPL volumes bailed from each well during each removal event, and Figure 3 plots cumulative LNAPL removal on an annual basis. An estimated total of 2.44 liters of LNAPL was bailed in 2019. Since bailing began in 2012, an estimated total of nearly 23 liters of LNAPL have been removed.

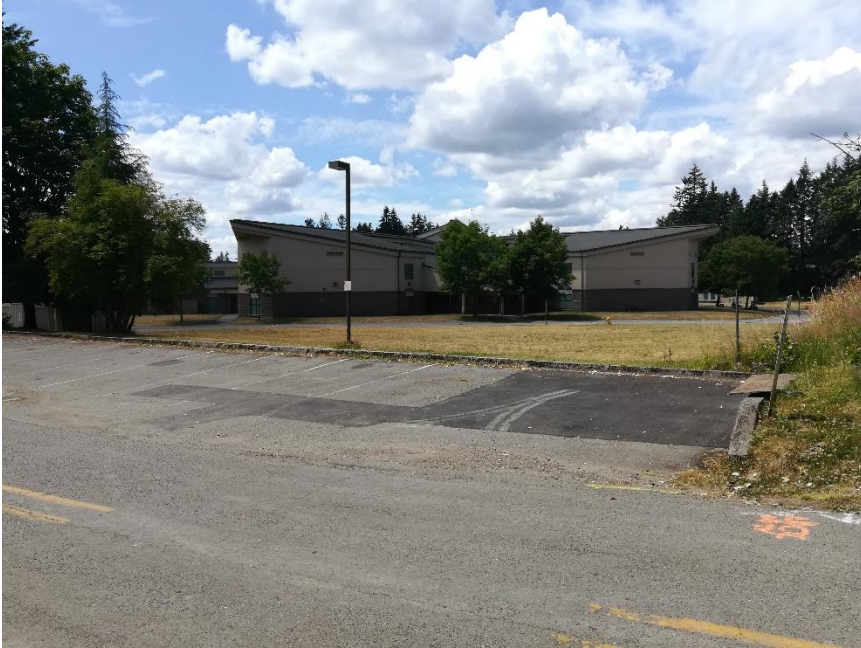
- Photo Location 1 – Pavement in the parking area along Bertha Avenue NW, where an RI soil sample collected from beneath the pavement (composite sample to 3-foot depth) contained lead at a concentration exceeding the cleanup level.

Photo Location 1, 6/25/19 site inspection

In July 2018, asphalt repairs were completed at three locations in the Bertha Ave NW parking area (Photo Location 1) after potholes were observed (documented in Aspect, 2019). The parking area appeared to be in excellent condition and the soil/sod cover at Photo Locations 2 through 4 appeared to be in good condition during both 2019 inspection events. The 2019 inspections did not identify any cover system deficiencies in other areas of the Site or other action items.

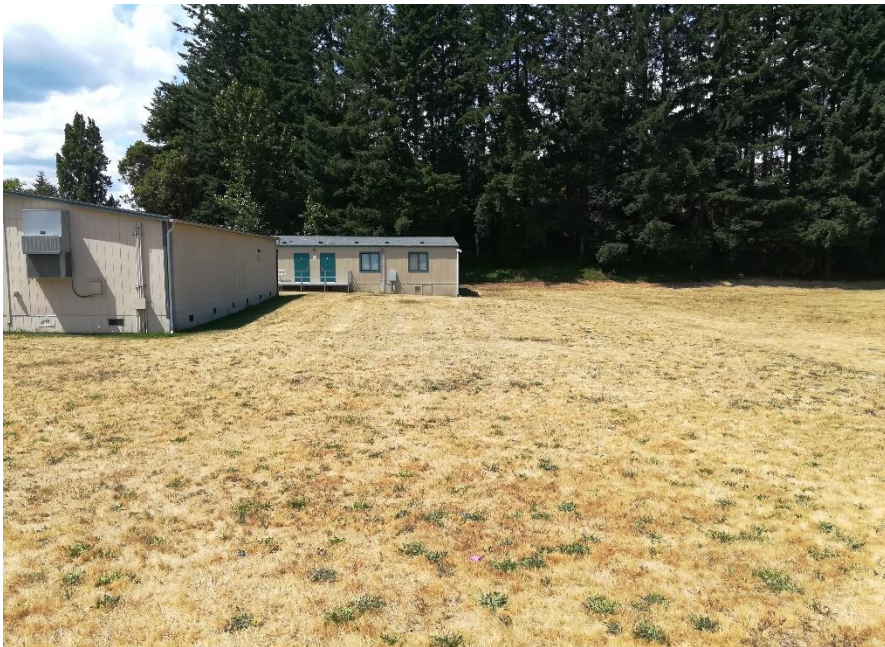
- Photo Locations 2 and 4 – Soil/sod covers next to the portable classroom building and in the southeast corner of the School property, where lead cleanup level exceedances were identified in soil samples collected from the 1- to 3-foot depth range. In summer 2013, these two areas were covered with a geotextile fabric (placed directly on the undisturbed ground surface) and an additional 1-foot thickness of fill soil was imported and hydroseeded to supplement the pre-existing clean soil cover layer.

Photo Location 2, 6/25/19 site inspection

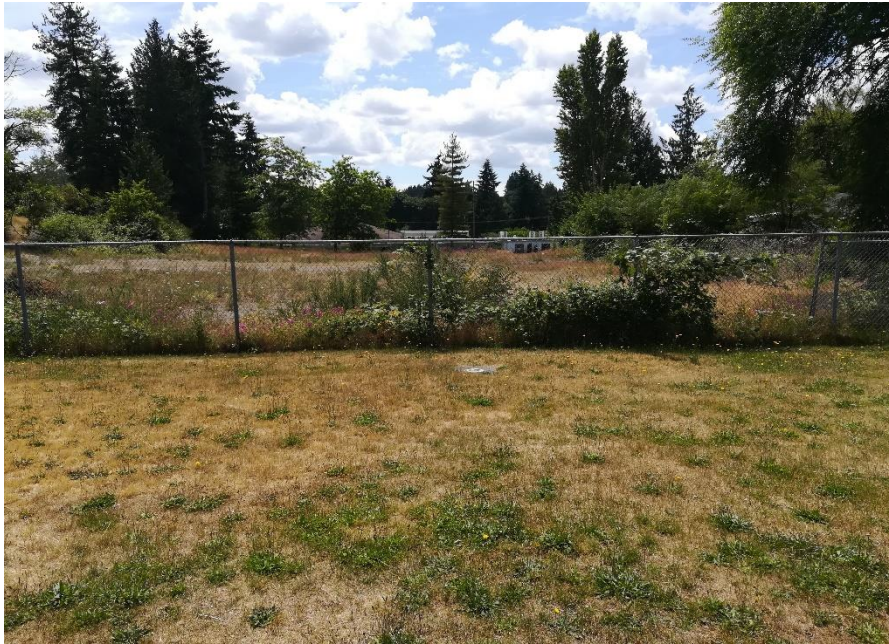
- Photo Location 3 – A soil/sod cover in the northwest corner of the BUMC property (and extending approximately 10 feet onto the School property), where an interim action was completed in spring 2012 in which contaminated surface soils were removed to a 1-foot depth, a geotextile fabric was placed on remaining contaminated soils, and a 1-foot thickness of fill soil was imported and hydroseeded.

Photo Location 3, 6/25/19 site inspection

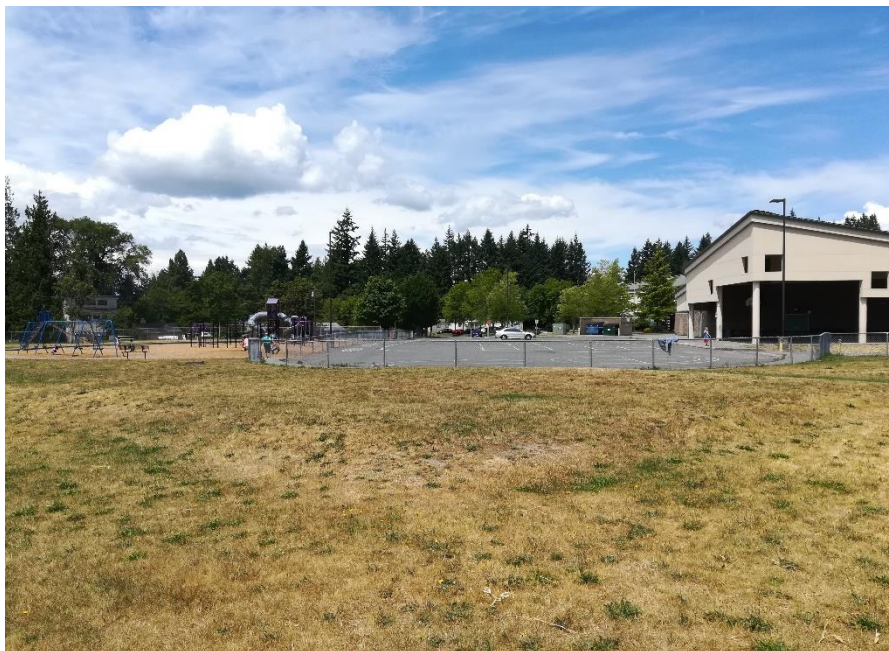
Photo Location 4, 6/25/19 site inspection

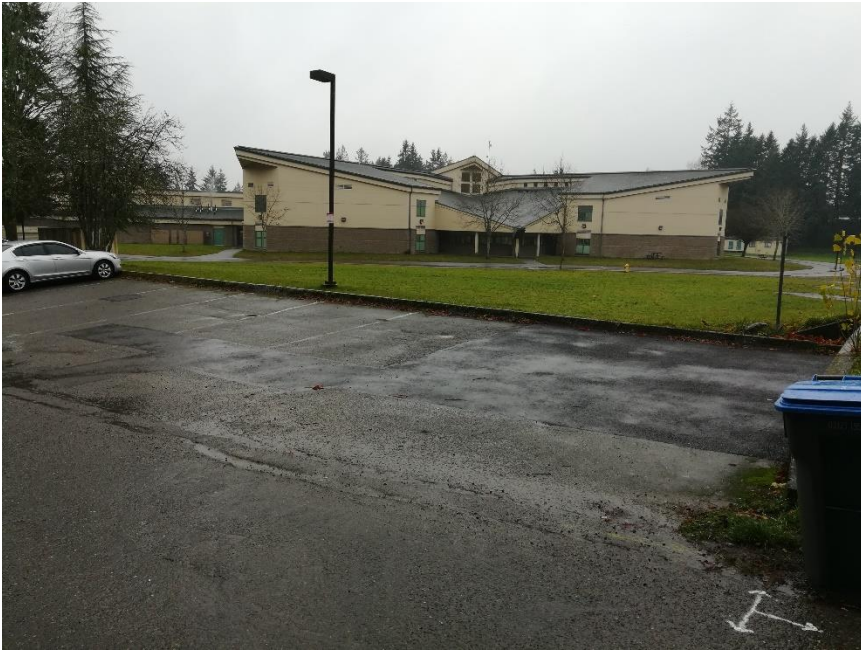
Photo Location 1, 12/11/19 site inspection

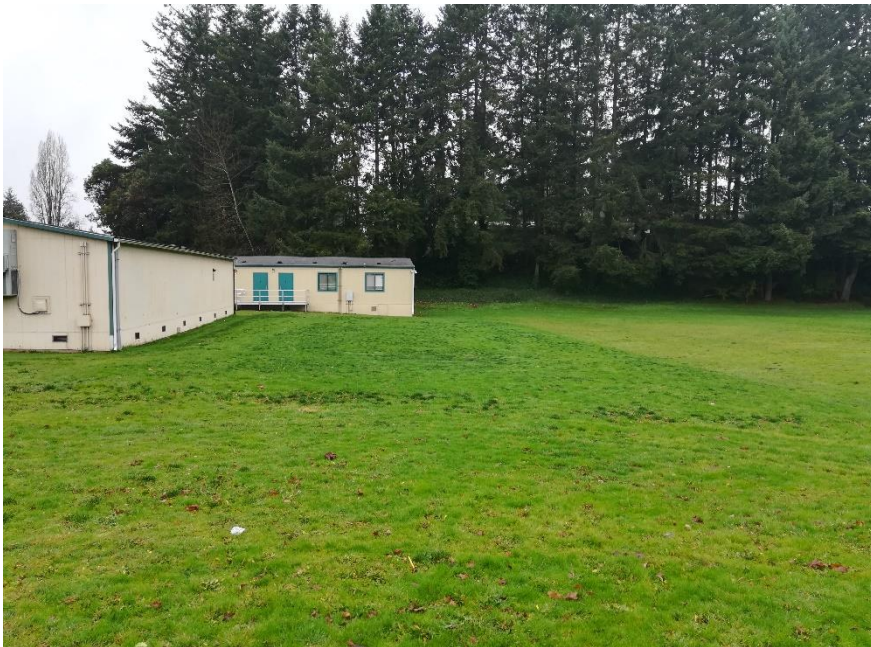
Photo Location 2, 12/11/19 site inspection

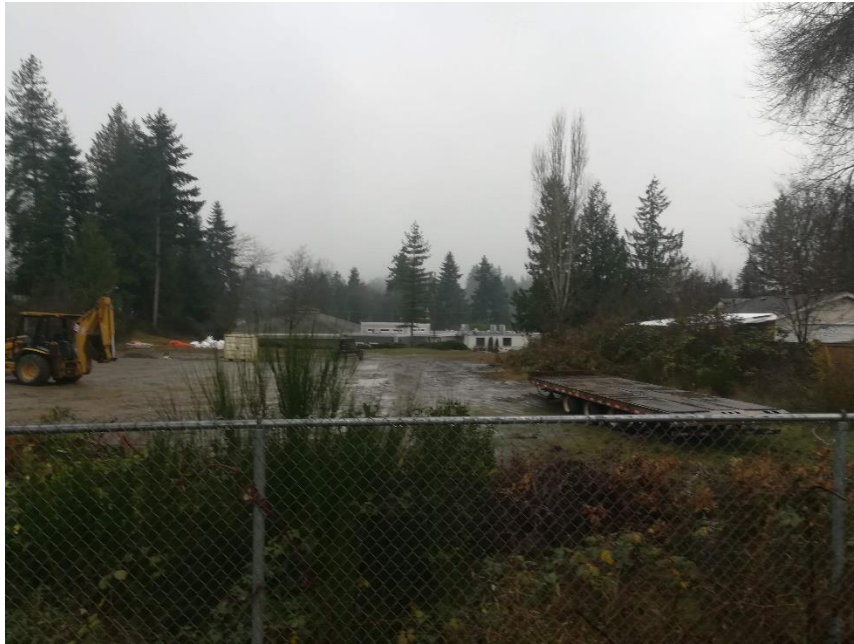
Photo Location 3, 12/11/19 site inspection

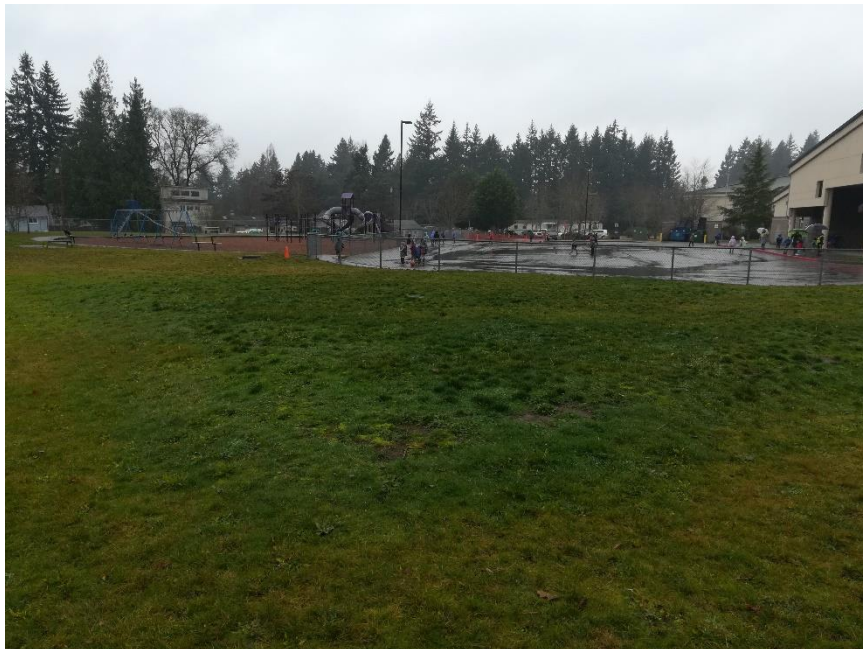
Photo Location 4, 12/11/19 site inspection
