INITIAL INVESTIGATION FIELD REPORT

<u>Site Name (Name over door):</u> A Ave Landfill	<u>Site Address (including City, State and Zip):</u> A Ave & 37th St Anacortes, WA 98221	<u>Phone</u> <u>Email</u>
<u>Site Contact, Title, Business:</u> Britt Pfaff-Dunton (Skagit County Public Health)	<u>Site Contact Address (including City, State and Zip):</u> 700 South 2nd, Rm 301 Mount Vernon, WA 98273	<u>Phone</u> (360) 416-1500 <u>Email</u> brittp@co.skagit.wa.us
<u>Site Owner, Title, Business:</u> City of Anacortes	<u>Site Owner Address (including City, State and Zip):</u> PO Box 547 Anacortes, WA 98221	<u>Phone</u> <u>Email</u>
<u>Site Owner Contact, Title, Business:</u> Jonh Lunsford, Parks & Rec Director City of Anacortes	<u>Site Owner Contact Address (including City, State and Zip):</u> 904 6th St Anacortes, WA 98221	<u>Phone</u> (360) 299-1953 <u>Email</u> jonnl@cityofanacortes.org
<u>Previous Site Owner(s):</u>	<u>Additional Info (for any Site Information Item):</u>

Based on a review of available information, I recommend rescinding the no further action determination. Additional surface water samples are needed to characterize the site. Recommendation: Re-list the Site on the Confirm

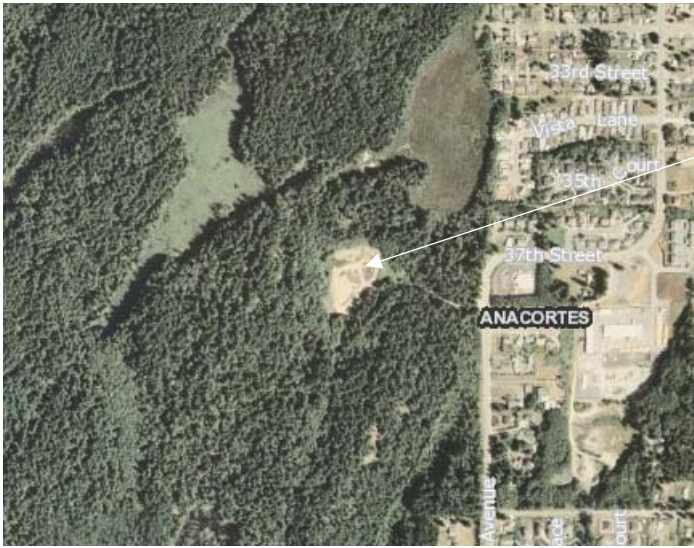
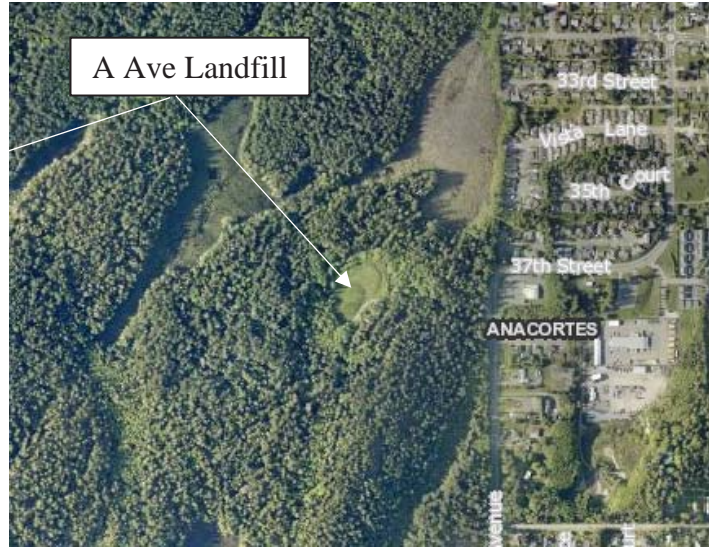
FIGURES 1-2: 2006 VS 2019 AERIAL PHOTOS OF A AVE LANDFILL

2006

2019

The A Ave. Landfill Site was a 1.58-acre, unpermitted landfill operated by the City of Anacortes that accepted (primarily) municipal waste until the 1970s (Figure 1 and 2). The waste material was burned onsite. Between then and 2006, the City of Anacortes used the property to temporarily store solid waste materials (including PCS, concrete, metals, yard waste, creosote railroad ties, etc.) until it was transported offsite. The property is currently owned by the City of Anacortes and is designated as Anacortes Community Forest Lands, a forested area with multiple trails. The main portion of the former landfill was originally "capped" with about two feet of soil but waste material (such as tires, appliances, glass and other solid waste - Images 3 through 6) extends down steep slopes (Image 7) into forested wetlands surrounding the landfill, especially on its western flanks. Based on 1990s assessment work, Skagit County Public Health (SCPH) does not believe there are methane concerns at this site.

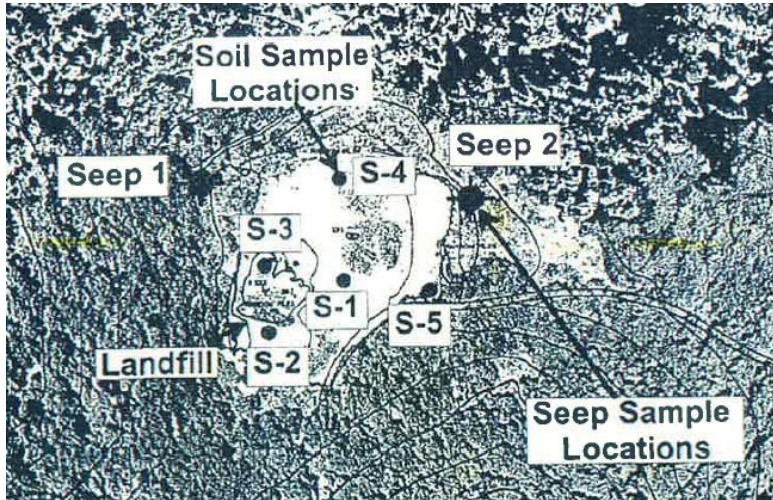
FIGURE 4: 2003 SAMPLE LOCATIONS

The Site was placed on the CSCS List in 2003 after SCPH conducted an initial investigation, which included surface soil and surface water sampling (Figure 4). Five soil samples were collected by Geomatrix from the landfill's cap and analyzed for TPH, total metals and SVOCs. TPH was detected in three samples with one exceeding Method A cleanup levels (2970 mg/kg). Two surface water seep samples were collected from the NW and NE sides of the landfill and analyzed for VOCs, total metals and other physical and chemical properties. With the exception of manganese and p-isopropyltoluene in the NE sample, concentrations did not exceed Method A or B cleanup standards. No groundwater sampling has been conducted and no samples have been analyzed for PAHs, a by-product of burning solid waste.

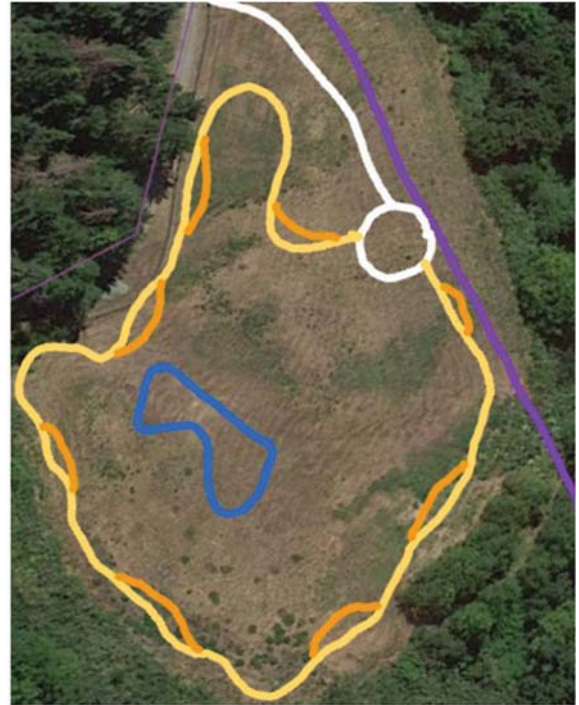
FIGURE 5: PROPOSED BIKE SKILLS PARK ROUTES

In 2019, City of Anacortes received a proposal to construct a bike skills (consisting of multiple courses) park on the landfill (Figure 5). The project would include importing up to 450 cubic yards of soil and gravel to construct the skills course on top of the 1.58 acre "impervious" cap. The proposal noted "no new impervious surface would be added." The project would also include maintaining grassy areas to filter stormwater runoff from the cap, hydroseeding steep slopes, maintaining all native vegetation, and installing metal fencing along the wetland buffer lines, where no fence currently exists.

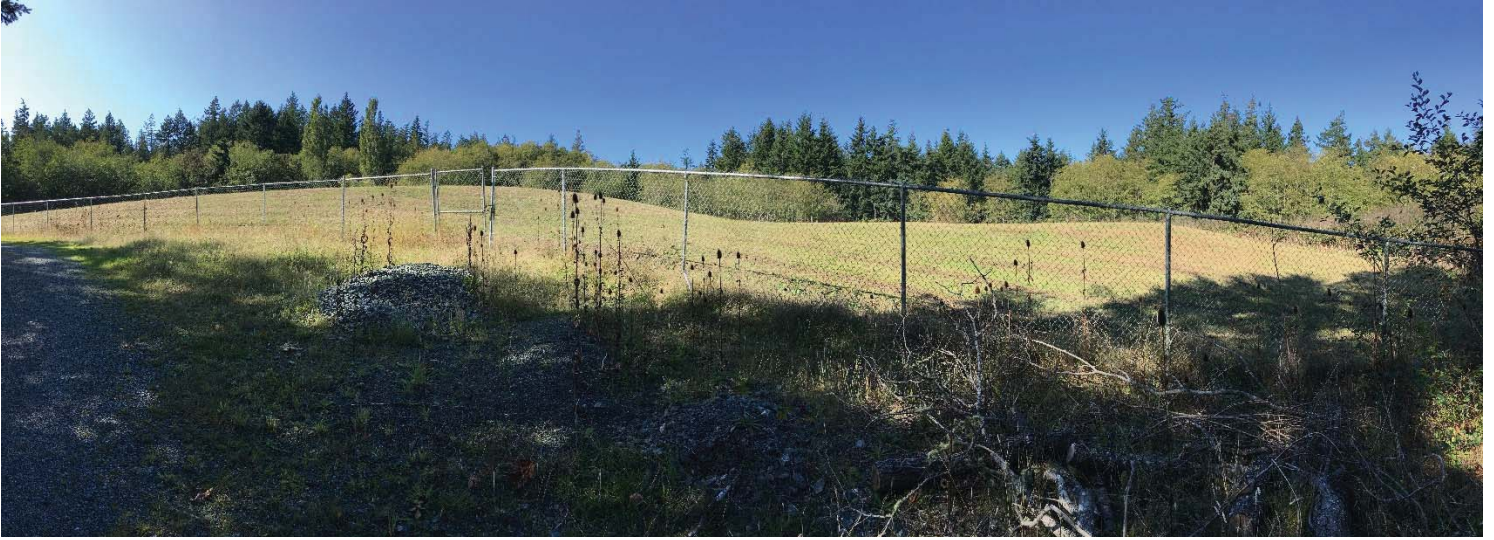
IMAGE 1: CURRENT LANDFILL CONDITIONS (TAKEN FROM POSITION #1 IN FIGURE 5)

The closure plan also required maintaining the existing fencing (Figure 6), hydroseeding the cap (Images 1 and 2), minimizing access by the public and 5- and 10-year sampling events. Samples were to be analyzed for pH, metals, nitrates, nitrites, sulfides, low level vinyl chloride and VOCs. During the 2014 5-year sampling event, the seeps were dry and no sampling was conducted by SCPH. City of Anacortes and SCPH will coordinate the 10-year sampling event during the 2019-2020 winter season.

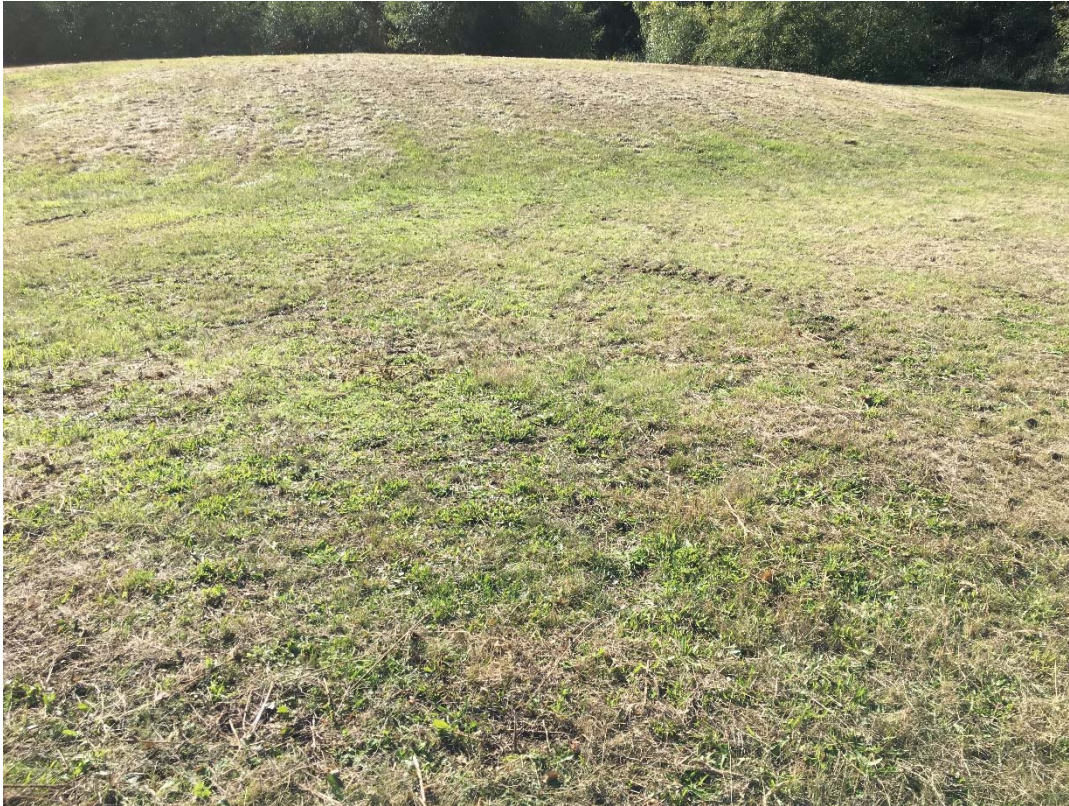
IMAGE 2: CLOSE-UP OF LANDFILL COVER (FROM POSITION #2 IN FIGURE 5)

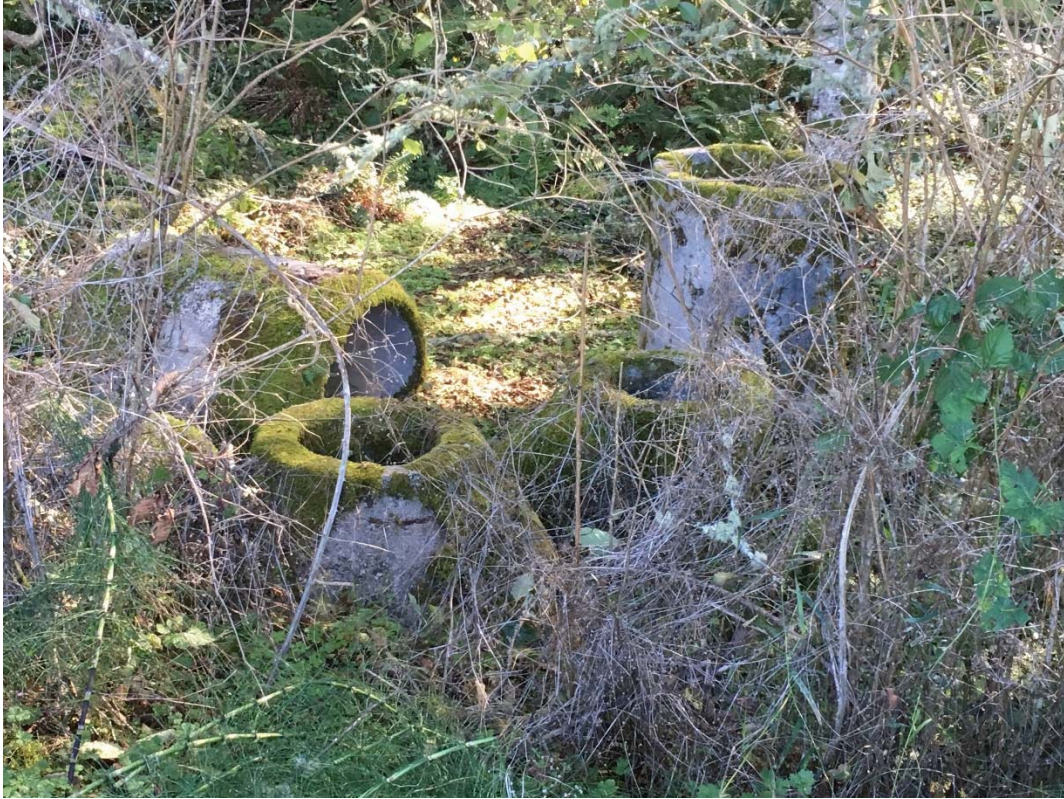
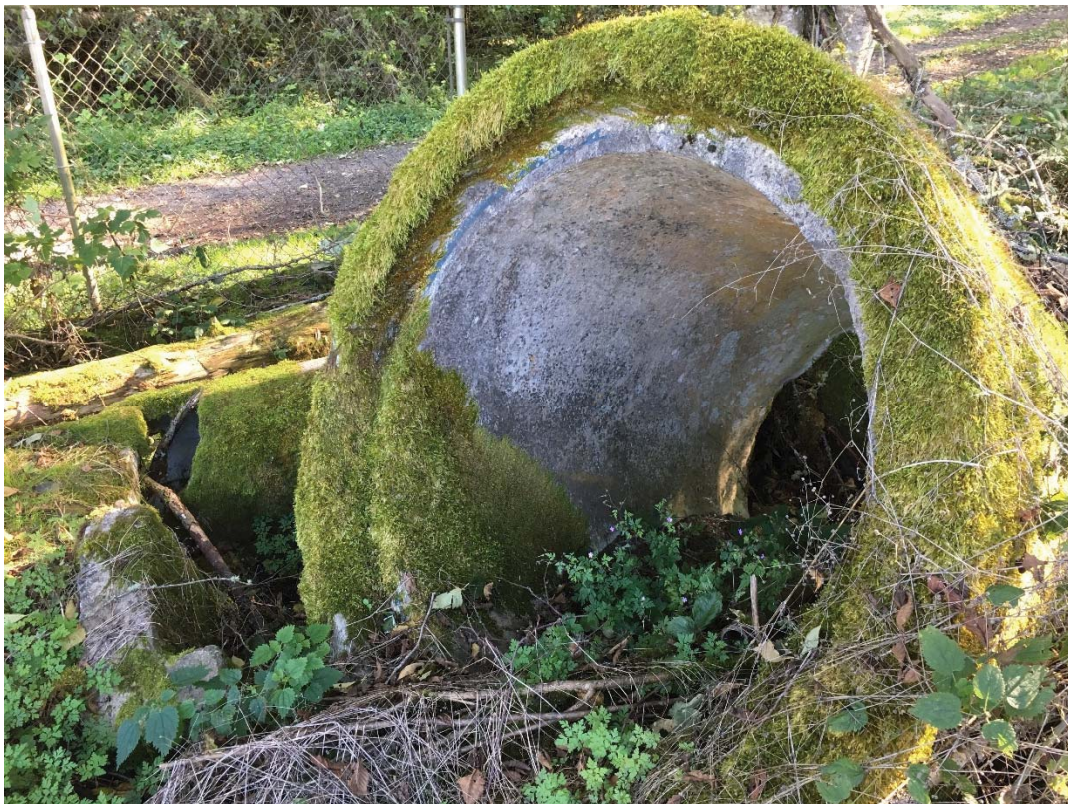
IMAGE 3-4: REMAINING DEBRIS ON WEST SIDE OF LANDFILL (FROM POSITION #3 IN FIGURE 5)

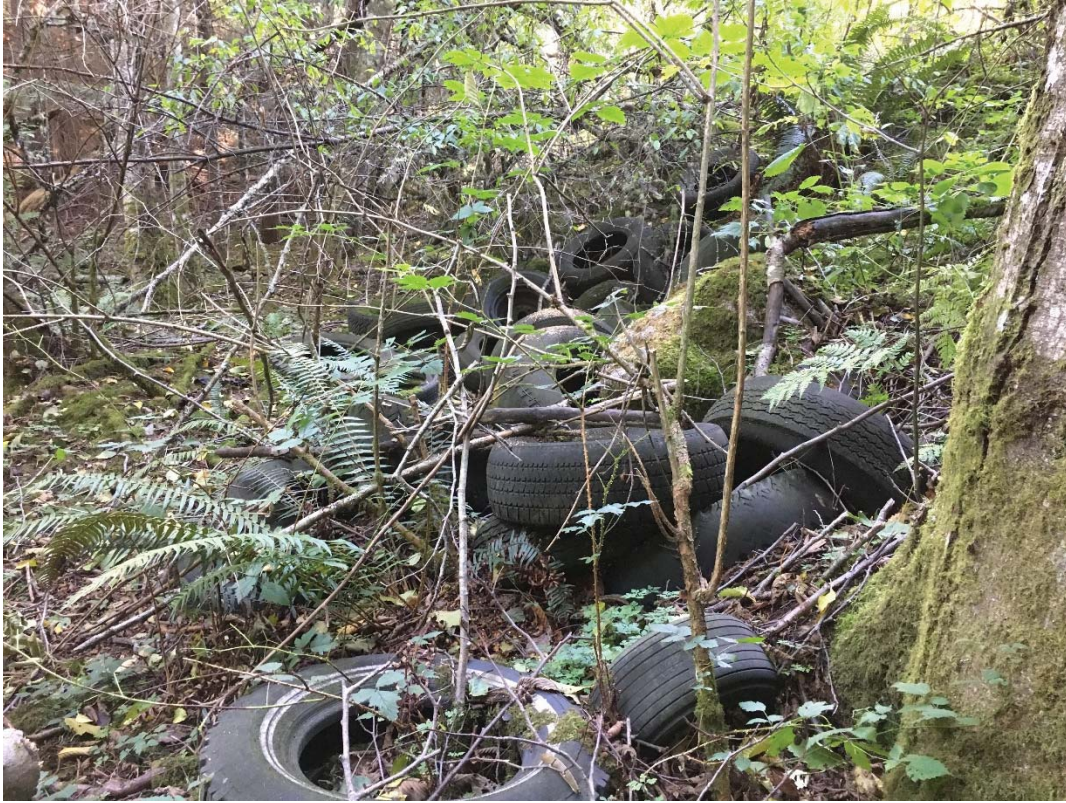
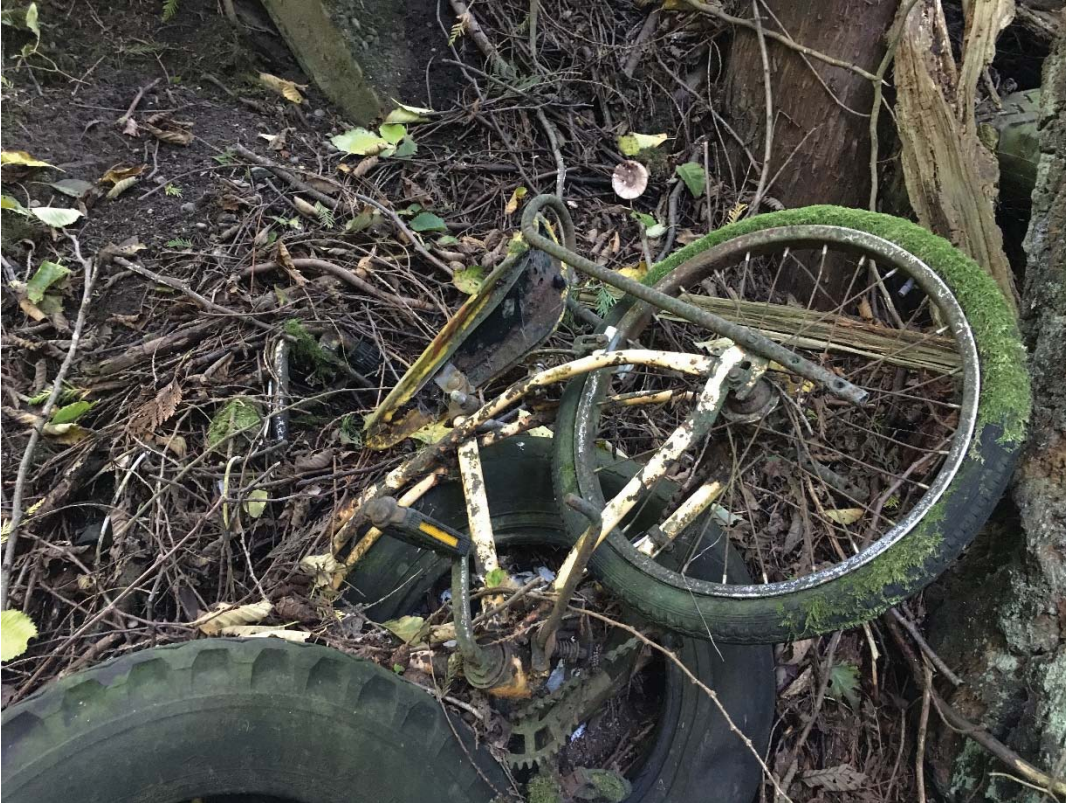
IMAGES 5-6: REMAINING DEBRIS ON NORTHWEST SIDE OF LANDFILL (FROM POSITION #4 IN FIGURE 5)

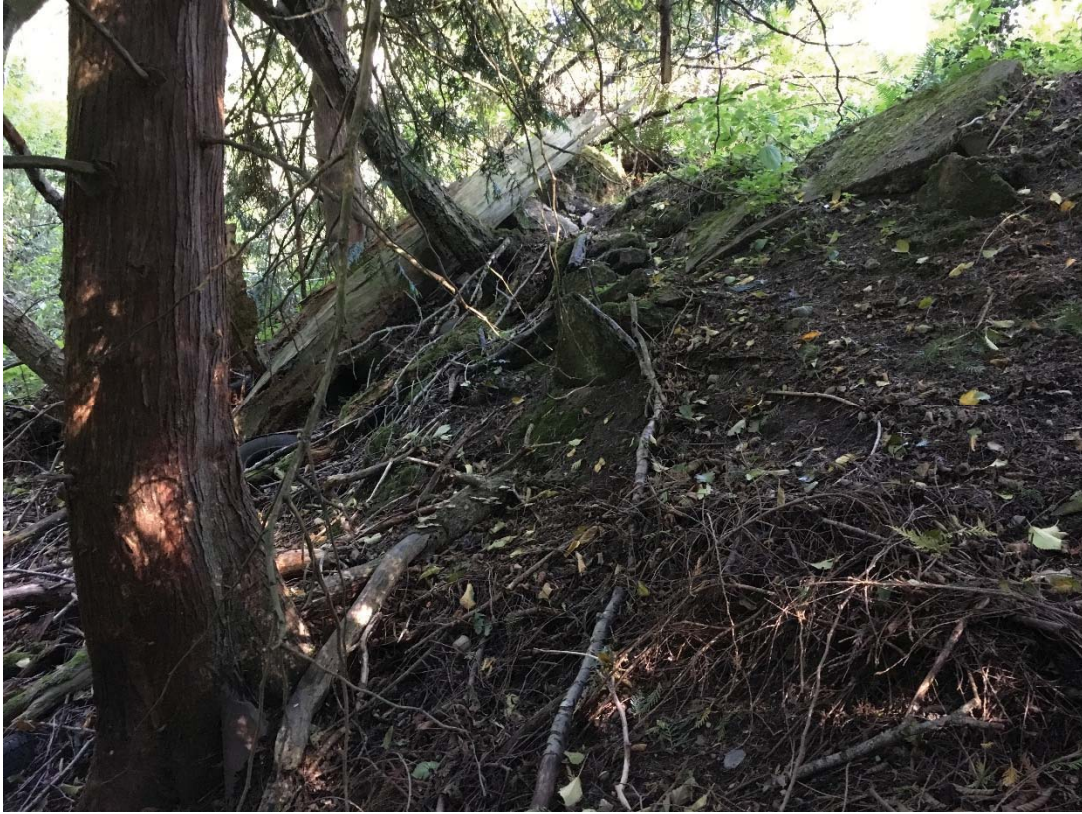
Currently, access to the capped landfill is limited by a fence running the length of the access road and extensive blackberry bushes and/or steep slopes along the rest of the landfill's perimeter. There are no formal restricted uses on the property but SCPH oversees activities at the former landfill and would be closely involved if changes to the property were proposed by the City. SCPH has informed City of Anacortes that if the bike park is constructed, the City must maintain the cap integrity and not add any additional water load or erosional impacts to the site. The area is currently designated as a city park.

IMAGE 7: STEEP SLOPE OBSERVED AROUND LANDFILL WITH DENSE VEGETATION AT LANDFILL GRADE
